**Model Year 2002-2006 BMW X5, 3 and 5 Series  
Driver's Front Air Bag Module  
Safety Recall 15V-318  
Last updated: 11/29/2016**

RE: B651115: Recall Campaign 15V-318: Driver-Side Front Air Bag Module (Final Repair)

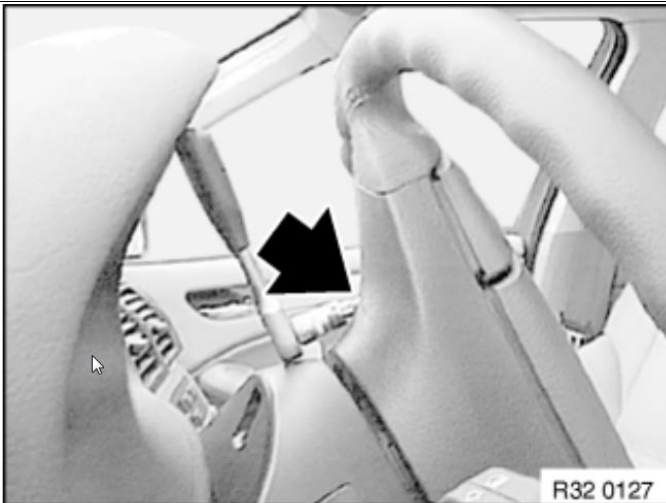
- Release screws on both sides (Torx socket T30).

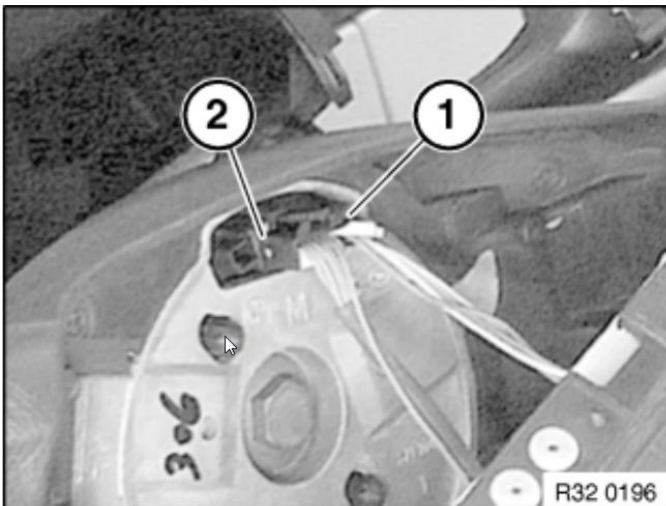
- Tilt airbag unit forwards.
- Disconnect plug connections (1, 2) and remove airbag unit.

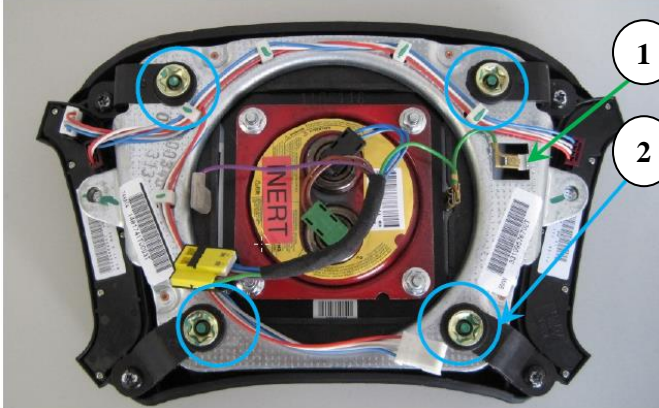
- Pull the ground connector (1).
- Remove 4 bolts holding the horn ring (9.7x11.4 with Torx 55 (2)).
- Watch the 4 springs under bolts.
- Remove the contact ring with MFL from air bag module.

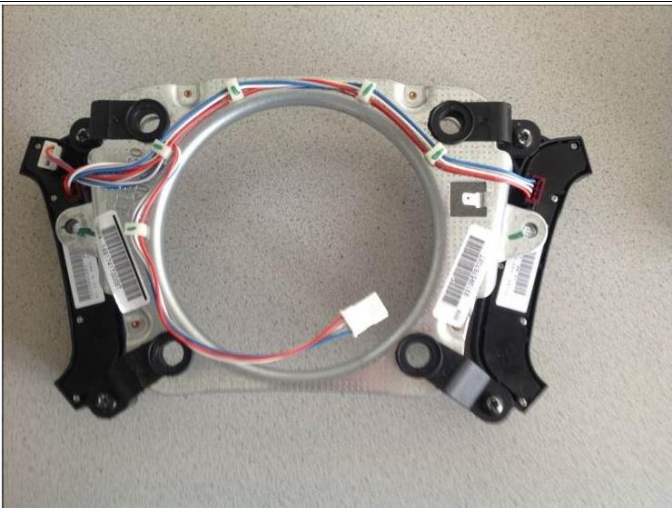
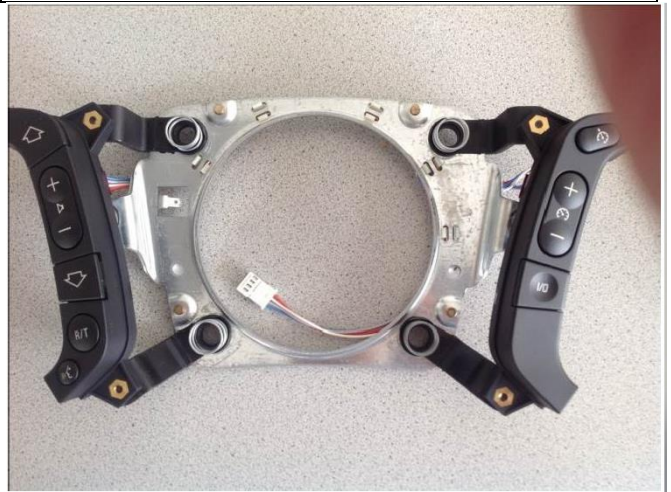
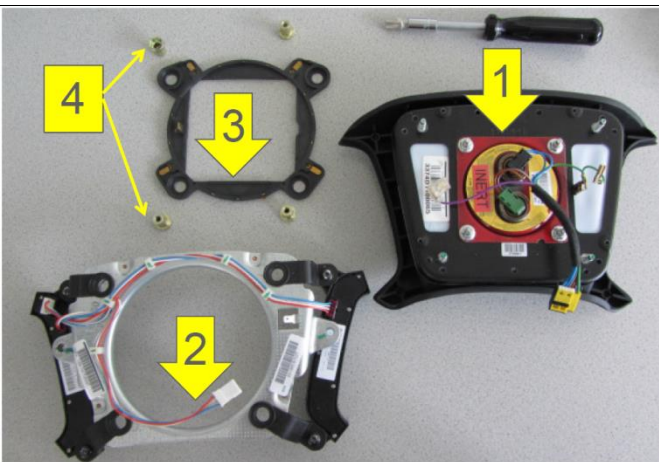
After disassembly:

- 1- Module
- 2- Horn Ring with MFL
- 3- Horn contact path
- 4- Torx bolt

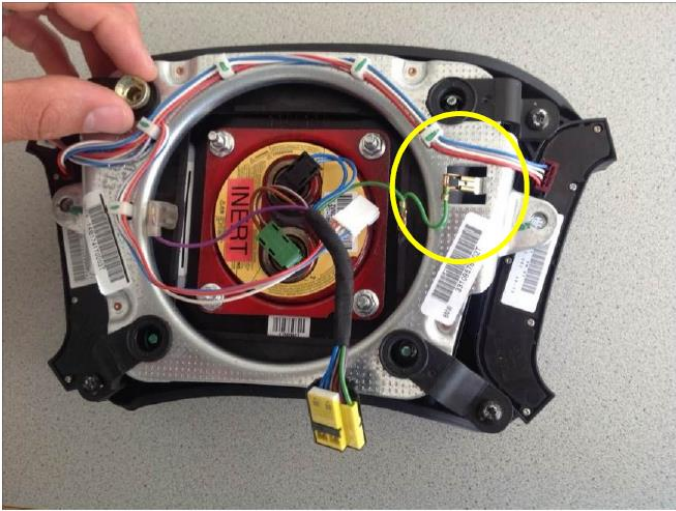
- Reinstall the contact ring with MFL to the new replacement air bag module.
- Tightening torque for the contact ring bolts is  $5 \pm 0.2$  Nm.
- Reconnect the horn ground cable.

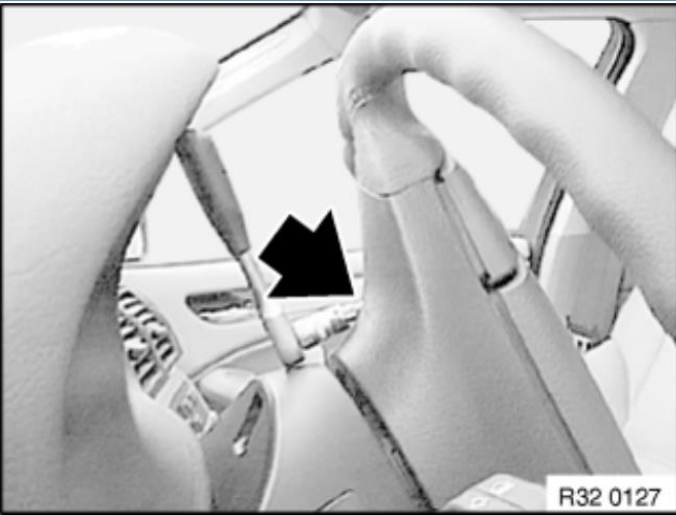
- Make sure electrical leads are correctly positioned and connected.
- Tightening torque:  
E39 / E46 2 Nm  
E53 8Nm
- Reconnect the battery and recheck operation and function.
- Use the same box and follow the return procedure attached to the SI.

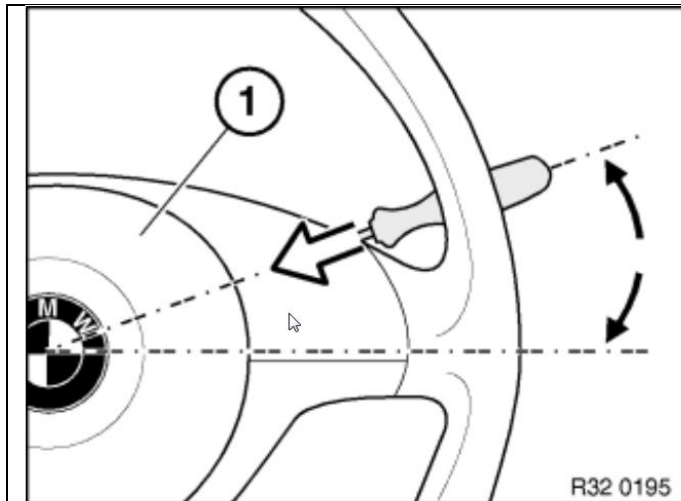
- Insert a screwdriver through the opening on the rear side of the steering wheel and press on the lock.
- In the event of a spring resistance, press the lock up to the limit position and simultaneously pull away the airbag unit (1) from the steering wheel.
- Repeat the process on the opposite side.

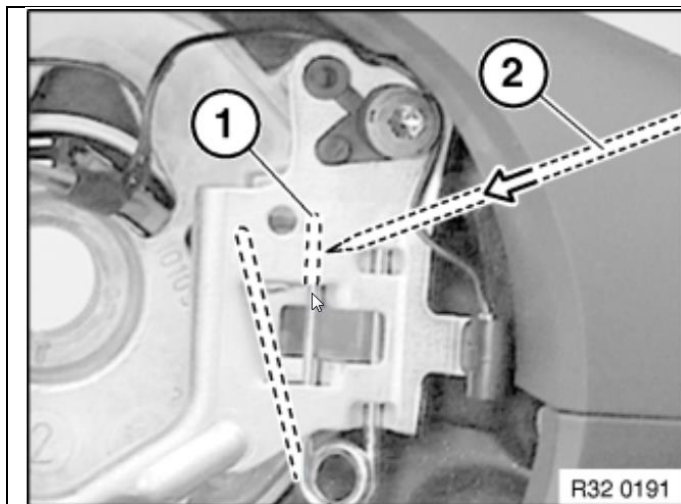
- This photo is illustrated without the airbag unit to make it clearer and shows the spring location behind the air bag.
- Use the screwdriver (2) to press on the lock (1).

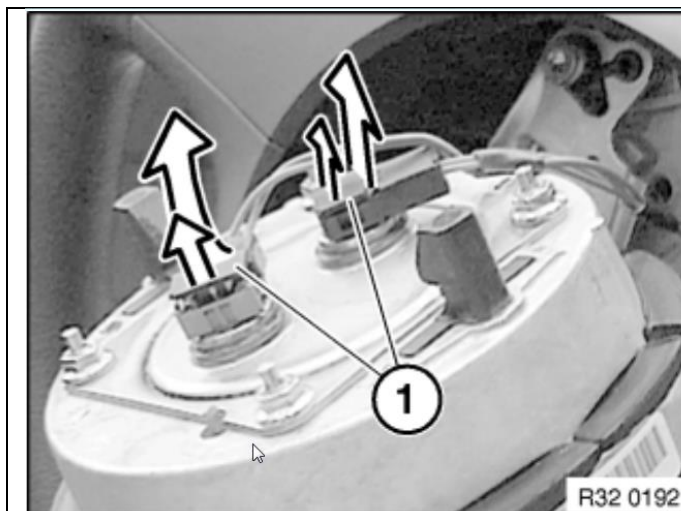
- Open the locks (1) and pull off the connector.
- Remove airbag unit.

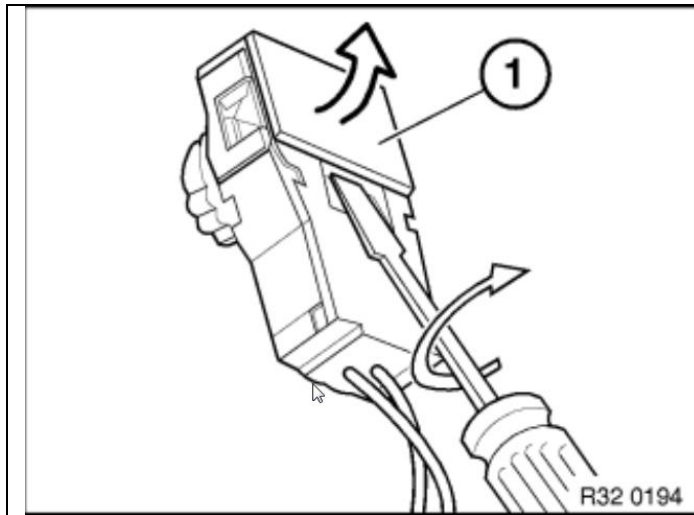
Unlocking the airbag plug connection:

- Lever out the lock (1) with a screwdriver.

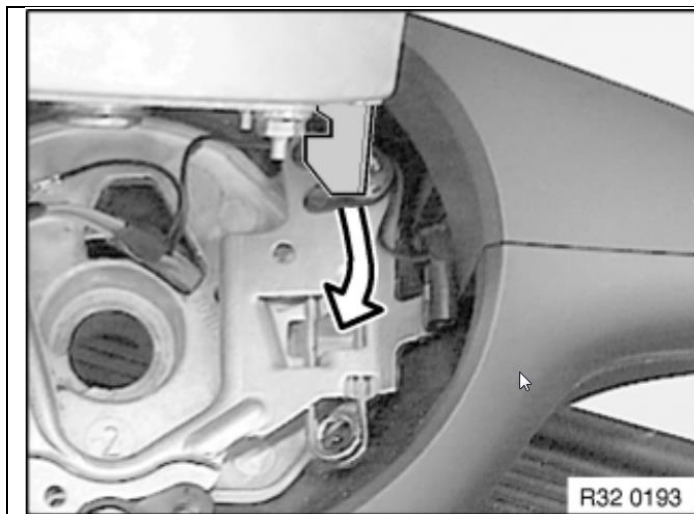
- Make sure electrical leads are correctly positioned.
- Insert the airbag unit into the locks with the hooks and press it into the steering wheel.
- Reconnect the battery and recheck operation.
- Use the same box and follow the return procedure attached to the SI.
