# Product Safety Recall

## 15040 Front Passenger Air Bag Inflator

**Release Date:** November 2018

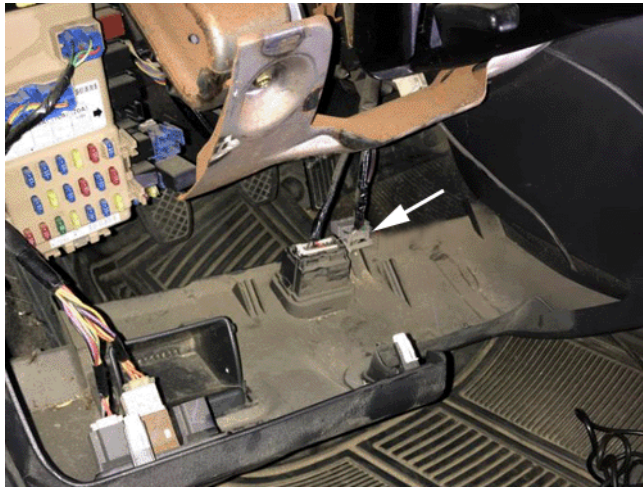
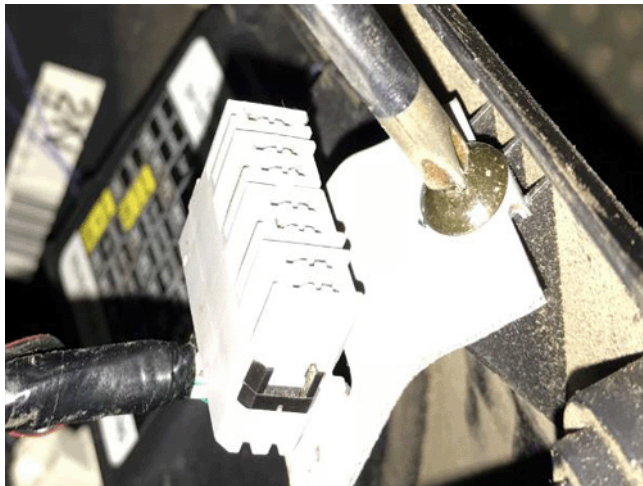
1.3 Locate the B79 Check Connector near the OBDII connector.

1.4 Disconnect the two connectors to the switches on the left side of the panel to provide additional clearance.

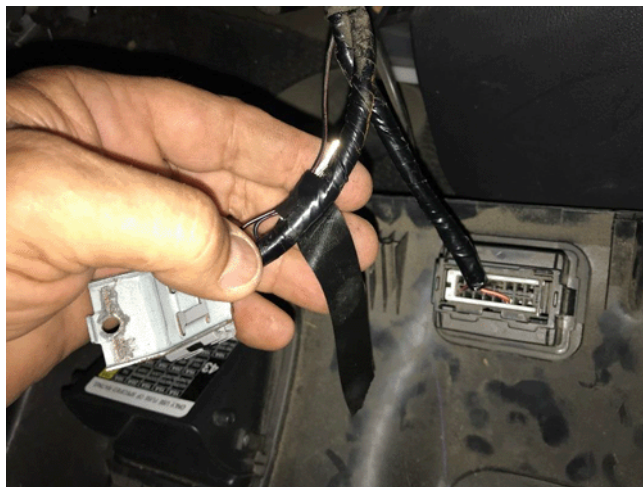
5145816

- 1.5 Carefully rotate the panel counter-clockwise to remove the B79 Check Connector screw. Leave the OBDII connector attached to the panel.

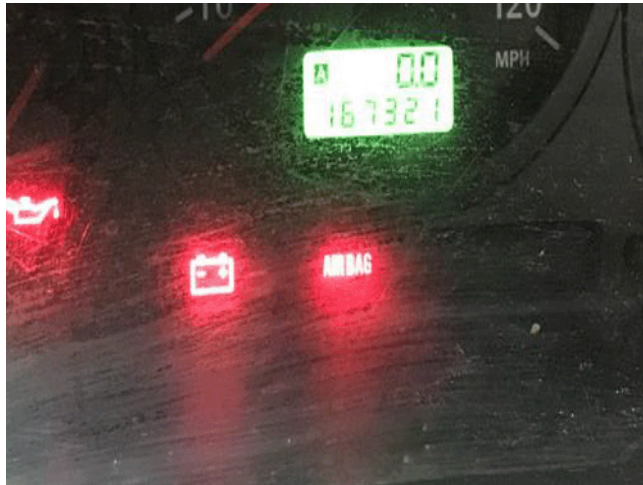
5145828

- 1.4 Watch the "AIRBAG" warning light in the cluster. It will begin to blink.
- 1.5 The long segments (1.2 seconds on) indicates a "ten", and the short segment (0.3 seconds on) indicates a "one". The warning light flashes a code corresponding to the fault.
- 1.6 There will be a brief pause approximately 6 seconds long between each DTC (No Light).
- 1.7 Read all codes until they begin to repeat. Write down all the codes.
- 1.8 See **DTC Code Listing chart – Table 1** at bottom of document for DTC code descriptions.

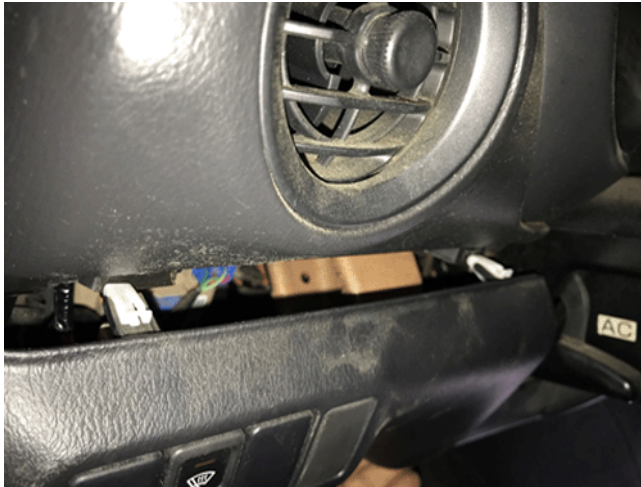
5145832

- 1.7 Rotate panel back to correct orientation.
- 1.8 Carefully line up the 3 upper clips that hold the panel on.

- 1.9 Snap the trim panel back into place.
- 1.10 Reinstall the 3 Phillips screws.
- 1.11 Turn Ignition Switch on.
- 1.12 Verify that the "AIRBAG" warning light comes on for 3 seconds and then goes out.

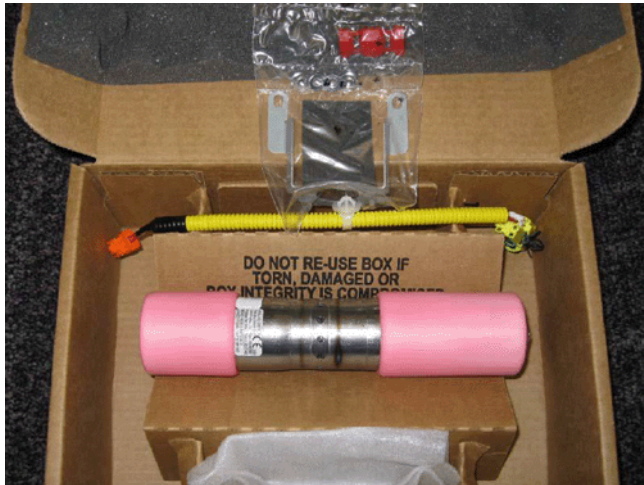
5145838

6. Open the front passenger air bag inflator kit box and confirm all the necessary components are included:
- 4 Self-Locking nuts
  - New Type 2 Inflator (pink collars on each end identify it as the replacement part)
  - New Inflator Harness
  - New Stopper Plate
  - Electro-Tap (red shorting crimp connector)
  - 1 ½" X 2 ¼" piece of self-adhesive Sponge Tape
  - Shipping Documentation and Instructions

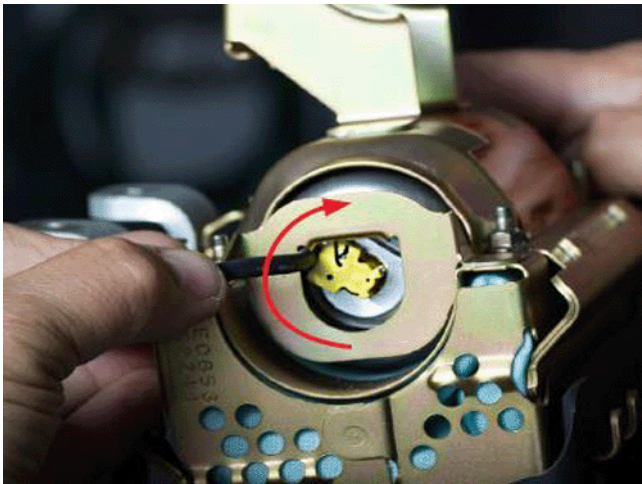
5145849

12. With the stopper plate removed and the other 2 self-locking nuts loosened, unseat the inflator off the mounting bracket end plate then rotate it slightly **CLOCKWISE** to make it easier to remove as shown in the photo to the right. Slide the inflator out of its mounting while feeding the cut off portion of the wiring harness through the “D-Shaped” hole in the end of the mounting bracket. **NEVER ATTEMPT TO REMOVE THE HARNESS FROM THE INFLATOR!**

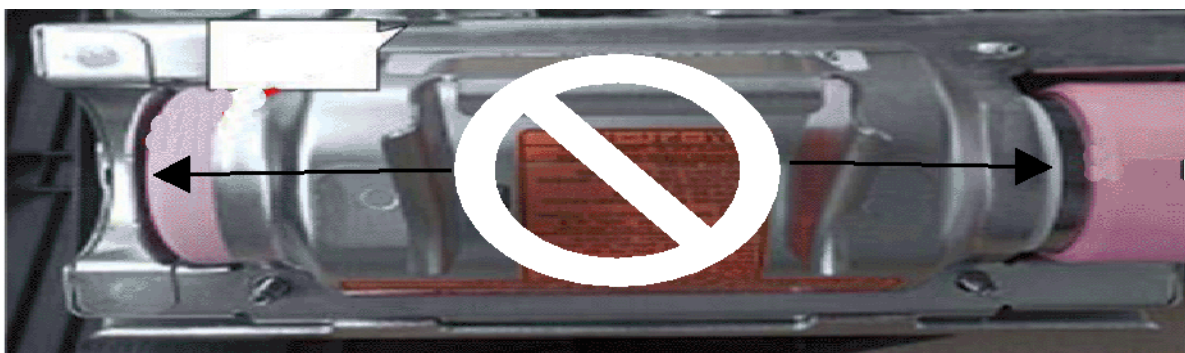
15. Inspect the new **Type 2** inflator to confirm the locating protrusions on each of the pink-collar portions are aligned as shown below. The “short” collar can be rotated as needed to align it with the protrusion on the “long” collar if necessary.

**NOTE:** The Type 2 inflator is installed in the opposite direction of the original. This change puts the connector on the other end. The new harness has been extended approximately 2” to compensate.

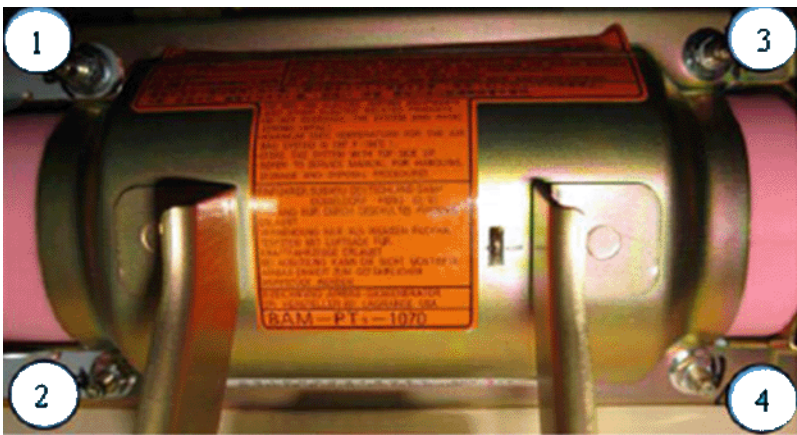
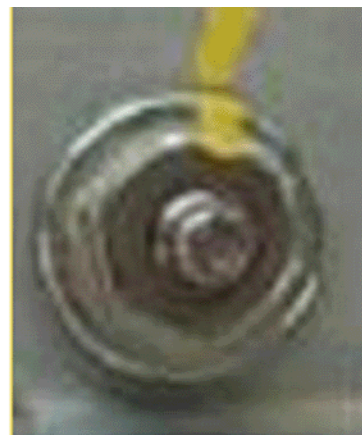
5145865

17. Install the new stopper plate over the harness connector end of the new inflator.

18. Remove the 2 nuts still installed on the mounting bracket and replace them with 2 **NEW** self-locking nuts. Once all 4 **NEW** nuts are in place, torque to 31-38-inch pounds in the new sequence shown below. Use a marker to mark the nuts after torquing indicating they have been fully tightened.

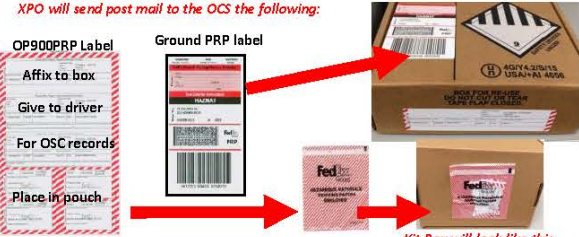
- Peel off the backing of the FedEx Ground PRP Shipping label and **affix to top of each box to left of the Class 9 label (see below)**
  - Use the scribe line on the box as a guide.
  - The FedEx Ground PRP Shipping label must not touch any portion right of the scribe line.
- OP900PRP label is a multiple part label, please see below for further instructions**
- A single combined shipment of your individually labeled boxes will **be scheduled by XPO (Example: one shipment of 9 boxes)**
- Do Not** contact FedEx **unless you are instructed to by XPO.**

*Kit Box will look like this*
