## PRODUCT CAMPAIGN BULLETIN

**APPLICABILITY:** 2003-2004 Baja  
 2003-2008 Legacy and Outback  
 2004-2005 Impreza, WRX, STI

**SUBJECT:** Takata Front Passenger Air Bag  
 Inflator Replacement

**NUMBER:** WQR-53R

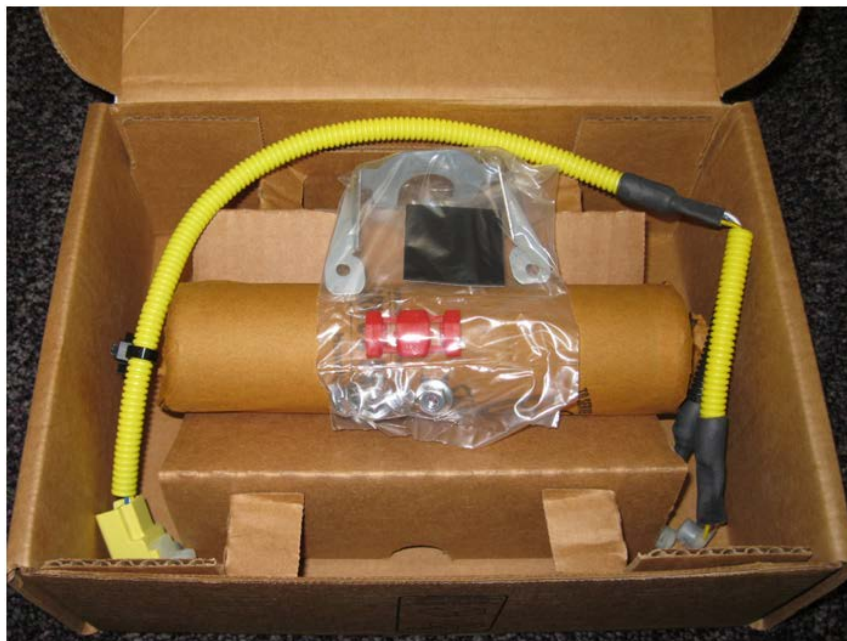
**Open the Kit Box and confirm all the necessary components are included**

- 4 Self-Locking nuts
- New Inflator (yellow tape applied to one end to identify it as the replacement part)
- New Inflator Harness
- Electro-Tap (red shorting crimp connector)
- New Stopper Plate with D-Shaped hole
- Self-Adhesive Foam Protector
- Shipping Documentation

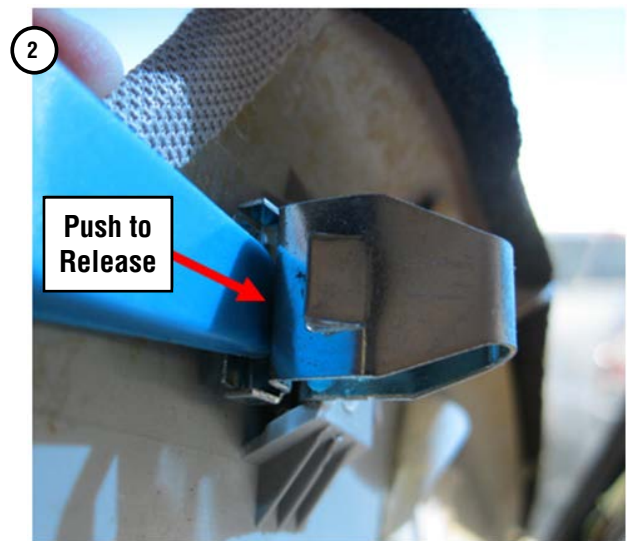
To access the passenger's airbag module, the complete instrument panel assembly must be removed. Follow the procedures in the applicable Service Manual for removing the instrument panel assembly in addition to the necessary related interior trim components.

**NOTE:** When removing the “A” pillar trim, be **VERY CAREFUL** not to damage the upper metal retaining clip. The clip is located just below where the trim panel meets the head liner. If the metal retaining clip becomes damaged or separated from the trim panel, the trim panel **MUST** be replaced as the clip is not available separately. Use a plastic trim tool to push and release the upper portion of the metal clip from the body. Be careful to not pull the trim panel open any further than necessary to gain access for releasing the clip. There is a plastic retaining clip in the lower portion of the trim panel which will release easily once the upper retaining clip is loose. At reassembly and using a plastic trim tool, make sure the inner lip of the door weatherstrip overlaps the outer fabric edge of the trim panel to help secure it.

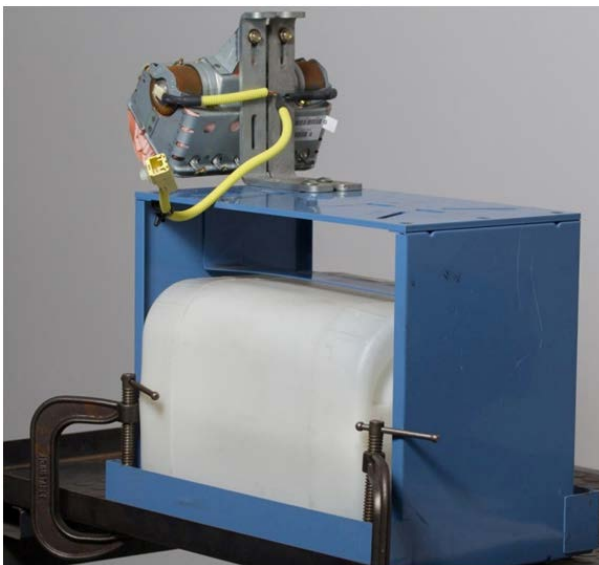
**IMPORTANT: The removed airbag module must be mounted to the Airbag Deployment Fixture (part number J-39401-B) as shown in the photo below to better secure it during the inflator and wiring harness component replacement procedures.** When mounting the module to the fixture, pay close attention to the harness routing as shown in the photo below. Always perform this work in an area away from others to reduce chances of inadvertent injury should any deployment occur. Take your surroundings into account to avoid possible hazards should inadvertent deployment occur or sources of static or other electricity that could potentially induce such a deployment.

**STEP 2-** Remove both sides of the harness from the retainer bracket holders then secure the airbag module to the Airbag Deployment Fixture as shown in the photos below.

**IMPORTANT NOTE:** The photos available at the time of this procedure’s preparation do not show the removed airbag module assembly as being secured to the J-39401-B Airbag Deployment Fixture during inflator replacement. Subaru of America, Inc. **STRONGLY RECOMMENDS ALWAYS** utilizing a J-39401-B fixture whenever performing **ANY** airbag inflator replacement service procedure.

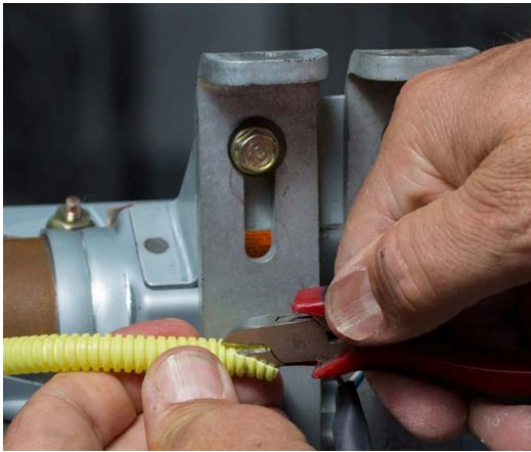
**STEP 3- CAREFULLY** cut the yellow harness cover (approximately 1 1/2 inches) enough to expose the 2 yellow and red wires inside and provide enough room to install the Electro-Tap (shorting) connector using a scissor or wire cutter (no knives or razors).

**TAKE YOUR TIME AND BE CAREFUL TO NOT CUT THE 2 WIRES!**

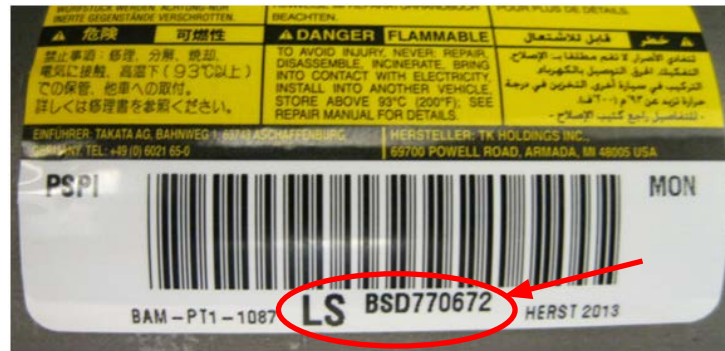
**STEP 7 - VERY IMPORTANT:** Record the **11-digit alpha-numeric serial number** for **both the new and the removed inflators** on the hard copy of the Repair Order. This information will be required for completion of the Part Return Notice which will be forwarded by the retailer to the PCC.

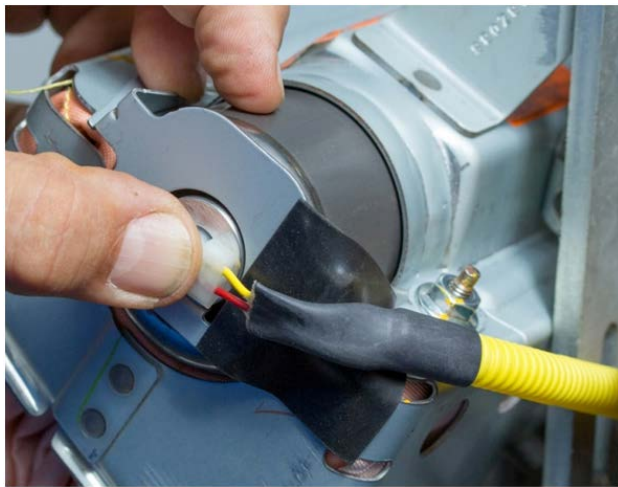
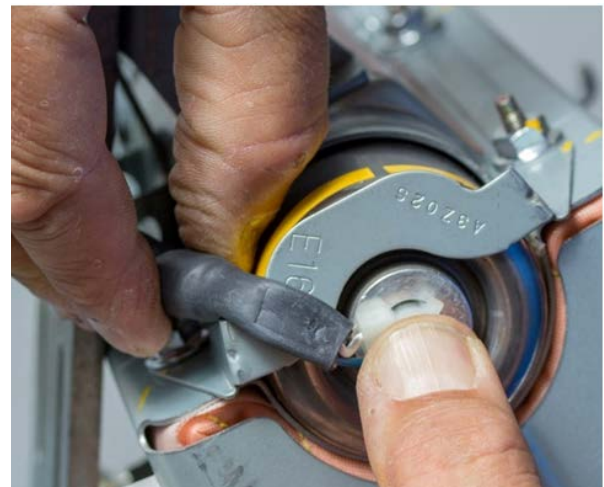
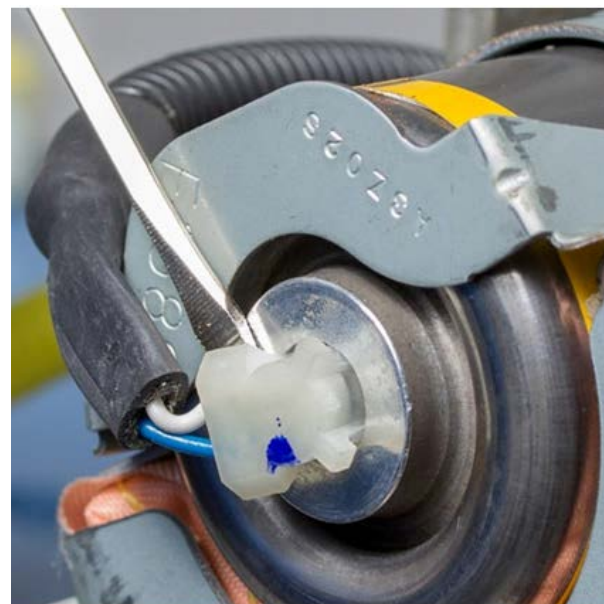
**STEP 11-** The new inflator wiring harness has 2 “sides” with round 2-pin connectors on both ends. The side with the yellow corrugated tube and red / yellow wires will connect to the end of the inflator with the D-Shaped wiring harness connector boss, new stopper plate and foam protector as shown below. Peel off the white dust cover from the D-Shaped end of the inflator **ONLY**. **IMPORTANT: NEVER PEEL BOTH THE WHITE DUST COVERS OFF AT THE SAME TIME!** CAREFULLY align the pins with the female terminals of the harness connector (red / yellow wires) as shown in the photos below. Once pin alignment is confirmed, push down firmly to engage the connector’s 3 locking tangs into the locking groove inside the connector boss. Confirm the connector is locked by prying up **LIGHTLY** with a small flat-blade screwdriver. Repeat the procedure on the opposite end with the blue / white wires.

**VERY IMPORTANT:** When connecting the new harness to the inflator, both sides of the harness **MUST** be routed toward the module’s mounting brackets as shown in the photos below.

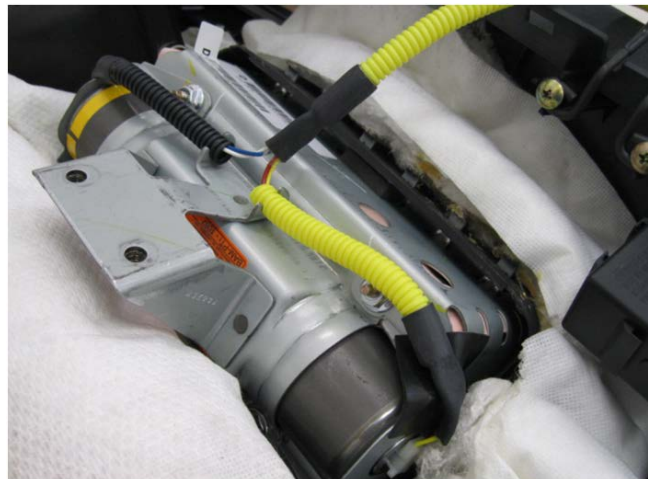
**STEP 13- CAREFULLY** reinstall the airbag module assembly into the instrument panel as shown below.

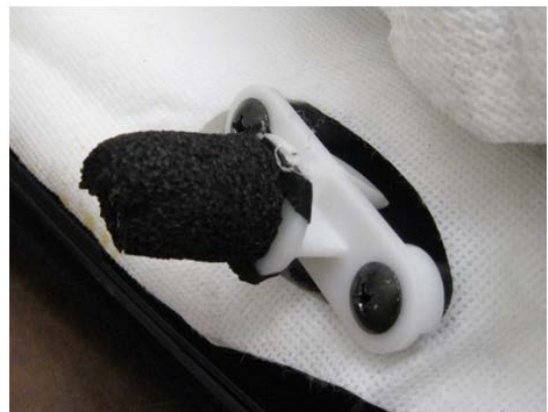
**STEP 14-** To eliminate a possible source of a rattling sound from the dash, wrap the 2 hooks and locator pin with non-woven material, p.n. SOA963W110 (or an equivalent self-adhesive foam) as shown below.

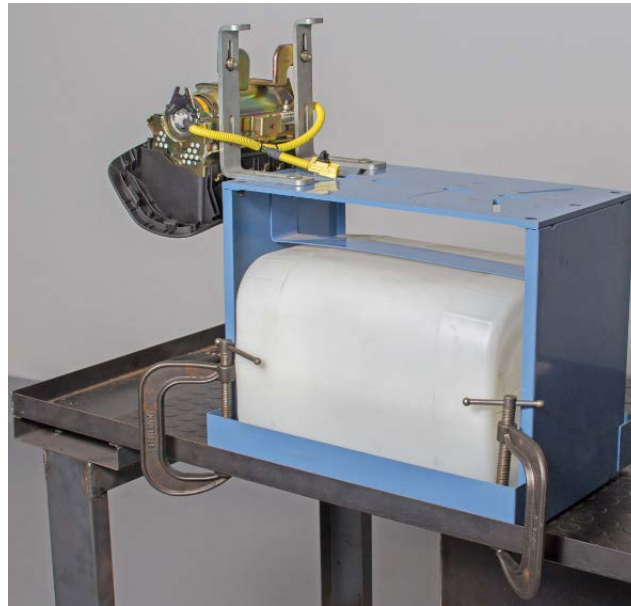
**REMINDER:** It is **STRONGLY RECOMMENDED** the removed airbag module **ALWAYS** be mounted to the Airbag Deployment Fixture (part number J-39401-B and file photo shown below) to better secure it during the inflator replacement procedure. When mounting the module to the fixture, pay close attention to the harness routing. Always perform this work in an area away from others to reduce chances of inadvertent injury should any deployment occur. Take your surroundings into account to avoid possible hazards should an inadvertent deployment occur or sources of static or other electricity that could potentially induce such a deployment.

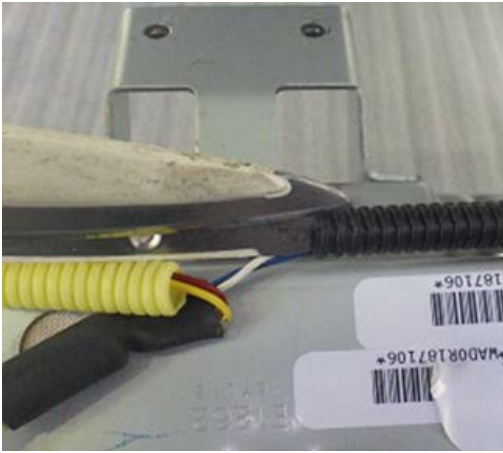
**STEP 4-** Using a scissor or wire cutter (no knives or razors) **CAREFULLY** cut the black harness cover tube (approximately 1 1/2 inches) enough to expose the blue and white wires inside and provide enough room to install the Electro-Tap (shorting) connector.

**TAKE YOUR TIME AND BE CAREFUL TO NOT CUT THE 2 WIRES!**

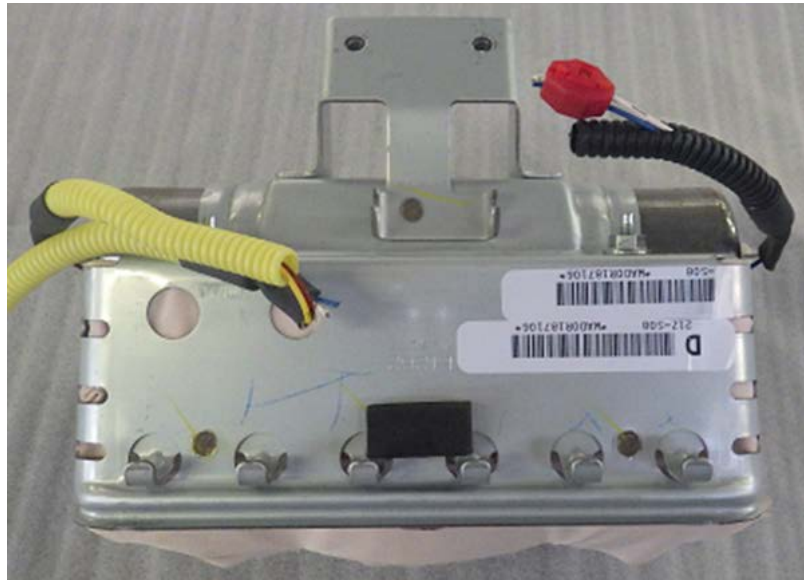
**STEP 6-** Once the Electro-Tap connector is fully crimped in place, cut the white and blue wires **on the body harness connector side** of the Electro-Tap connector.

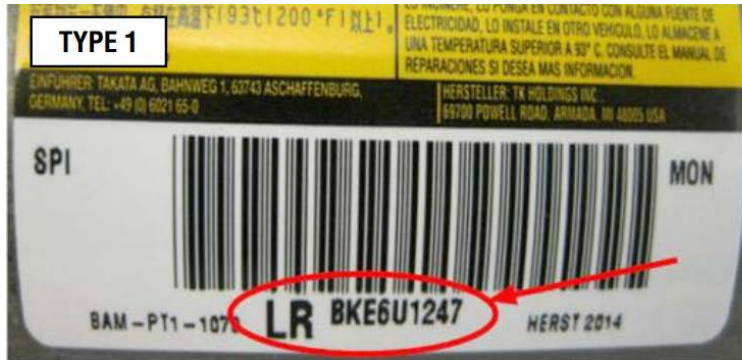
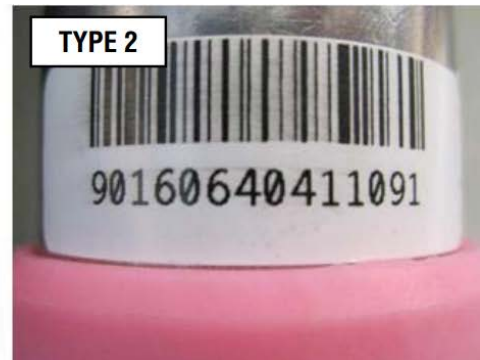
**STEP 9 - VERY IMPORTANT:** Record the **11-digit alpha-numeric serial number** for both the new **Type 2** and the original **Type 1** inflators on the hard copy of the Repair Order. This information will be required for completion of the Part Return Notice which will be forwarded by the retailer to the PCC.

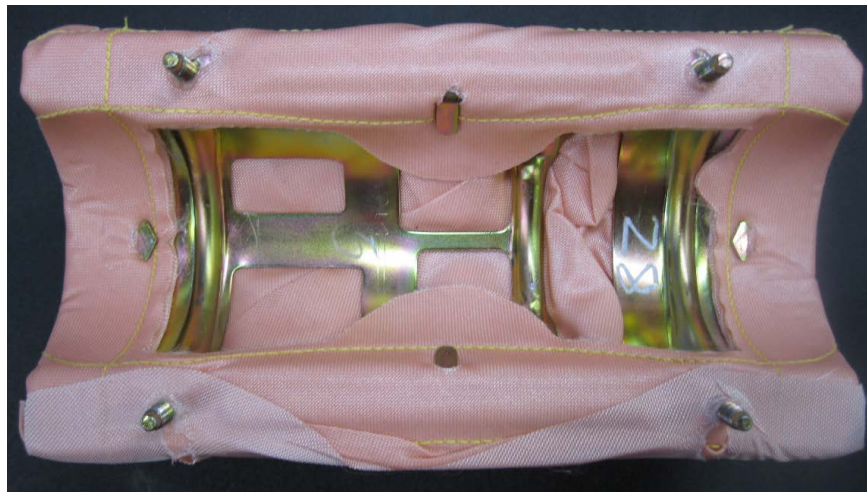
**STEP 10- CAREFULLY** remove the airbag from the mounting bracket (case).

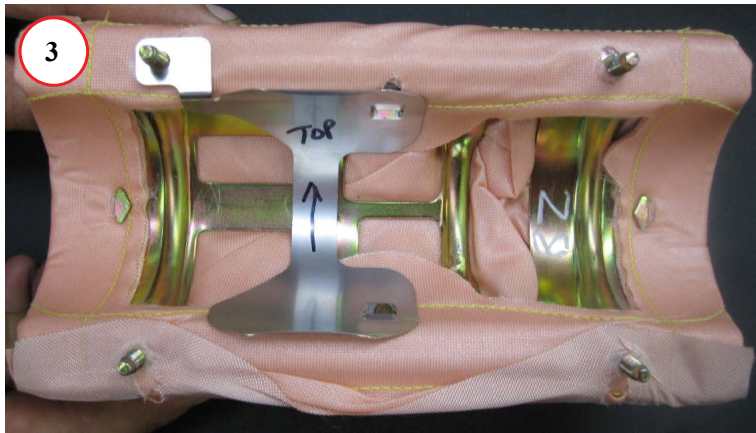
**STEP 11- CAREFULLY** Install the heat insulating plate into the back (inflator) side of the airbag as shown in photo 1 below. **The plate can only be installed in one direction.** Make sure the 2 retaining claws come through the corresponding holes in the insulator plate as shown in photo 2. The airbag is ready to refit to the mounting bracket in photo 3 and is being reinstalled in photo 4.

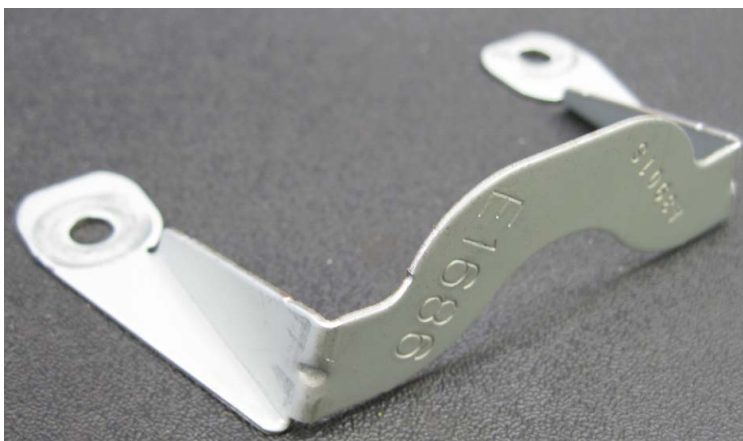
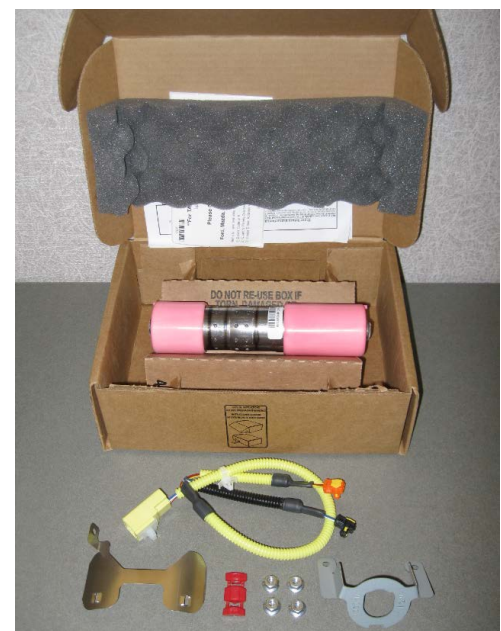
**STEP 14-** Install the original stopper plate onto the opposite end of the mounting bracket / inflator in the same manner as described in STEP 13 above. Rotate the inflator as needed to insure there is no gap between the collar and stopper plate. **NOTE:** Stopper plates only fit one way as their holes are offset.

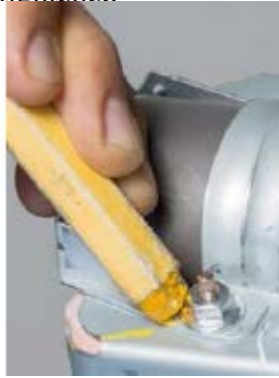
**STEP 15-** Reinstall the 4 **NEW** self-locking nuts. **SLOWLY**

tighten (to prevent over-tightening) then torque the nuts to 31-38 inch-pounds. When complete, use a marker to indicate they have been fully tightened

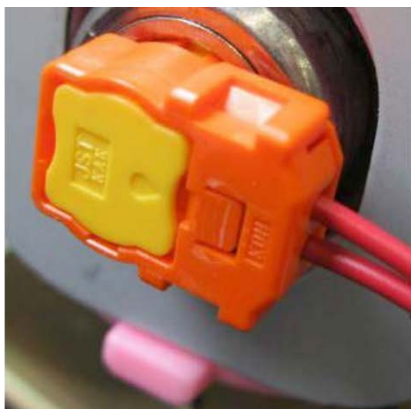
**STEP 17-** Peel off **one** white dust cover and **CAREFULLY** align the tang of the new harness connector with the receiving slot in the inflator connector. This assures proper routing of the harness in relation to the airbag assembly mounting bracket.

Once alignment is confirmed, push down firmly to engage the connector. When fully seated, press down on the yellow tab locking the connector to the inflator.

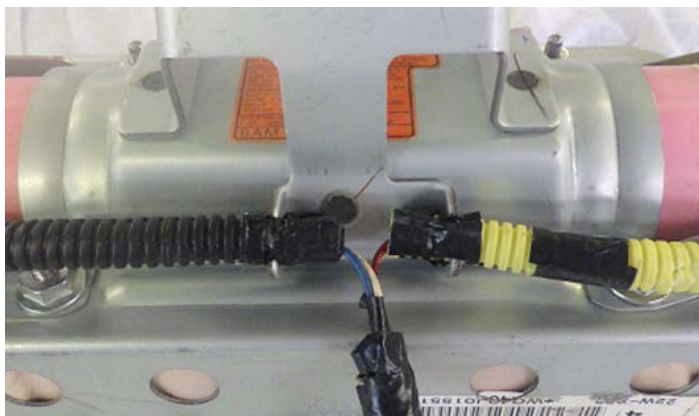
**STEP 18-** After connecting both sides of the harness, refit the harness cover tube back into the mounting brackets.

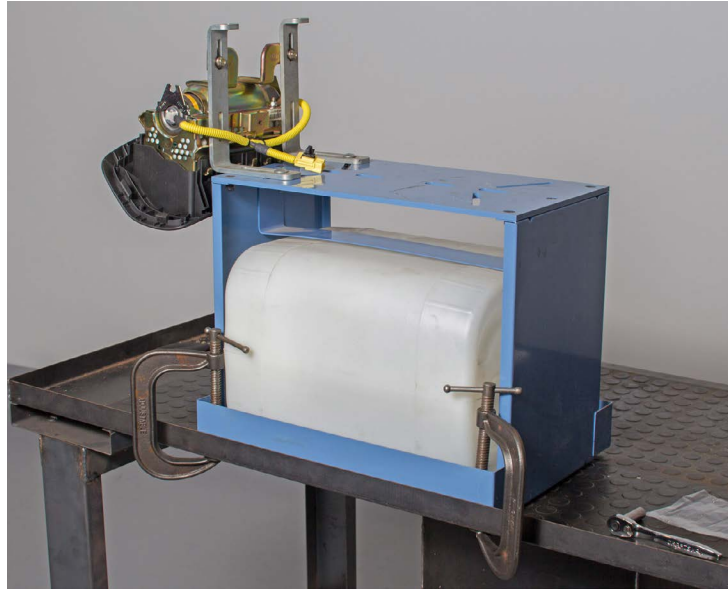
- **IMPORTANT: The removed airbag module must be mounted to the Airbag Deployment Fixture (part number J-39401-B) as shown in the photo below to better secure it during the inflator and wiring harness component replacement procedures.**

When mounting the module to the fixture, pay close attention to the harness routing as shown in the photo below. Always perform this work in an area away from others to reduce chances of inadvertent injury should any deployment occur. Take your surroundings into account to avoid possible hazards should inadvertent deployment occur or sources of static or other electricity that could potentially induce such a deployment.

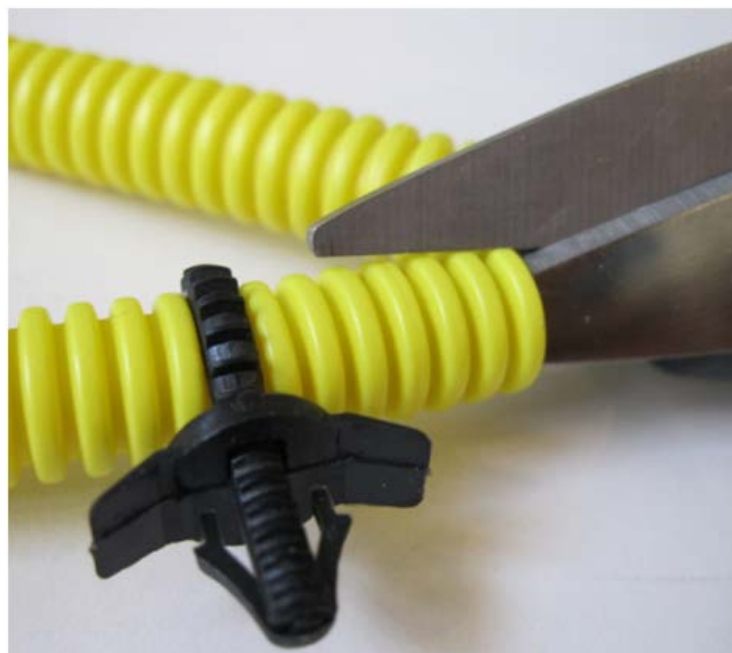
**STEP 3- CAREFULLY** cut the yellow harness cover (approximately 1 1/2 inches) enough to expose the 2 yellow wires inside and provide enough room to install the Electro-Tap (shorting) connector using a scissor or wire cutter (no knives or razors). **TAKE YOUR TIME AND BE CAREFUL TO NOT CUT THE 2 YELLOW WIRES!**

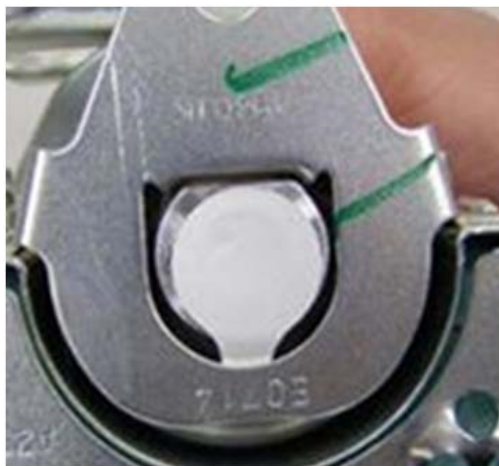
**Inflator properly seated against mounting bracket (NO GAP)**

**STEP 9-** Install the new inflator into the mounting bracket so the yellow taped end aligns with the removed stopper plate. Make sure the “D-shaped” portion of the inflator harness connector boss aligns with the “D-shaped” portion of the hole in the end of the mounting bracket as shown below. When properly installed, the end of the inflator will be seated tight against the mounting bracket. Do not peel the white harness connection dust cover at this time.

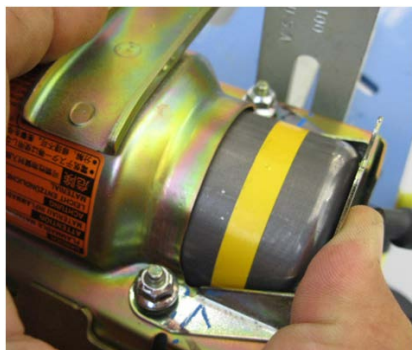
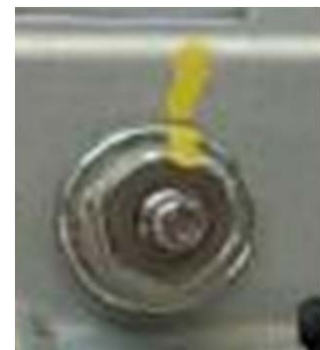
**STEP 10-** As shown below, install but **do not fully tighten** 2 of the **NEW** self-locking nuts while holding the stopper plate tight against the inflator. Remove the nuts still installed on the mounting bracket and replace them with 2 **NEW** self-locking nuts. Once all 4 **NEW** nuts are in place, **torque to 31 - 38 inch pounds in the sequence shown below**. Use a marker to mark the nuts after torquing to indicate they have been fully tightened.

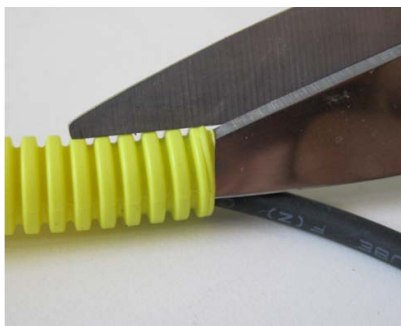
**STEP 3- CAREFULLY** cut the yellow harness cover enough (approximately 2 inches) to expose the 2 red (or yellow) wires inside and provide enough room to install the Electro-Tap (shorting) connector using a wire cutter or scissor (no knives or razors). **TAKE YOUR TIME AND BE CAREFUL TO NOT CUT THE 2 WIRES!**

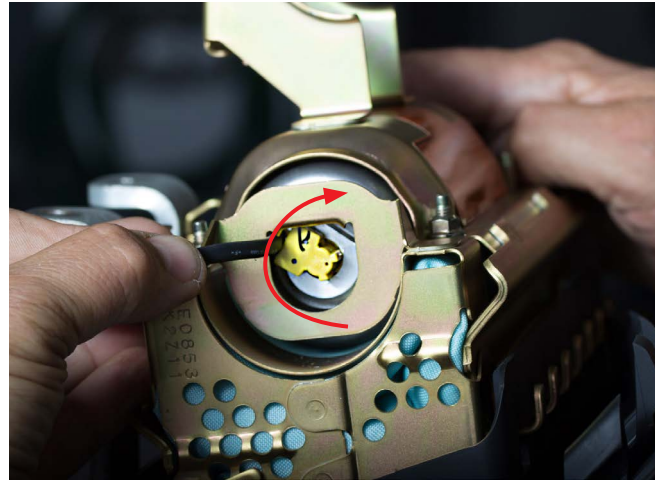
**STEP 7-** With the stopper plate removed and the other 2 self-locking nuts loosened, unseat the inflator off the mounting bracket end plate then rotate it slightly **CLOCKWISE** to make it easier to remove as shown in the photo to the right. Slide the inflator out of its mounting while feeding the cut off portion of the wiring harness through the “D-Shaped” hole in the end of the mounting bracket.

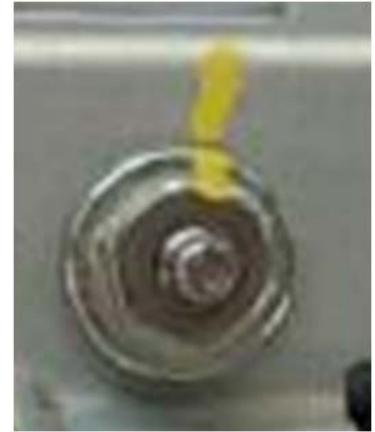
**STEP 10-** As shown below, install but do not fully tighten 2 of the NEW self-locking nuts while holding the stopper plate tight against the inflator. Remove the nuts still installed on the mounting bracket and replace them with 2 NEW self-locking nuts. Once all 4 NEW nuts are in place, torque to 31 - 38 inch pounds in the sequence shown below. Use a marker to mark the nuts after torquing indicating they have been fully tightened.

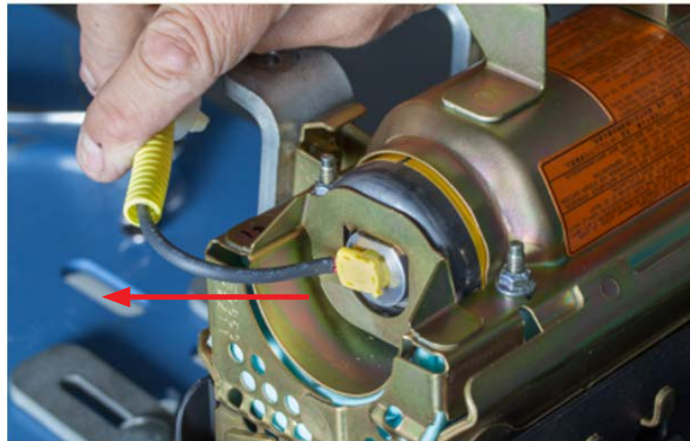
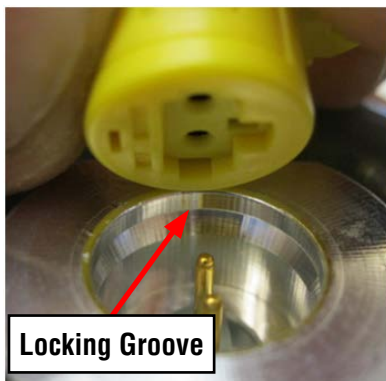
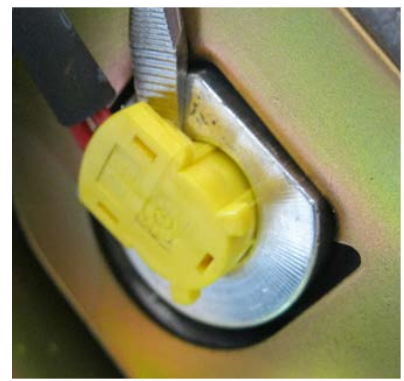
**STEP 11- VERY IMPORTANT:** When connecting the new harness to the inflator, the harness **MUST** be routed toward the module's mounting brackets as shown in the photo below. Peel off the white dust cover and **CAREFULLY** align the 2 inflator pins with the female terminals of the harness connector as shown in the sequence below. Once pin alignment is confirmed, push down firmly to engage the connector's 2 locking tangs into the locking groove of the connector boss. Confirm the connector is fully locked by prying up **LIGHTLY** with a small flat-blade screwdriver.

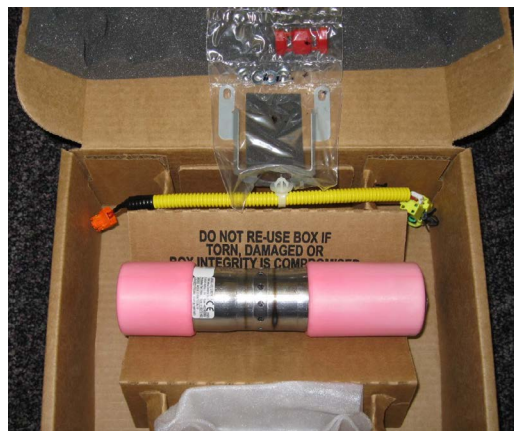
- Open the Kit Box and confirm all the necessary components are included:
  - 4 Self-Locking nuts
  - New **Type 2** Inflator (pink collars on each end identify it as the replacement part)
  - New Inflator Harness
  - New Stopper Plate
  - Electro-Tap (red shorting crimp connector)
  - 1 ½" X 2 ¼" piece of self-adhesive Sponge Tape
  - Shipping Documentation and Instructions

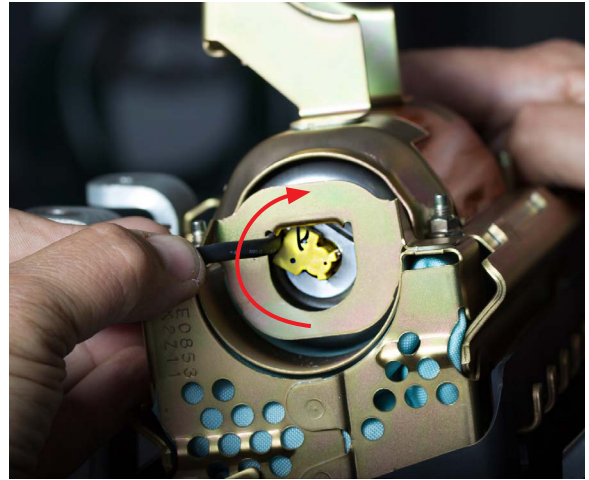
**STEP 7-** With the stopper plate removed and the other 2 self-locking nuts loosened, unseat the inflator off the mounting bracket end plate then rotate it slightly **CLOCKWISE** to make it easier to remove as shown in the photo to the right. Slide the inflator out of its mounting while feeding the cut off portion of the wiring harness through the “D-Shaped” hole in the end of the mounting bracket. **NEVER ATTEMPT TO REMOVE THE HARNESS FROM THE INFLATOR!** Place the removed original air bag inflator in the “cradle” of the Kit Box insert.

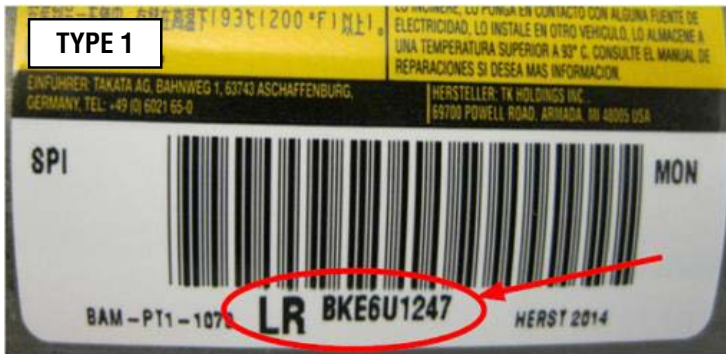
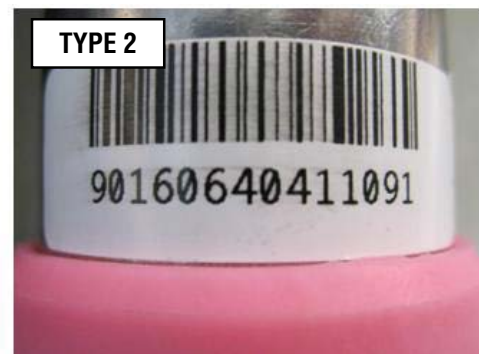
**STEP 8- VERY IMPORTANT:** Record the **11-digit alpha-numeric serial number for both the removed (Type 1) and 14-digit numeric serial number for the new (Type 2) inflator** on the Repair Order hard copy. This information will be required for completion of the Part Return Notice which will be forwarded by the retailer to the PCC. The new 14 digit numeric serial number is also a requirement for claim entry.

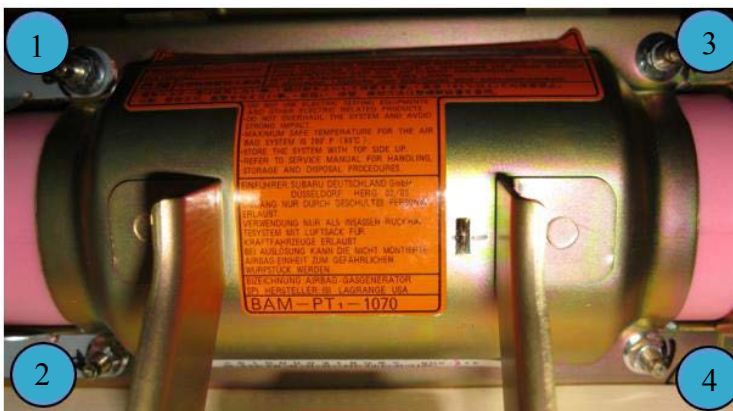
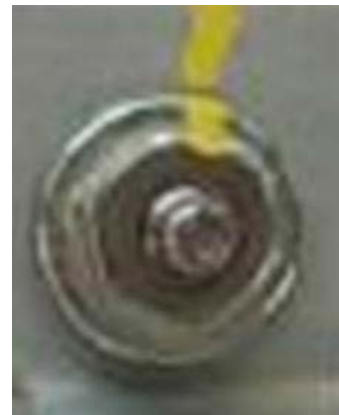
Remove the 2 nuts still installed on the mounting bracket and replace them with 2 **NEW** self-locking nuts. Once all 4 **NEW** nuts are in place, torque to 31 - 38 inch pounds in the new sequence shown below. Use a marker to mark the nuts after torquing indicating they have been fully tightened.

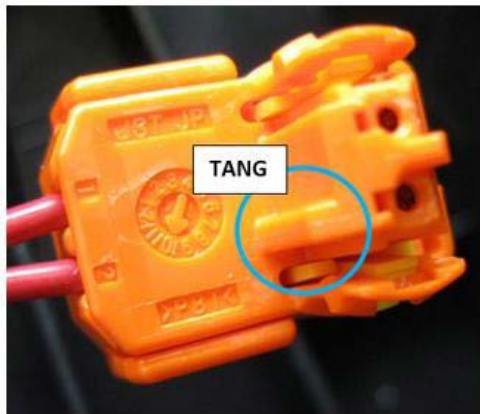
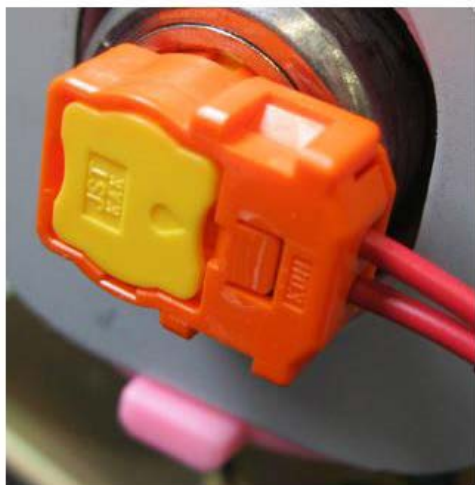
**STEP 12-** Peel off the white dust cover and **CAREFULLY** align the tang of the new harness connector with the receiving slot in the inflator connector. This assures proper routing of the harness in relation to the airbag assembly mounting brackets.

Once alignment is confirmed, push down firmly to engage the connector. When fully seated, press down on the yellow tab locking the connector to the inflator.

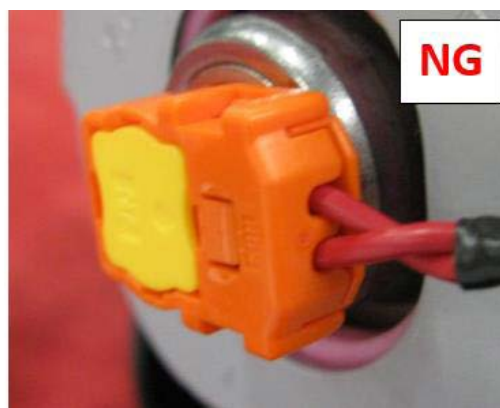
**Step 13-** Reinstall the wiring harness retaining clip into its position on the mounting bracket.  
**IMPORTANT:** Confirm the harness is not twisted at the inflator connector as shown below.
