## PRODUCT CAMPAIGN BULLETIN

**APPLICABILITY:** 2003-2004 Baja  
 2003-2008 Legacy and Outback  
 2004-2005 Impreza, WRX, STI

**SUBJECT:** Takata Front Passenger Air Bag  
 Inflator Replacement

**NUMBER:** WQR-53R

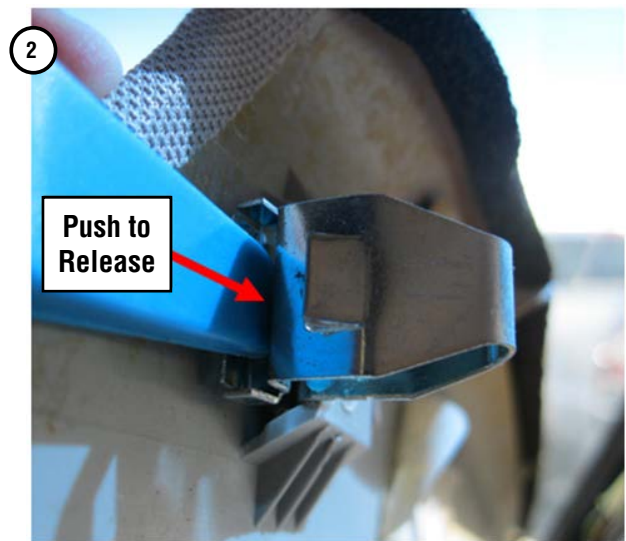
To access the passenger's airbag module, the complete instrument panel assembly must be removed. Follow the procedures in the applicable Service Manual for removing the instrument panel assembly in addition to the necessary related interior trim components.

**NOTE:** When removing the "A" pillar trim, be **VERY CAREFUL** not to damage the upper metal retaining clip. The clip is located just below where the trim panel meets the head liner. If the metal retaining clip becomes damaged or separated from the trim panel, the trim panel **MUST** be replaced as the clip is not available separately. Use a plastic trim tool to push and release the upper portion of the metal clip from the body. Be careful to not pull the trim panel open any further than necessary to gain access for releasing the clip. There is a plastic retaining clip in the lower portion of the trim panel which will release easily once the upper retaining clip is loose. At reassembly and using a plastic trim tool, make sure the inner lip of the door weatherstrip overlaps the outer fabric edge of the trim panel to help secure it.

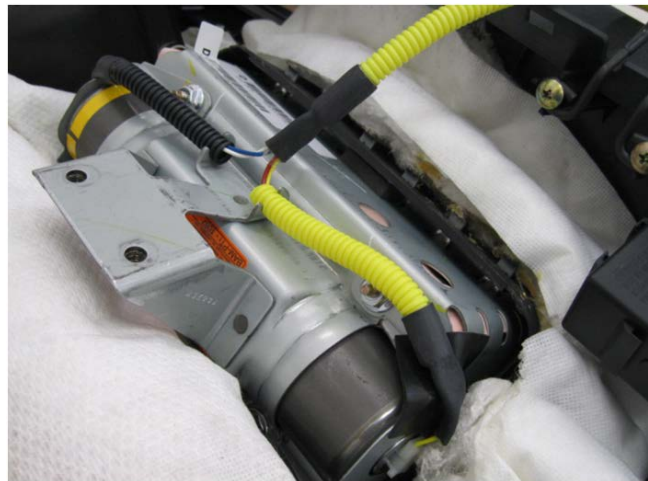
**STEP 13- CAREFULLY** reinstall the airbag module assembly into the instrument panel as shown below.

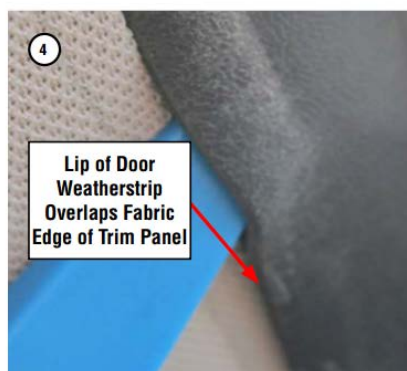
**STEP 2-** To access the passenger’s airbag module, the complete instrument panel assembly must be removed. Follow the procedures in the applicable Service Manual for removing the instrument panel assembly in addition to the necessary related interior trim components.

**NOTE:** When removing the “A” pillar trim, be **VERY CAREFUL** not to damage the upper metal retaining clip. The clip is located just below where the trim panel meets the head liner. If the metal retaining clip becomes damaged or separated from the trim panel, the trim panel **MUST** be replaced as the clip is not available separately. Use a plastic trim tool to push and release the upper portion of the metal clip from the body. Be careful to not pull the trim panel open any further than necessary to gain access for releasing the clip. There is a plastic retaining clip in the lower portion of the trim panel which will release easily once the upper retaining clip is loose. At reassembly and using a plastic trim tool, make sure the inner lip of the door weatherstrip overlaps the outer fabric edge of the trim panel to help secure it.

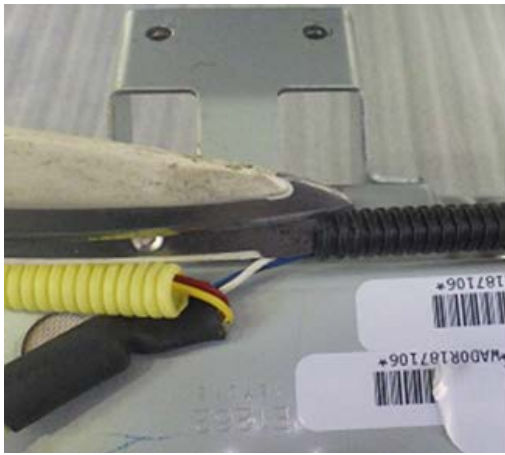
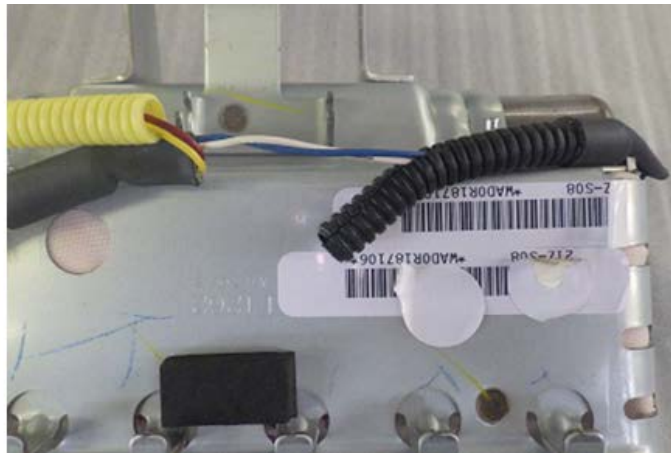
**STEP 4-** Using a scissor or wire cutter (no knives or razors) **CAREFULLY** cut the yellow harness cover tube (approximately 1 1/2 inches) enough to expose the yellow and red wires inside and provide enough room to install the Electro-Tap (shorting) connector.

**TAKE YOUR TIME AND BE CAREFUL TO NOT CUT THE 2 WIRES!**

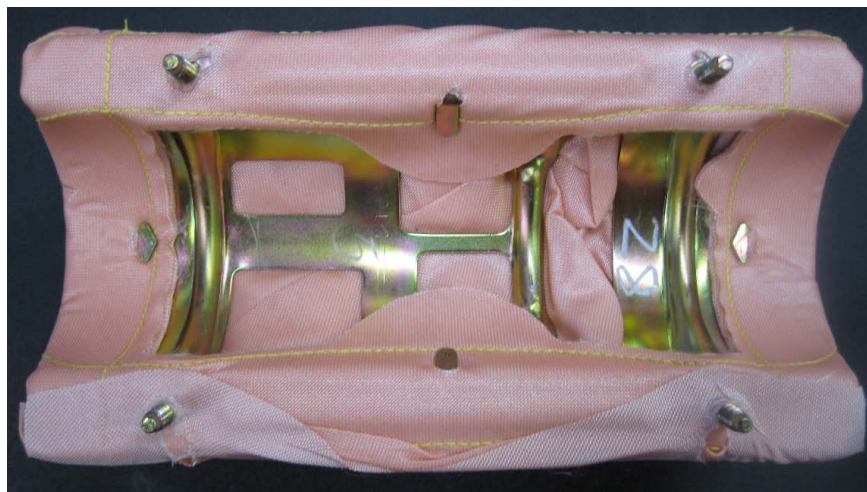
**STEP 10- CAREFULLY** remove the airbag from the mounting bracket (case).

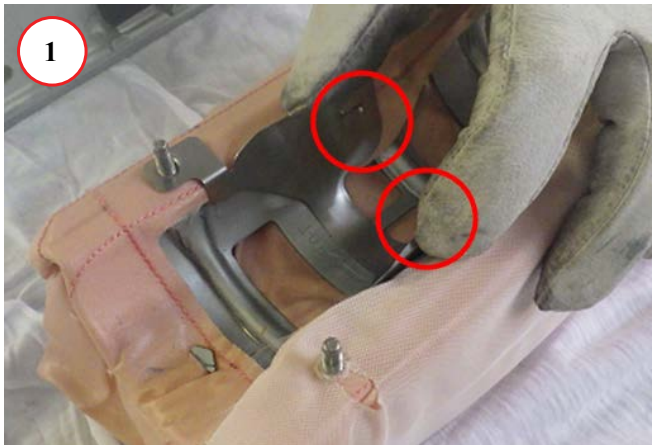
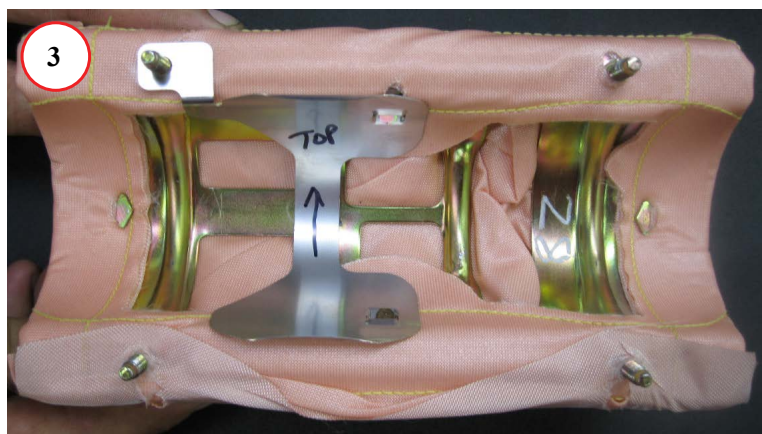
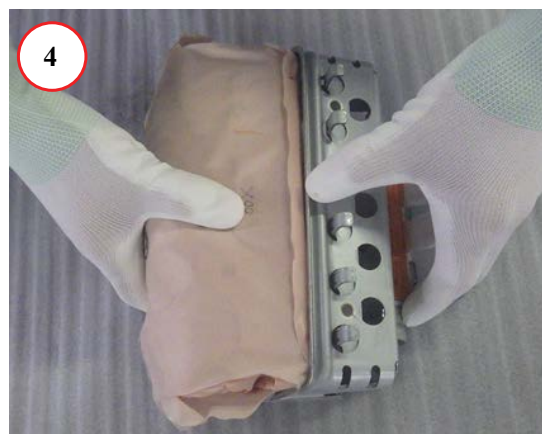
**STEP 11- CAREFULLY** Install the heat insulating plate into the back (inflator) side of the airbag as shown in photo 1 below. **The plate can only be installed in one direction.** Make sure the 2 retaining claws come through the corresponding holes in the insulator plate as shown in photo 2. The airbag is ready to refit to the mounting bracket in photo 3 and is being reinstalled in photo 4.

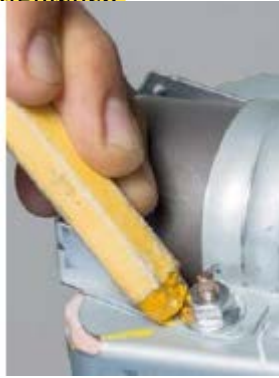
**STEP 15-** Reinstall the 4 **NEW** self-locking nuts. **SLOWLY**

tighten (to prevent over-tightening) then torque the nuts to 31-38 inch-pounds. When complete, use a marker to indicate they have been fully tightened

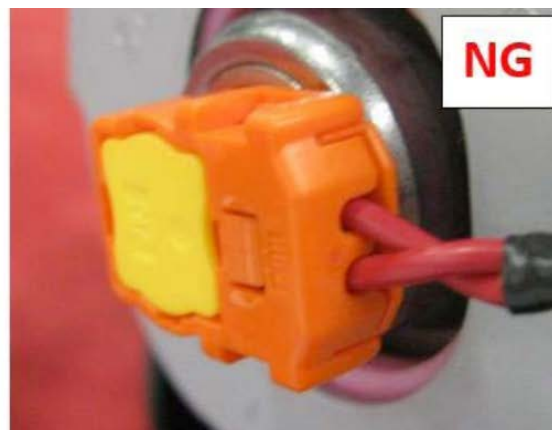
**STEP 16-** The new inflator wiring harness has 2 “sides” with 2-pin connectors on both ends. The side with the black harness tube goes with the black inflator connector and the other side (yellow harness tube) will connect to the orange connector. The end of the inflator aligned with the new Stopper Plate (A) will have a black harness connector while the connector on the opposite end of the inflator will be orange. This makes it impossible to install the harness backwards as the tangs (shown in Step 17) are also in different positions.

**BEFORE** connecting the harness to the inflator, make sure the harness is not twisted as shown below.

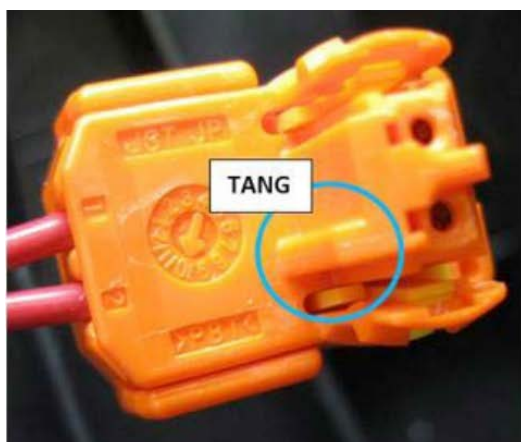
**STEP 17-** Peel off **one** white dust cover and **CAREFULLY** align the tang of the new harness connector with the receiving slot in the inflator connector. This assures proper routing of the harness in relation to the airbag assembly mounting bracket.

Once alignment is confirmed, push down firmly to engage the connector. When fully seated, press down on the yellow tab locking the connector to the inflator.

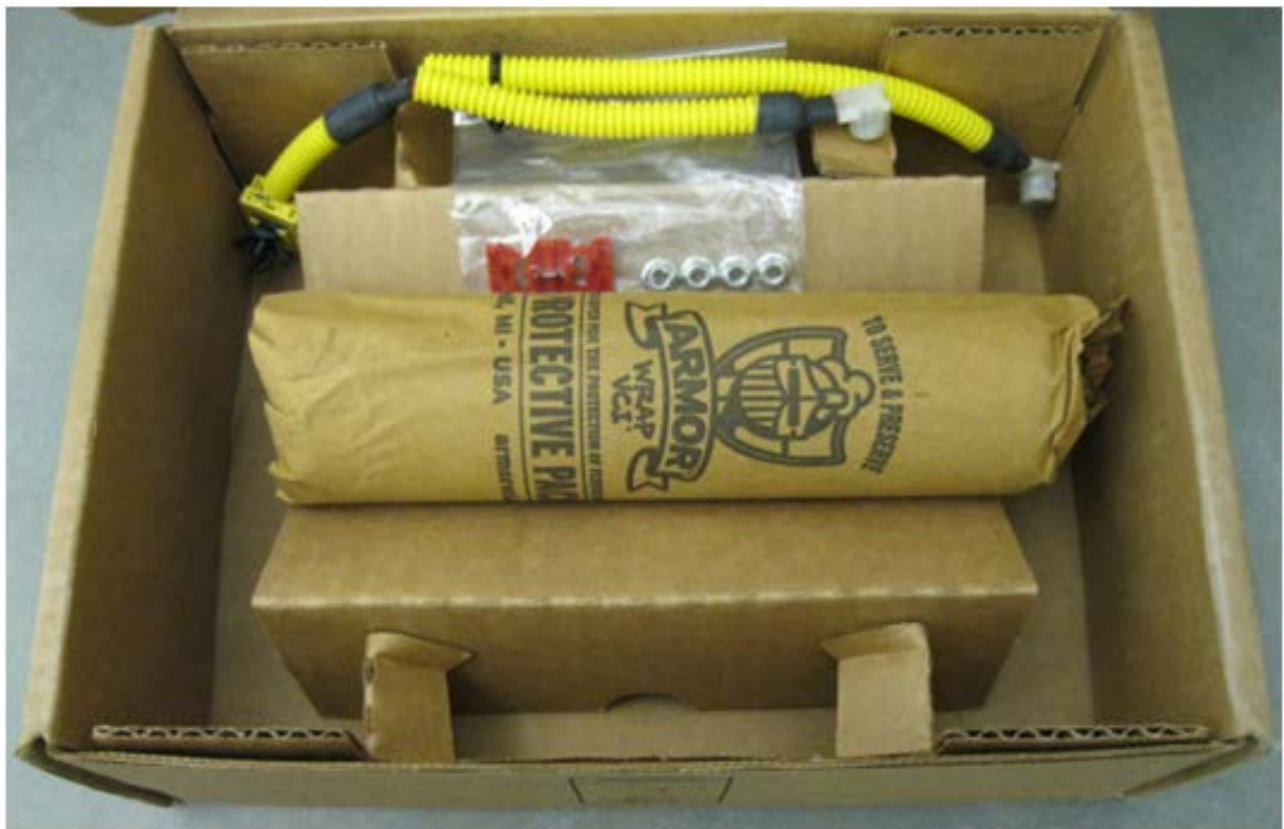
- Open the Kit Box and confirm all the necessary components are included:
  - 4 Self-Locking nuts
  - New Inflator (yellow tape applied to one end to identify it as the replacement part)
  - New Inflator Harness
  - Electro-Tap (red shorting crimp connector)
  - Shipping Documentation and Instructions

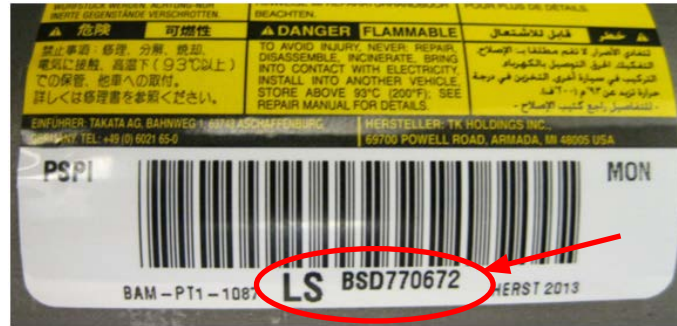
**STEP 8- VERY IMPORTANT:** Record the **11-digit alpha-numeric serial number** for both the **new and the removed inflators** on the hard copy of the Repair Order. This information will be required for completion of the Part Return Notice which will be forwarded by the retailer to the PCC.

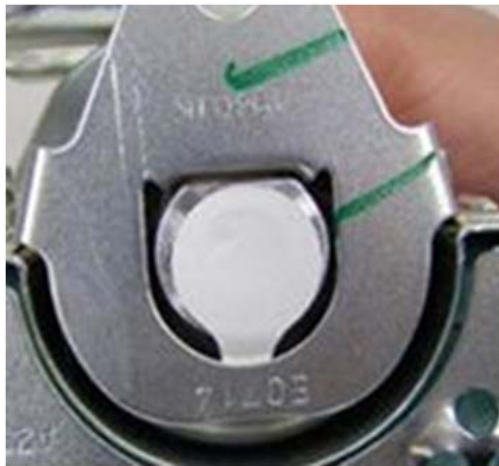
**STEP 9-** Install the new inflator into the mounting bracket so the yellow taped end aligns with the removed stopper plate. Make sure the “D-shaped” portion of the inflator harness connector boss aligns with the “D-shaped” portion of the hole in the end of the mounting bracket as shown below. When properly installed, the end of the inflator will be seated tight against the mounting bracket. Do not peel the white harness connection dust cover at this time.

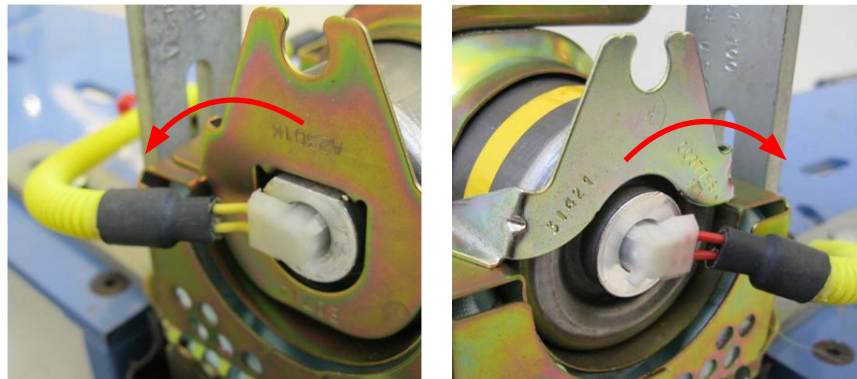
**STEP 11-** The new inflator wiring harness has a “long side” and a “short side” with round 2-pin connectors on both ends. The short side with red wires will connect to the end of the inflator with the round wiring harness connector boss, yellow tape and removable stopper plate. **VERY IMPORTANT: When connecting the new harness to the inflator, both sides of the harness MUST be routed toward the module’s mounting brackets as shown in the photos below.**

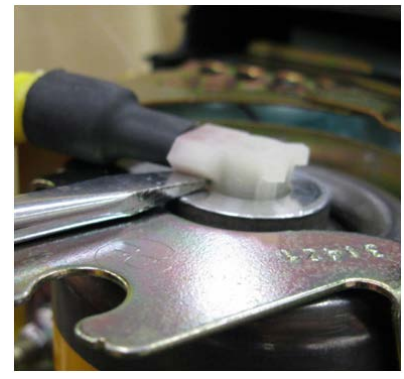
Peel off the white dust cover from the round connector boss end of the inflator **ONLY**. **CAREFULLY** align the pins with the female terminals of the harness connector (2 red wires) as shown in the sequence below. **IMPORTANT: NEVER PEEL BOTH THE WHITE DUST COVERS OFF AT THE SAME TIME!** Once pin alignment is confirmed, push down firmly to engage the connector’s 3 locking tangs into the locking groove inside the connector boss. Confirm the connector is locked by prying up **LIGHTLY** with a small flat-blade screwdriver. Repeat the procedure on the D-shaped connector boss end (2 yellow wires). Reinstall the black wiring harness retaining clip into the mounting bracket to complete the airbag reassembly.

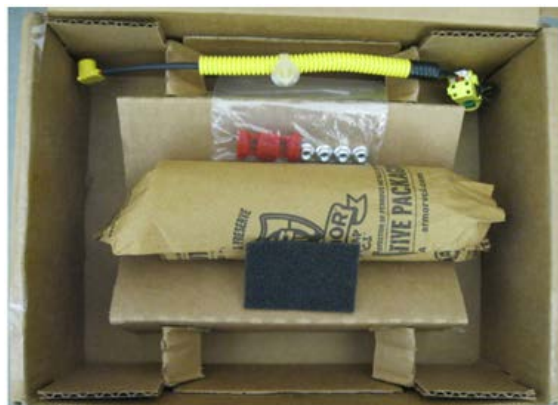
- Open the Kit Box and confirm all the necessary components are included:
  - 4 Self-Locking nuts
  - New **Type 1** Inflator (yellow tape applied to one end to identify it as the replacement part)
  - New Inflator Harness
  - Electro-Tap (red shorting crimp connector)
  - 1 ½" X 2 ¼" piece of self-adhesive Sponge Tape
  - Shipping Documentation and Instructions

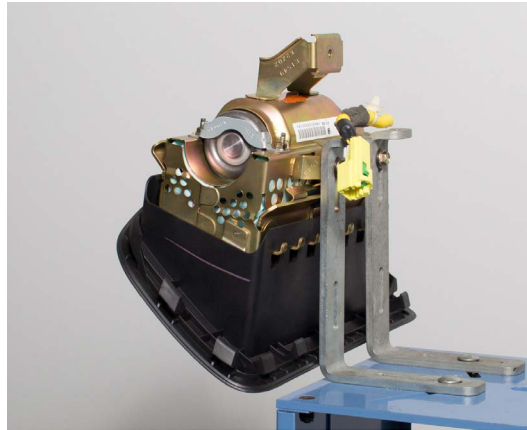
**IMPORTANT:** The removed airbag module must be mounted to the Airbag Deployment Fixture (part number J-39401-B) as shown in the photo below to better secure it during the inflator and wiring harness component replacement procedures. Always perform this work in an area away from others to reduce chances of inadvertent injury should any deployment occur. Take your surroundings into account to avoid possible hazards should inadvertent deployment occur or sources of static or other electricity that could potentially induce such a deployment.

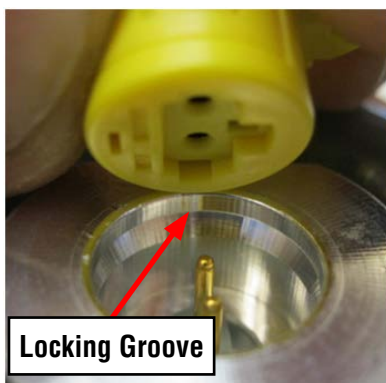
**STEP 11- VERY IMPORTANT:** When connecting the new harness to the inflator, the harness **MUST** be routed toward the module's mounting brackets as shown in the photo below. Peel off the white dust cover and **CAREFULLY** align the 2 inflator pins with the female terminals of the harness connector as shown in the sequence below. Once pin alignment is confirmed, push down firmly to engage the connector's 2 locking tangs into the locking groove of the connector boss. Confirm the connector is fully locked by prying up **LIGHTLY** with a small flat-blade screwdriver.

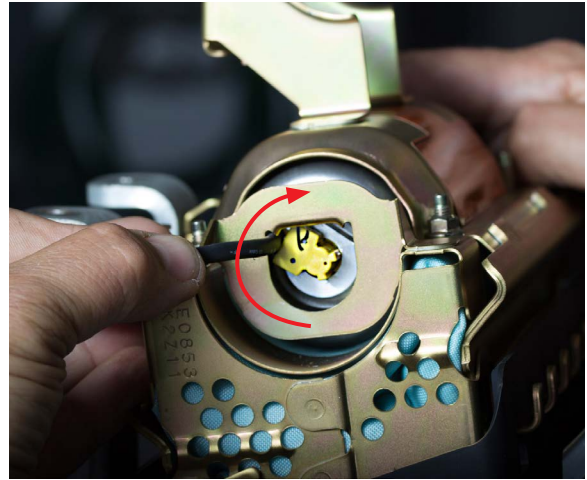
**STEP 7-** With the stopper plate removed and the other 2 self-locking nuts loosened, unseat the inflator off the mounting bracket end plate then rotate it slightly **CLOCKWISE** to make it easier to remove as shown in the photo to the right. Slide the inflator out of its mounting while feeding the cut off portion of the wiring harness through the “D-Shaped” hole in the end of the mounting bracket. **NEVER ATTEMPT TO REMOVE THE HARNESS FROM THE INFLATOR!** Place the removed original air bag inflator in the “cradle” of the Kit Box insert.

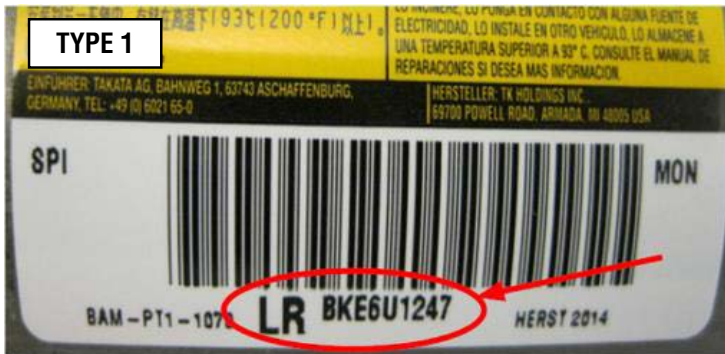
**STEP 8- VERY IMPORTANT:** Record the **11-digit alpha-numeric serial number for both the removed (Type 1) and 14-digit numeric serial number for the new (Type 2) inflator** on the Repair Order hard copy. This information will be required for completion of the Part Return Notice which will be forwarded by the retailer to the PCC. The new 14 digit numeric serial number is also a requirement for claim entry.

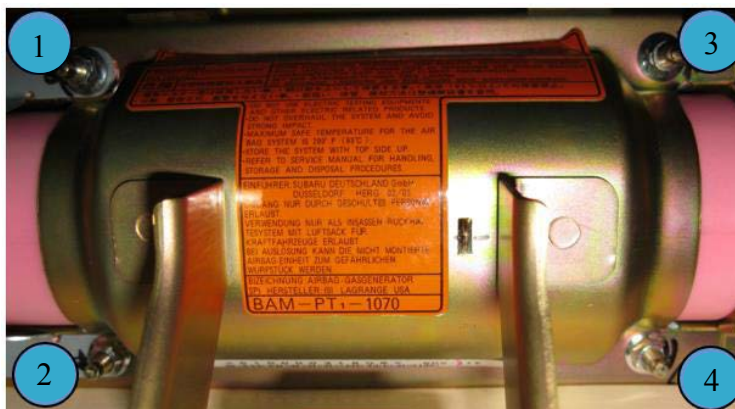
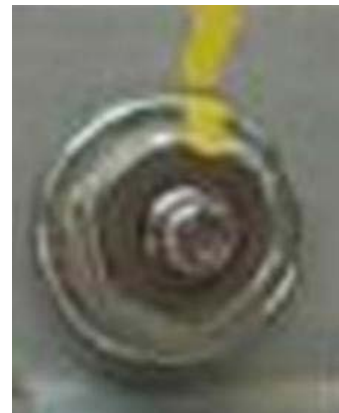
Remove the 2 nuts still installed on the mounting bracket and replace them with 2 **NEW** self-locking nuts. Once all 4 **NEW** nuts are in place, torque to 31 - 38 inch pounds in the new sequence shown below. Use a marker to mark the nuts after torquing indicating they have been fully tightened.

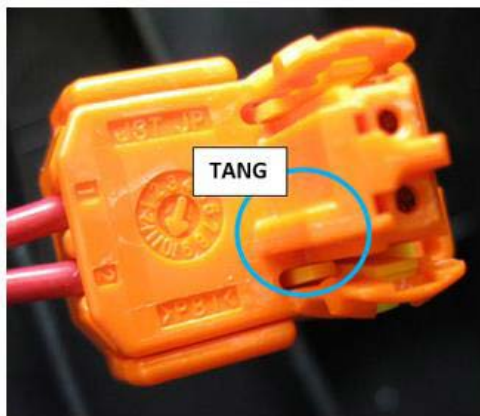
**STEP 12-** Peel off the white dust cover and **CAREFULLY** align the tang of the new harness connector with the receiving slot in the inflator connector. This assures proper routing of the harness in relation to the airbag assembly mounting brackets.

Once alignment is confirmed, push down firmly to engage the connector. When fully seated, press down on the yellow tab locking the connector to the inflator.

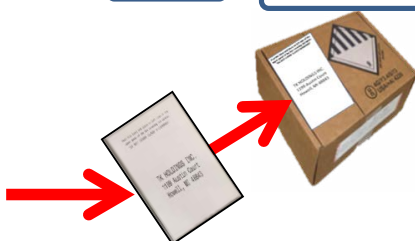
2. Peel off 'Ship To' Label.

3. Affix Label to Box. Do not cover up Class 9 Marking.
