TECHNICAL INSTRUCTIONS

SAFETY RECALL FOR

SOFTWARE UPDATE FOR MOTOR GENERATOR ECU AND POWER MANAGEMENT ECU

CERTAIN: 2012-2014 PRIUS V

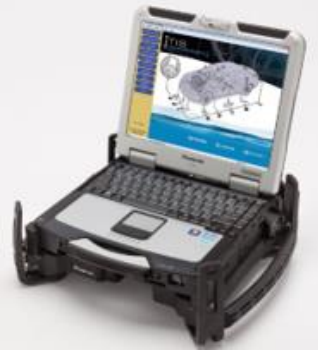
V. INSPECT INVERTER CONDITION

1. PERFORM HEALTH CHECK

- a. Using a Techstream, perform a Health Check.

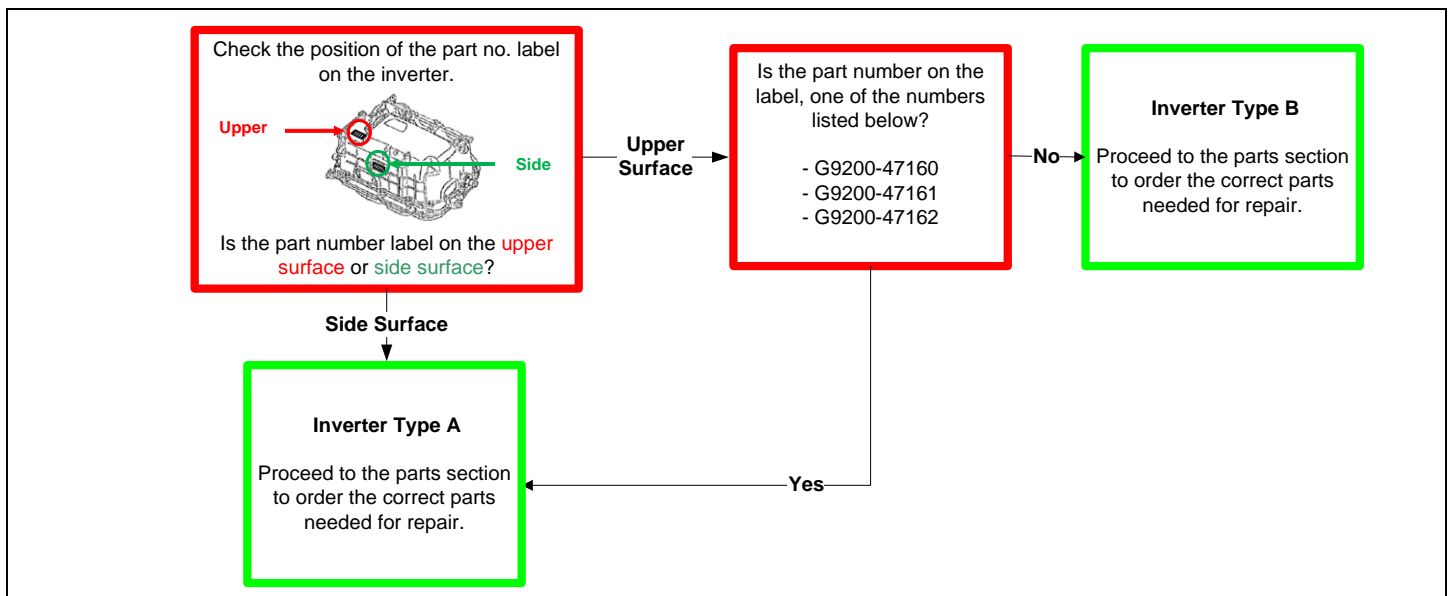
1. DETERMINE INVERTER ASSEMBLY TYPE

- a. Using the flowchart below determine the inverter type (A or B).

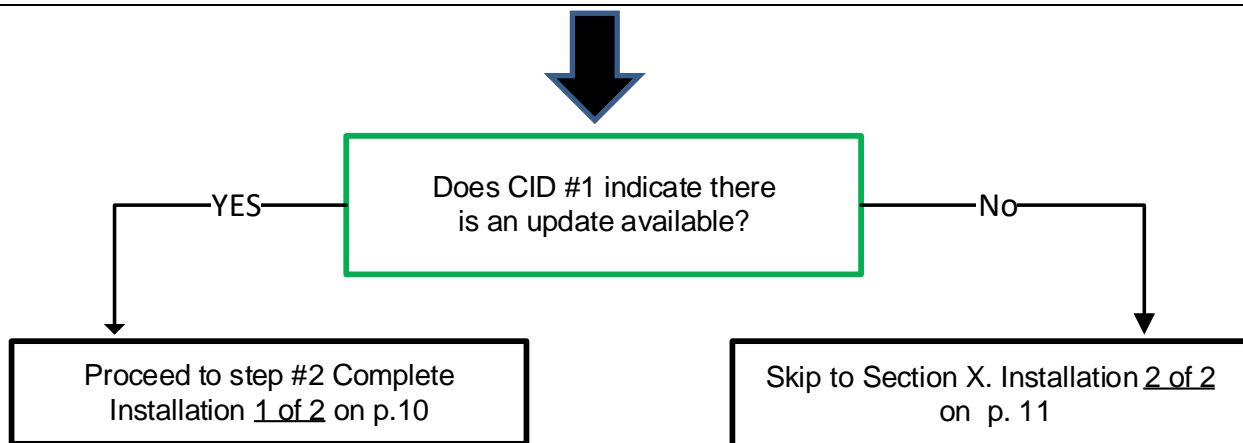
The screenshot shows the Techstream interface for a 2014 Prius 2ZR-FXE. The 'Stored Data' tab is selected. The 'Health Check Results' section indicates that the health check does not display live data and that changes in vehicle condition will not update until the refresh button is clicked. The 'Campaign Status' is 'Y' and 'PERMANENT' is 'NO'. A table lists various systems and their update status:

Red annotations highlight the 'Stored Data' tab, the 'Hybrid Control' system, and the 'Yes' update status for the Hybrid Control CID #1. A red arrow points to the 'Yes' status with the text 'Status of available Update'. Another red arrow points to the 'Yes' status with the text 'CID #1 & #2'.

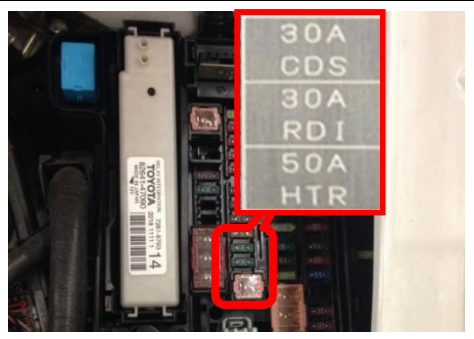
1. REINSTALL JOINT FUSE INTO ENGINE ROOM FUSE BOX

- Confirm the joint fuse orientation before reinstalling because the joint fuse can be installed in either direction.
- Reinstall the joint fuse that encases the CDS (30A), RDI (30A) and HTR (50A).

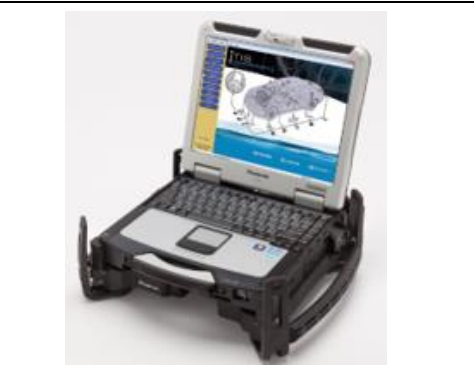
2. PERFORM VERIFICATION HEALTH CHECK

- Using a Techstream, perform a Health Check.
- Clear DTC's that may have set during the re-flash procedure.
- Re-run the Health Check to confirm that no DTC's reappear.

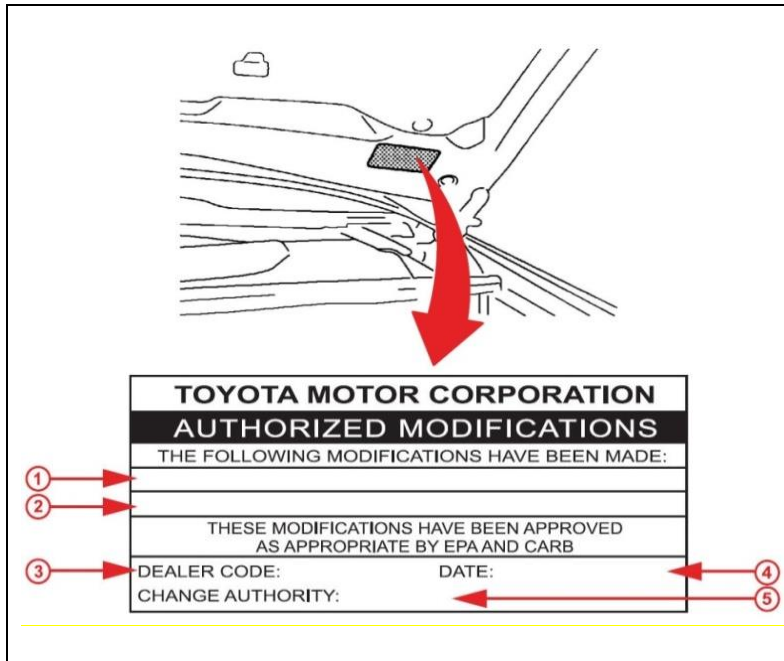
5. ATTACH THE AUTHORIZED VEHICLE MODIFICATION LABEL

- a. Fill out the label.
- b. Affix the label to the under-side of the hood.
