# TECHNICAL INSTRUCTIONS

SAFETY RECALL FOR

SOFTWARE UPDATE FOR MOTOR GENERATOR ECU AND POWER  
MANAGEMENT ECU

CERTAIN: 2012-2014 PRIUS V

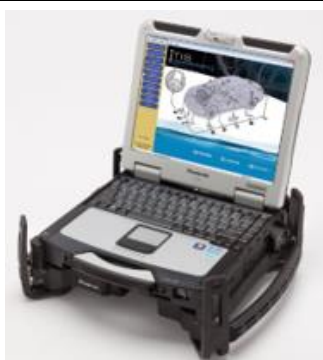
## V. INSPECT INVERTER CONDITION

### 1. PERFORM HEALTH CHECK

- a. Using a Techstream, perform a Health Check.

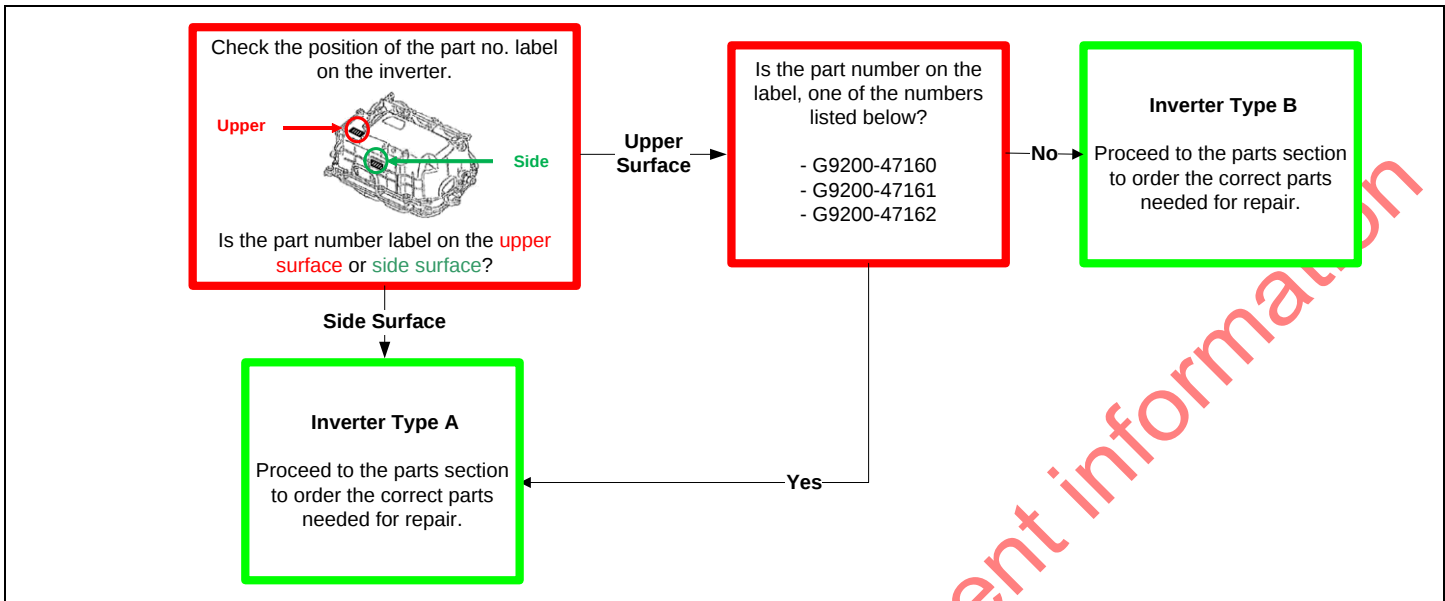
## 1. DETERMINE INVERTER ASSEMBLY TYPE

a. Using the flowchart below determine the inverter type (A or B).

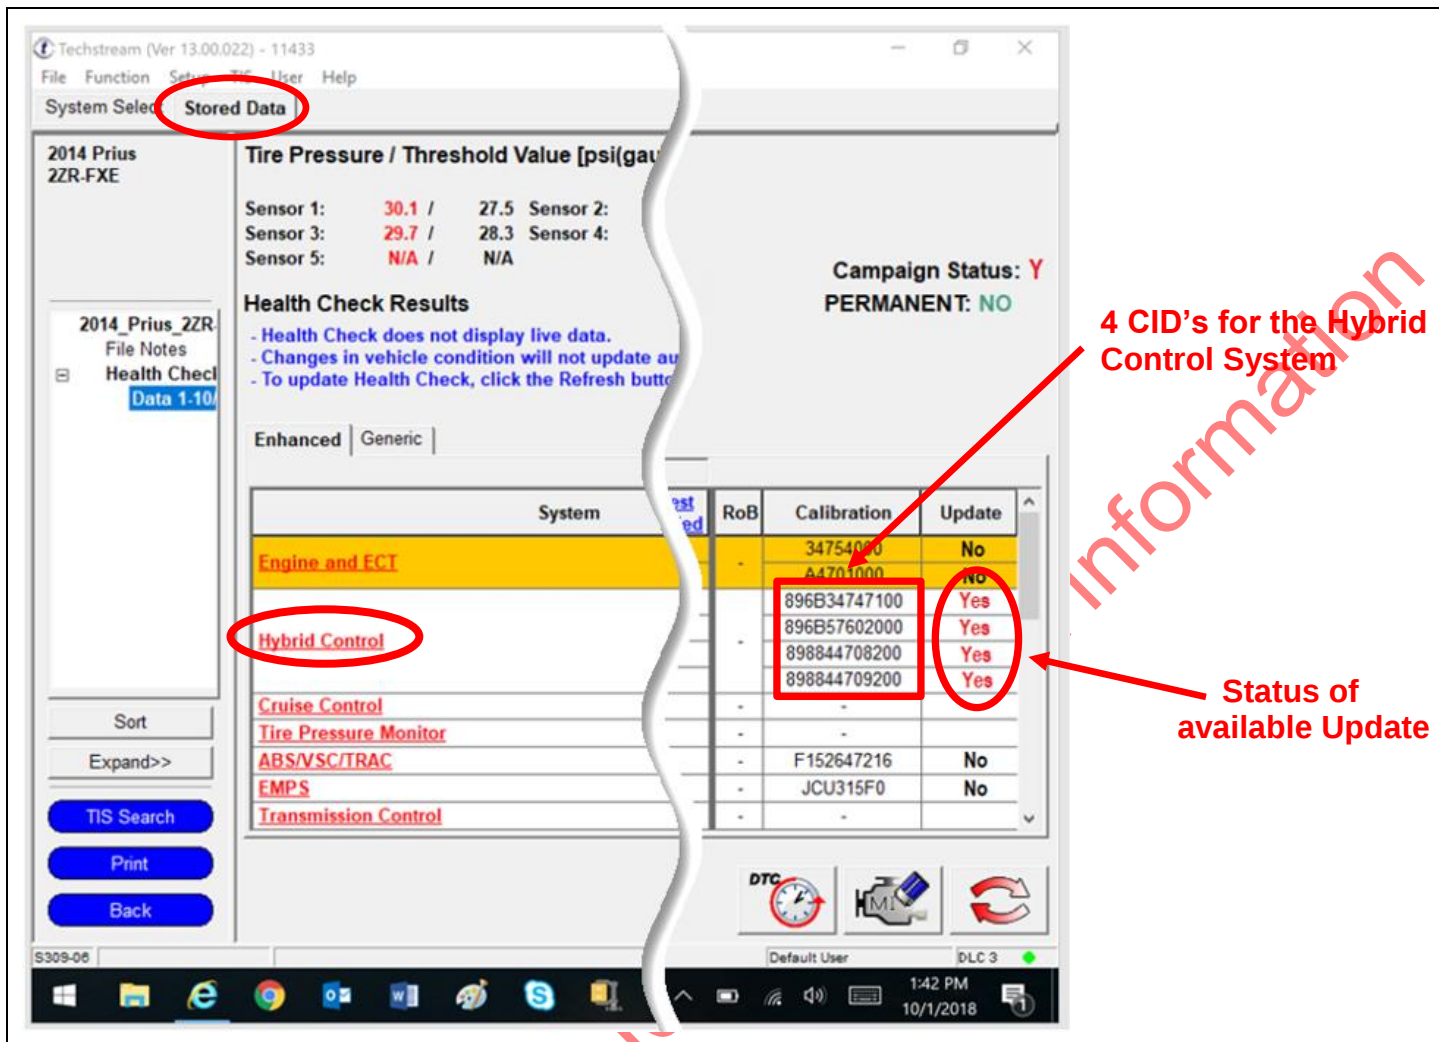
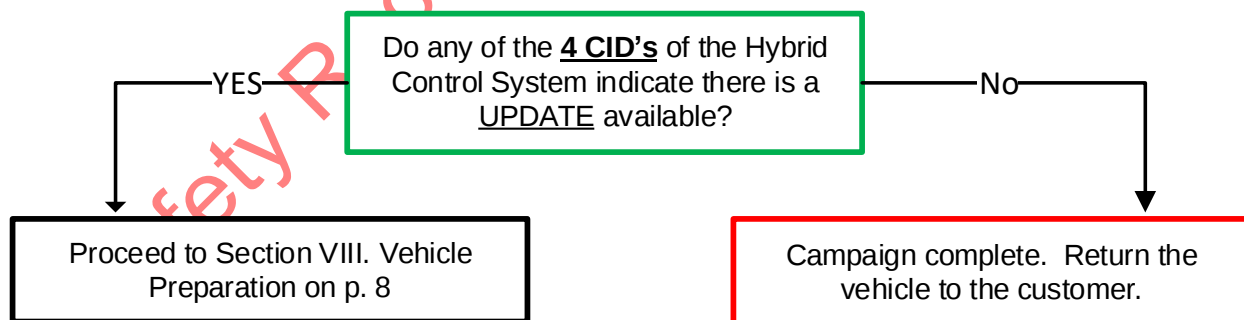
### 1. DETERMINE STATUS of HYBRID CONTROL SYSTEM CID's

- Locate the Update column for the Hybrid Control System in the Stored Data tab.
- Determine the status of the 4 CID's for the Hybrid Control ECU; indicated by a YES or NO in the Update column.

Note: If the Hybrid Control System does not need any of the **4 CID's** updated (indicated with "No" in the Update column), the campaign is complete. No further action is required. Submit the warranty claim to complete this vehicle.

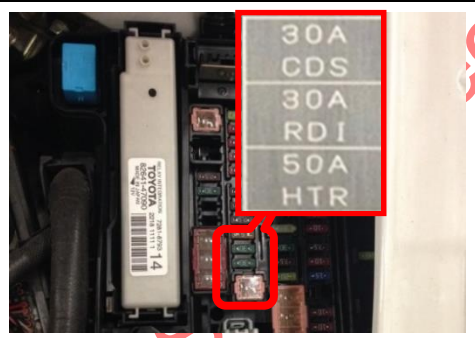
### 1. REINSTALL JOINT FUSE INTO ENGINE ROOM FUSE BOX

- Confirm the joint fuse orientation before reinstalling because the joint fuse can be installed in either direction.
- Reinstall the joint fuse that encases the CDS (30A), RDI (30A) and HTR (50A).

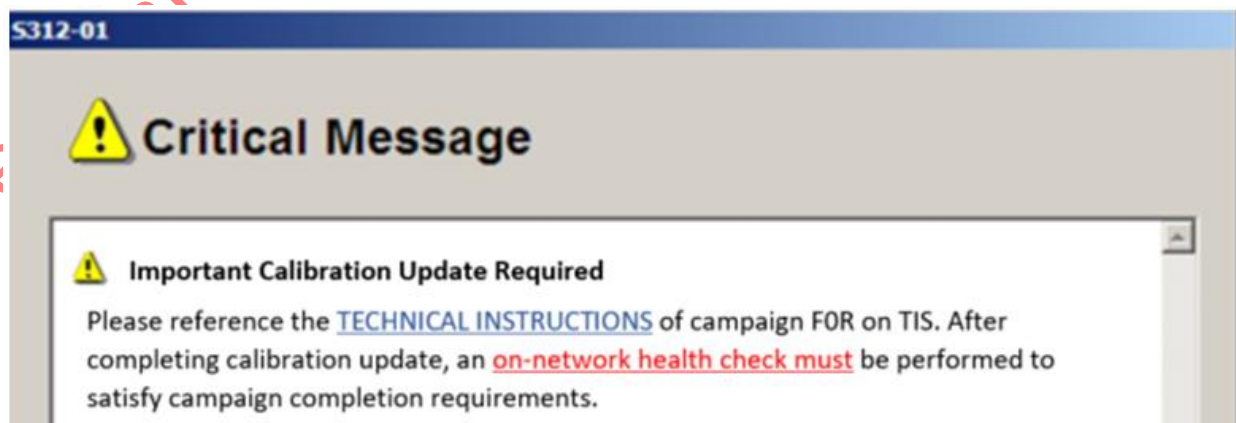
Note: If you receive the following message after the final Health Check, you have not properly completed the Required Calibration Updates!!

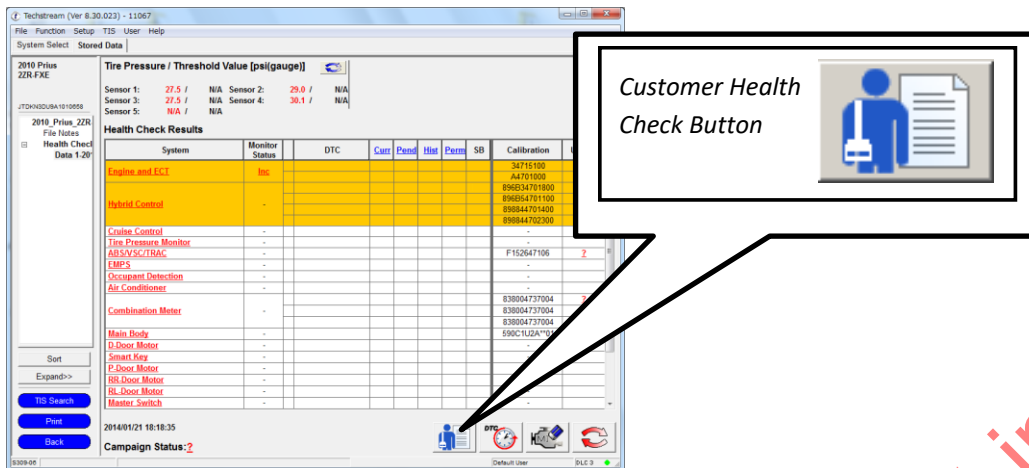
#### 4. PRINT CUSTOMER HEALTH CHECK REPORT

- From the Stored Data tab, select the Customer Health Check Report button (TIS will launch when button is pressed).

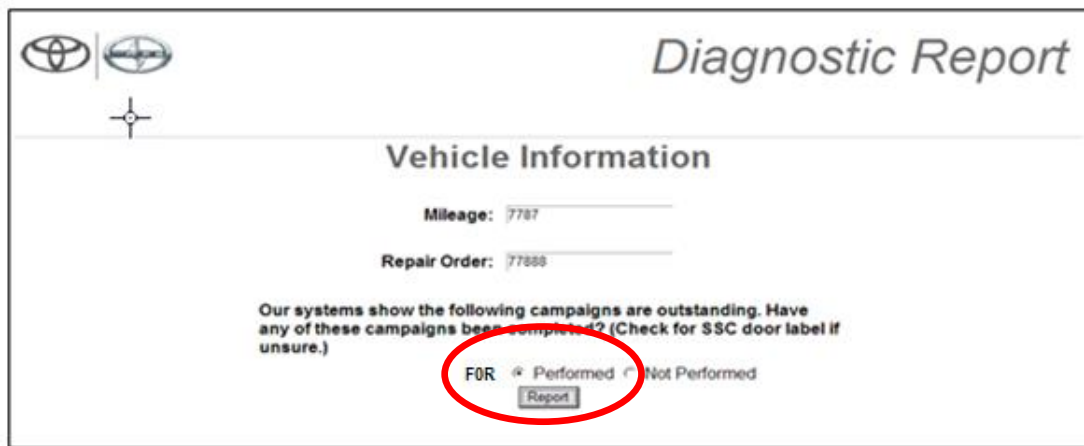
- Log in to TIS.
- Input Vehicle Mileage and Repair Order number.
- Check the "Performed" campaign button for campaign EOE.
- Select the Report button.
