**TECHNICAL INSTRUCTIONS**  
**FOR**  
**SAFETY RECALL FOR**  
**SOFTWARE UPDATE FOR MOTOR GENERATOR ECU AND POWER**  
**MANAGEMENT ECU**

**CERTAIN 2012-2014 MODEL YEAR PRIUS V**

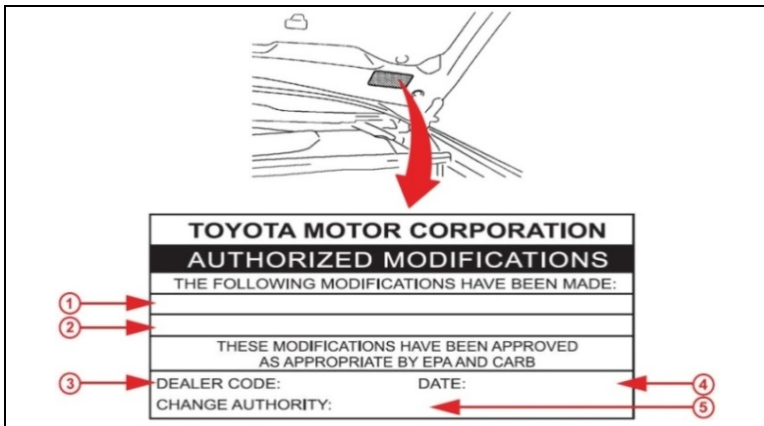
11. Affix the label to the under-side of the hood.

The authorized modification label only needs to have the Power Management ECU Information.

<b>1</b>	Replacement ECU P/N* 89681-47183 89681-47342 89681-47422 <b>Part # varies by model year and production period.</b>
<b>2</b>	New Power Management ECU Calibration ID
<b>3</b>	Dealer Code
<b>4</b>	Date Completed
<b>5</b>	Campaign Code (FOR)

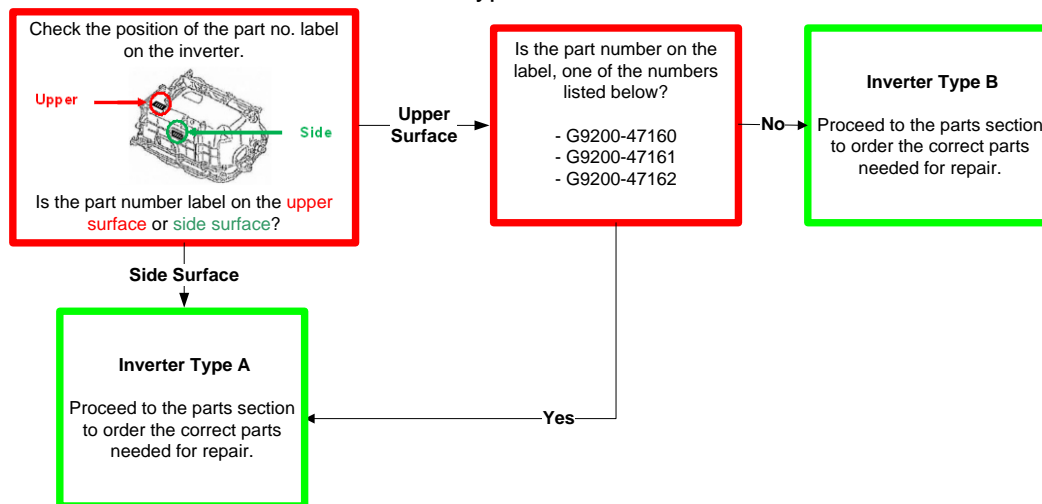
### 1. DETERMINE INVERTER ASSEMBLY TYPE

a) Using the flowchart below determine the inverter type.
