Safety Recall R60 / NHTSA 15V-673 Occupant Restraint Control Module

Models

2003 (KJ) Jeep® Liberty

2004 (WJ) Jeep® Grand Cherokee

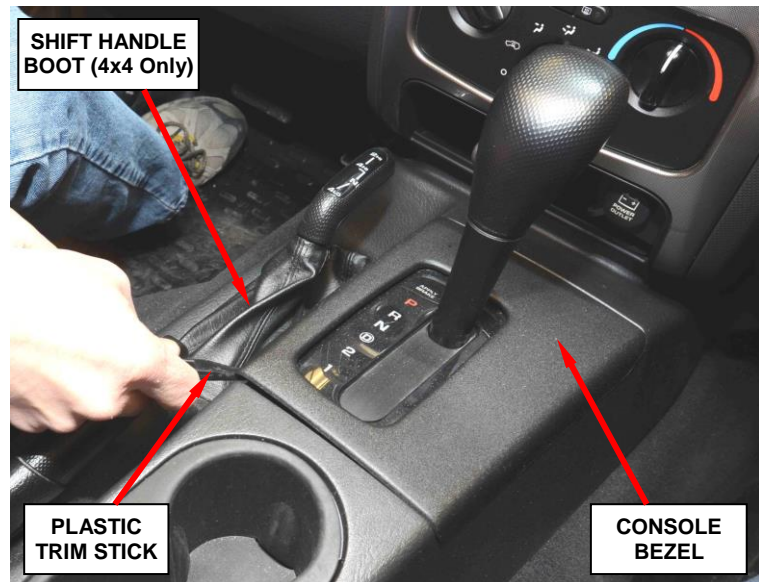
Figure 1 – Center Console Bezel and Shift Boot

1. Open the hood and disconnect the negative battery cable from the battery.
2. Remove and save the gear shift lever center console bezel (Figure 1).
3. Apply the park brake and place gear shift lever in the neutral position.
4. **For vehicles equipped with four wheel drive**, place the four wheel drive selector handle in the “four wheel low” position.
5. **For vehicles equipped with four wheel drive**, remove and save the four wheel drive lever shift handle boot (Figure 1).
6. **For vehicles with power windows**, remove and save the front window switch assembly (Figure 2).

23. Install the four center console retaining screws.
24. Install the rear window switch assembly (Figure 3).
25. Install the front window switch assembly (Figure 2).
26. **For vehicles equipped with four wheel drive**, install the four wheel drive lever shift handle boot (Figure 1).
27. Install the gear shift lever center console bezel (Figure 1).

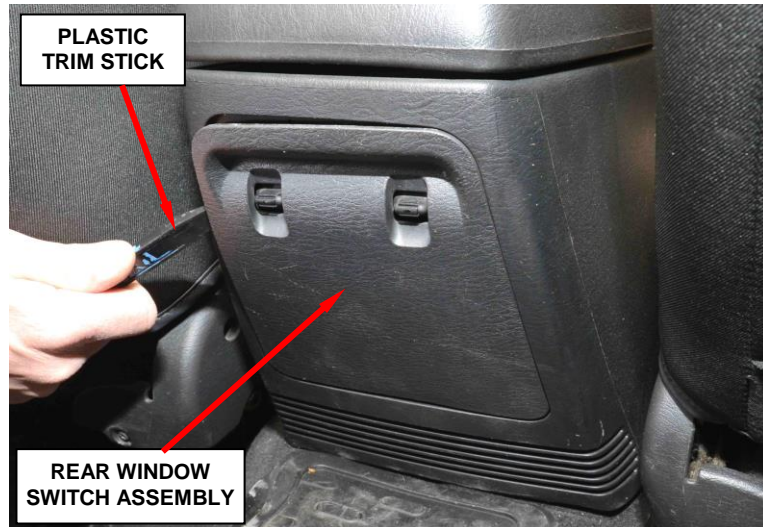
Figure 3 – Rear Window Switch Assembly

7. Remove and save the rear window switch assembly from the center console (Figure 3).
8. Remove and save the four center console retaining screws.
9. Carefully remove and save the center console assembly.
10. **For vehicles that had Safety Recall M35 performed**, remove and discard the foil mastic patch from the ORC module rubber cover (Figure 4).

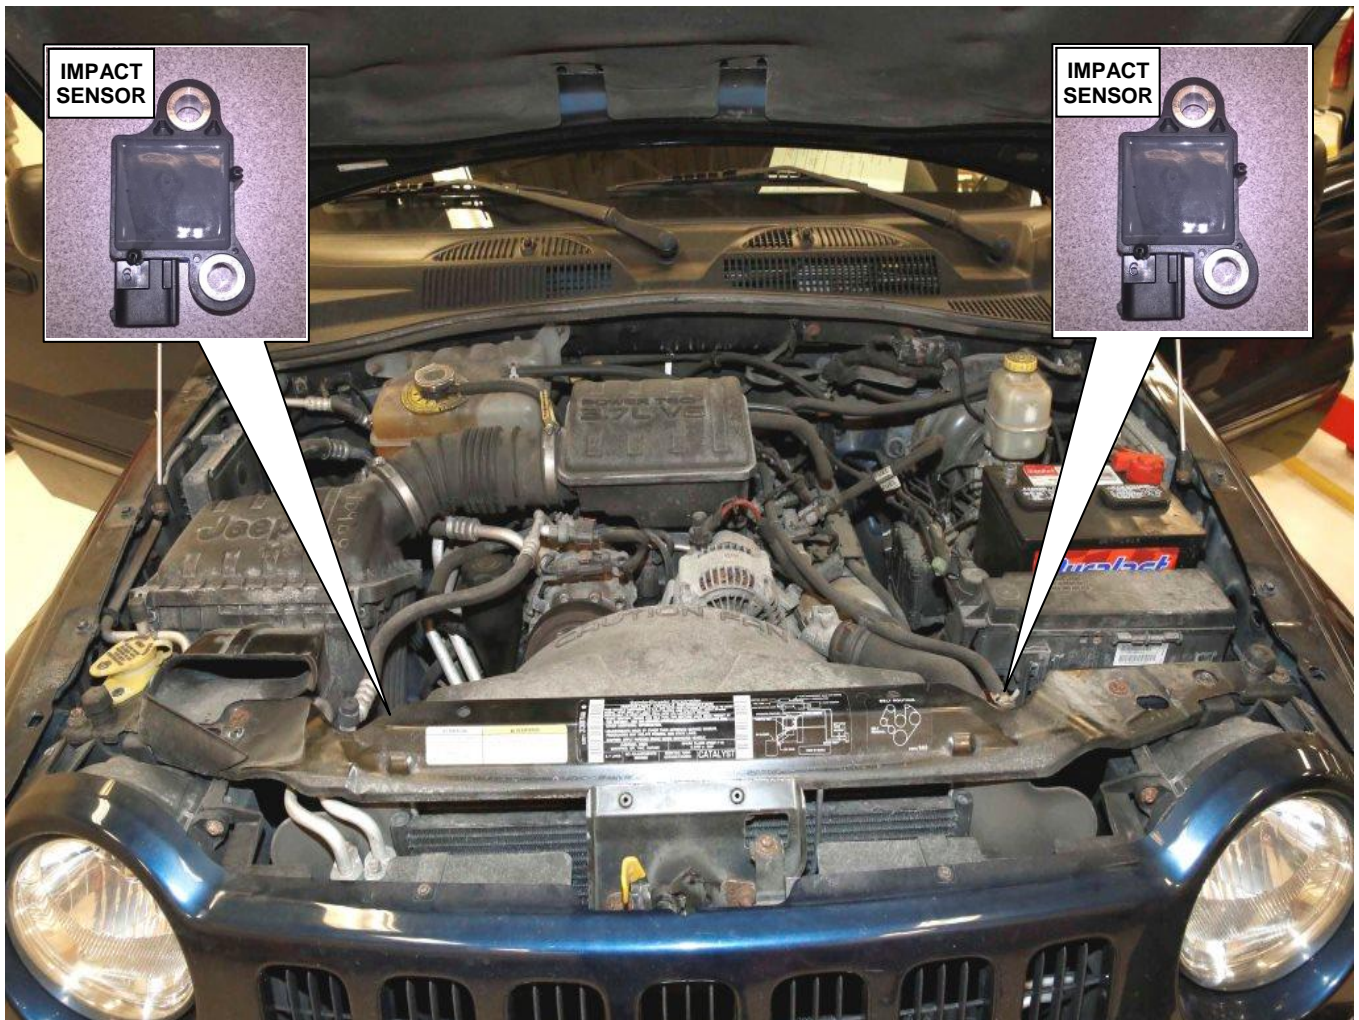
Figure 10 – Front Impact Sensor Location

NOTE: The front impact sensors are located to the right and left of the radiator on the radiator support vertical member (Figure 10).

2. Remove and save the two mounting bolts on the front impact sensor.
3. Disconnect the electrical connector from the front impact sensor.
4. Remove and discard the original front impact sensor.

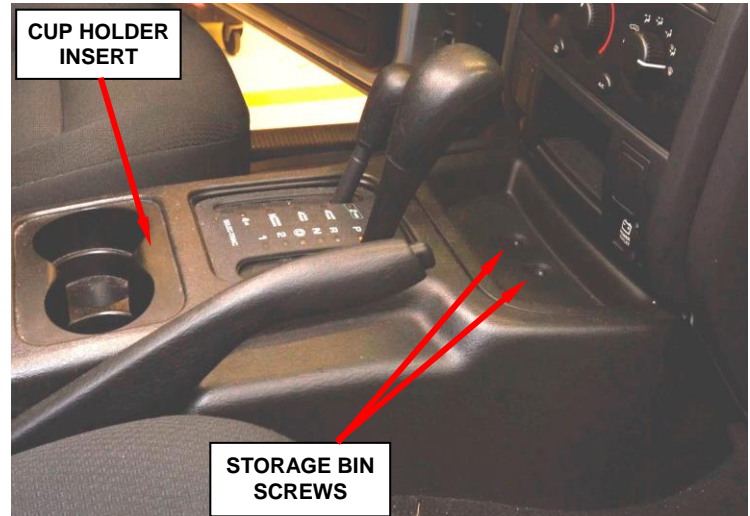
**Figure 11 – Storage Bin Screws**

1. Disconnect the negative battery cable.
2. Remove and save the center console using the following procedure:
 - a. Remove and save the two retaining screws in the console storage bin (Figure 11).
 - b. Remove and save the cup holder insert from the console (Figure 11).
 - c. Remove and save the two screws under the cup holder insert (Figure 12).

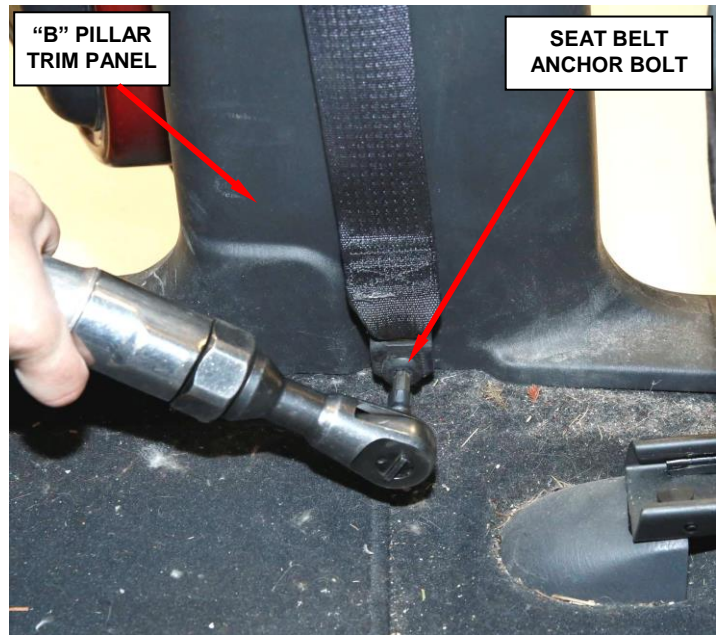
Figure 21 – Seat Belt Anchor Bolt

10. Install the center console.
11. **For vehicles that require side impact sensor replacement,** perform the following steps:
 - a. Remove and save the seat belt anchor bolt (Figure 21).
 - b. Remove and save the “B” pillar trim panel (Figure 21).
 - c. Remove and discard the original side impact sensor (Figure 22).
 - d. Install the new side impact sensor. Tighten the retaining bolts to 105 in. lbs. (12 N·m).

- e. Install the “B” pillar trim panel.
- f. Install the seat belt anchor bolt (Figure 21).
- g. Repeat Steps 11a. through 11f. on the opposite side of the vehicle to replace the second side impact sensor.

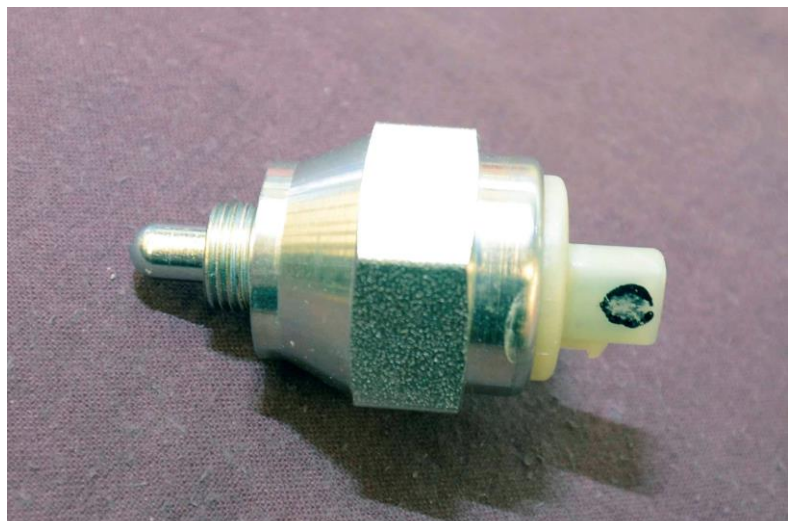
**Figure 24 – Transfer Case Switch**

5. Using a 1 ½ inch socket, remove and discard the original transfer case four wheel drive indicator light switch (Figure 24).
6. Install the new transfer case four wheel drive indicator light switch. Tighten the switch to 20 ft. lbs. (27 N·m).
7. Place the transfer case shift cable bracket and shift cable into position.
8. Install the three transfer case shift cable bracket mounting bolts. Tighten the bolts securely.
9. Connect the transfer case shift cable to the transfer case lever on the transfer case.
10. Lower the vehicle from the hoist.
