# Safety Recall

## Code: 23R1

<b>Subject</b>	<b>Camshaft (ECM Software) - MY 2015 Vehicles ONLY</b>
<b>Release Date</b>	February 17, 2016
<b>Important Information 2015 MY ONLY</b>	<b>Beginning on February 17, 2016, recall repairs can begin for 2015 MY vehicles ONLY.</b> Dealerships are encouraged to review their schedules to ensure necessary staffing is in place so repairs can begin as soon as possible.  Affected 2016 MY vehicles remain REPAIR NOT YET AVAILABLE and cannot be offered for sale/lease. We are working diligently to have the SVM code available for 2016 MY, and will release it as soon as possible.
<b>Affected Vehicles</b>	<b>U.S.A. &amp; CANADA: Certain 2015 MY Volkswagen Vehicles with 1.8T &amp; 2.0T Gasoline Engines</b>  <i>Check Campaigns/Actions screen in Elsa on the day of repair to verify that a VIN qualifies for repair under this action. Elsa is the <u>only</u> valid campaign inquiry &amp; verification source.</i> <ul style="list-style-type: none"><li>✓ Campaign status must show "open."</li><li>✓ If Elsa shows other open action(s), inform your customer so that the work can also be completed at the same time the vehicle is in the workshop for this campaign.</li></

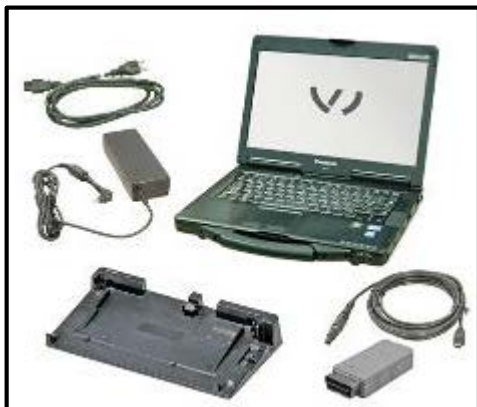
- VAS6150C – Diagnostic Tester (or equivalent)

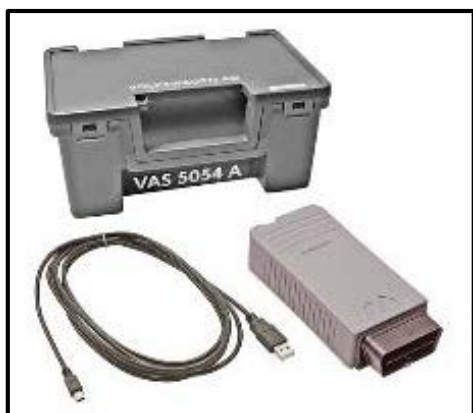
- VAS5054A – Remote Diagnosis Head (or equivalent)

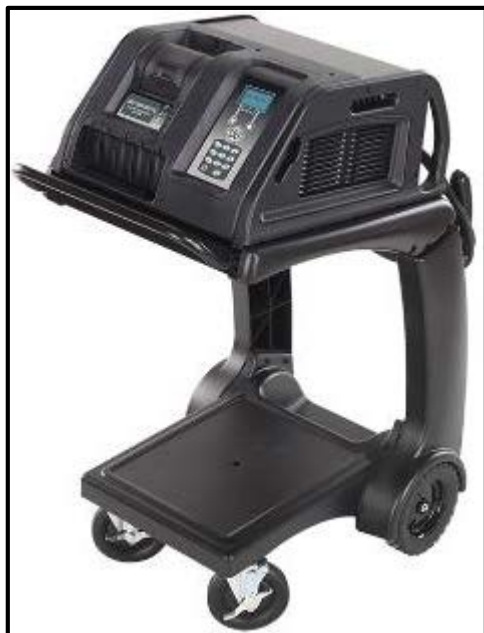
- GRX3000VAS – Battery Tester/Charger (or equivalent)

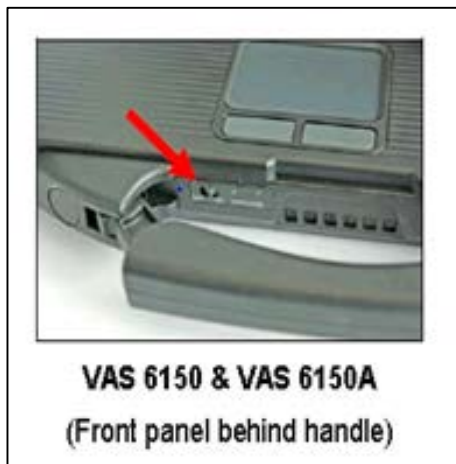
- Switch the ignition OFF.
- Open the hood.
- Connect the battery charger to the vehicle.
- Connect the VAS tester to the on-line network using an Ethernet cable.
- Connect the VAS 5054A transmitter head to the VAS tester using the USB cable.
- Disable the Bluetooth by physically turning the switch to the “off” position.

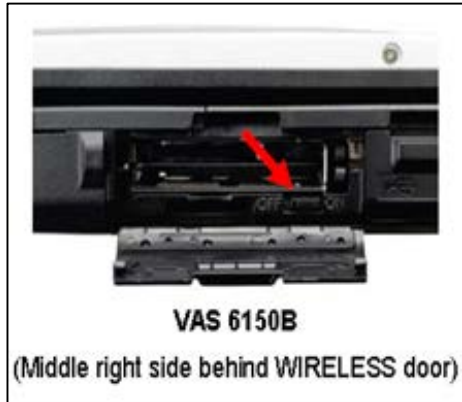
If the Bluetooth wireless VAS 5054A transmitter head is used in conjunction with a VAS tester, the transmitter head **MUST BE** connected with a USB cable to the tester.

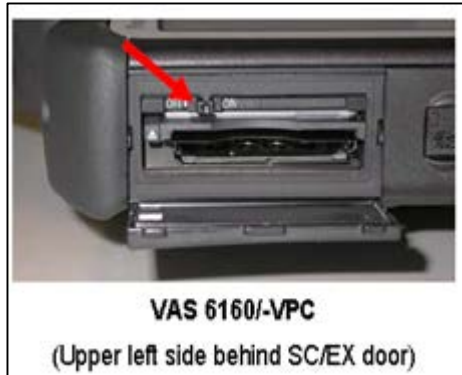
The Bluetooth function of the scan tool **MUST BE PHYSICALLY SWITCHED OFF** prior to performing this update. <See pictures>

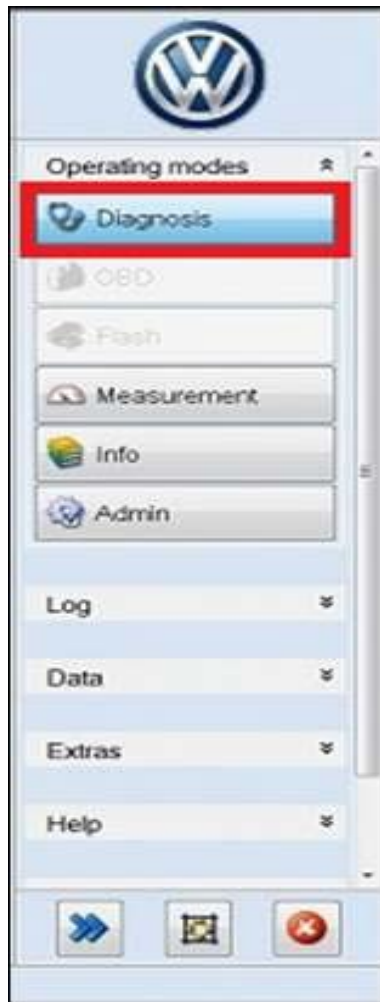
- Switch the ignition on.
- Attach an appropriate VAS tester to the vehicle.

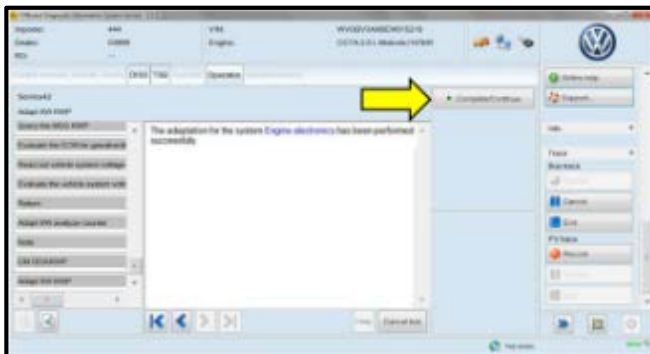
5. If the old and new software versions displayed are different, Select "Yes" and follow the on-screen prompts to complete the test plan.
6. Reference the ECM Software Change Table above for affected ECMs.
