Bulletin No.: 15757B  
Date: April 2016

# Recall Bulletin

**SUBJECT:** Under Hood Fire

**MODELS:** 1997-2004 Buick Regal  
2000-2004 Chevrolet Impala  
1998-1999 Chevrolet Lumina  
1998-2004 Chevrolet Monte Carlo  
1998-1999 Oldsmobile Intrigue  
1997-2004 Pontiac Grand Prix  
Equipped with 3.8L V6 Engine (RPO L26, L32, L36 or L67)

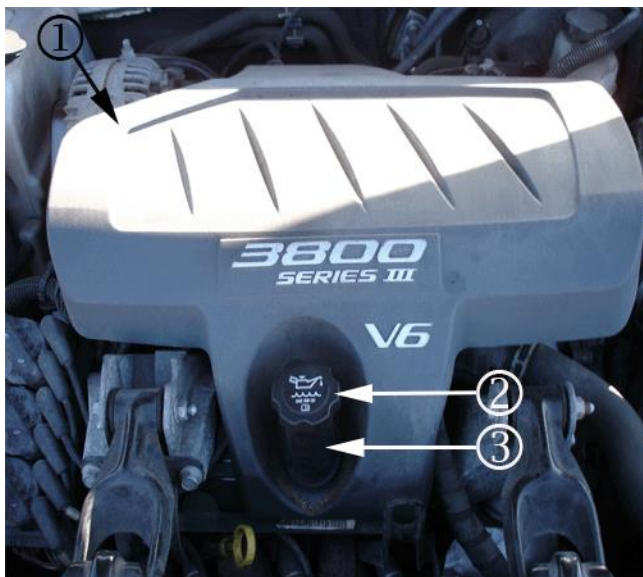
4358359

1. Perform steps 1.1 through 1.4 to remove and discard the fuel injector sight shield (1).

- 1.1. Remove the oil fill cap (2) by twisting it counterclockwise.
- 1.2. Remove the oil fill tube (3) by twisting it counterclockwise and discard.
- 1.3. Lift the fuel injector sight shield up at the front and slide the tab out of the engine bracket.
- 1.4. Discard the fuel injector sight shield. Do NOT reinstall the sight shield.
- 1.5. Inspect the oil fill cap o-ring for damage. If there are signs of damage, replace the o-ring.
- 1.6. Reinstall the oil fill cap in the valve cover to prevent engine oil contamination.

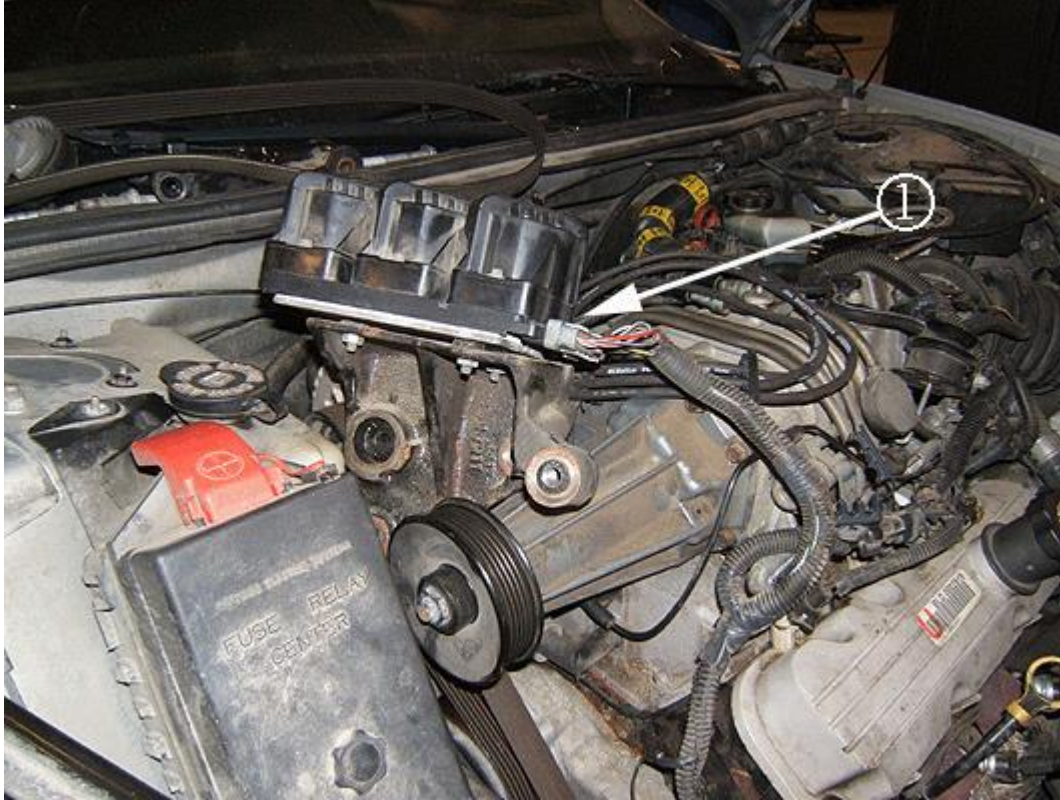
2077654

**Note:** It is not necessary to remove the ignition coils/module or the 14-way connector (1) from the left engine mount strut bracket.

4. Remove the left engine mount strut bracket (1) as an assembly.
  - 4.1. Remove the left engine mount strut bracket assembly nuts.
  - 4.2. Remove the stud holding the electronic ignition control module ground and left engine mount strut bracket assembly to the cylinder head.
  - 4.3. Remove the left engine mount strut bracket assembly (1) from the cylinder head and set aside.

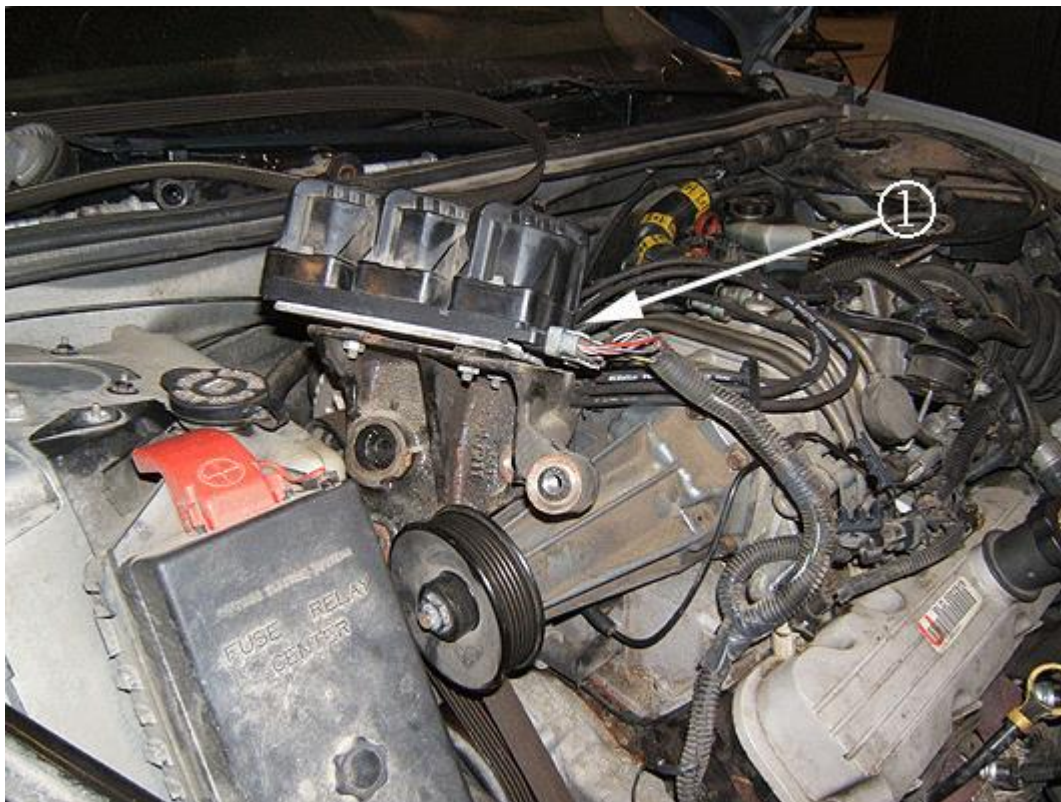
2077654

7. Install the left engine mount strut bracket assembly to the cylinder head (1).
  - 7.1. Install the left engine mount strut bracket nuts and stud.
  - 7.2. Install the stud holding the electronic ignition control module ground and left engine mount strut bracket assembly to the cylinder head.
  - 7.3. Tighten the left engine mount strut bracket nuts and stud to 50 Nm (37 lb ft).
8. Install all six spark plug wires to the ignition coils.

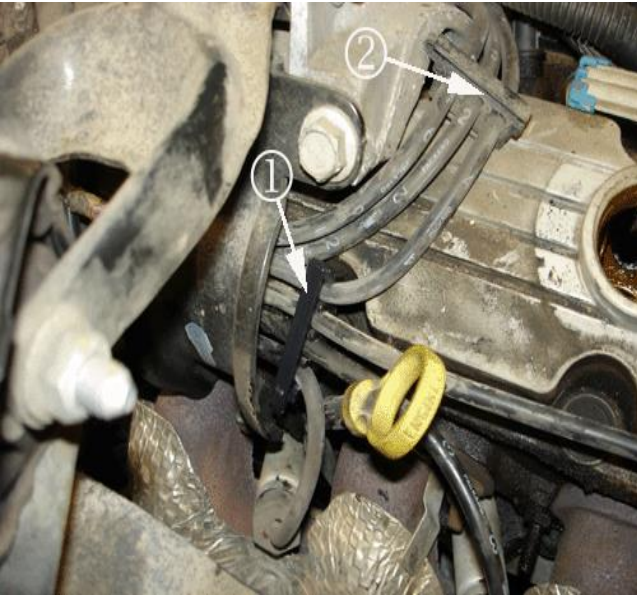
2257359

9. Ensure that spark plug retainer (1) is connected to spark plug wire 4 and spark plug wires 1, 3, and 5. Make sure that spark plug wires 2, 4 and 6 are secured to the original retainers and under the left engine mount strut bracket (2).

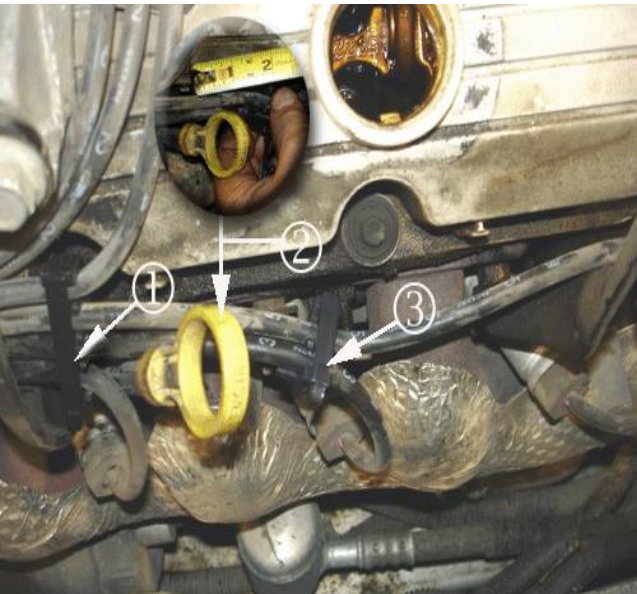
2257363

**Note:** Do NOT position the retainers above an exhaust runner.

10. Ensure that spark plug wires 3 and 5 are routed behind the oil level indicator and lift bracket. Verify that spark plug retainers (1 and 3) are positioned above the #1 and #3 cylinder spark

plug wire boots as shown above. Verify that spark plug retainer (3) is approximately 50mm (2 in) from the oil level indicator (2).

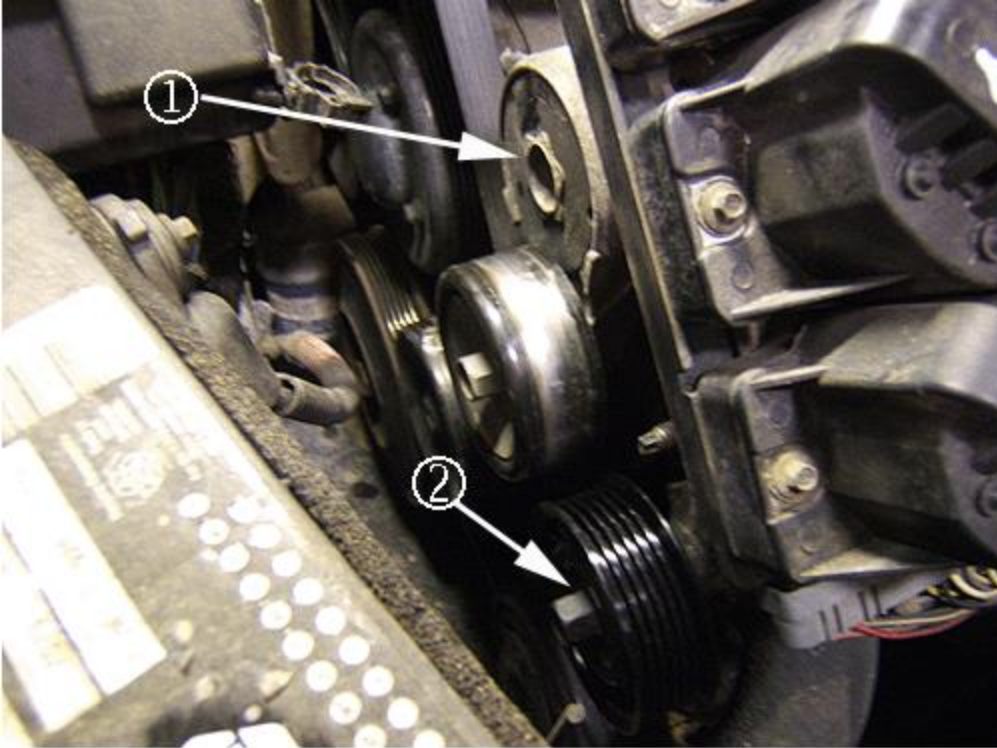
2074283

- 11. First install the supercharger drive belt idler pulley and bolt (2). Then install the supercharger drive belt tensioner and nut (1).
- 12. Tighten both the supercharger drive belt idler pulley bolt and supercharger drive belt tensioner nut to 50 Nm (37 lb ft).

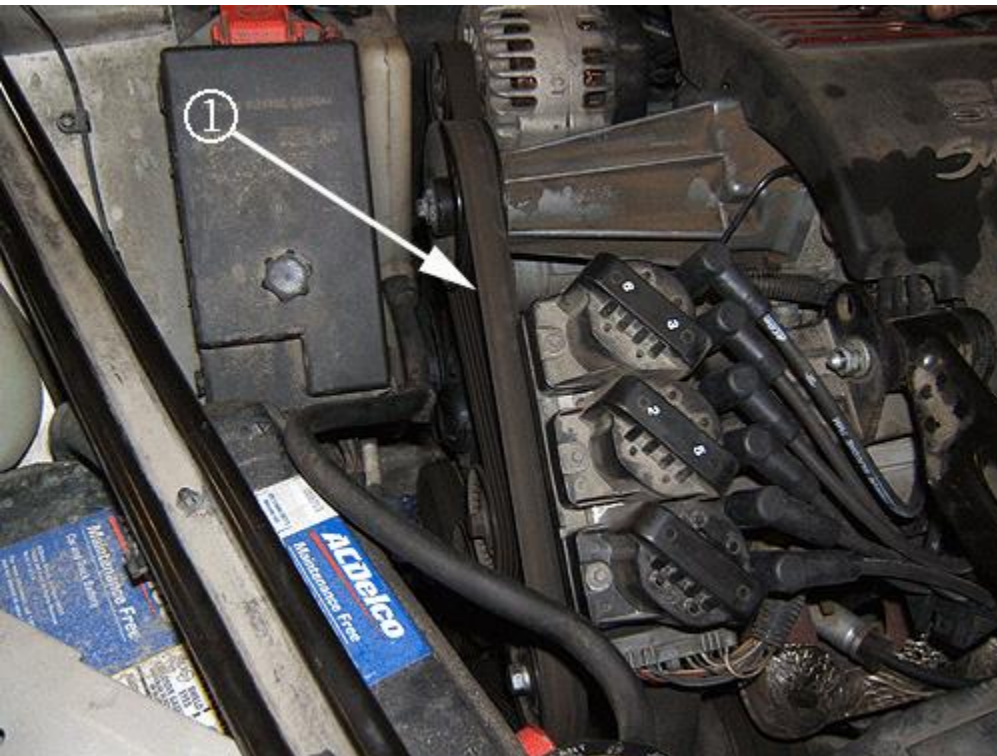
2077658

13. Install the supercharger drive belt (1). Lift or rotate the drive belt tensioner using a 15 mm box end wrench on the pulley nut and install the supercharger drive belt.

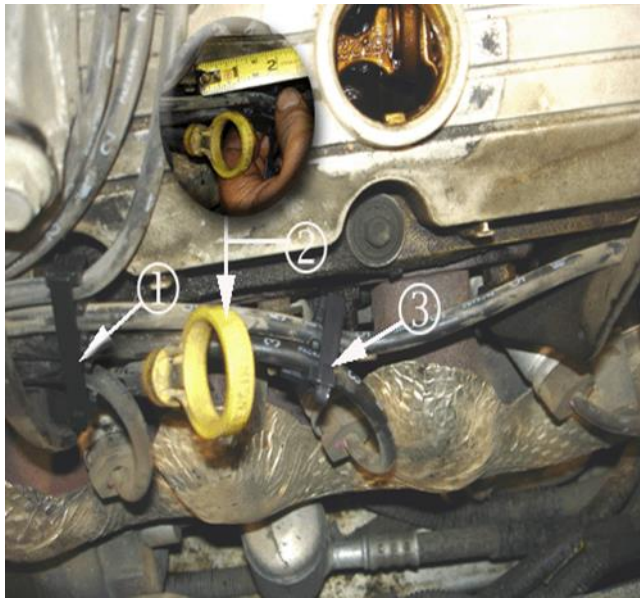
2257363

**Note:** Do NOT position the retainers above an exhaust runner.

8. Ensure that spark plug wires 3 and 5 are routed behind the oil level indicator and lift bracket. Verify that spark plug retainers (1 and 3) are positioned above the #1 and #3 cylinder spark plug wire boots as shown above. Verify that spark plug retainer (3) is approximately 50mm (2 in) from the oil level indicator (2).
