## newschannel update

| RE: <b>Recall Campaign 2018100009 Takata- Priority Group 5 Phase 2 All Zones Replace Driver-side and Passenger-side Airbags</b> -Certain MY10 W207 (E-Class Coupe), MY08-09 204 (C-Class), and MY 2010 X204 (GLK-Class) vehicles | DATE: October 29, 2018 |

### IMPORTANT TAKATA RECALL INFORMATION

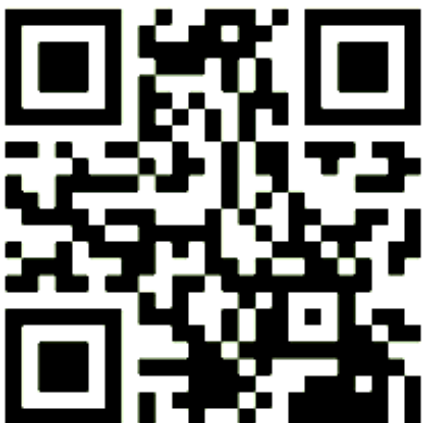
Figure 1

- To install and transmit the data a WiFi connection is required.
- After downloading the App, a one-time security authentication is required by means of encrypted QR code. Verification can be performed by scanning the QR code below, before using the application.

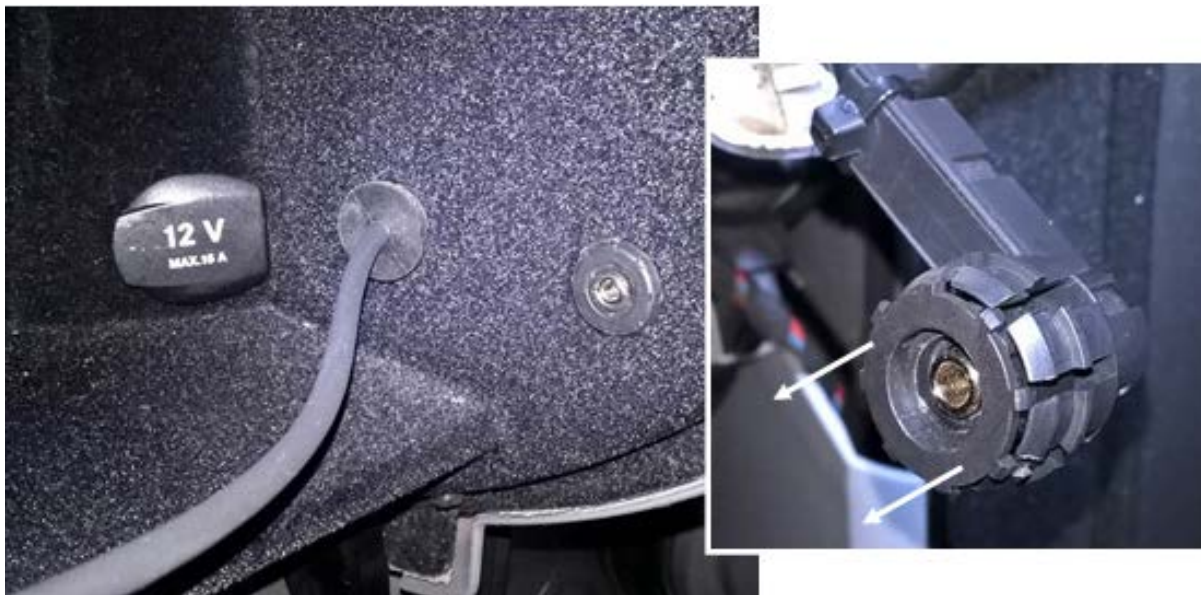
Figure 3

**i** Release inner retaining ring (**figure 3**) at the AUX connection towards the inside. The connection can then be removed from the glove box housing.

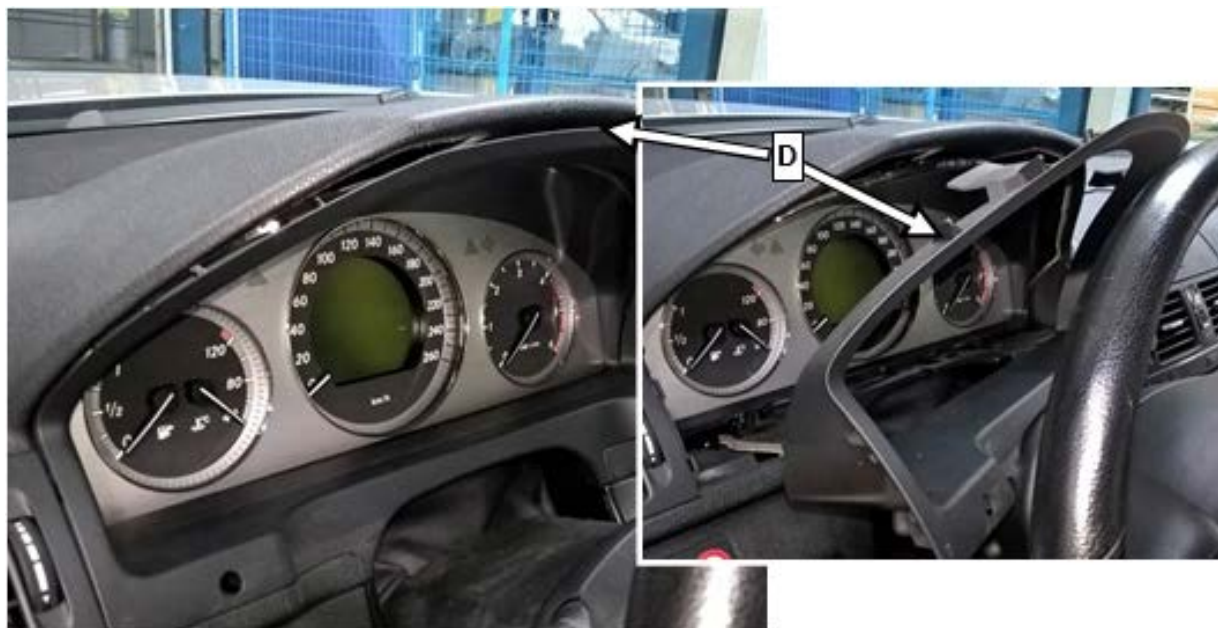
Figure 7

For basic data of model 207, see **AR83.25-P1124EC**
9. Remove trim (**D, figure 7**) around the instrument cluster.
  -

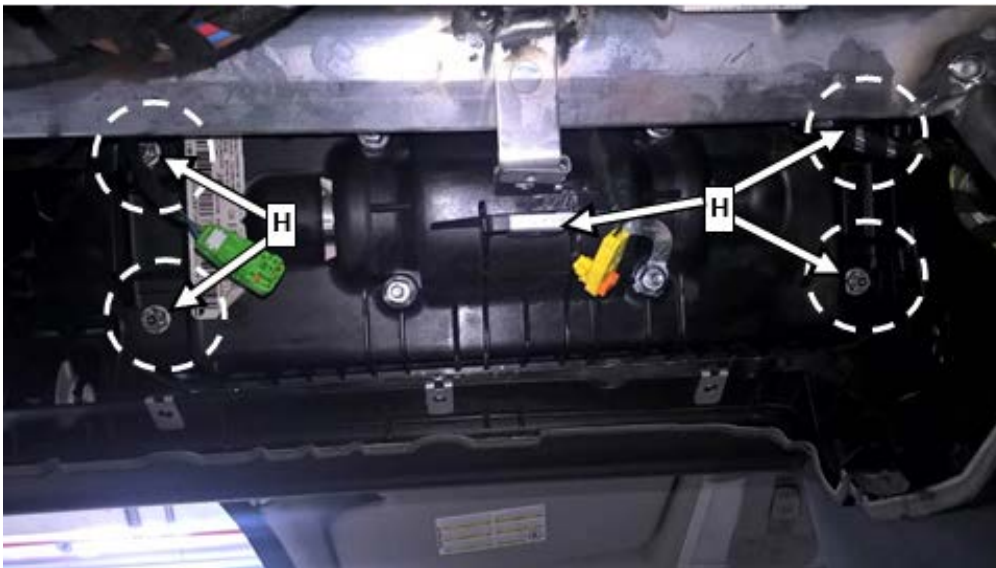
Figure 11

13. Remove lock nuts (**H**, **figure 11**) for the front the passenger airbag.

**i** Lock nuts should only be replaced if they are damaged. For more info see: **AH00.00-N-0001-01A / Modification notes 27.10.2016**

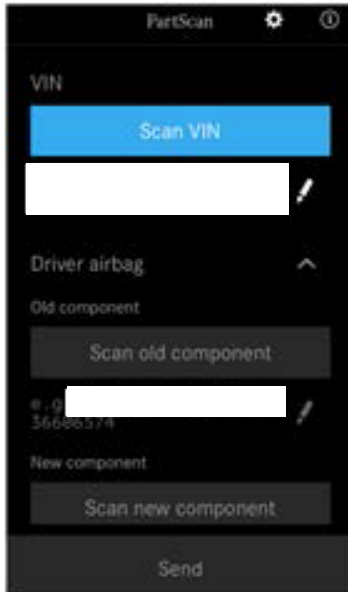
**Figure 12**

14. Slightly raise instrument panel at the front passenger side and remove the front passenger airbag in a downwards direction. Take special care not to crack the dashboard material. **DO NOT REMOVE THE DASHBOARD**
15. Use the "Scan VIN" button (**figure 12**) to scan the vehicle identification number either by the barcode or the text field.
- i** After scanning, compare the vehicle identification number that has been read in the app any correct any scanning errors manually.

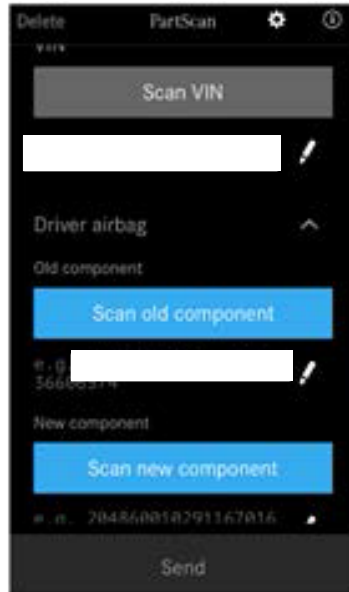
**Figure 13**

16. Scan barcodes of the removed driver airbag using the button "Scan old component" (**figure 13**).

17. Scan the barcodes of the new driver airbag using the button "Scan new component" (**figure 13**).

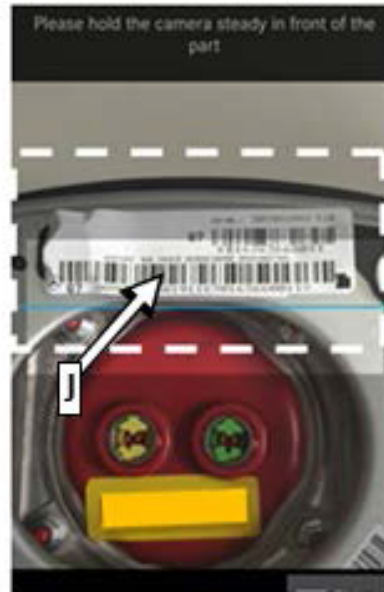
**Figure 14**

**i** Ensure that the lower barcode (**J, figure 14**) is scanned.

**i** Ensure that the lower barcode (**J, figure 14**) is scanned.

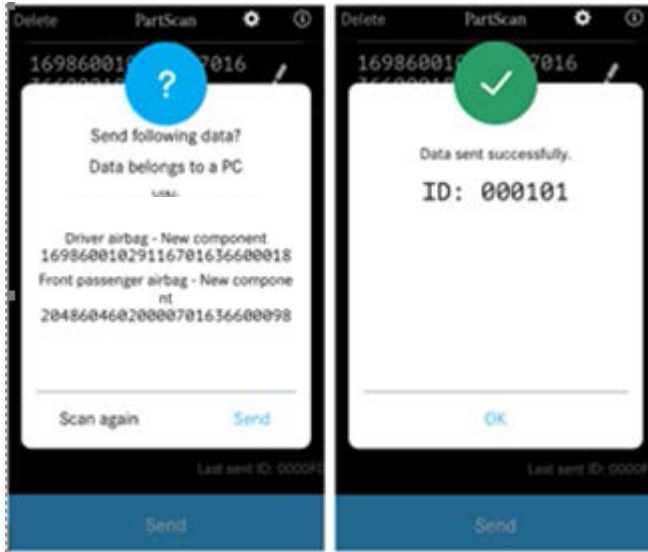
Figure 15

19. Create a scan ID via the "Send" button (**figure 15**).

**i** The generated scan ID (**figure 16**) must be recorded in writing in the workshop order and then stored in a tamper-proof manner.

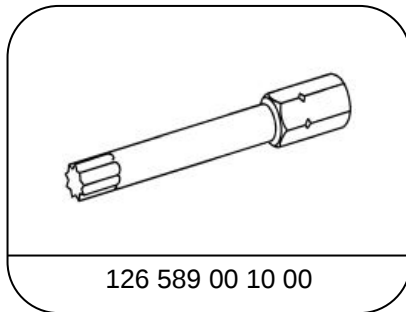
Screwdriver bit

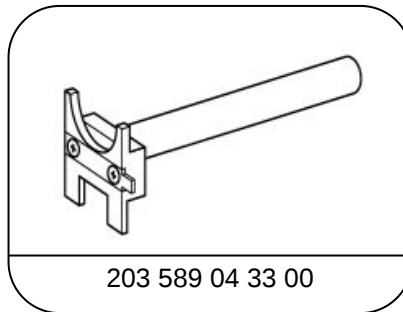
Removal lever (or locally sourced equivalent)

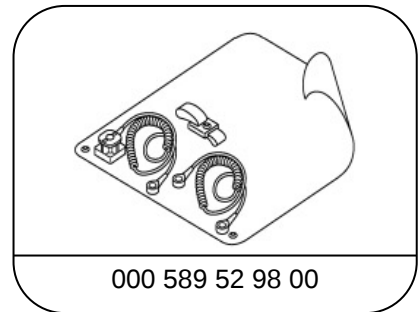
Electro Static Discharge (ESD) kit (or locally sourced equivalent)

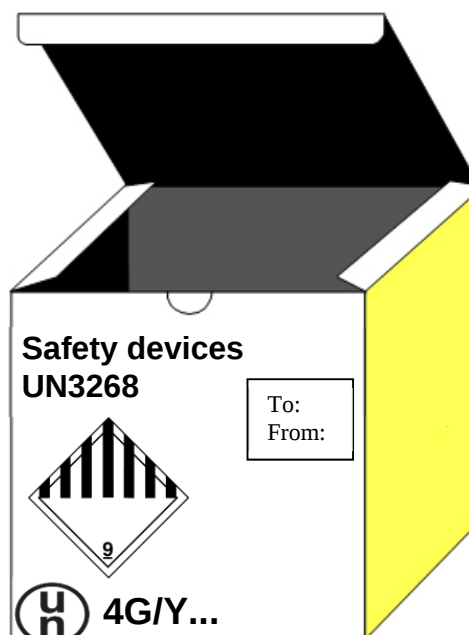
- Note:** The Packing Group and the EX# are no longer required to be printed on the HAZMAT bill of lading.
- Package example:**

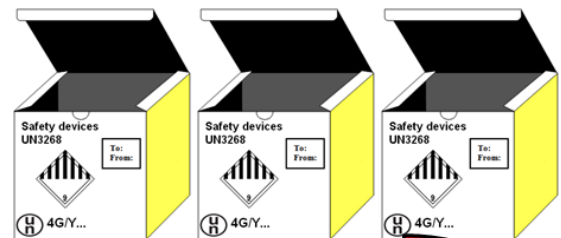
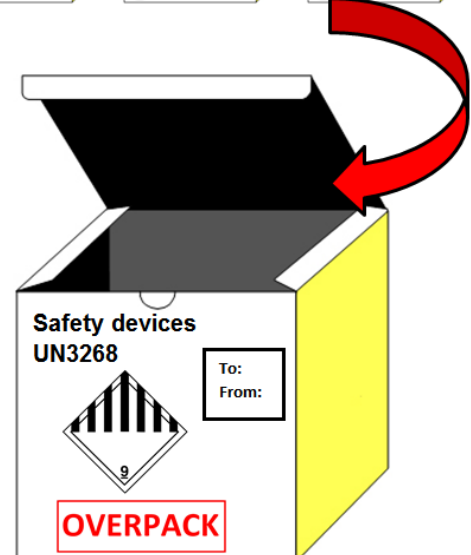
- Package each airbag in a separate UN spec box prepared with the labels/markings described above.
- Place each individual airbag box inside a larger non-UN spec box to keep the shipment together.
- This larger box is called an "OVERPACK."

- The OVERPACK must have the identical markings and label as the boxes contained inside.
- The OVERPACK must have the "OVERPACK" statement on the same face as the hazard markings and labels. **Package example:**
