| RE: <b>Recall Campaign 2018100010 Takata- Priority Group 5 Phase 2 All Zones Replace Driver-side Airbags</b> –Certain MY 10 W212 (E-Class Sedan), MY09 W/X164(ML-Class, GL-Class) and W251 (R-Class) vehicles | DATE: October 29, 2018 |

SUBJECT: **Model 164, 251 and 212**  
**Model Years 2009 - 2010**  
**Replace Driver-Side Airbag**

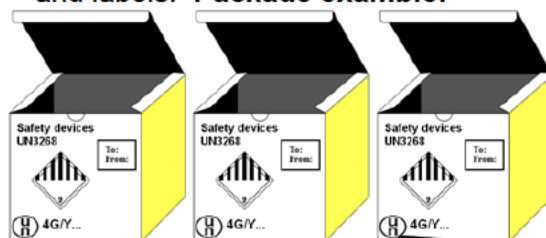
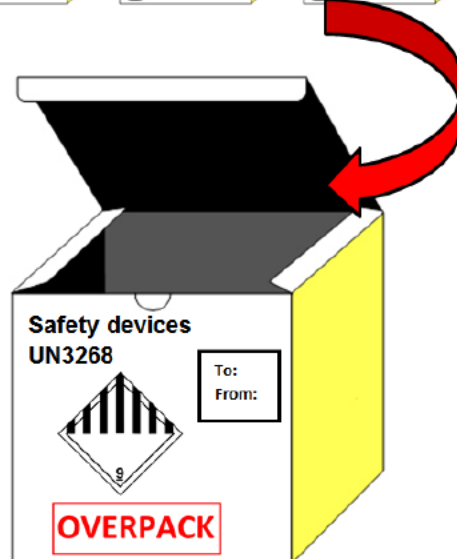
- Package each airbag in a separate UN spec box prepared with the labels/markings described above.
- Place each individual airbag box inside a larger non-UN spec box to keep the shipment together.
- This larger box is called an "OVERPACK."

- The OVERPACK must have the identical markings and label as the boxes contained inside.
- The OVERPACK must have the "OVERPACK" statement on the same face as the hazard markings and labels. **Package example:**
