| RE: <b>Recall Campaign Launch Notification – 2019050010 Takata PG4 and PG5 DRIVER and PASSENGER AIRBAGs</b><br>Certain MY10-11 C63 AMG (204) | DATE: May 24, 2019 |

SUBJECT: **Model 204 (C63 AMG only) Model Years 2010-2011**  
**Replace Driver-Side and Front Passenger-side Airbag**

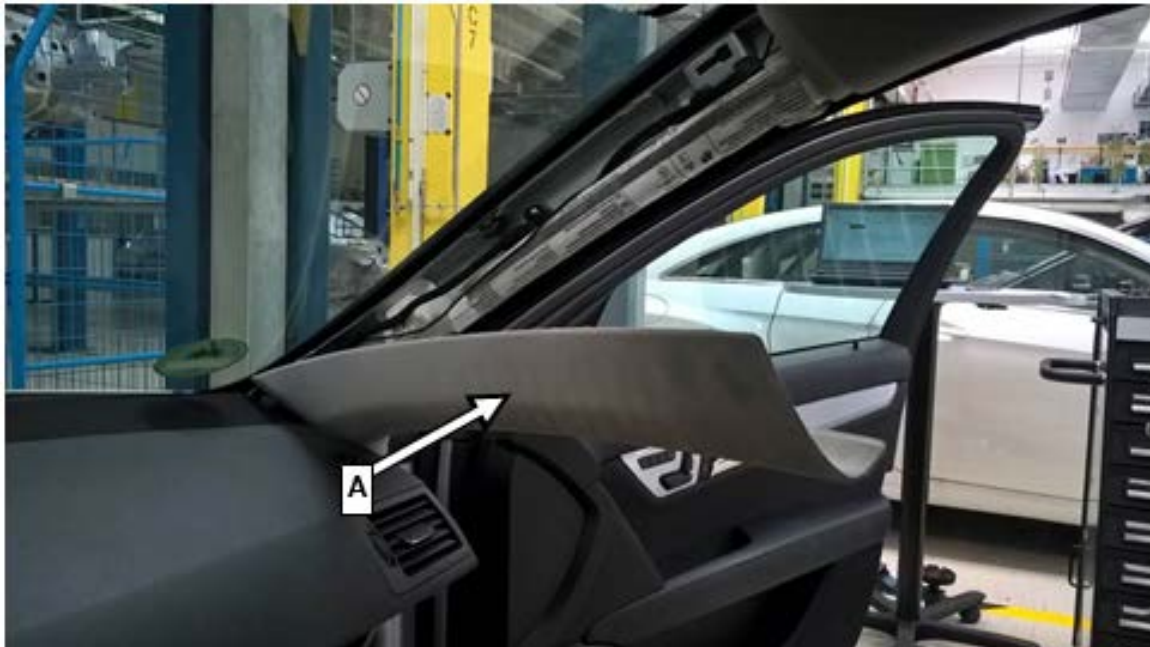
Figure 2

3. Remove right A-pillar trim (**A**, figure 2).

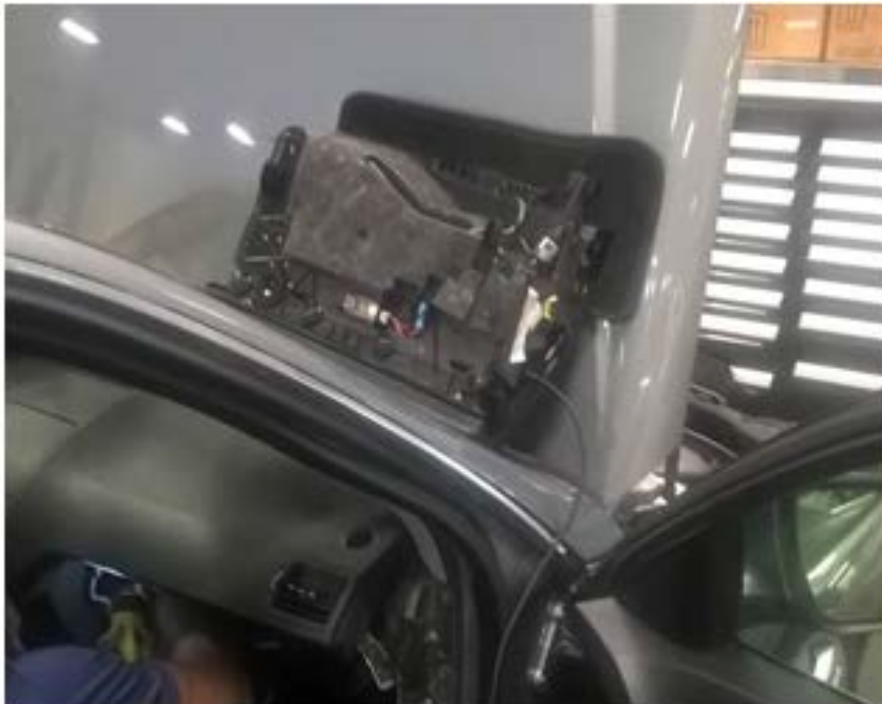
**Figure 4**

**i** Pull out the iPod cable as far as possible and set down glove box housing on the windshield **with** exterior iPod cable connected (**figure 4**).

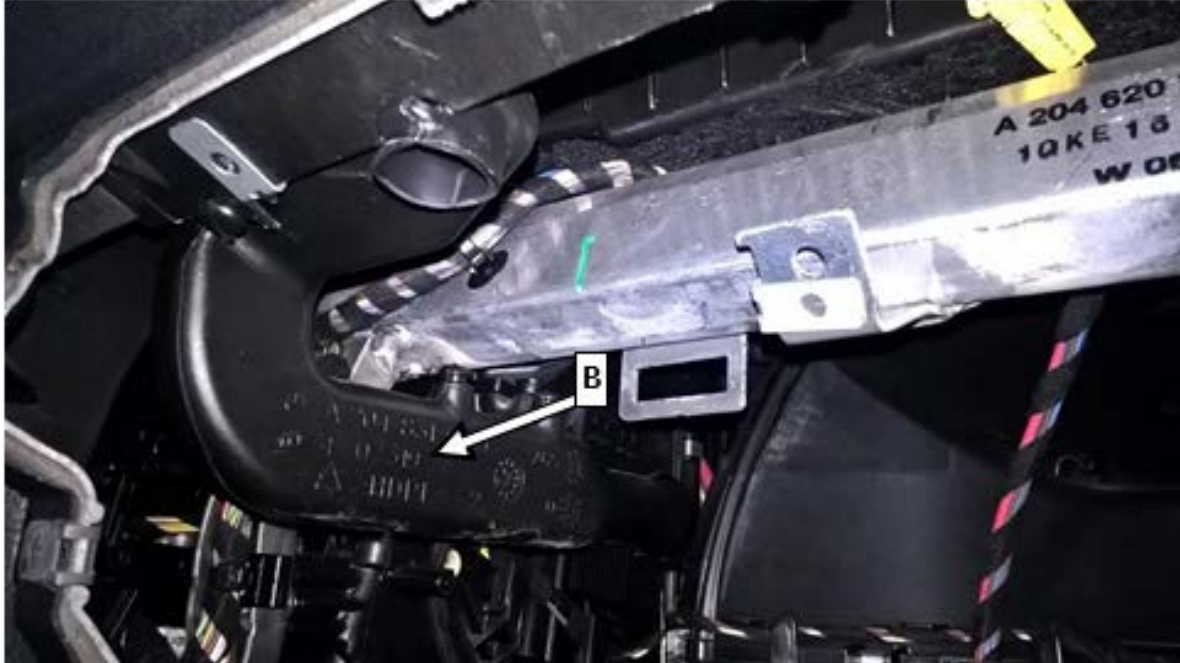
**Figure 5**

5. Remove air duct (**B**, **figure 5**) above the glove compartment.

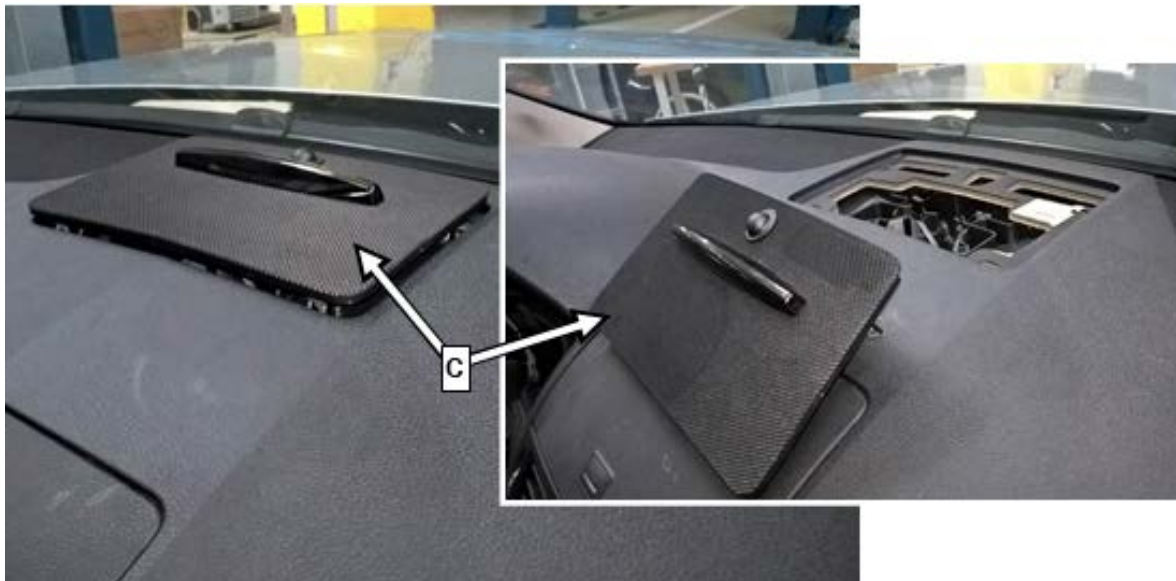
**Figure 6**

6. Unclip and remove cover (**C**, **figure 6**) at the instrument panel on top.

**i** With a sound system, also remove speaker under the cover.

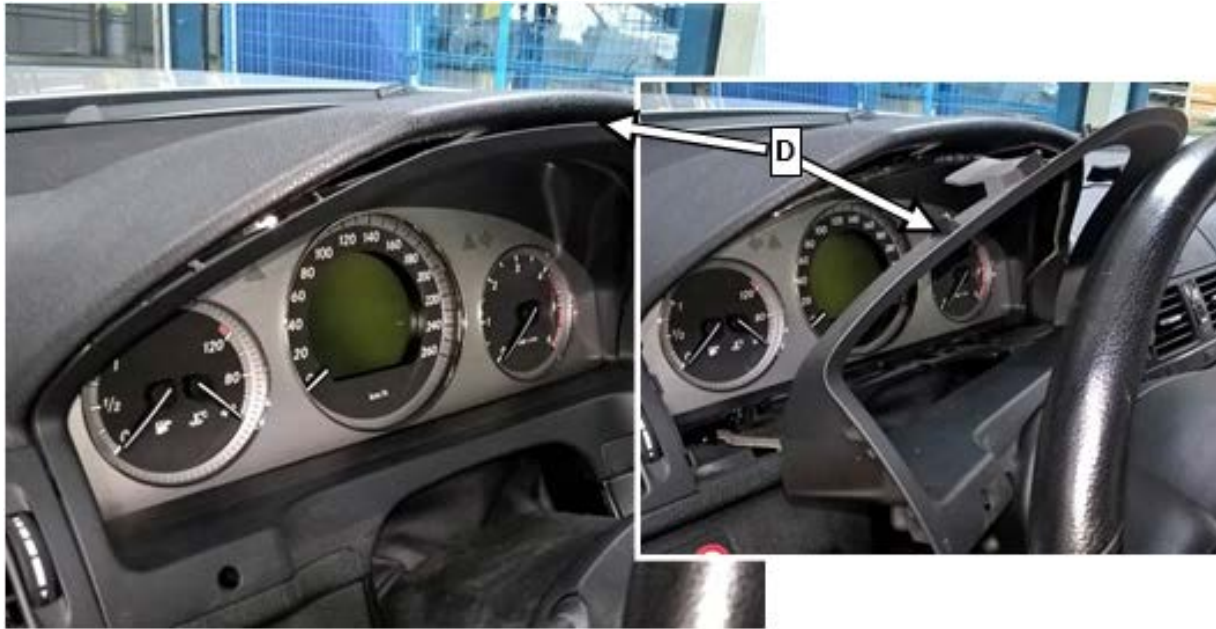
Figure 7

7. Remove center console (**AR68.20-P-2000CW**).
8. Remove automatic climate control and operating unit (**AR83.40-P-6350CW**).
9. Remove trim (**D, figure 7**) around the instrument cluster.
  - i** For basic data, see **AR54.30-P-6015CW**.

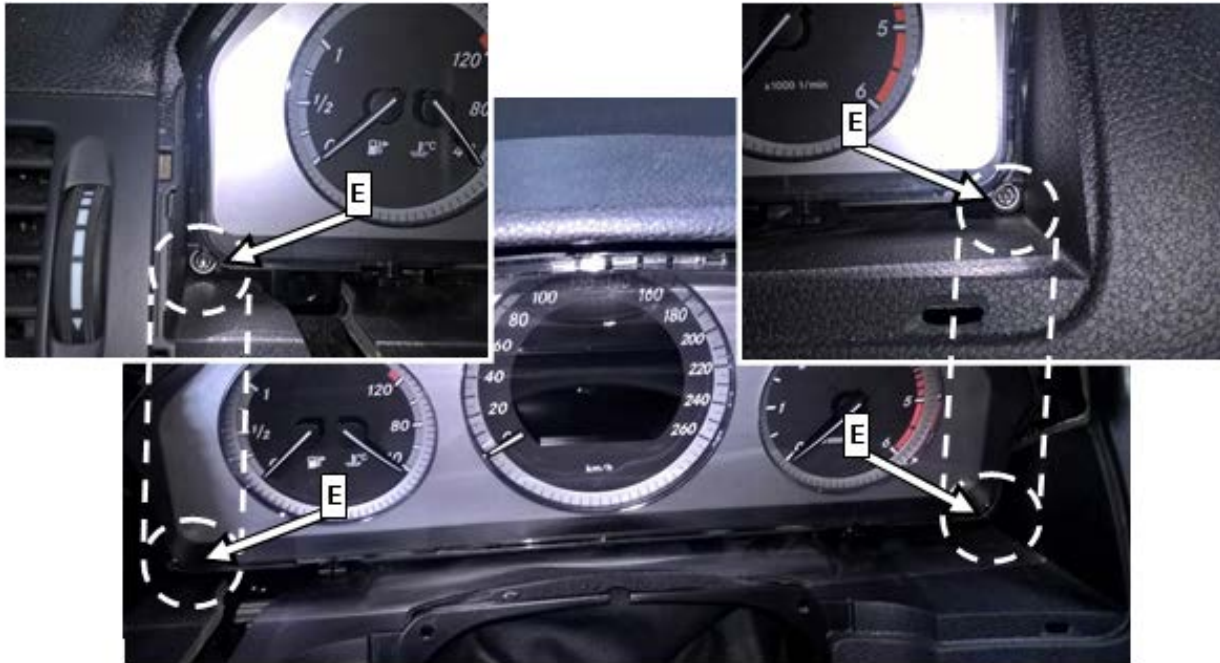
Figure 8

10. Remove the two bottom threaded connections (**E, figure 8**) of the instrument cluster.
  - i** These screws are simultaneously fasteners for the instrument panel.
  - i** The upper two screws do not need to be removed.

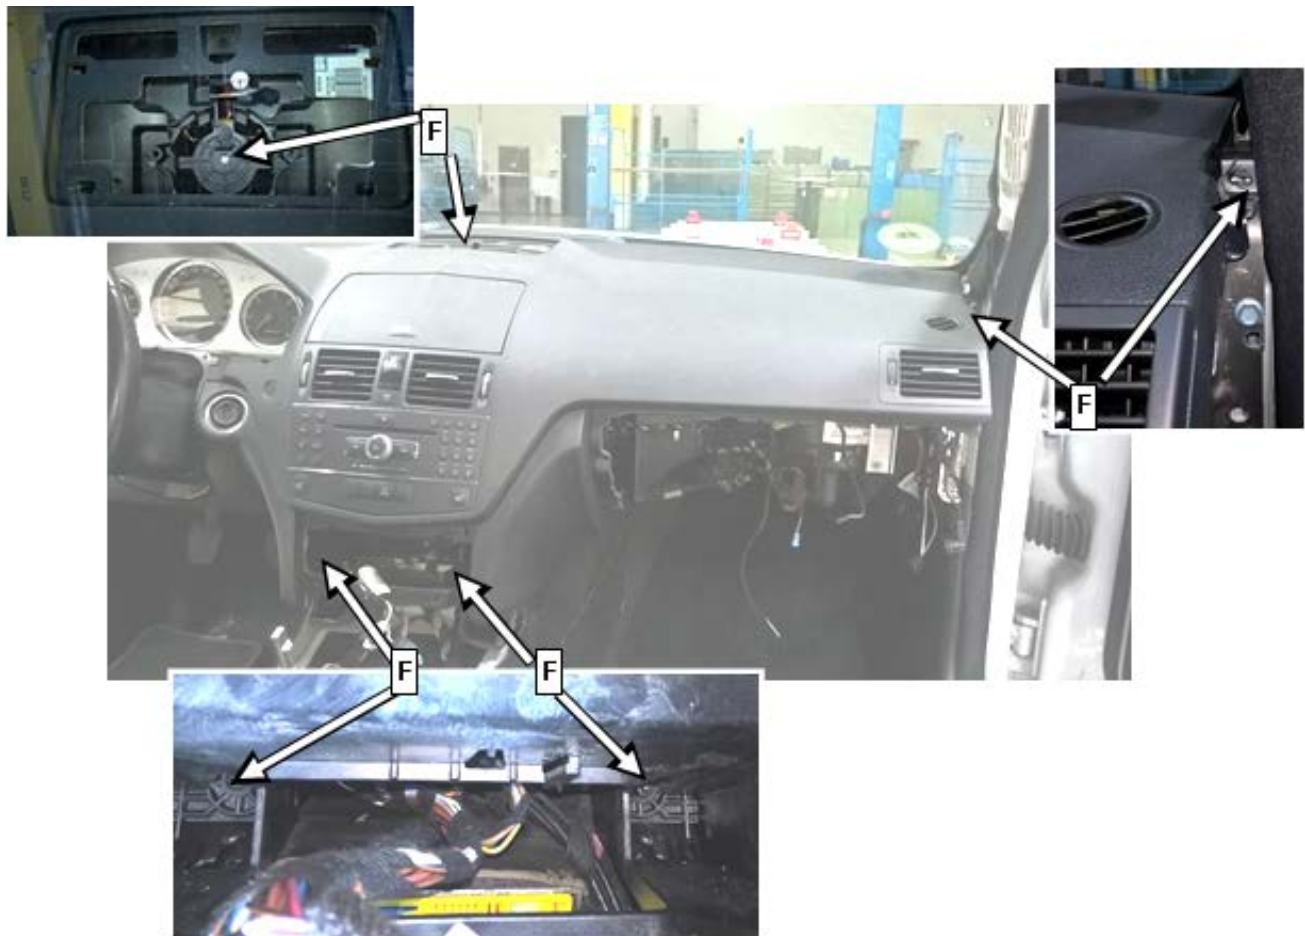
Figure 9

11. Remove four screws (F, figure 9) for fastening the instrument panel

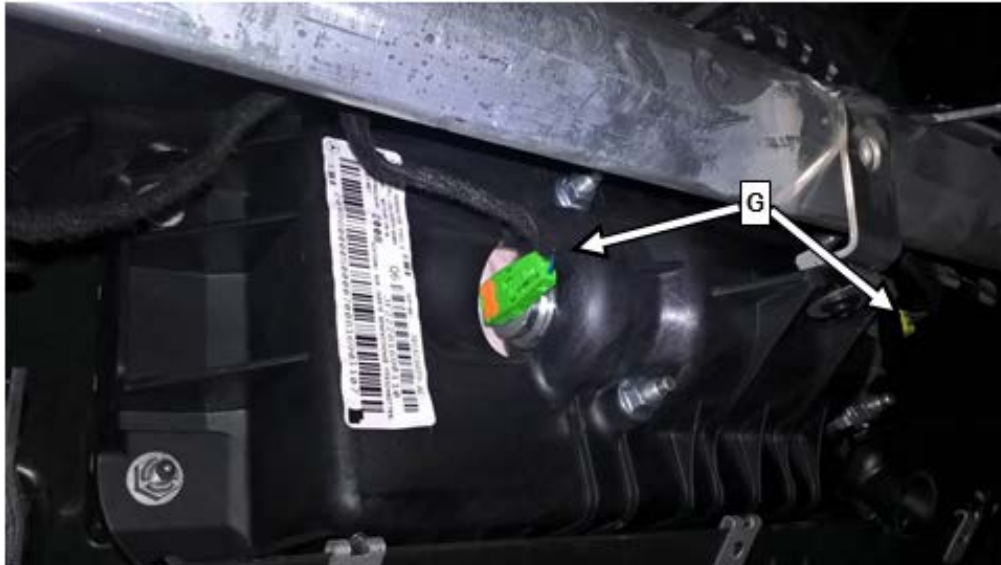
Figure 10

12. Disconnect electrical contacts (**G**, **figure 10**) at the front passenger airbag.

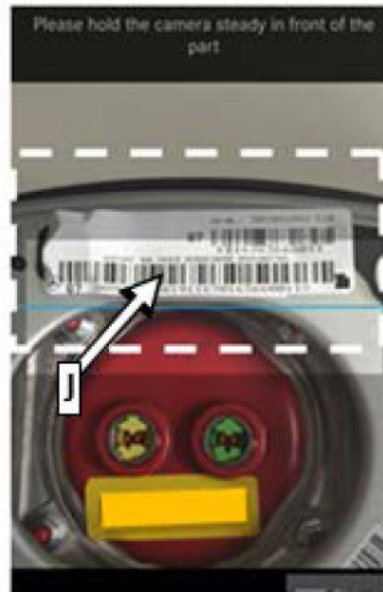
Figure 14

**i** Ensure that the lower barcode (J, figure 14) is scanned.

**i** Ensure that the lower barcode (J, figure 14) is scanned.
