Product Safety Recall

15816 Front Passenger Air Bag Inflator

Reference Number: N150816

Correction	Dealers are to replace the front passenger air bag inflator.

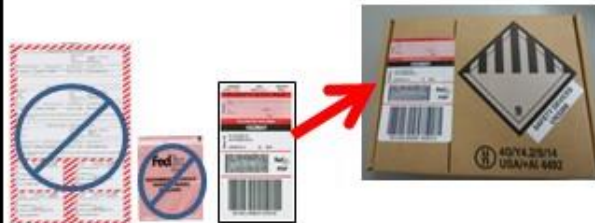
- Place the Barcode label on the box as pictured below
- The Address info on the Label **DOES NOT** need to be completed
- Throw away the OP900 (Red Stripe Form) and the Plastic Pouch
