| RE: <b>Recall Campaign UPDATE – 2019090009 Takata PG6 DRIVER and PASSENGER AIRBAGS</b><br>Additional 2010 – 2011 E-Class Coupes and MY2011 Cabrios (207) | DATE: October 31, 2019 |

SUBJECT: **Model 204, 207, X204 and 197****Model Years 2010 – 2015****Replace Driver-Side and Front Passenger-side Airbag**

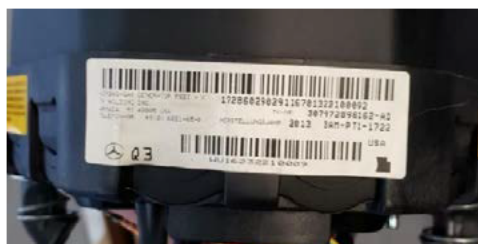
If the customer's vehicle has a different Mercedes-Benz steering wheel and airbag module, please remove the airbag module and take detailed photographs of the labels on the module, including the part numbers. Please send the photographs in a zip folder to your AOM with a request to forward to MBUSA for further investigation. MBUSA will then advise as to the correct part number to use for the repair or will close the campaign out manually if the airbag does not have to be replaced. Please see below example image of label.

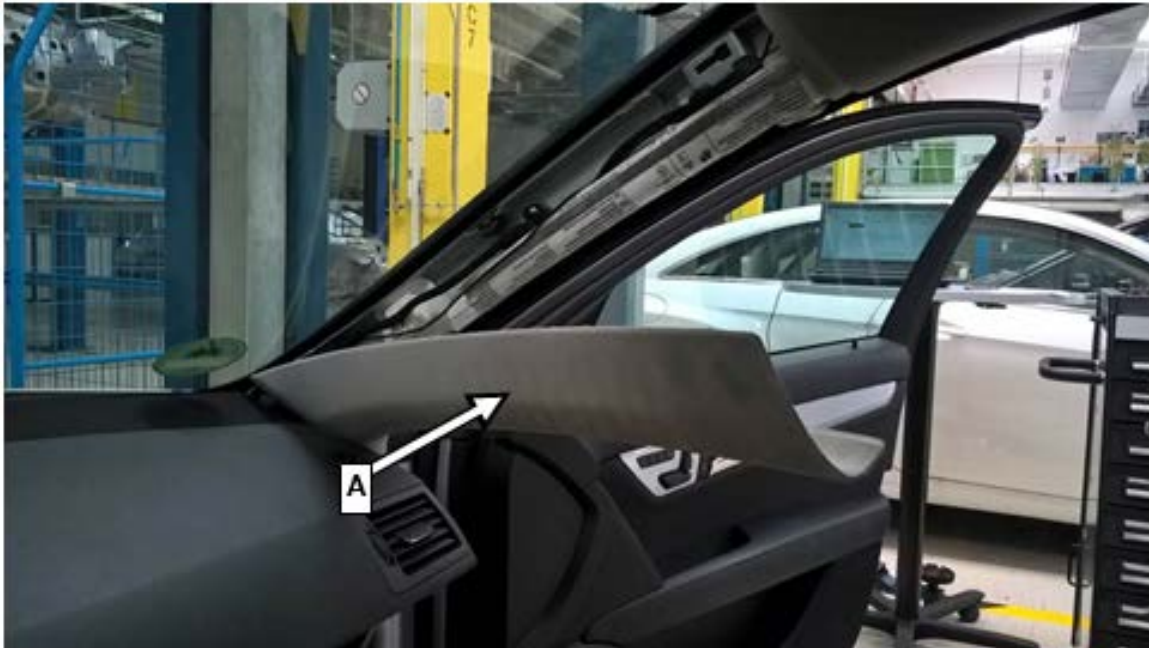
**Figure 2**

1. Disconnect ground line from the on-board electrical system battery.
2. Remove driver airbag at the steering wheel.
  - i** For basic data of model 204, see **AR91.60-P-0660CW**
  - i** For basic data of model 207, see **AR91.60-P-0660EW**
  - i** For vehicles with code 428, switch up the connector coupling for steering wheel shift paddles, rework to the new driver airbag (**BT54.18-P-0002-01CW**).
  - i** Do not install the new driver airbag at the steering wheel until after the scan procedure in operation step 19.
3. Remove right A-pillar trim (**A, figure 2**).

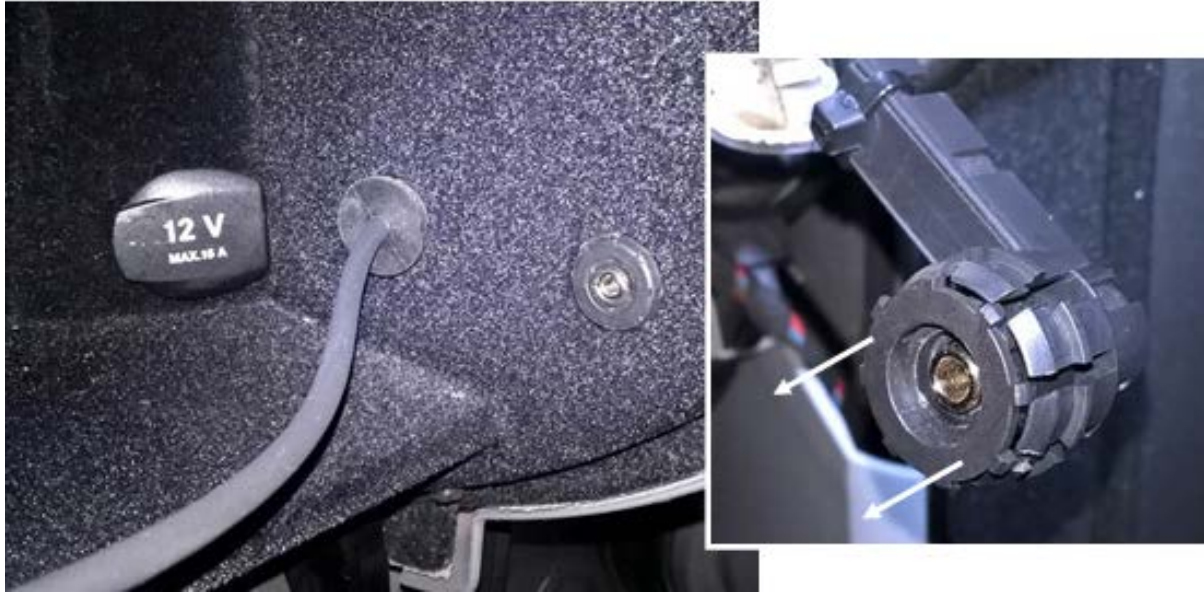
Figure 3

4. Remove glove box housing
  - i** For basic data of model 204, see **AR68.10-P-1200CW**
  - i** For basic data of model 207, see **AR68.10-P-1400EC**
  - i** Release inner retaining ring (**figure 3**) at the AUX connection towards the inside. The connection can then be removed from the glove box housing.
  - i** Pull iPod cable **with** rubber grommet out of glove box housing until the connector plug makes contact with the housing. **Do not pull cable out of rubber grommet** because it is bonded to the rubber grommet and will otherwise be damaged!

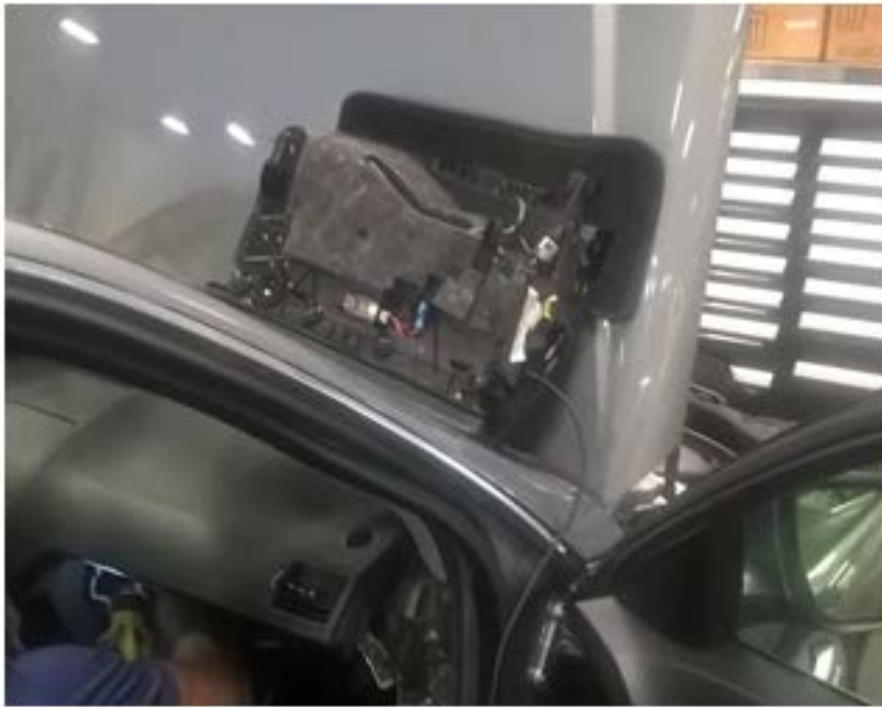
Figure 4

**i** Pull out the iPod cable as far as possible and set down glove box housing on the windshield **with** exterior iPod cable connected (**figure 4**).

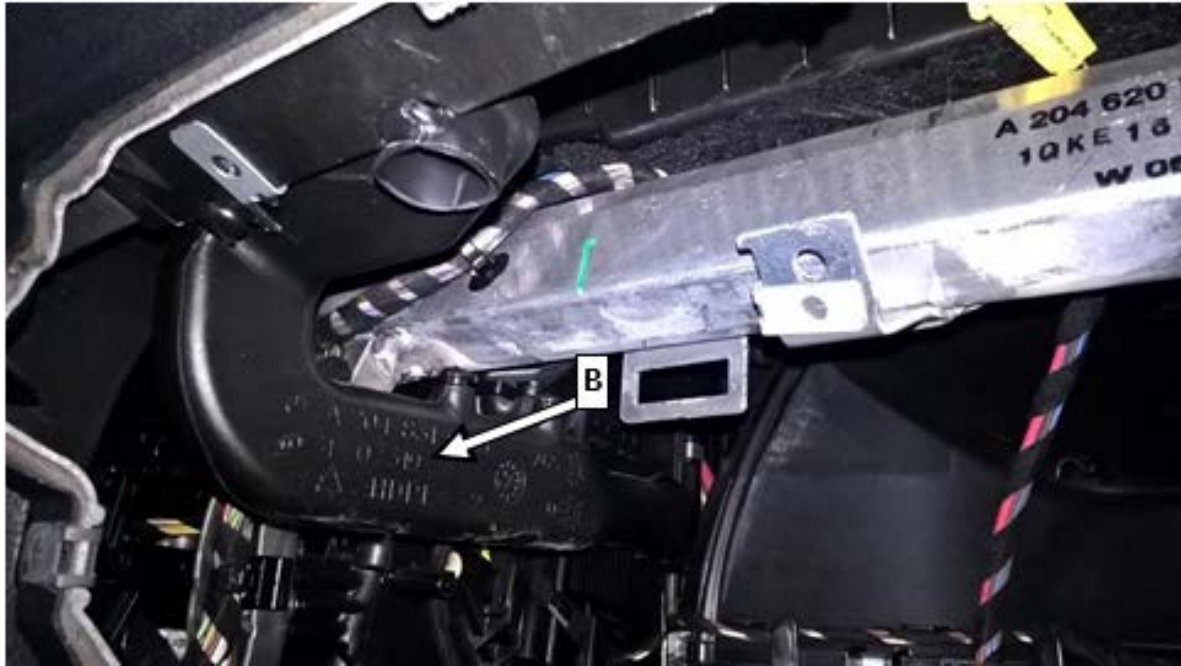
Figure 5

5. Remove air duct (**B**, **figure 5**) above the glove compartment.

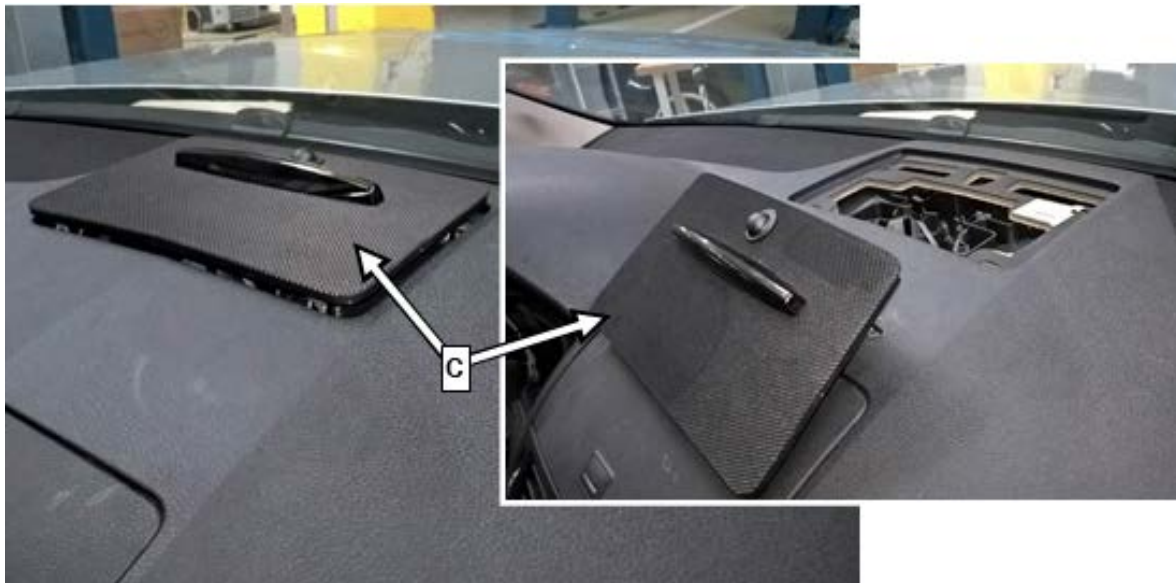
Figure 6

6. Unclip and remove cover (**C**, **figure 6**) at the instrument panel on top.  
**i** With a sound system, also remove speaker under the cover.

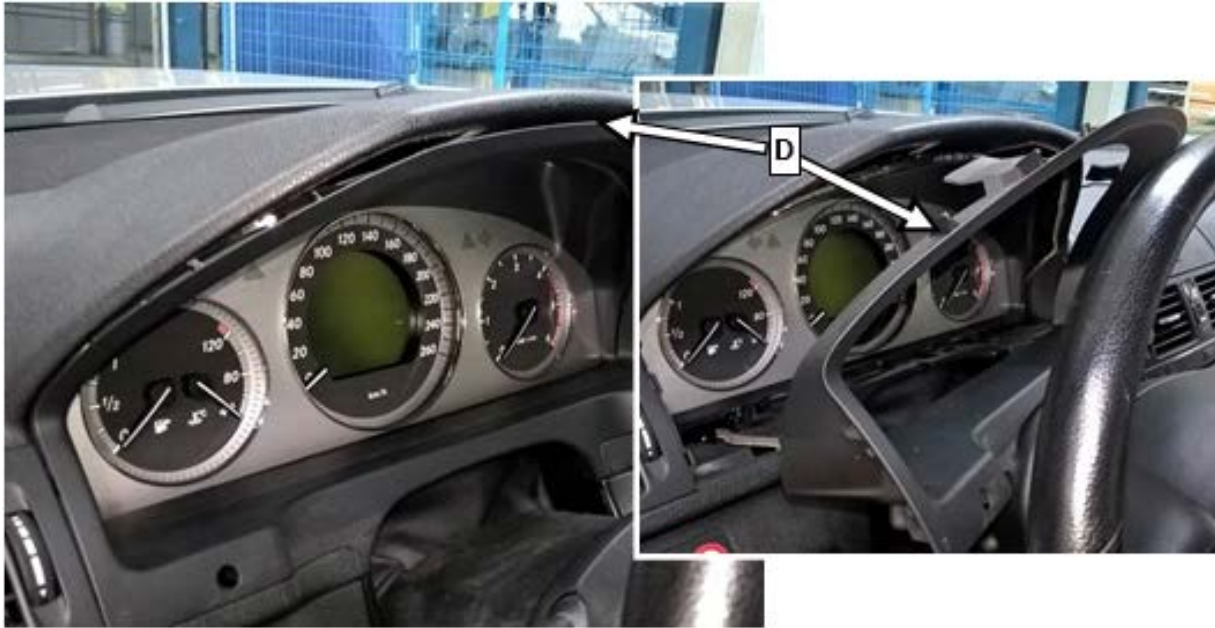
Figure 7

9. Remove trim (**D, figure 7**) around the instrument cluster.

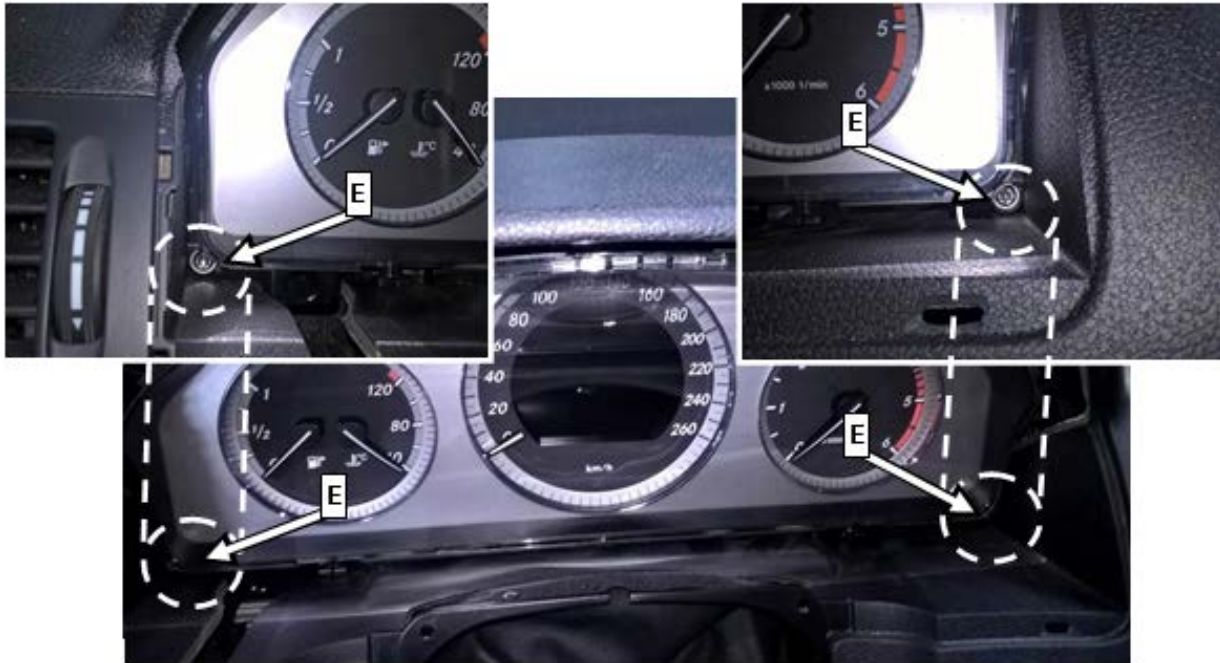
Figure 8

10. Remove the two bottom threaded connections (**E, figure 8**) of the instrument cluster.

The upper two screws do not need to be removed.

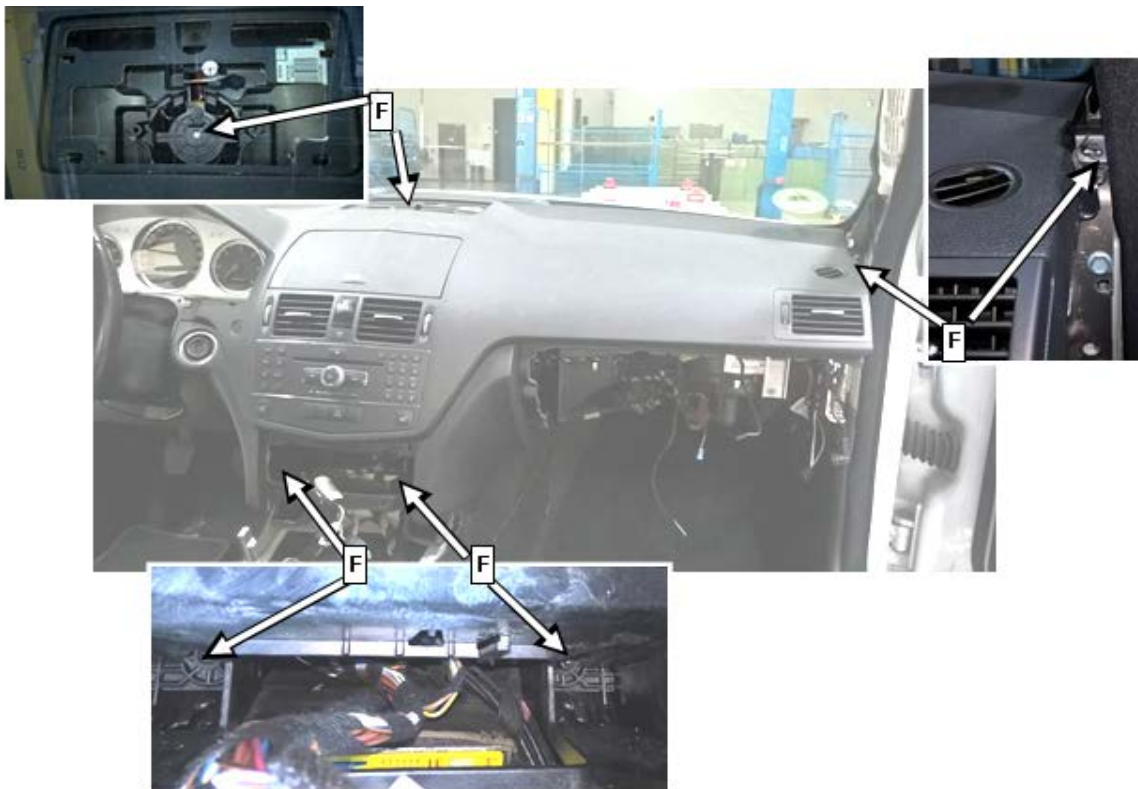
Figure 9

11. Remove four screws (**F**, figure 9) for fastening the instrument panel

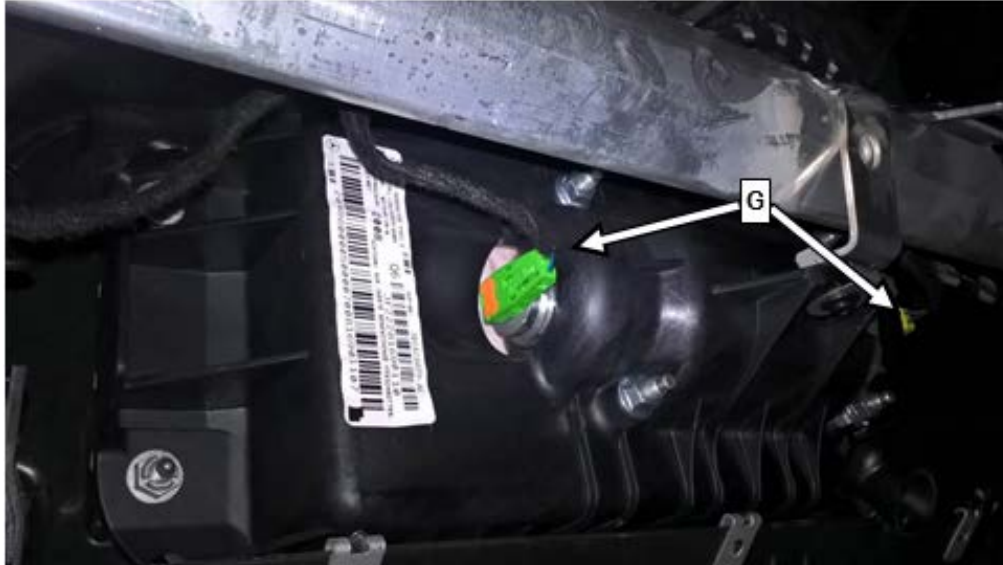
Figure 10

12. Disconnect electrical contacts (**G**, figure 10) at the front passenger airbag.

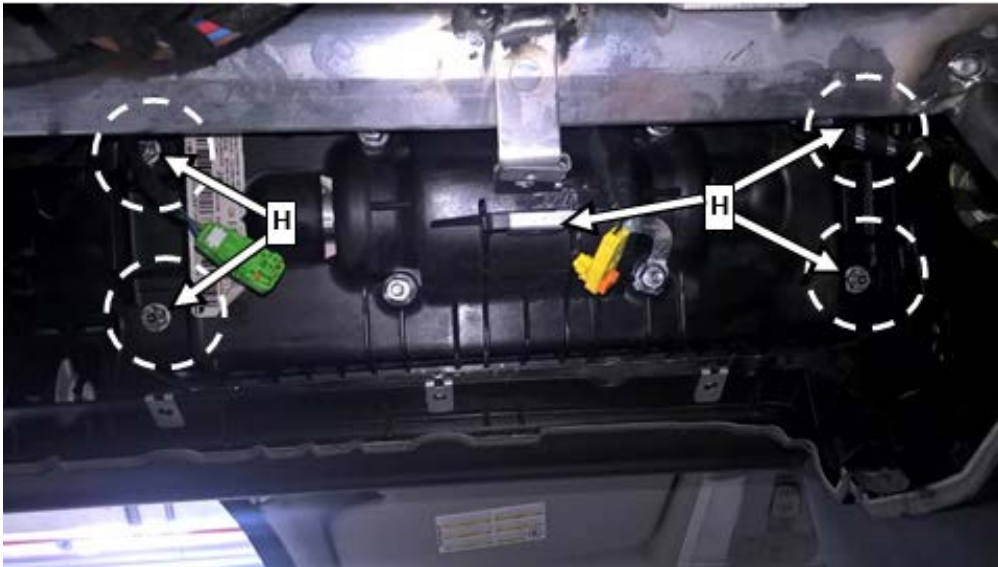
Figure 11

13. Remove lock nuts (**H, figure 11**) for the front the passenger airbag.

**i** Lock nuts should only be replaced if they are damaged. For more info see:  
**AH00.00-N-0001-01A / Modification notes 27.10.2016**

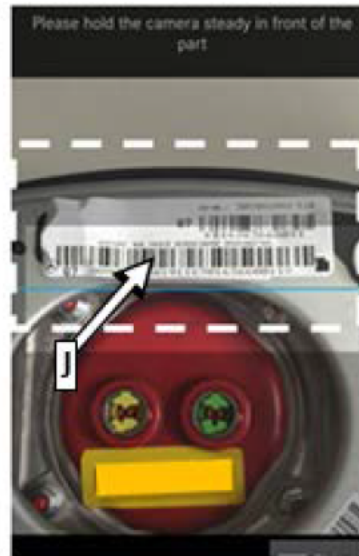
Figure 14

- ☐ Ensure that the lower barcode (J, figure 14) is scanned.
- ☐ All required data can also be read off and entered manually.

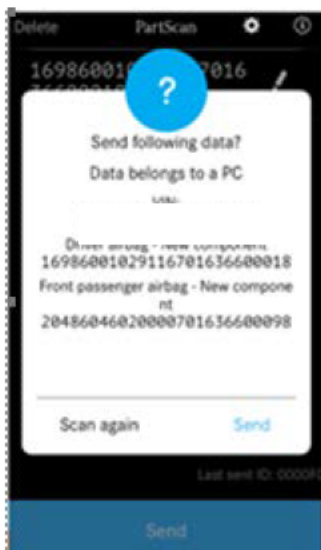
Figure 15

19. Create a scan ID via the "Send" button (figure 15).

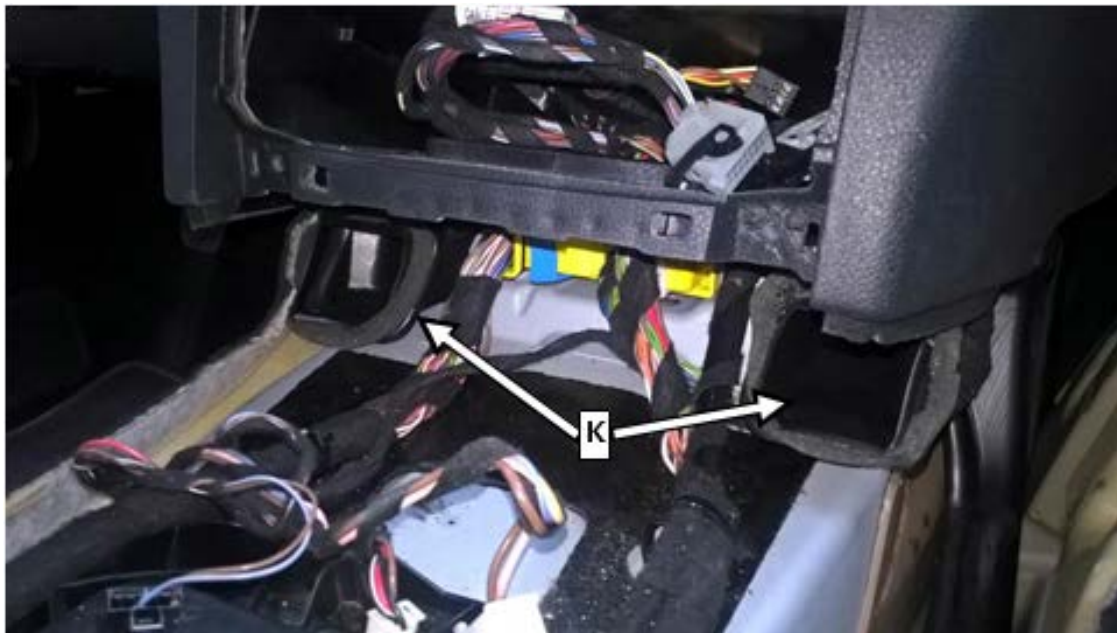
Figure 17

22. Place instrument panel back into position and install the air ducts (**K**, figure 17) correctly.

**i** The air ducts are pulled out when the instrument panel is raised.

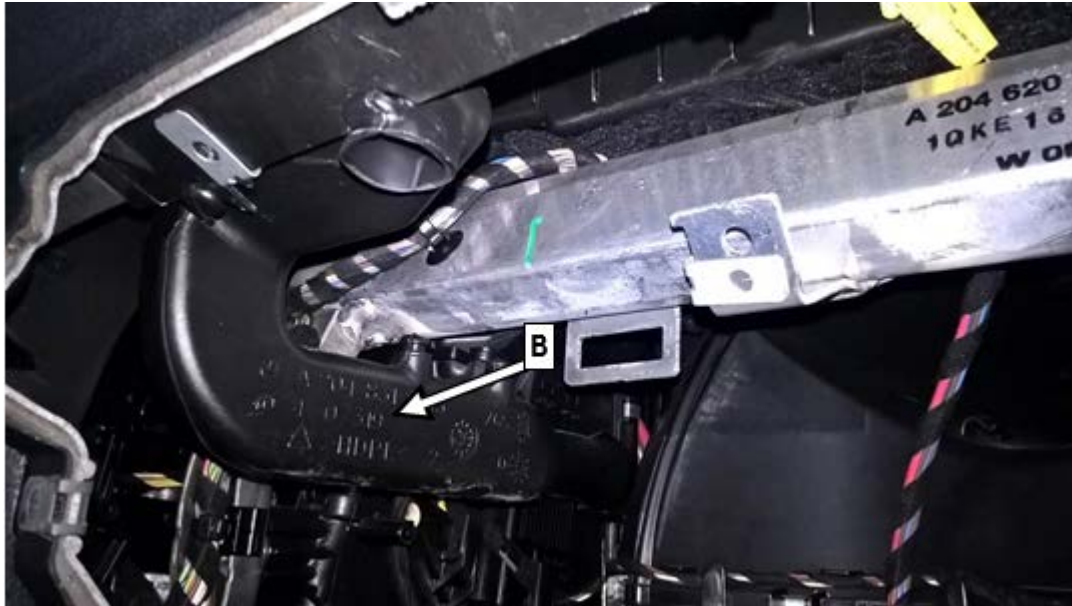
**Figure 1**

1. Disconnect ground line from the on-board electrical system battery.
2. Remove driver airbag at the steering wheel.  
**i** For basic data of model X 204, see **AR91.60-P-0660CW**
3. Remove glove compartment housing (**AR68.10-P-1200CY**).
4. Remove air duct (**B, figure 1**) above the glove compartment.

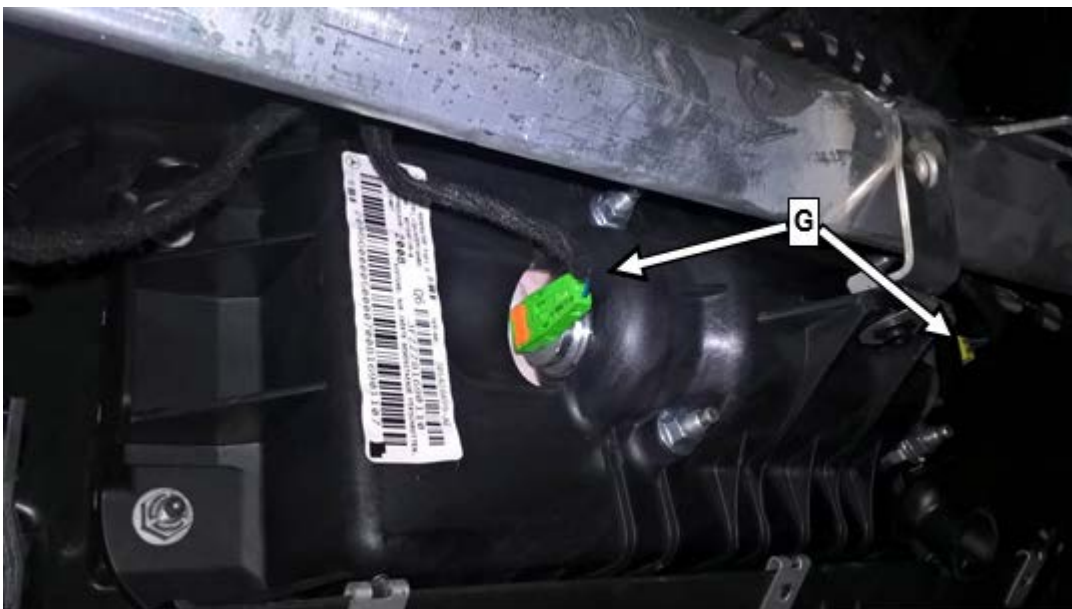
**Figure 2**

5. Disconnect electrical contacts (**G, figure 2**) at the front passenger airbag.

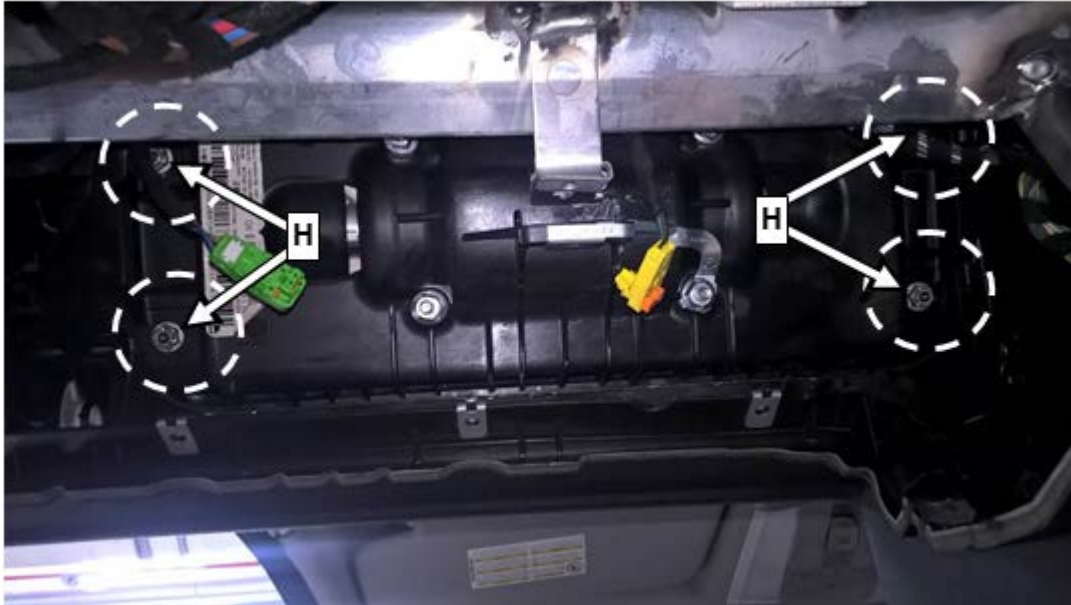
Figure 3

6. Remove threaded connections (**H**, figure 3) for the front the passenger airbag.

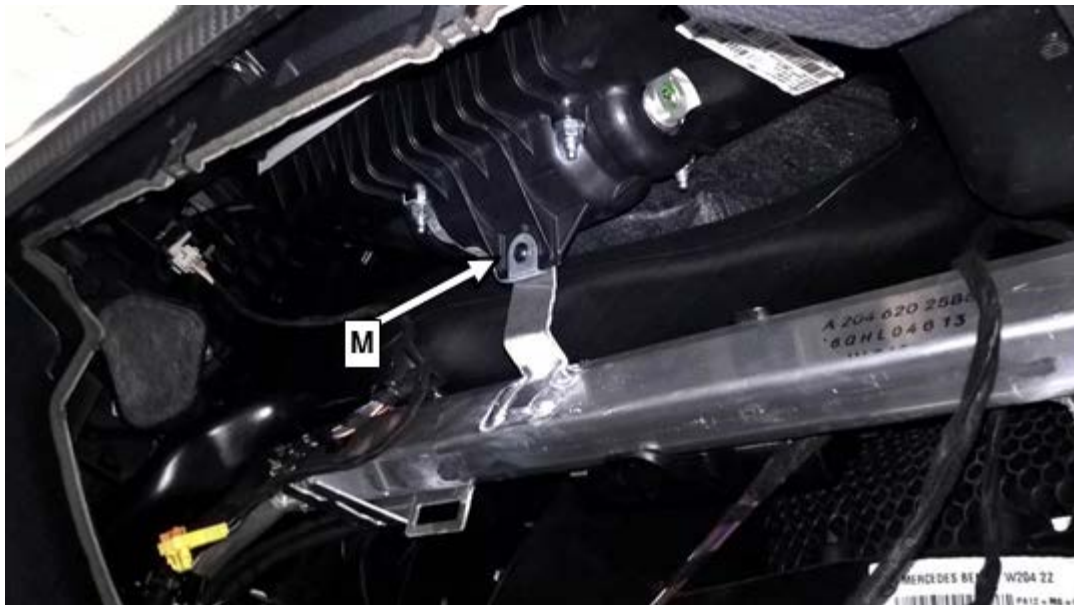
Figure 4

7. Remove Screw (**M**, figure 4) for the front passenger airbag.

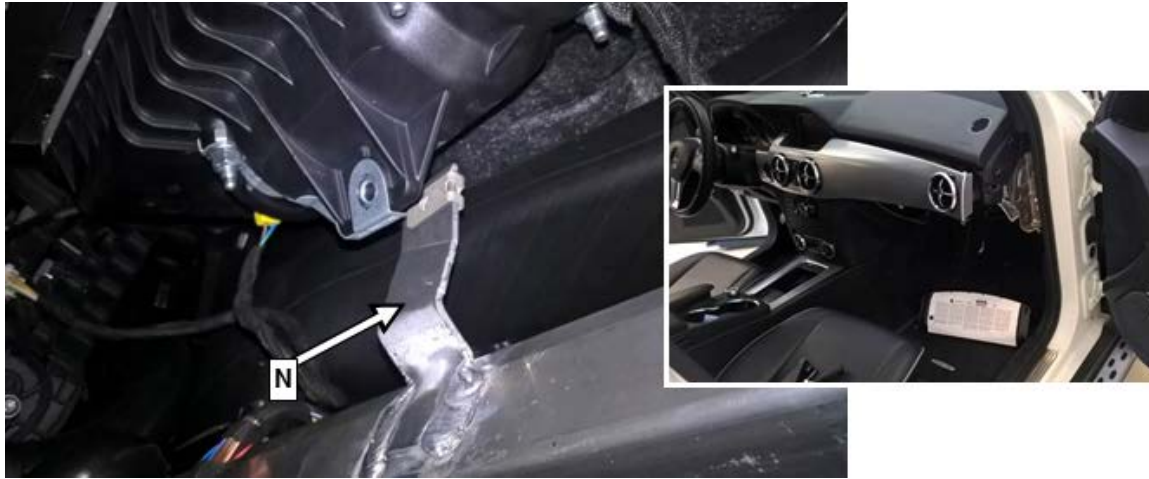
Figure 5

**i** To remove the front passenger airbag, slightly push the bracket (**N**, **figure 5**) forward.

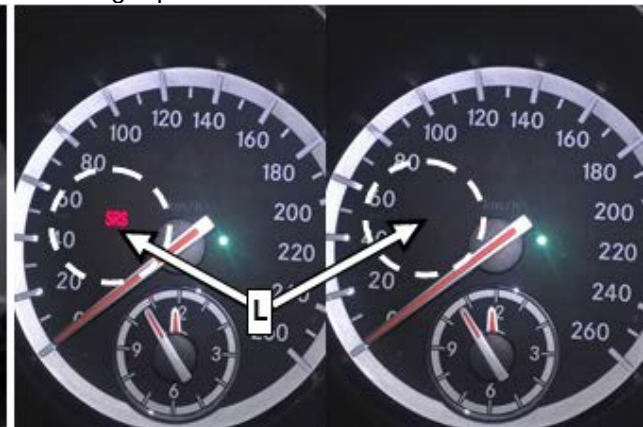
14. Turn the transmitter key in the electronic ignition lock to **position 1** and check whether the airbag indicator lamp (**L**, **figure 6 or 7**) correctly switches off after a few seconds.
