**SUBJECT: Safety Recall 16S26 – *Supplement #8***  
Certain 2005-2006 Ford GT, 2005-2011 Mustang, 2006-2011 Fusion and Milan,  
2006 Zephyr, 2007-2011 MKZ, 2007-2010 Edge and MKX, and 2007-2011 Ranger  
Vehicles  
Passenger Airbag Inflator Replacement

## CERTAIN 2005-2006 FORD GT AND 2010-2011 MUSTANG VEHICLES — PASSENGER AIRBAG INFLATOR REPLACEMENT

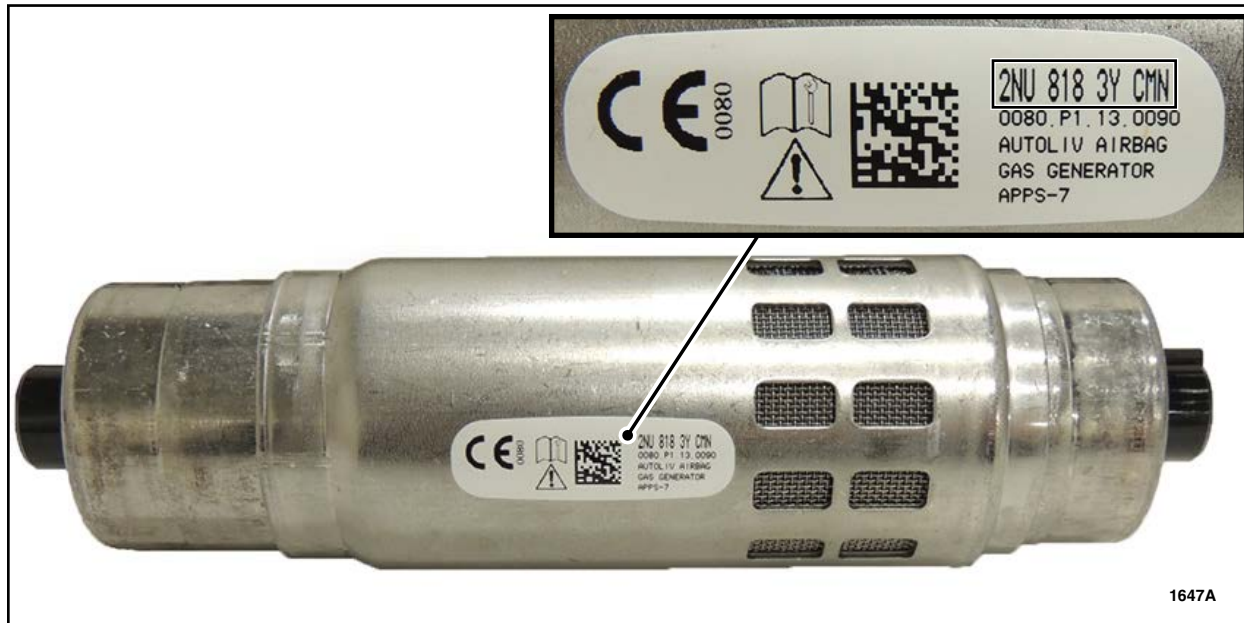
**FIGURE 7**

9. Record the 11 character serial number of the *new* airbag inflator on the repair order. See Figure 7.

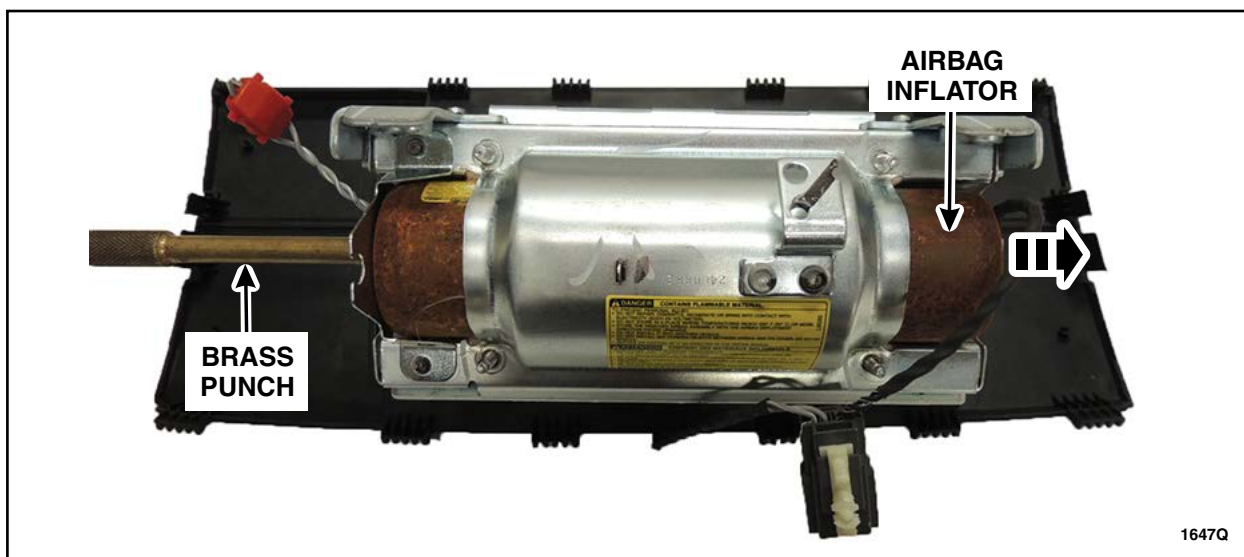
FIGURE 6

8. With an assistant holding the passenger airbag assembly, remove the inflator from the assembly by pushing outward on the inflator. Set the airbag inflator aside for return shipping. See Figure 6.
- If required, use of a brass punch is permitted (only at the location shown) to free the inflator from its mounted position.

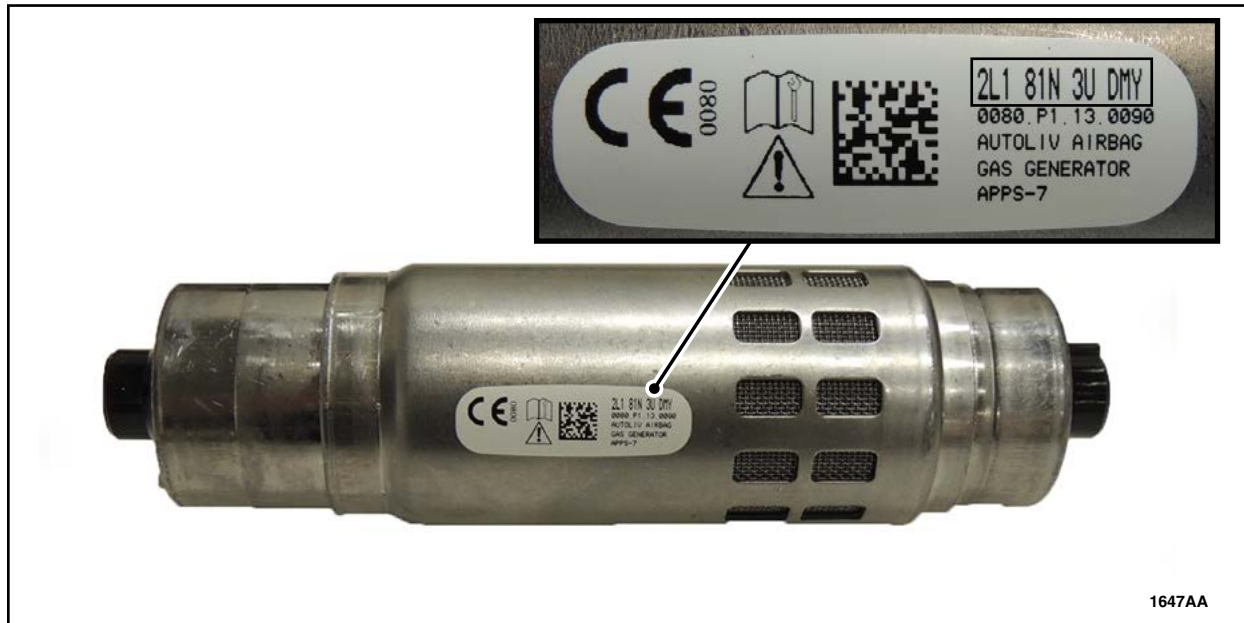
**FIGURE 7**

9. Record the 11 character serial number of the *new* airbag inflator on the repair order. See Figure 7.

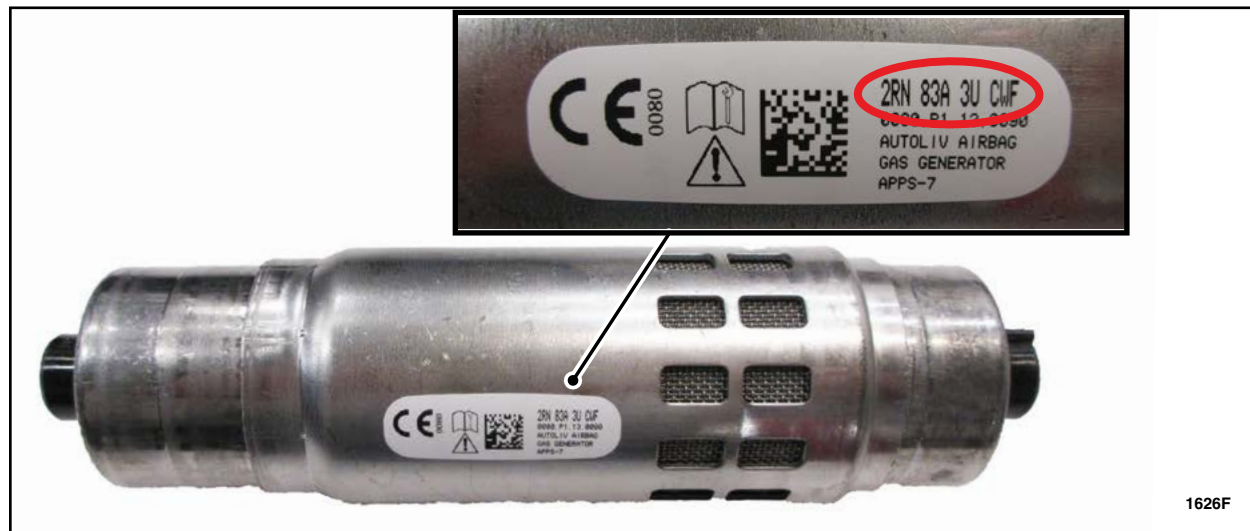
FIGURE 6

9. Record the 11 character serial number of the *new* airbag inflator on the repair order. See Figure 6.

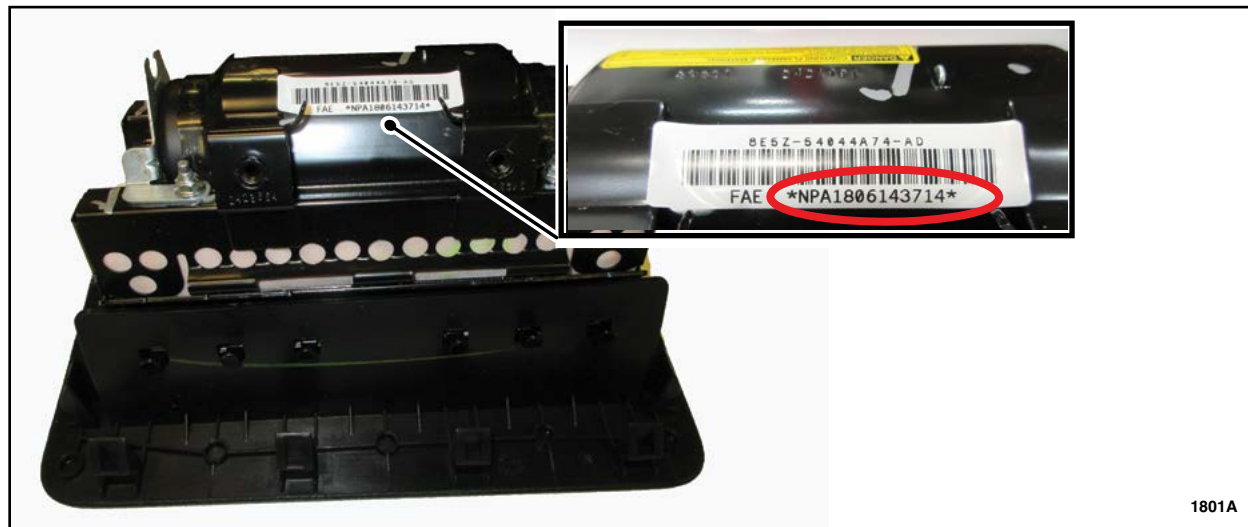
FIGURE 1

1. Record the 13 character serial number of the new airbag module on the repair order. See Figure 1.
2. Replace the passenger airbag module. Refer to section 501-20B of the workshop manual.
3. Package the replaced airbag module in the new part box and provide to the appropriate dealership personnel for part returns.

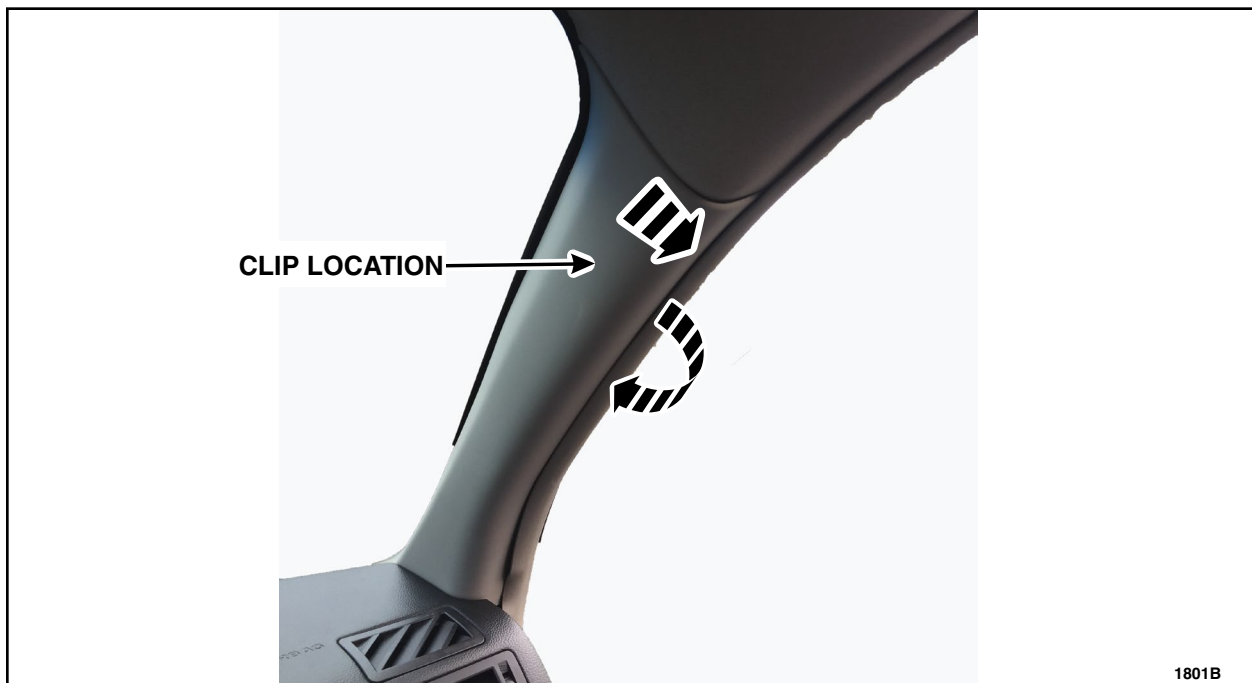
FIGURE 2

2. Remove the left hand and right hand A-Pillar trim panels. Reuse the LH and RH trim panels for this repair. See Figure 2.
  - Grasp the trim panel approximately 5 inches from the top and pull downward toward the door, then rotate the panel inward toward the windshield to slide it off of the a-pillar clip.

**NOTE:** Do not bend or flex the trim panels during removal to avoid stress marks from occurring.

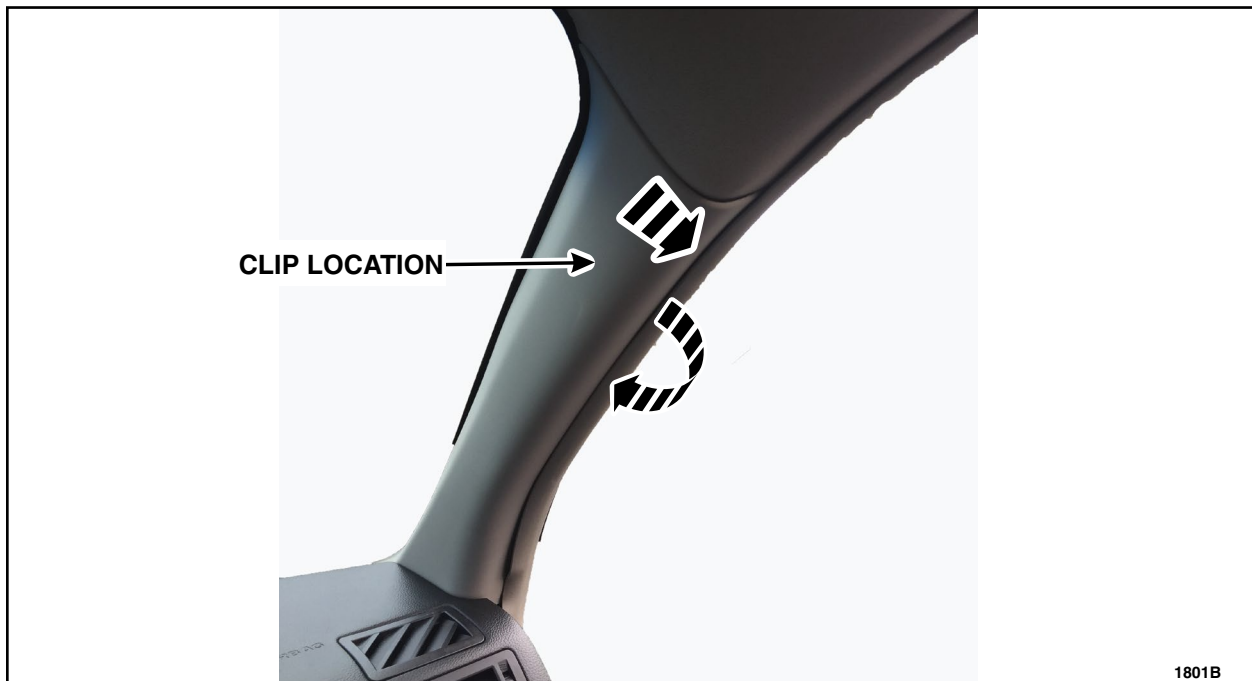
FIGURE 2

**NOTE:** Do not bend or flex the trim panels during removal to avoid stress marks from occurring.

**NOTE:** MKZ A-Pillar trim is wrapped in fabric, be sure to protect the fabric from stains when removing.
