REF #: ICI21-023

**SUBJECT: Takata Airbag Inflator Returns Revision (FL684 & FL714)**

## Passenger Airbag Inflator Replacement

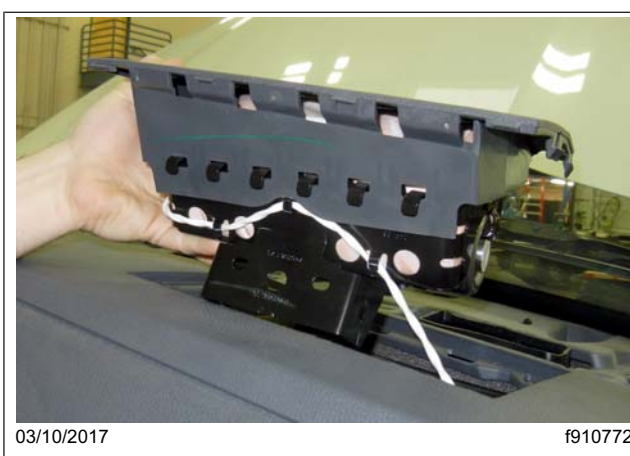
**Fig. 6, Removing the Airbag**

9. Using a trim stick or another suitable wide flat-bladed tool, pry the forward edge, then the outboard edge of the airbag cover panel from dash far enough to disengage the panel from the dash. See [Fig. 5](#). Remove the airbag and the airbag cover panel as a unit. See [Fig. 6](#).
