LEXUS

Subject: Safety Recall GLK - *Remedy Notice*
2010 Model HS 250h Vehicles
Rear Lower Suspension Arm No. 1 Assemblies

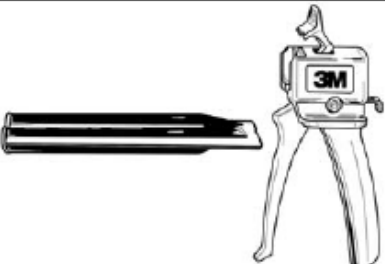
1

4 halves / 2 completed molds
Epoxy Applicator

The SST below was provided to your dealership in November 2016. This tool is being introduced to assist technicians when performing the repair.
