Lexus Fixed Operations

Subject: Safety Recall GLK - *Remedy Notice*
2010 Model HS 250h Vehicles
Rear Lower Suspension Arm No. 1 Assemblies

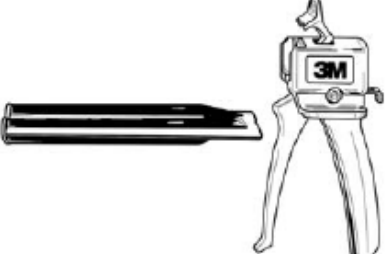
1

4 halves / 2 completed molds
Epoxy Applicator

The SST below was provided to your dealership in November 2016. This tool is being introduced to assist technicians when performing the repair.
