October 2016
FL718A-D
NHTSA #16V-634
Transport Canada #16-419

Subject: Front Axle Hub Rating

Models Affected: Specific Freightliner 108SD, 114SD, Business Class M2, Cascadia, and Coronado vehicles; and Western Star 4700, 4800, and 5700 vehicles manufactured April 29, 2013, through July 29, 2016.

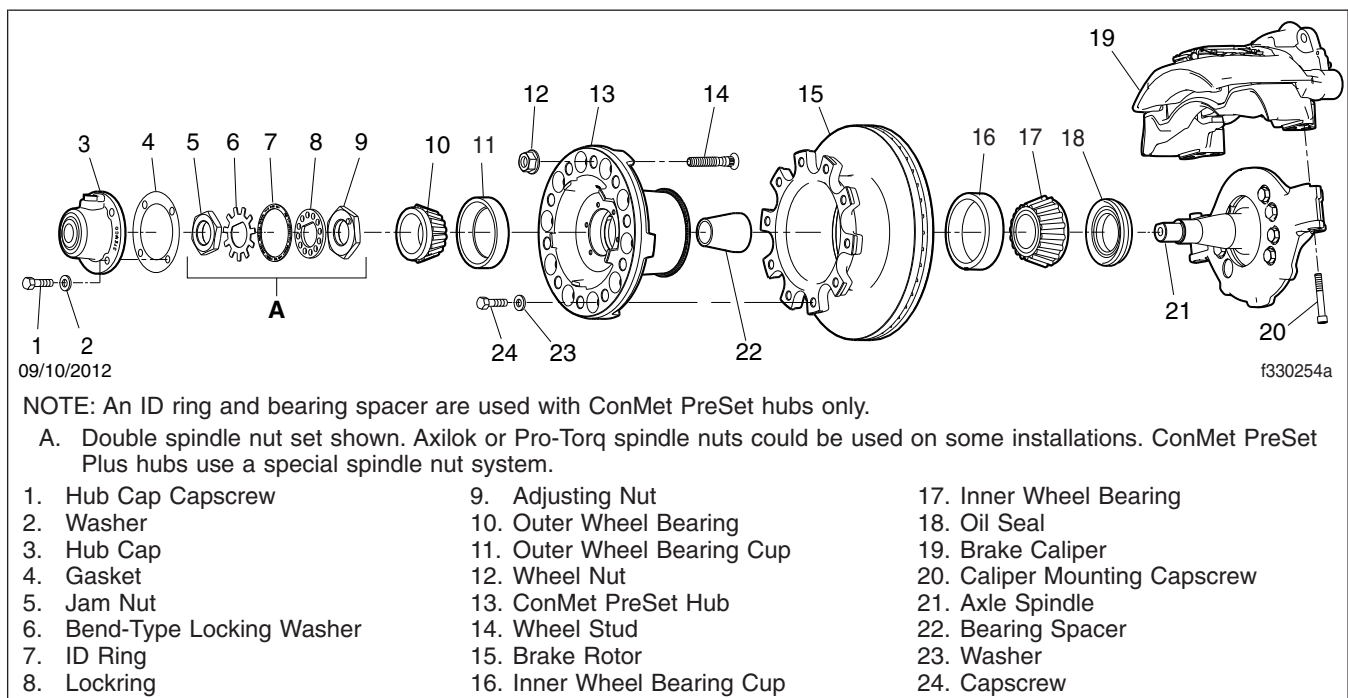
Fig. 1, Typical Wheel End Assembly, Front Axle with Disc Brakes

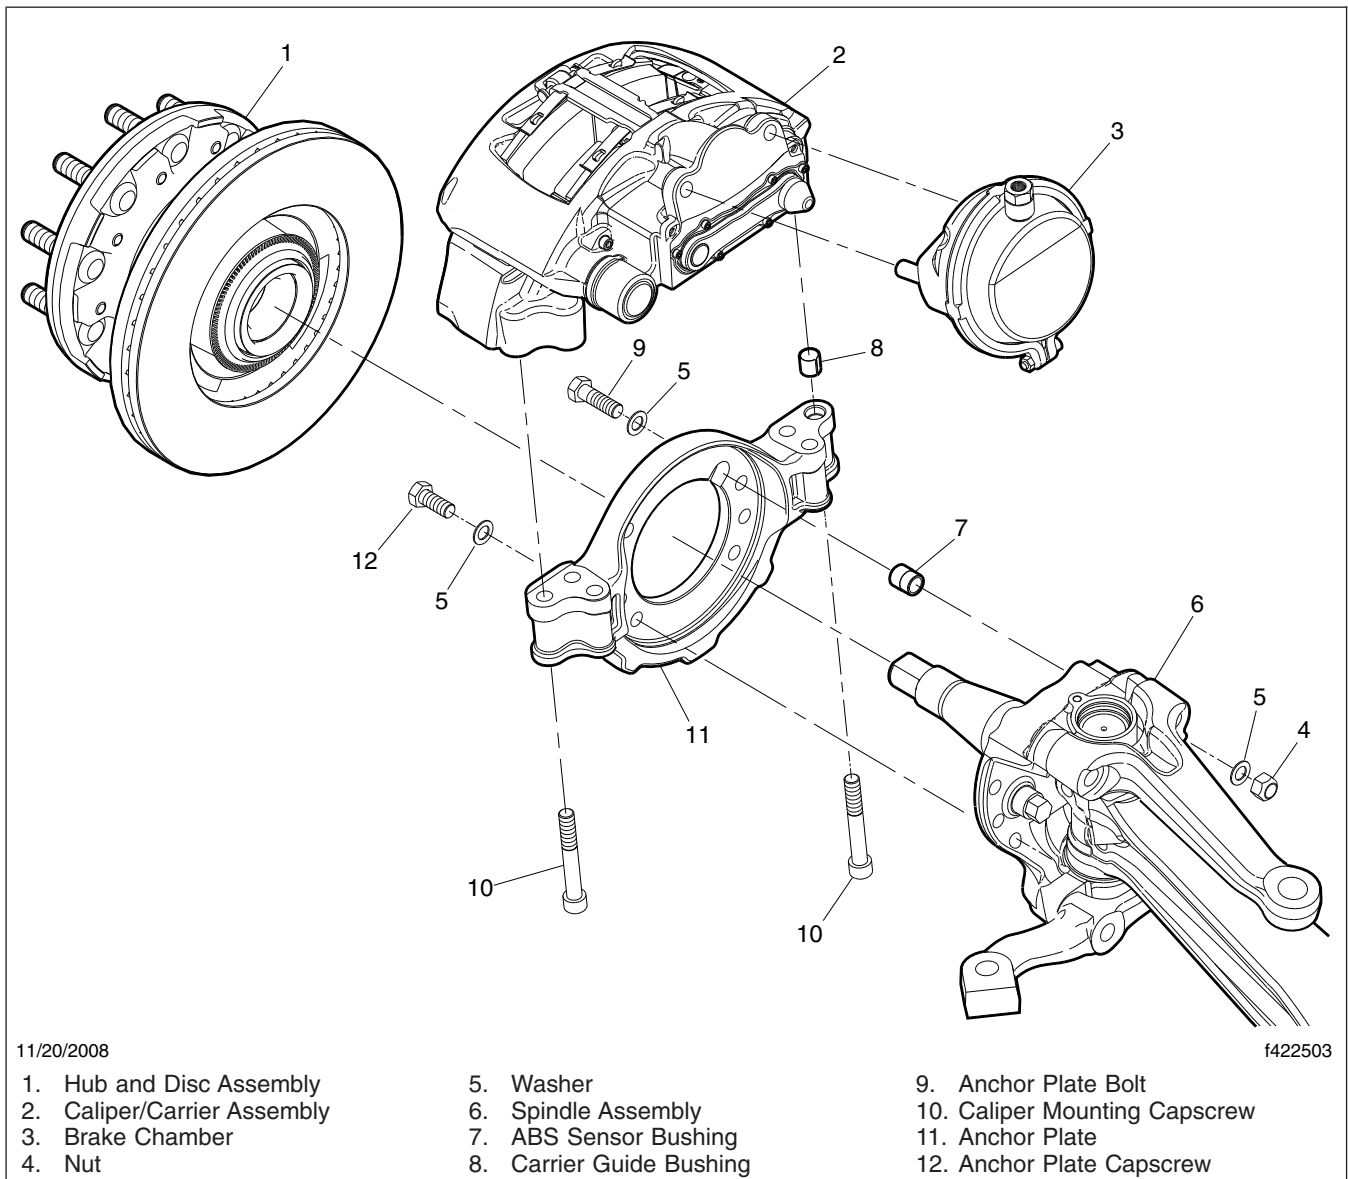
Fig. 2, Front Caliper and Carrier Assembly Installation

4. Remove the wheel and tire assembly.
5. Remove the brake caliper as follows. Refer to **Fig. 2** for front caliper/carrier removal and installation.
 - 5.1 Drain the air from the air brake system.
 - 5.2 Disconnect the supply and return lines from the brake chamber.
 - 5.3 Cut the zip ties holding the ABS harness to the brake hose as needed.
 - 5.4 Back off the manual brake adjuster 1/4 turn.
 - 5.5 Remove the six brake caliper/carrier assembly retaining bolts, and discard the bolts.

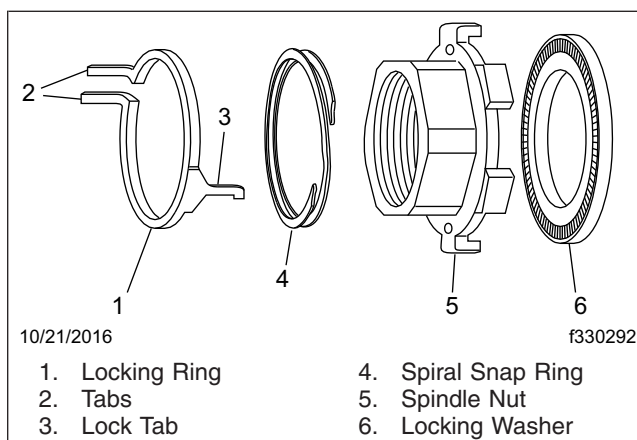
Fig. 3, PreSet Plus Spindle Nut System

7. ConMet PreSet Plus hubs use a special integrated spindle nut designed specifically for PreSet Plus hubs. See **Fig. 3**. Remove the axle nut as follows.

- 18.1 If the red locking snap ring is locked into the spindle nut, compress the tabs and pivot the ring to remove it from the nut. See [Fig. 3](#).
- 18.2 If needed, install the PreSet Plus spindle nut components as shown in [Fig. 3](#).
Ensure that the spiral snap ring fully seats into the groove in the hub. See [Fig. 5](#) and [Fig. 6](#).
- 18.3 Tighten the spindle nut 300 lbf-ft (407 N·m) while rotating the hub. Do not back off the spindle nut.

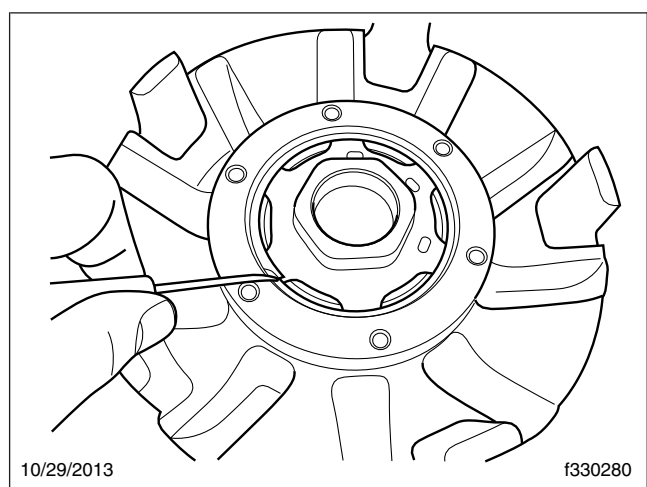
Fig. 4, Removing a Spiral Snap Ring

- 7.2 Loosen the spindle nut. As the spindle nut is loosened, it can act as a hub puller. However, if the hub will not come off of the spindle without exceeding 50 lbf-ft (68 N·m) of torque, remove the spiral snap ring (see **Fig. 4**) and then the spindle nut assembly.

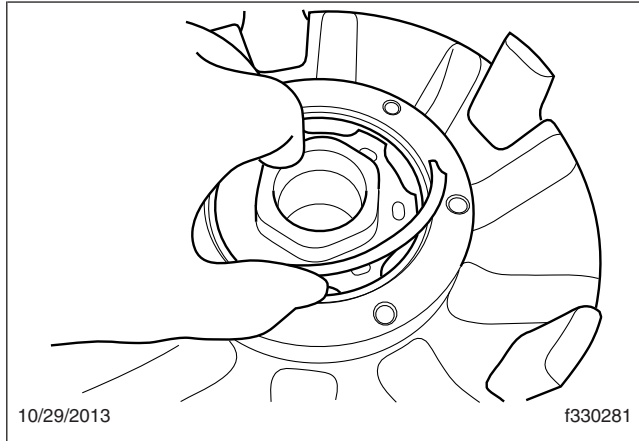
Fig. 5, Installing a Spiral Snap Ring

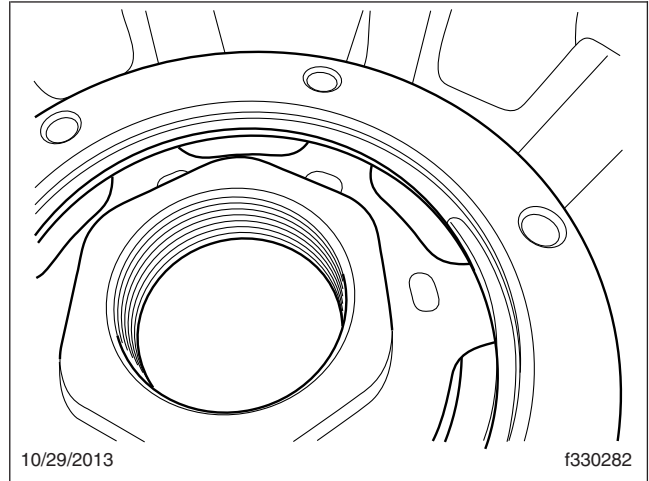
Fig. 6, Fully Seated Spiral Snap Ring

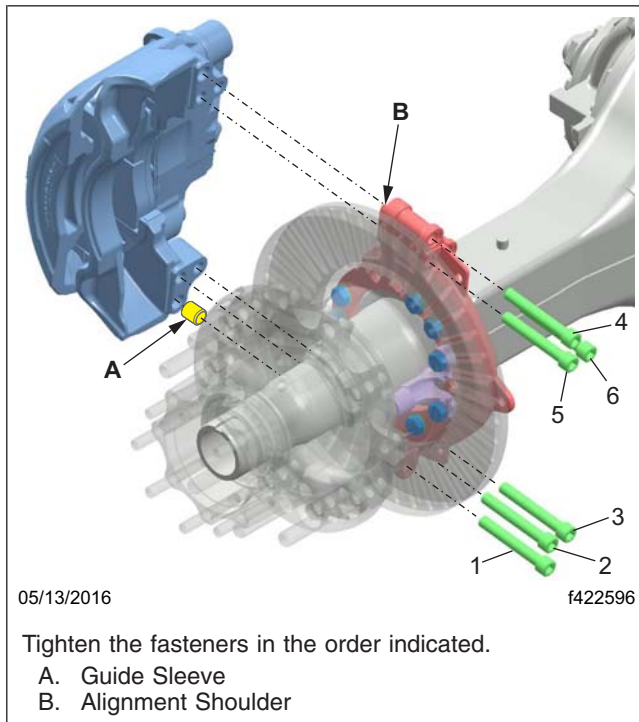
Fig. 7, Tightening Pattern

- NOTE: The tightening pattern will always start on the short (floating) pin side, with the bolt that passes through the shear sleeve.
- 22.2 Tighten the carrier mounting bolts in two steps, using the pattern shown in [Fig. 7](#). Initially tighten all six bolts 40 to 50 lbf-ft (54 to 68 N·m). Perform the final torque spec of 180 to 200 lbf-ft (244 to 271 N·m).

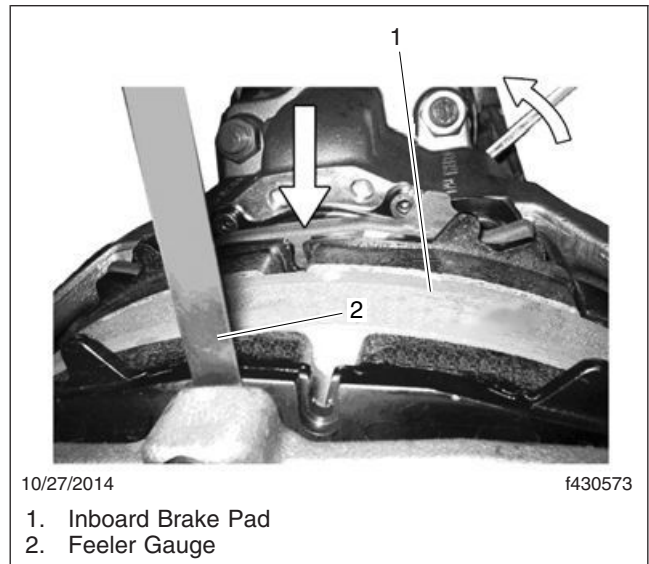
Fig. 8, Adjusting the Clearance

- 22.4 Install the brake pads.
- 22.5 Using a 0.047 inch (1.2 mm) feeler gauge, adjust the clearance. See the arrow in [Fig. 8](#). Insert the feeler gauge between the brake pad of the rim side and the brake caliper.
