February 2017
FL721A-E
NHTSA #16V-656
Transport Canada #16-441
SECOND REVISED NOTICE

Subject: CNG Fuel Tank and CPDM Mounting Location

Models Affected: Specific Freightliner Cascadia vehicles manufactured September 24, 2012, through May 27, 2015, built with CNG fuel tanks

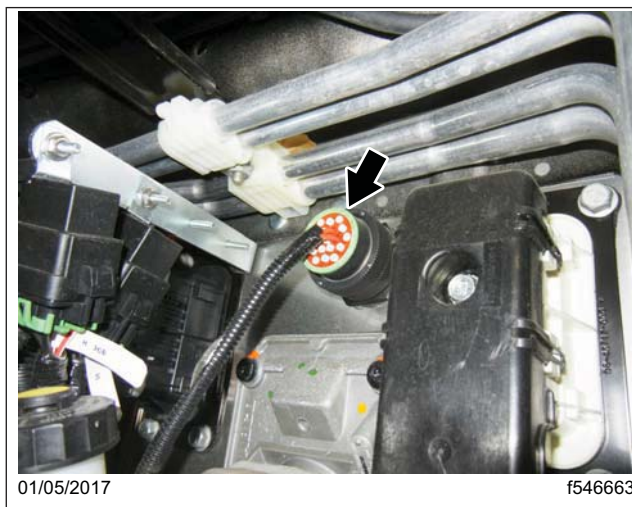
1. Shut off the gas valve and disconnect the batteries.
2. Remove the driver-side kick panel, the center lower dash cover, and the instrumentation control unit (ICU).
3. Raise the hood and disconnect the bulkhead connector 1A. See [Fig. 1](#). Remove the nut that secures the dash side 1A bulkhead connector to the front wall.

Fig. 1, Bulkhead Connector

1. Shut off the gas valve and disconnect the batteries.
2. Remove the driver-side kick panel, the center lower dash cover, and the instrumentation control unit (ICU).
3. Raise hood and disconnect bulkhead connector 1A. See [Fig. 1](#) . Remove the nut that secures the dash side 1A bulkhead connector to the front wall.

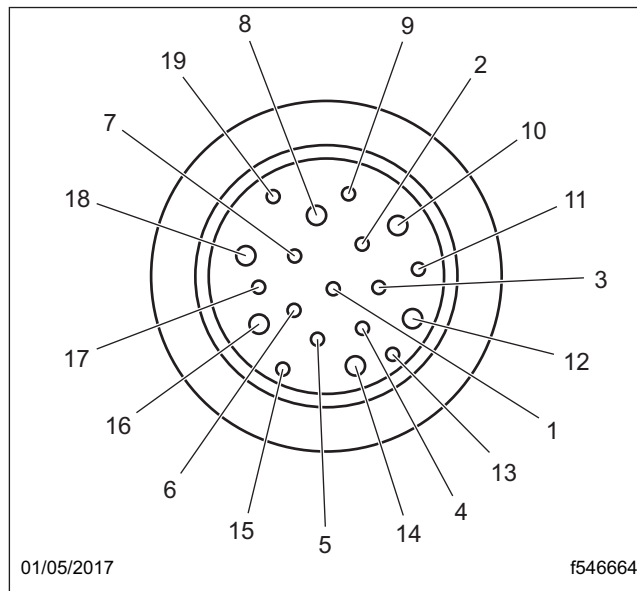
4. Insert the terminals shown in **Table 3** into their respective cavities in the dash side 1A bulkhead connector.
See **Fig. 2**.

Fig. 2, 1A Bulkhead Connector Pinout (view from insertion or back side of plug)

4. Insert the terminals shown in [Table 5](#) into their respective cavities in the dash side 1A bulkhead connector. See [Fig. 2](#).

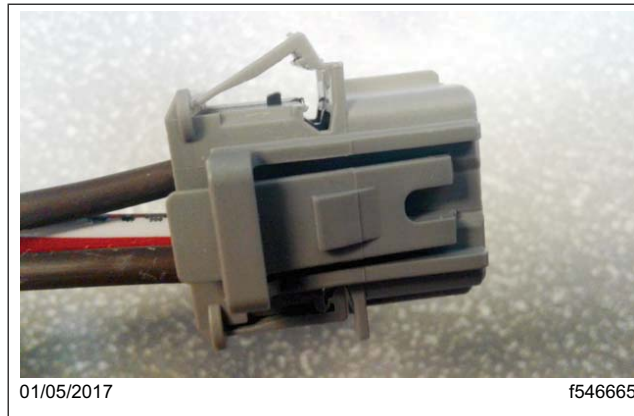
5. Unsnap the terminal lock from the only populated connector (55B) on harness A06-93000-000. See [Fig. 3](#).

Fig. 3, 55B Terminal Lock (released or unsnapped)

5. Unsnap the terminal lock on the only populated connector on harness A06-93000-000. See [Fig. 3](#).
6. Insert circuit 45 (dark blue) from harness A06-93209-003 into cavity 1 of connector 55B. See [Fig. 4](#) and [Fig. 5](#).

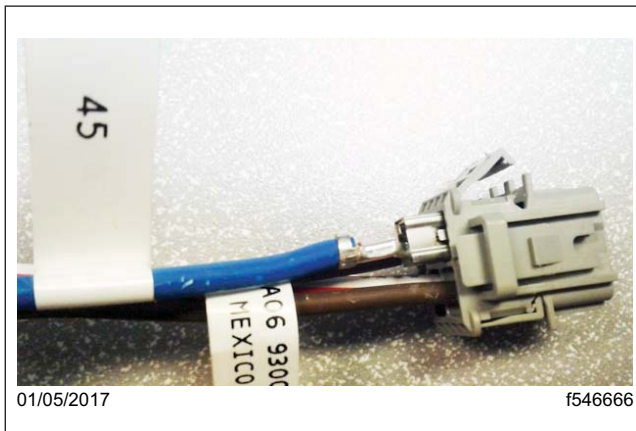
6. Insert circuit 45 (dark blue) from harness A06-93209-000 into cavity 1 of connector 55B. See [Fig. 4](#) and [Fig. 5](#).

Fig. 4, Circuit 45 into Connector 55B

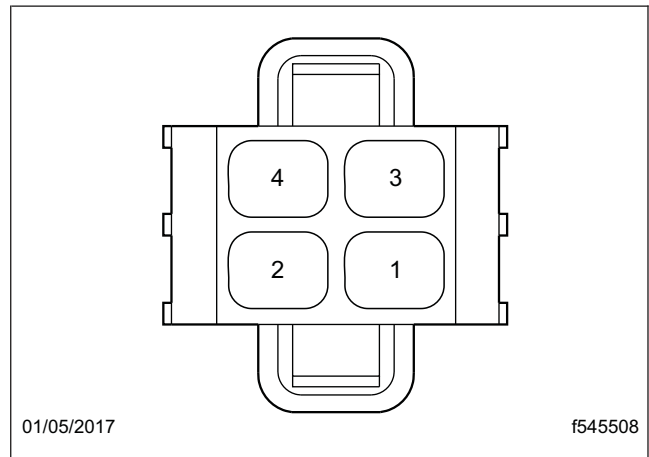
Fig. 5, 55B Pinout (view from insertion point)

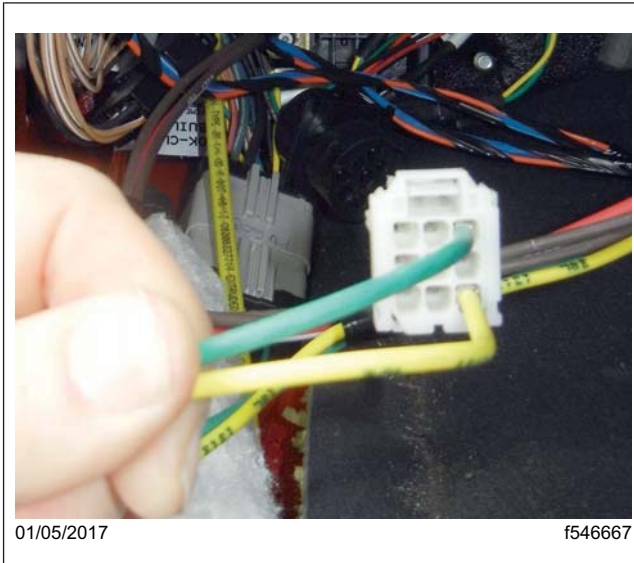
8. Insert circuits 38R (dark green) and 38L (yellow) from harness A06-93000-000 into cavities 7 and 9 respectively in connector 53B (the part is supplied loose in kit 23-13149-902). See [Fig. 6](#) and [Fig. 7](#).

Fig. 6, Wires Inserted into Connector 53B

7. Snap the terminal lock on connector 55B.
8. Insert circuits 38R (dark green) and 38L (yellow) of harness A06-93000-000 into cavities 7 and 9 respectively in connector 53B (supplied loose in kit 23-13149-902). See [Fig. 6](#) and [Fig. 7](#).

7. Snap the terminal lock on connector 55B.
8. Insert circuits 38R (dark green) and 38L (yellow) from harness A06-93000-000 into cavities 7 and 9 respectively in connector 53B (supplied loose in kit 23-13149-902). See [Fig. 6](#) and [Fig. 7](#).

18. Insert the free terminal on the end of harness A06-93208-000 into cavity 9 of SAM Cab connector 9B.
 19. Insert circuits 38R (dark green) and 38L (yellow) of harness A06-93208-000 into cavities 7 and 9 respectively in connector 53B (supplied loose in kit 23-13149-902). See [Fig. 6](#) and [Fig. 7](#).

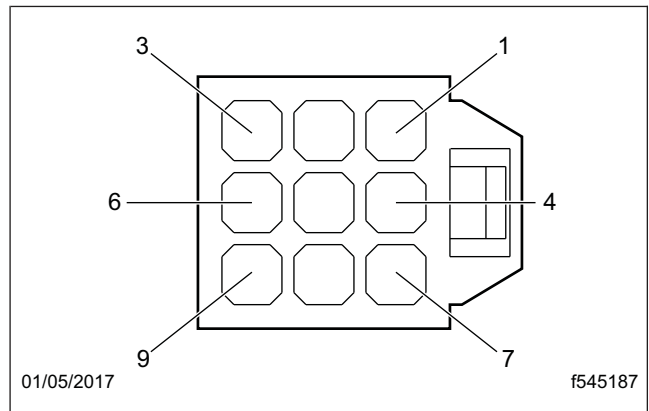
Fig. 7, 52B and 53B Pinout (view from insertion point)

12. Remove the wire in cavity 6 of connector 52B. Fold the wire back against itself, and cover the terminal with heat shrink tubing. See [Fig. 7](#).
13. Label the wire with tape with the description "Removed for FL721."
14. Insert circuit 376C (orange) from harness A06-93209-000 into cavity 6 on connector 52B. See [Fig. 7](#).
15. Snap the terminal lock and plug the connector into slot X52 on the SAM Chassis.
16. Plug the 4-wire connector on harness A06-93000-000 into slot X55 on the SAM Chassis. See [Fig. 10](#).

11. Unsnap the terminal lock. See [Fig. 9](#).
12. Remove the wire in cavity 6 of connector 52B. Fold the wire back against itself, and cover the terminal with heat shrink tubing. See [Fig. 7](#).

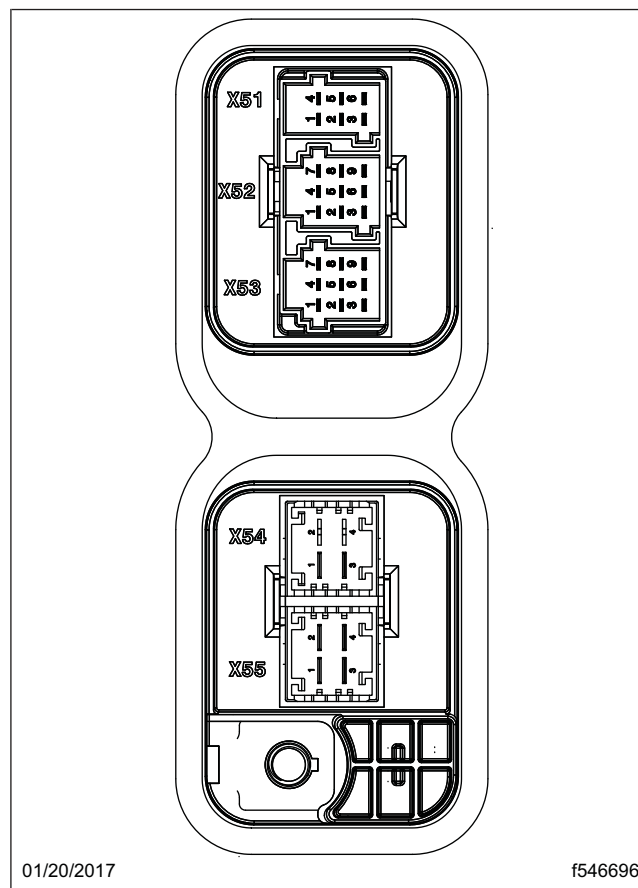
9. Snap the terminal lock and plug in the connector into cavity X53 on the SAM Chassis. See [Fig. 8](#).

Fig. 8, SAM Chassis Connector Locations

9. Snap the terminal lock and plug in the connector into cavity X53 on the SAM Chassis. See [Fig. 8](#).
10. Remove connector 52B from slot X52 in the SAM Chassis.

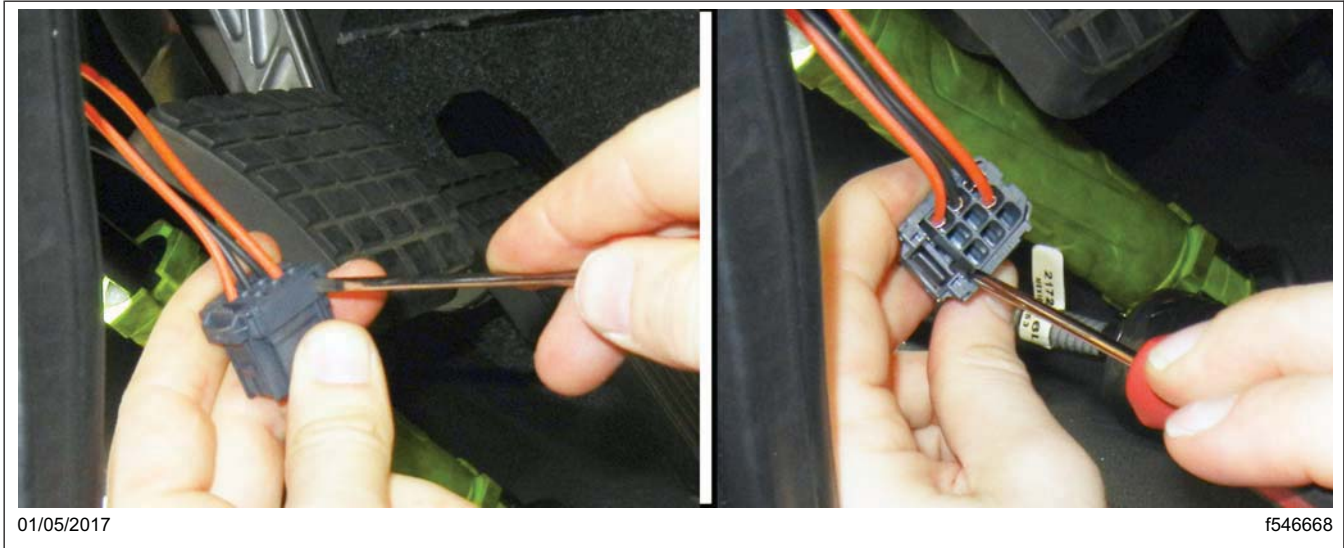
10. Remove connector 52B from slot X52 on the SAM Chassis.
11. Unsnap the terminal lock. See [Fig. 9](#).

Fig. 9, Removing the Terminal Lock on Connector 52B

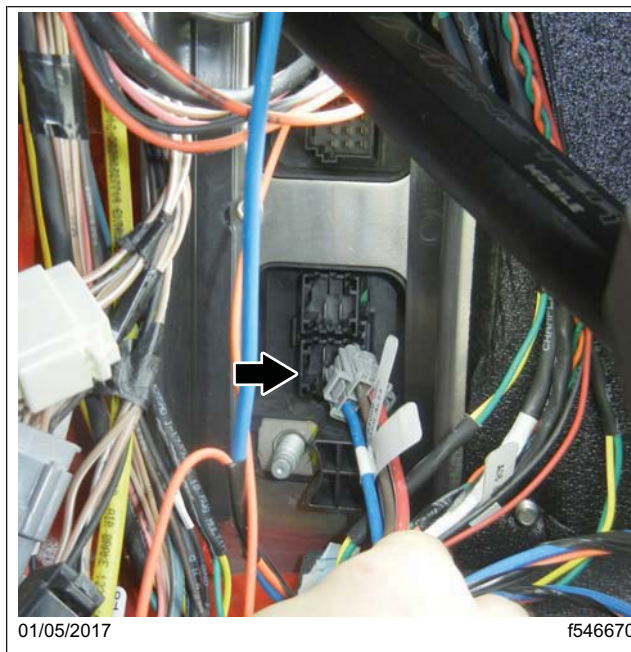
Fig. 10, Inserting the 4-Wire Connector into Slot X55 on the SAM Chassis

17. Plug the 4-wire connector on harness A06-93000-000 into slot x55 on the SAM Chassis. See [Fig. 10](#).
 18. Remove the green cover and grey terminal lock from the ABS ignition PLC filtered splice pack on harness A06-93209-003. See [Fig. 11](#).

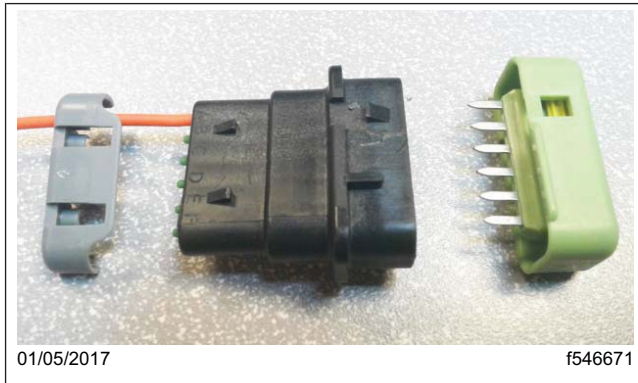
17. Remove the green cover and the grey terminal lock from the ABS ignition PLC filtered splice pack on harness A06-93209-000. See [Fig. 11](#).
18. Insert the GT150S terminal end of the single wire harness A06-93668-000 into any available cavity in the splice pack. See [Fig. 12](#). Install the terminal lock and cover.

Fig. 11, Splice Pack Cover and Lock (removed)

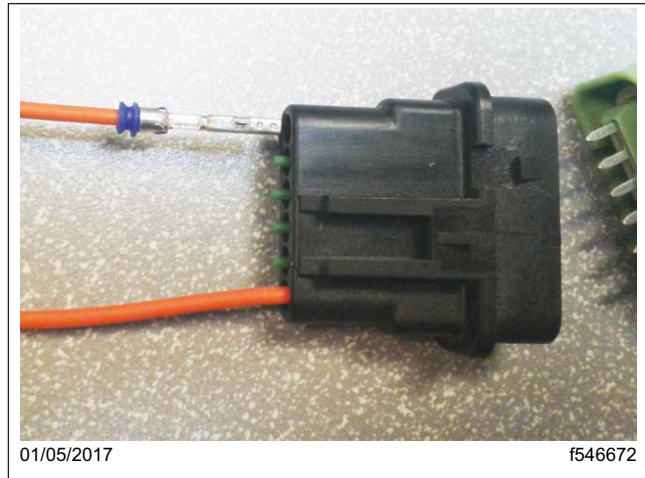
Fig. 12, Splice Pack Terminal Insertion

19. Insert the GT150S terminal end of the single wire harness A06-93668-000 into any available cavity in the splice pack. See [Fig. 12](#). Install the terminal lock and cover.

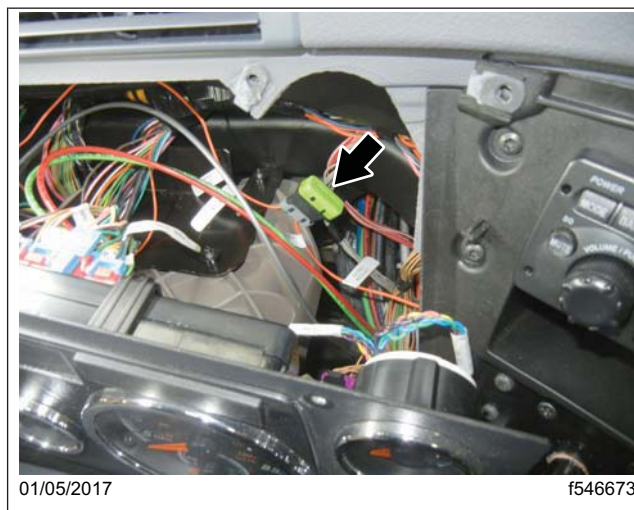
19. Route the splice pack behind the ICU near the radio. See [Fig. 13](#)

Fig. 13, Splice Pack Routing

20. Route the splice pack behind the ICU, near the radio. See [Fig. 13](#).
 21. Disconnect connector 2A from the back of the ICU, and remove the terminal locks. See [Fig. 14](#).

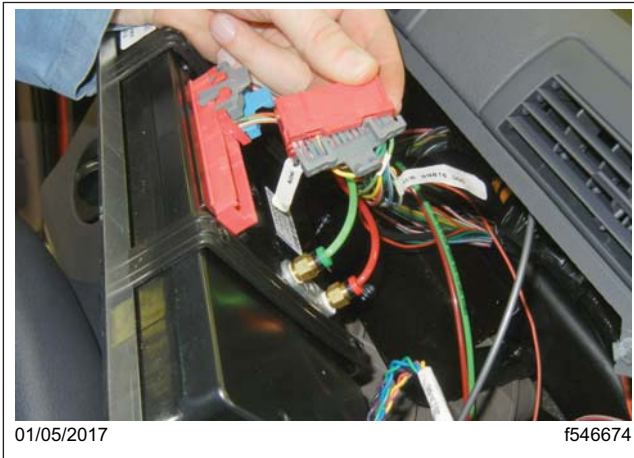
20. Disconnect the 2A connector from the back of the ICU, then remove the terminal locks. See [Fig. 14](#).

Fig. 14, ICU 2A connector Terminal Locks

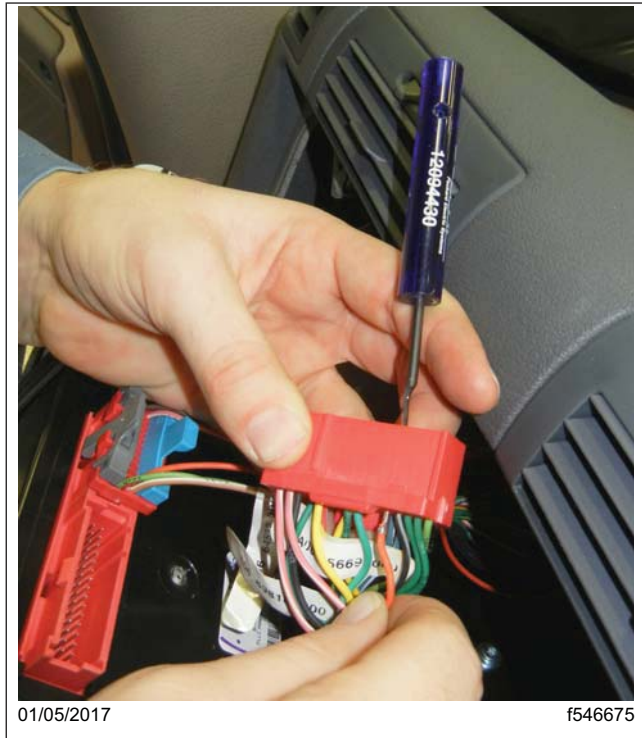
21. Remove the existing wire from cavity D12 of ICU connector 2A. See [Fig. 15](#).

Fig. 15, Wire Removal from Cavity D12 of ICU Connector 2A

22. Remove the existing wire from cavity D12 on ICU connector 2A. See [Fig. 15](#).
 23. Fold the removed wire back against itself, and cover the terminal with heat shrink tubing. See [Fig. 16](#).

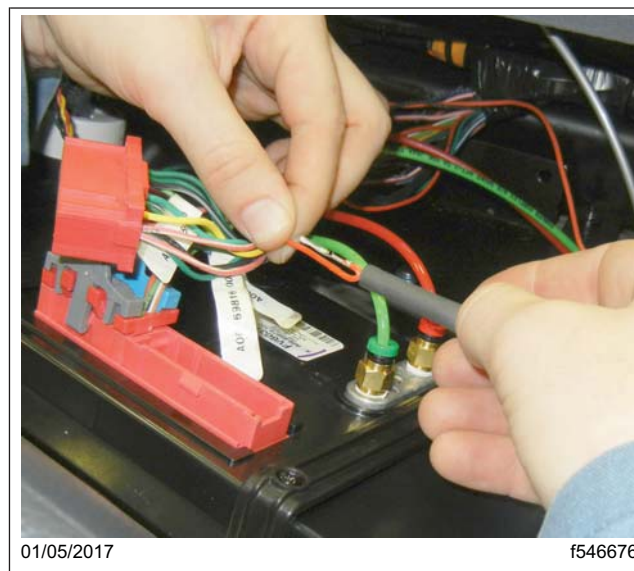
22. Fold the wire back against itself, and cover the terminal with heat shrink tubing. See [Fig. 16](#).

Fig. 16, 2A ICU Heat Shrink

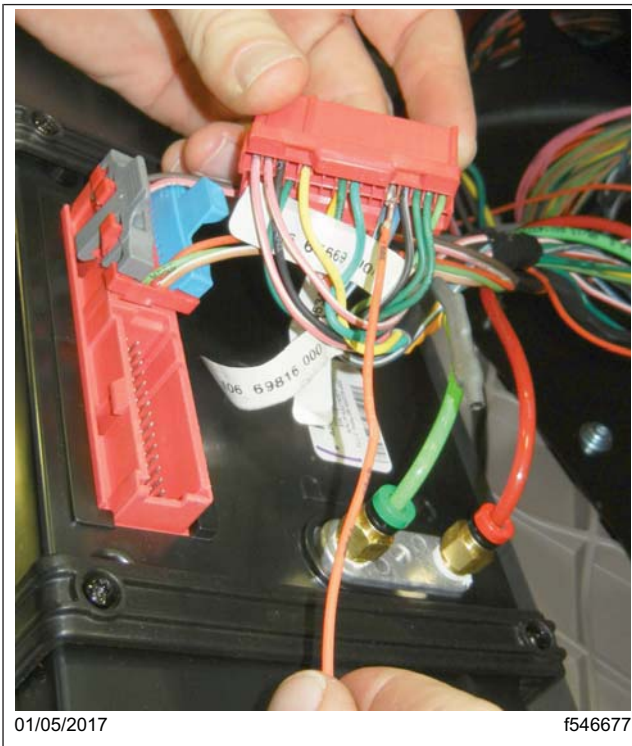
23. Label the wire with tape with the description "Removed for FL721."
24. Insert the metri-pac 100 terminal end from single wire harness A06-82360-000 into ICU connector 2A, cavity D12. See [Fig. 17](#).
25. Install the terminal lock and plug connector 2A into the ICU.
26. Route wires A06-93668-000 and A06-82360-000 behind the dash and down to the ABS module. See [Fig. 18](#).

01/05/2017 f546677
Fig. 17, Wire Insertion into Cavity D12 of ICU Connector 2A

24. Label the wire with tape with the description "Removed for FL721."
 25. Insert the metri-pac 100 terminal end from single wire harness A06-93167-000 into ICU connector 2A, cavity D12. See [Fig. 17](#).

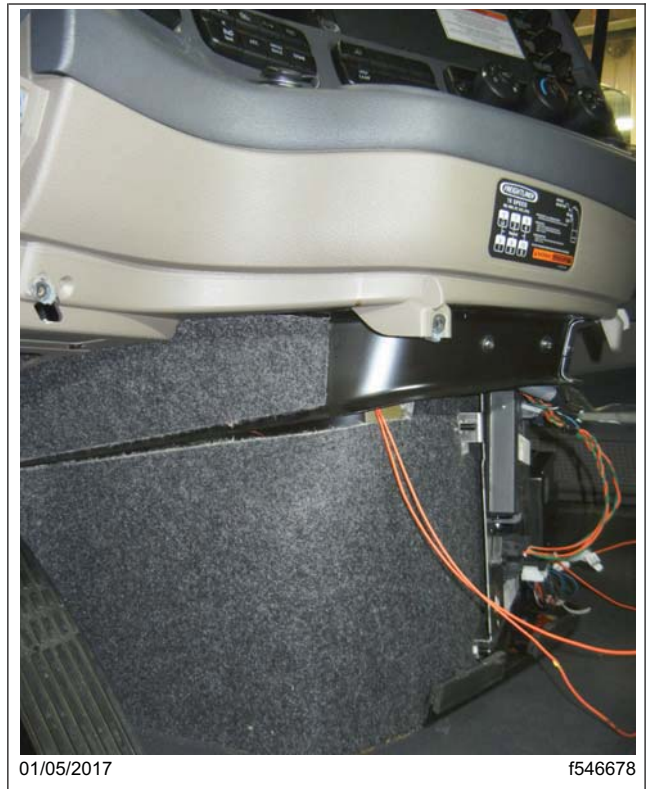
01/05/2017 f546678
Fig. 18, Routing the Wires to the ABS Module (FL721-A installation shown)

26. Install the terminal lock, and plug connector 2A into the ICU.
 27. Route wires A06-93668-000 and A06-93167-000 behind the dash down to the ABS module. See [Fig. 18](#).

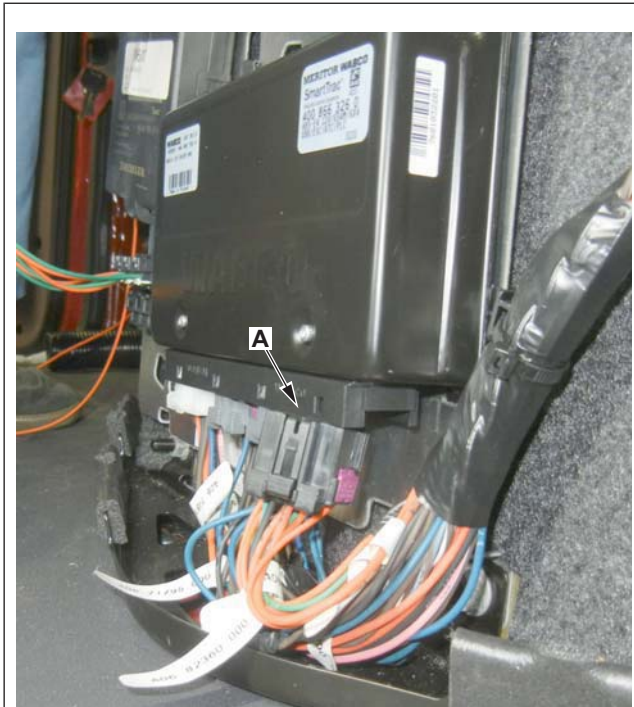
27. Disconnect connector X1A from the ABS module and remove the terminal lock. See [Fig. 19](#) and [Fig. 20](#)

A. Connector A is located on the right-hand side of the ABS module.

Fig. 19, Connector X1A on the ABS Module

28. Disconnect connector X1A from the ABS module and remove the terminal lock. See [Fig. 19](#) and [Fig. 20](#).
 29. Remove the existing wires from cavities 2 and 7 of ABS module connector X1A. See [Fig. 21](#) and [Fig. 22](#).

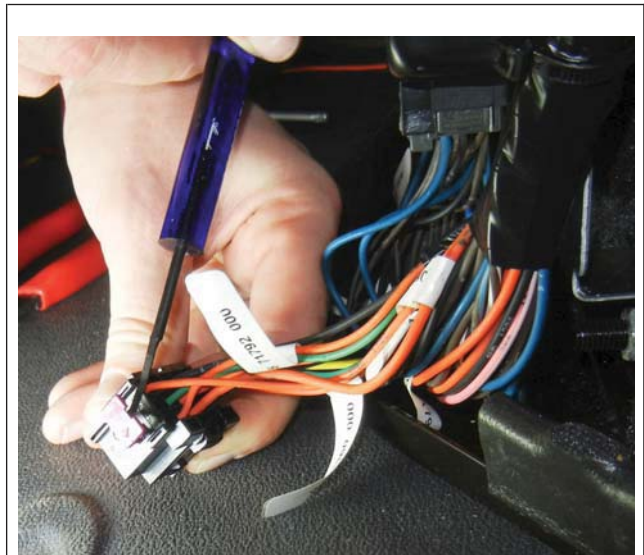
Fig. 20, Terminal Lock X1A

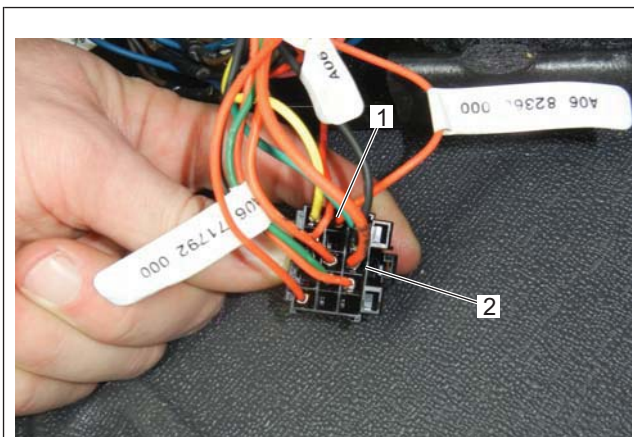
28. Remove the existing wires from cavities 2 and 7 of ABS module connector X1A. See [Fig. 21](#) and [Fig. 22](#).

- 1. Cavity 2
- 2. Cavity 7

Fig. 21, X1A Connector Terminals

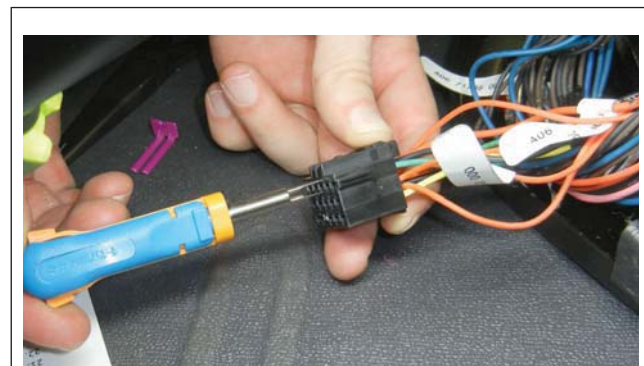
Fig. 22, Terminal X1A Removal

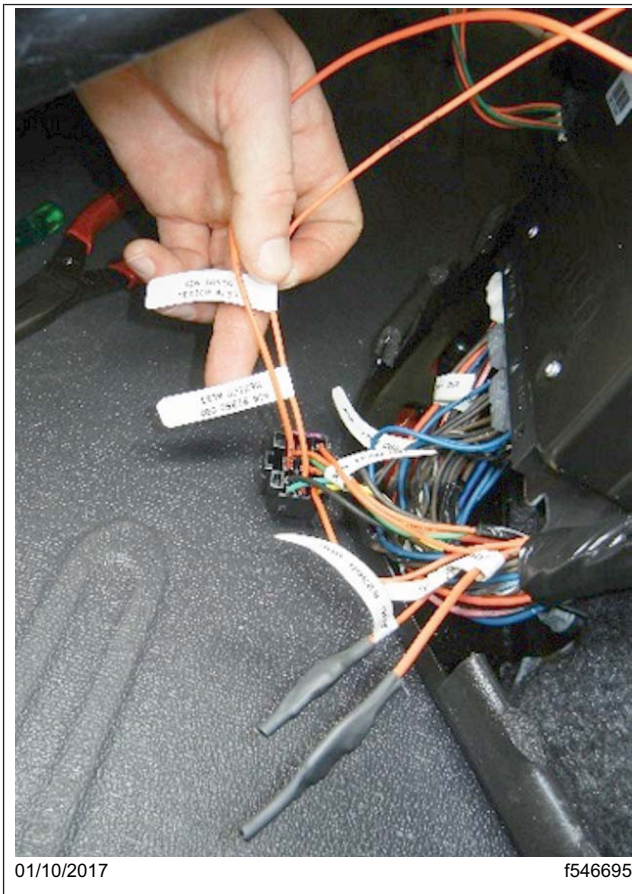
29. Fold the removed wires back against themselves, and cover the exposed terminal ends with heat shrink tubing.
30. Label the wire with tape with the description "Removed for FL721."
31. Insert the free ends of single-wire harnesses A06-93668-000 and A06-82360-000 into ABS module connector X1A. Connect A06-93668-000 into cavity 7, and A06-82360-000 into cavity 2. See **Fig. 23**.
32. Install the terminal lock in connector X1A and plug the connector back into the ABS module.
33. Use cable ties to secure the bundle to the HVAC ducting behind the ICU. See **Fig. 24**.

**Fig. 23, Both Wires Inserted into Connector X1A
(FL721-A installation shown)**

32. Insert the free ends of single-wire harnesses A06-93668-000 and A06-93167-000 into ABS module connector X1A. Connect A06-93668-000 into cavity 7, and A06-93167-000 into cavity 2. See [Fig. 23](#).

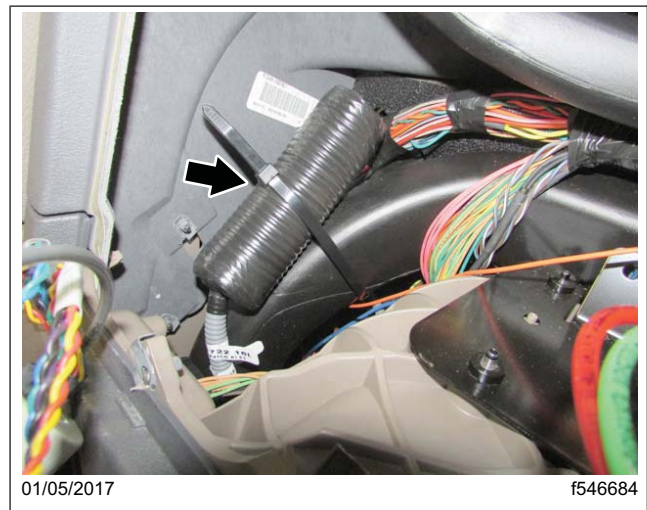
Fig. 24, PLC Bundle Mounting

33. Install the terminal lock in connector X1A and plug connector back into the ABS module.
 34. Use cable ties to secure the bundle to the HVAC ducting behind the ICU. See [Fig. 24](#).

26. Install the terminal lock in connector X1A and plug the connector back into the ABS module.
 27. Use cable ties to secure the bundle to the HVAC ducting behind the ICU. See [Fig. 24](#).
 28. Outside the cab, disconnect the chassis PDM (CPDM) harness and cap it with 23-13153-011. Plug each cavity with a cavity plug (23-13218-300). See [Fig. 25](#), [Fig. 26](#), and [Fig. 27](#).
- NOTE: Remove MEGA fuses from the PNDB if there are no other cables populated on the studs.
29. Disconnect the CPDM power cable from the PNDB and remove it from the vehicle. See [Fig. 28](#). Replace any cable ties that were removed, which are still needed to secure other hoses and wiring.
- NOTE: The CPDM should be discarded after it is removed from the vehicle. It will not be used again.
30. Remove the CPDM from the vehicle. See [Fig. 29](#).

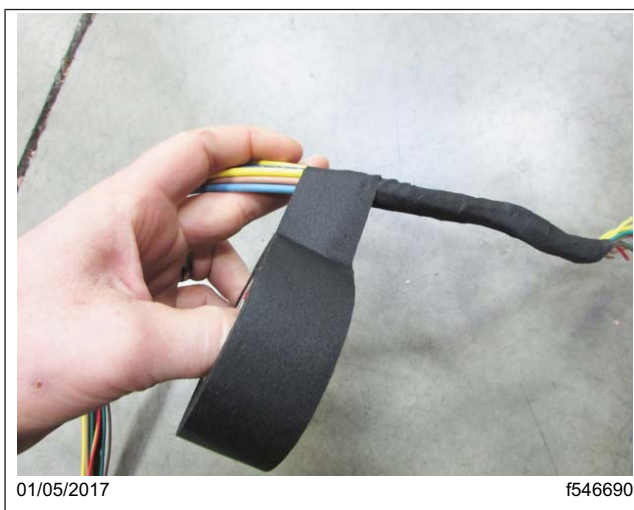
37. Wrap the exposed section of harness (A06-93018-084) with fiber wrap tape (48 25910 003). See [Fig. 30](#).

Fig. 30, Wrapping the Harness with Fiber Tape

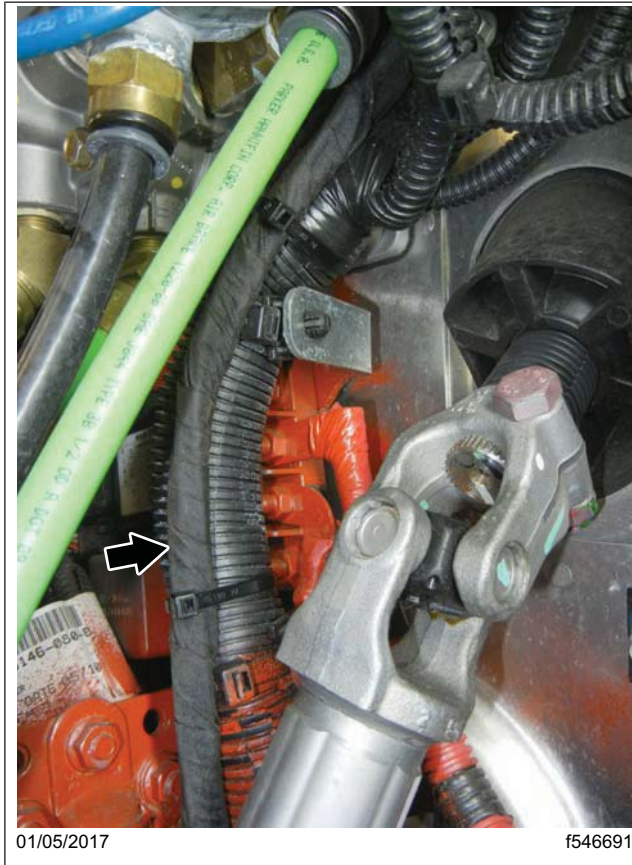
NOTE: Route the harness safely away from sharp points and edges, moveable parts, and other possible sources of abrasion, cutting, pinching, or crushing. Secure it to the frame rail at regular intervals using zip ties fastened to standoffs. Whenever possible, the harness should be routed behind the air and hydraulic lines.

38. Route harness A06-93018-084 along the frame rail to bulkhead connector 1A. See [Fig. 31](#).

Fig. 31, Bulkhead Harness Routing

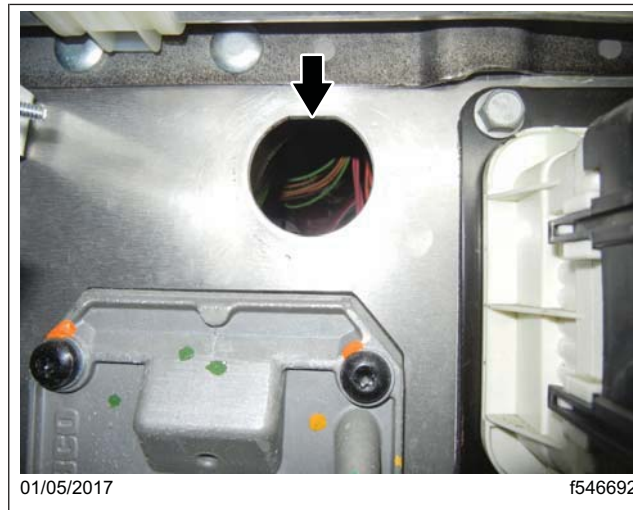
NOTE: The bulkhead connector is keyed with one flat side to be aligned with the D-shape in the frontwall hole.

40. Insert the cab side 1A bulkhead connector into the D-shaped hole and connect the engine side 1A bulkhead connector to it. See [Fig. 32](#).

Fig. 32, Bulkhead Connector 1A Cavity on the Frontwall

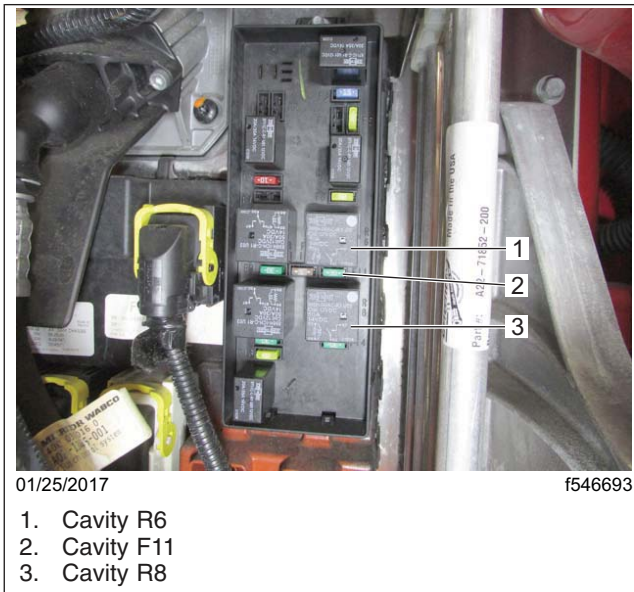
46. Install relay 23-11276-020 (vendor p/n 896-1AH-C-R1-U03-12VDC) into cavity R8, and verify there is a 30 amp fuse in cavity F14 on the SAM Chassis. See **Fig. 33**

**Fig. 33, Relays and Fuses on the SAM Chassis
(FL721-B installation shown)**

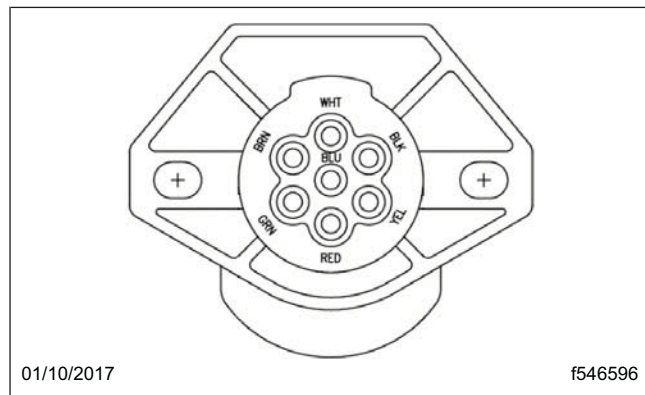
- **End-of-Frame Receptacle Power:** A0004478661-001 PARM-CHAS,EOF,SUP-R,NO CNT
 - **Trailer Configuration:** A0014470261-001 PARM-CHAS,TRA,BOC,IGN
49. Verify that the primary receptacle (**Fig. 34**) is functioning properly by performing the following checks with the ignition key in the ON position:

- 49.5 Verify there is battery voltage on the Blue terminal at all times.
 - 49.6 Verify there is battery voltage on the Yellow terminal while the left turn signal is activated.

Fig. 34, Primary Receptacle Pinout

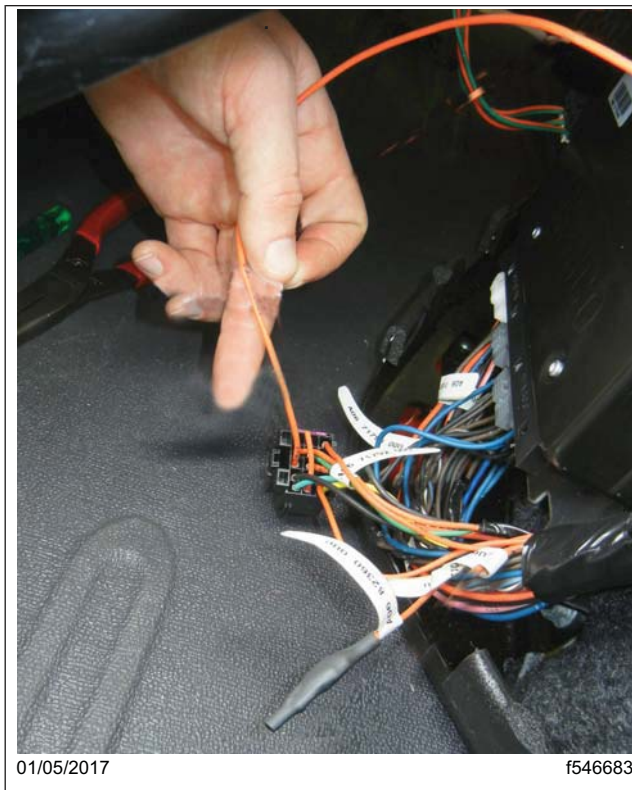
25. Insert the free ends of single-wire harness A06-93668-000 into ABS module connector X1A, cavity 7. Connect A06-93668-000 into cavity 7. See [Fig. 35](#)

Fig. 35, Wire Inserted into Connector X1A

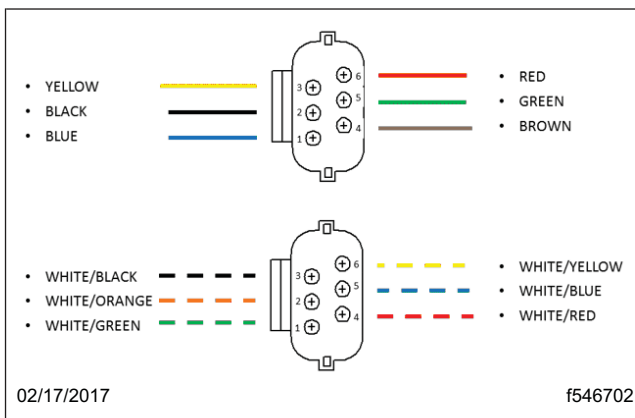
Fig. 36, Pinning From

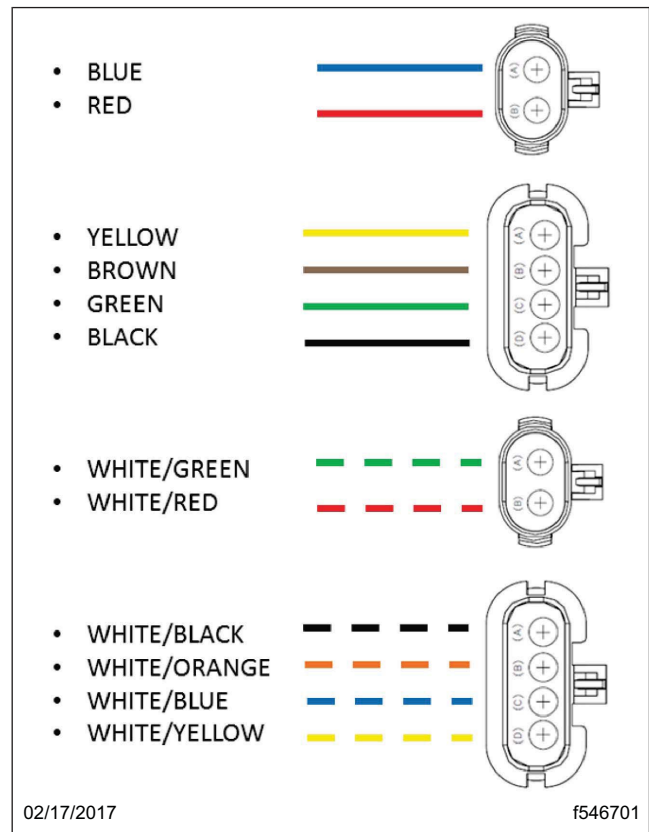
Fig. 37, Pinning To
