February 2017
FL721A-E
NHTSA #16V-656
Transport Canada #16-441
THIRD REVISED NOTICE

Subject: CNG Fuel Tank and CPDM Mounting Location

Models Affected: Specific Freightliner Cascadia vehicles manufactured September 24, 2012, through May 27, 2015, built with CNG fuel tanks

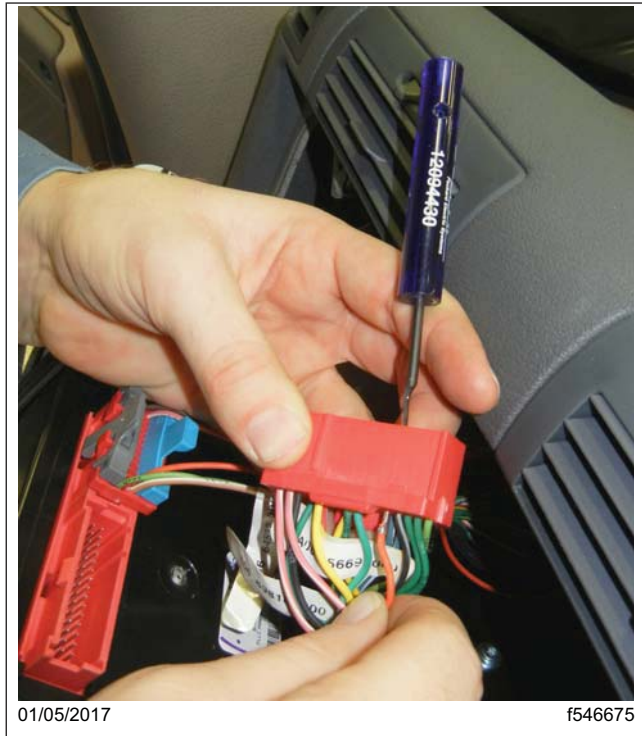
21. Remove the existing wire from cavity D12 of ICU connector 2A. See [Fig. 15](#).

Fig. 15, Wire Removal from Cavity D12 of ICU Connector 2A

22. Remove the existing wire from cavity D12 on ICU connector 2A. See [Fig. 15](#).
 23. Fold the removed wire back against itself, and cover the terminal with heat shrink tubing. See [Fig. 16](#).

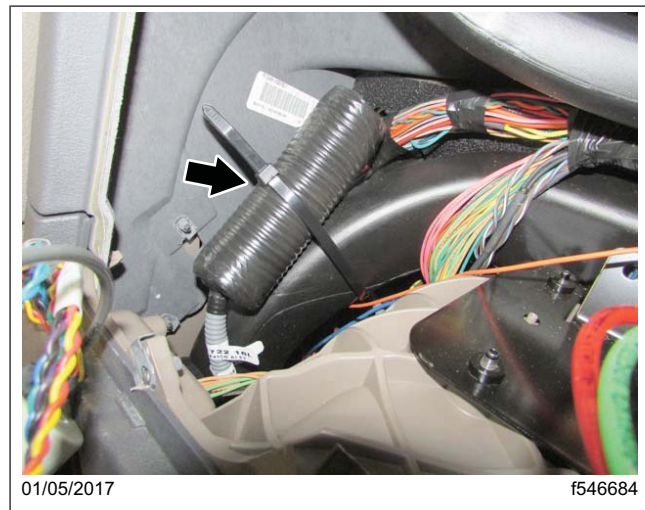
29. Fold the removed wires back against themselves, and cover the exposed terminal ends with heat shrink tubing.
30. Label the wire with tape with the description "Removed for FL721."
31. Insert the free ends of single-wire harnesses A06-93668-000 and A06-82360-000 into ABS module connector X1A. Connect A06-93668-000 into cavity 7, and A06-82360-000 into cavity 2. See **Fig. 23**.
32. Install the terminal lock in connector X1A and plug the connector back into the ABS module.
33. Use cable ties to secure the bundle to the HVAC ducting behind the ICU. See **Fig. 24**.

Fig. 24, PLC Bundle Mounting

33. Install the terminal lock in connector X1A and plug connector back into the ABS module.
 34. Use cable ties to secure the bundle to the HVAC ducting behind the ICU. See [Fig. 24](#).

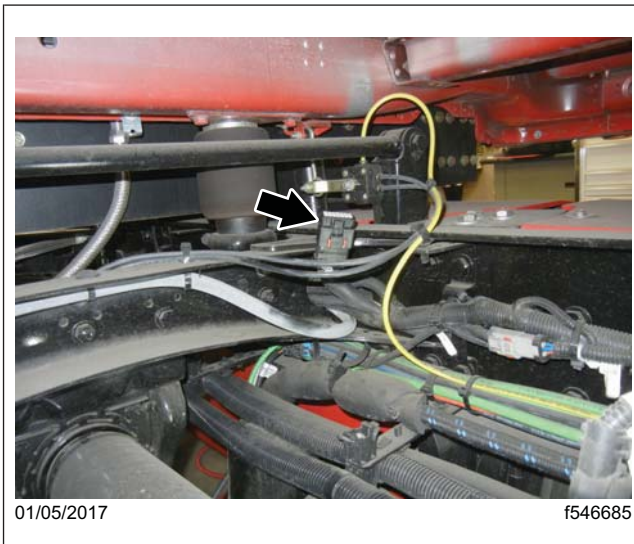
34. Outside the cab, disconnect the CPDM harness and cap it with part number 23-13153-011. Plug each cavity with a cavity plug (23 13218 300). See [Fig. 25](#), [Fig. 26](#), and [Fig. 27](#).

Fig. 25, CPDM Harness Capped

35. Outside the cab, disconnect the chassis PDM (CPDM) harness and cap it with 23-13153-011. Plug each cavity with a cavity plug (23-13218-300). See [Fig. 25](#), [Fig. 26](#), and [Fig. 27](#).

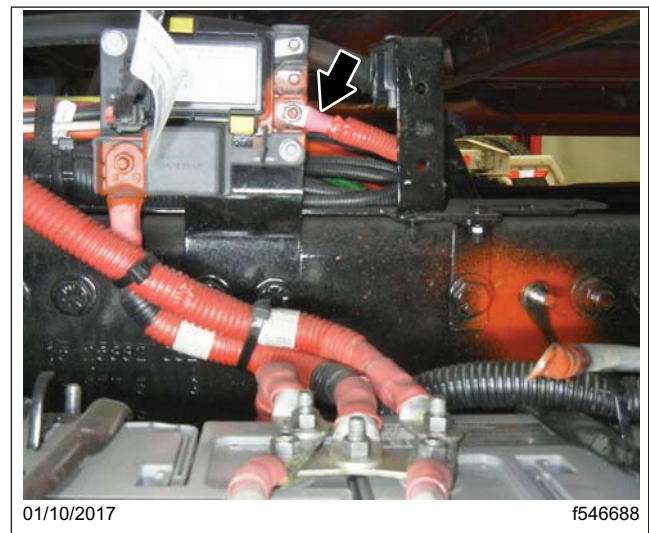
35. Disconnect the CPDM power cable from the PNDB and remove it from the vehicle. See [Fig. 28](#). Replace any cable ties that were removed, which are still needed to secure other hoses and wiring.

Fig. 28, CPDM Power Cable on the PNDB

- NOTE: Remove MEGA fuses from the PNDB if there are no other cables populated on the studs.
36. Disconnect the CPDM power cable from the PNDB and remove it from the vehicle. See [Fig. 28](#). Replace any cable ties that were removed, which are still needed to secure other hoses and wiring.

- NOTE: Remove MEGA fuses from the PNDB if there are no other cables populated on the studs.
35. Disconnect the CPDM power cable from the PNDB and remove it from the vehicle. See [Fig. 28](#). Replace any cable ties that were removed, which are still needed to secure other hoses and wiring.

- NOTE: Remove MEGA fuses from the PNDB if there are no other cables populated on the studs.
41. Disconnect the CPDM power cable from the PNDB and remove it from the vehicle. See [Fig. 28](#). Replace any cable ties that were removed, which are still needed to secure other hoses and wiring.

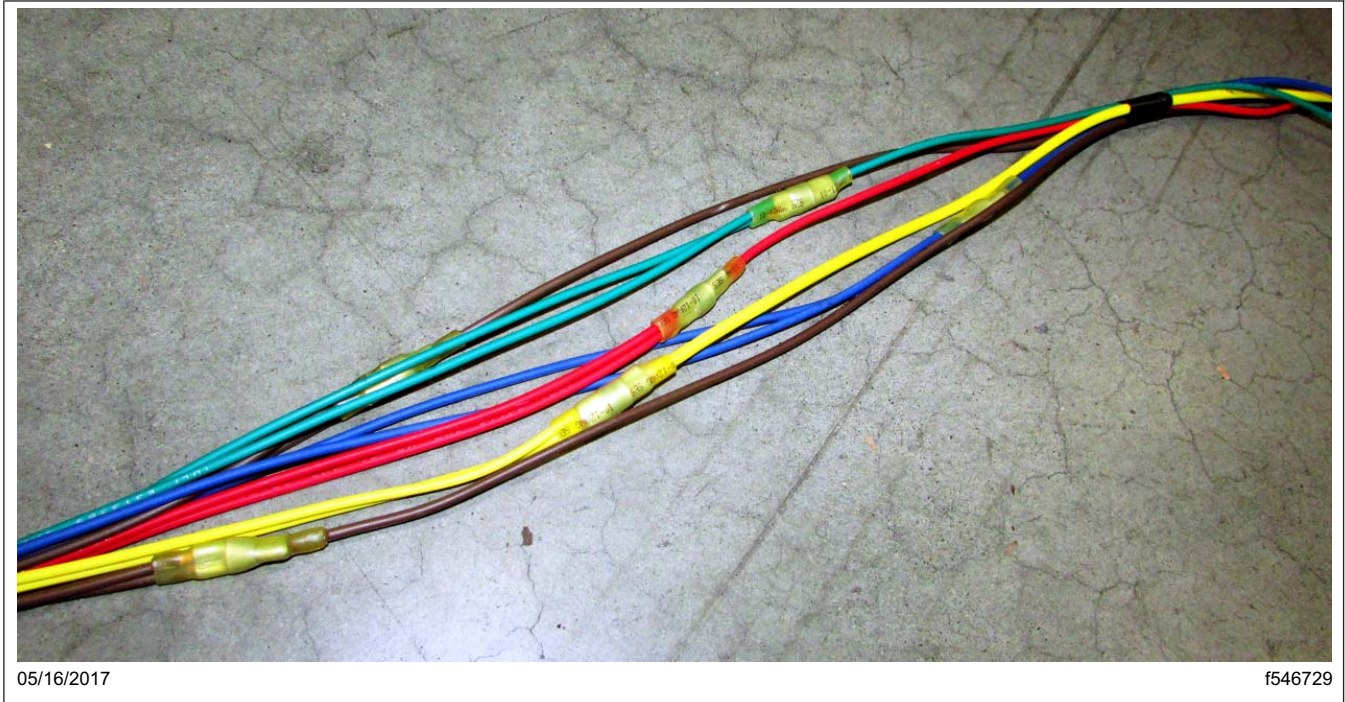
37. Using Phillips STA Dry Crimp Solder Seal connectors (48-02461-038) splice blunt cut individual circuit wires from harness A06-93227-000 with their corresponding circuit wire numbers on harness A06-93228-006 and A06-93229-132. Stagger the splices at varied lengths to keep bundle from becoming unmanageable. See [Fig. 35](#).

Fig. 35, Staggered Harness Splicing

THIRD REVISION: Figure 35 has been added to FL721-C, step 37.
