Recall Campaign 16V-071: Driver's Front Air Bag Module E83

This Service Information bulletin Replaces SI B65 04 16 **dated March 2016** for E83 vehicles only.

E83 (X3)

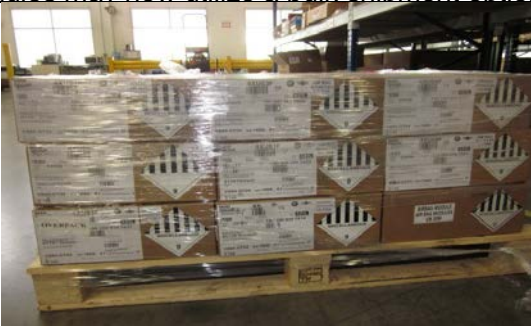
<p>1 Stacking:</p> <p>Place the safety device and shrink-wrap them on the pallet.</p> <p><u>(no more than 60 inches in height).</u></p>

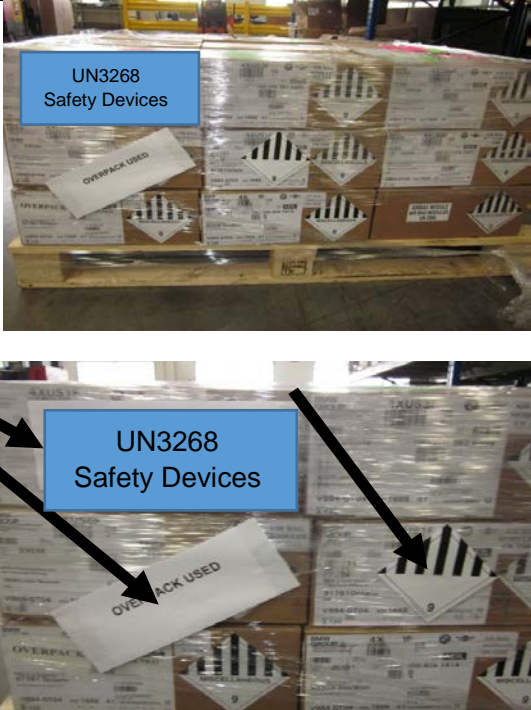
<p>2 Labeling:</p> <p>Put the following labels on both sides of the skid:</p> <ul style="list-style-type: none">• Class 9• UN3268 (Safety devices)*• OVERPACK USED* <p>*Can be printed on Letter Size paper using Microsoft Word</p>

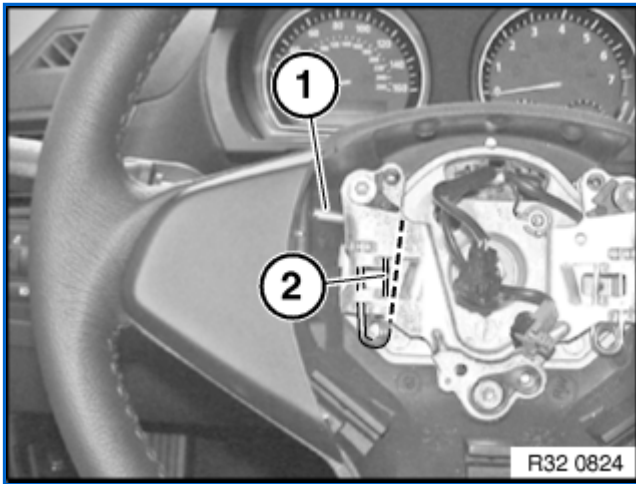
Insert Torx screwdriver T30 (1) horizontally into opening on reverse side of steering wheel until a spring resistance is felt (approx. 4 cm).

Press spring leg (2) with Torx screwdriver (1) up to stop and pull airbag unit away from steering wheel.

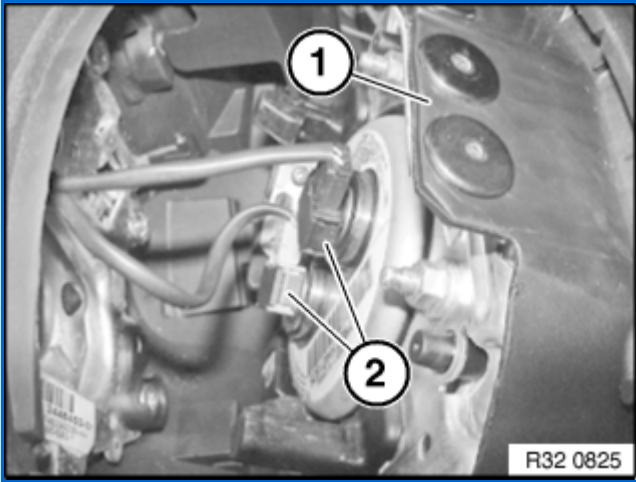
Tilt airbag unit (1) towards rear.

Disconnect [plug connections](#) (2) and remove airbag unit (1).

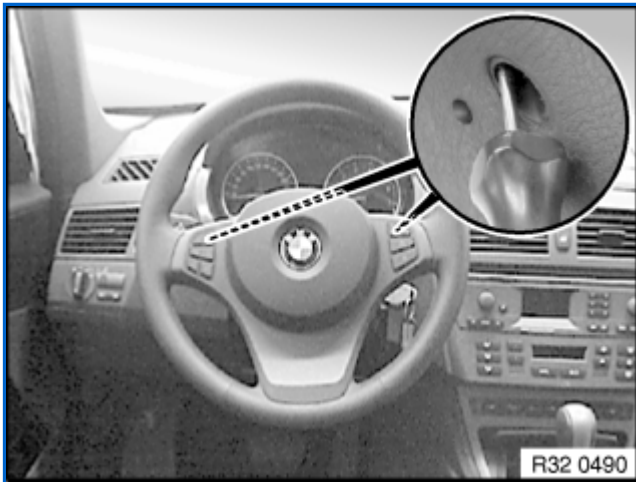
Insert Torx screwdriver (T30) horizontally into opening on reverse side of steering wheel up to stop (approx. 4.5 cm).

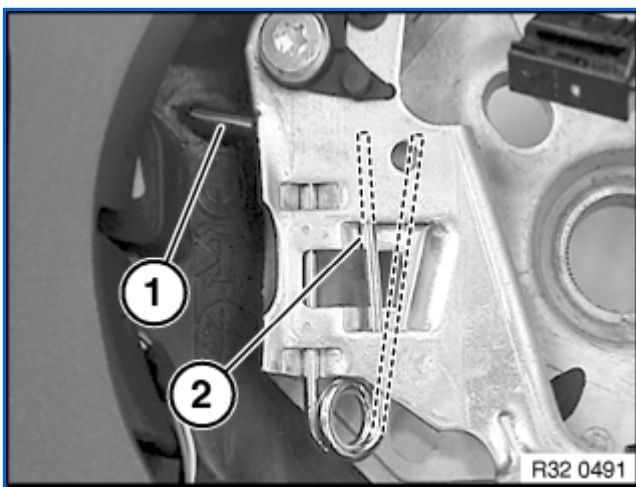
Increase pressure with Torx screwdriver T30 (1) on spring leg (2) until airbag unit is unlocked.

Repeat procedure on other side.

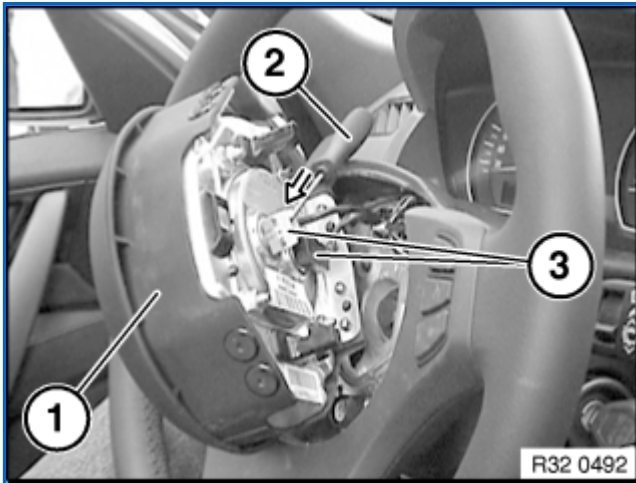
Tilt airbag unit (1) slightly to one side.

Slide screwdriver (2) from front into both plug connections (3) until cover lifts off.
