Safety Recall

Code: 69N1

Subject	TAKATA SDI Driver Frontal Airbag Inflator								
Release Date	March 8, 2017								
Revision Summary	Updated claim entry information and work procedure to include additional part numbers.								
Affected Vehicles	<i>U.S.A. & Canada: Certain 2009-2013 MY Audi vehicles equipped with a Takata SDI driver frontal airbag</i> <i>Check Campaigns/Actions screen in Elsa on the day of repair to verify that a VIN qualifies for repair under this action. Elsa is the <u>only</u> valid campaign inquiry & verification source.</i> <ul style="list-style-type: none">✓ <i>Campaign status must show "open."</i>✓ <i>If Elsa shows other open action(s), inform your customer so that the work can also be completed at the same time the vehicle is in the workshop for this campaign.</i>								
Takata Recall Priority Groups and Repair Rollout	This recall is being managed according to the requirements mandated by the NHTSA in the Coordinated Remedy Order. Transport Canada is following the same requirements. Vehicles affected by this recall fall into the following priority groups established by the NHTSA as shown below:

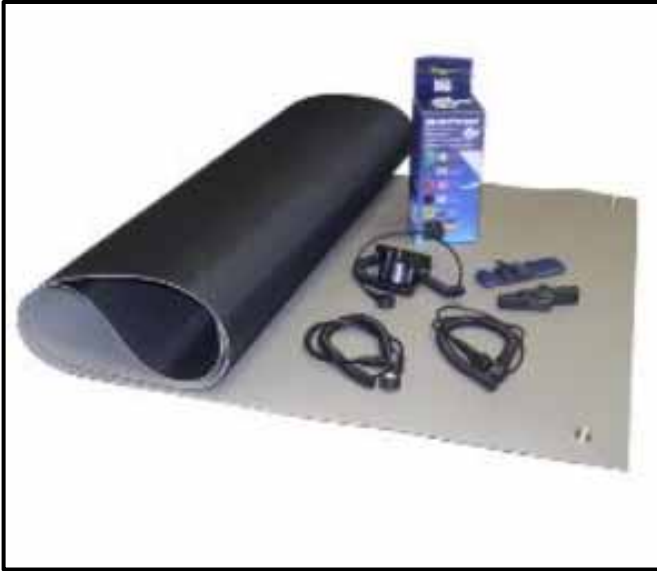
- ESD Worksurface - VAS 6613

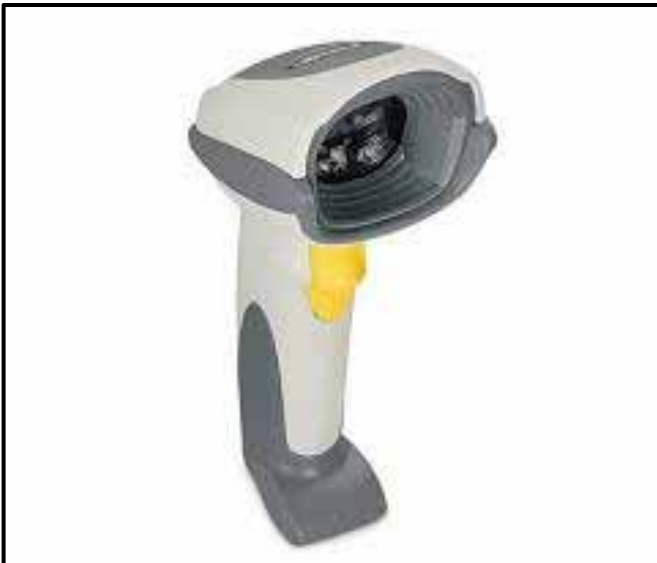
- Bar Code Scanner – VAS6161/1

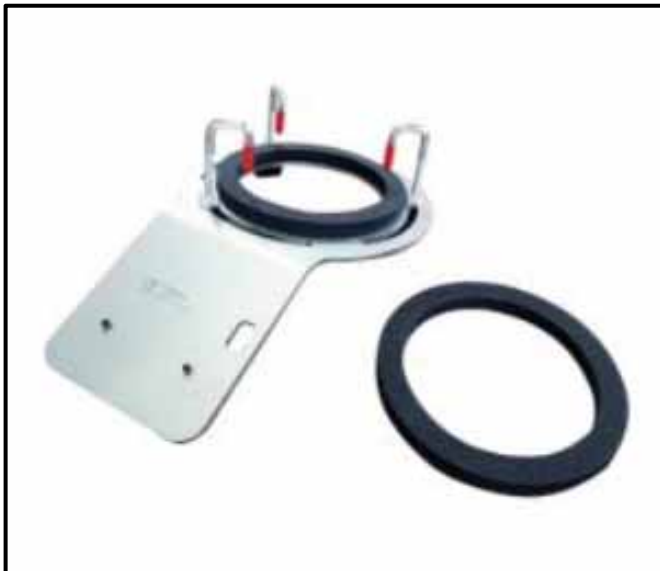
- Airbag Support - T10568

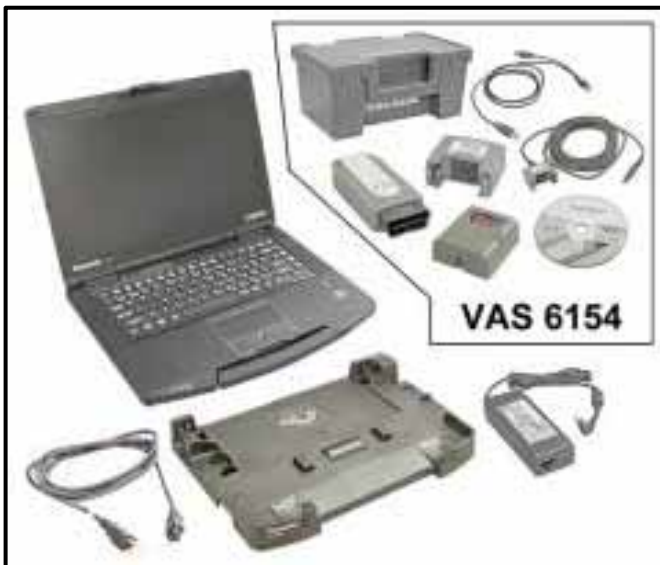
- VAS6150D - Diagnostic Tester (or equivalent)

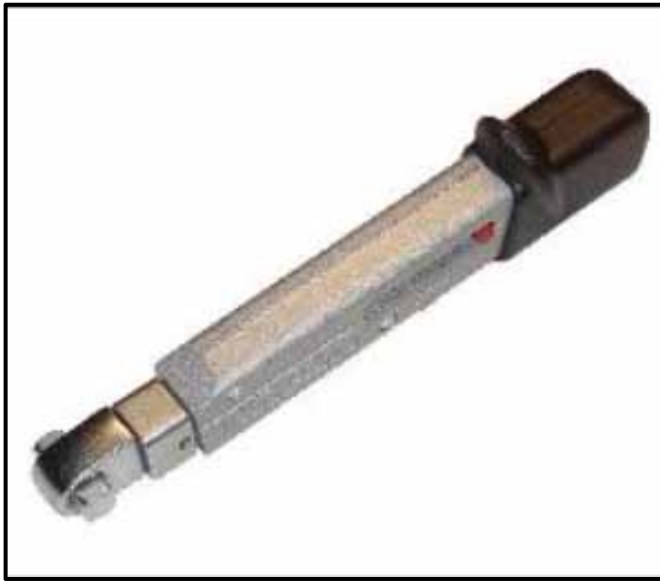
- VAG1410 – Torque Wrench (or equivalent)

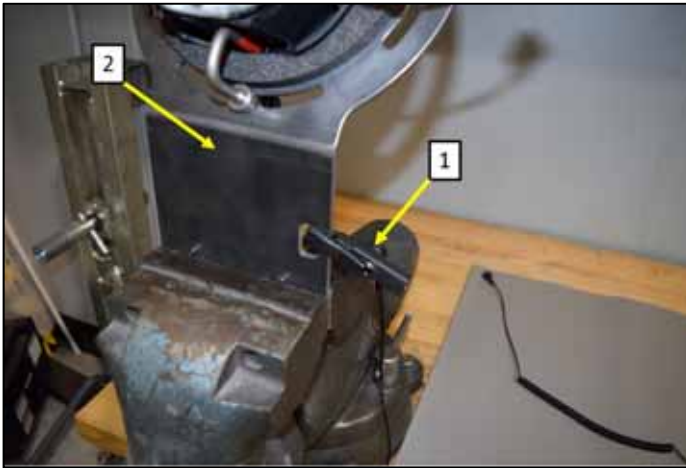
- Clamp Airbag Support T10568 <2> into the vice.
- Connect crocodile clip <1> to airbag support <2> and ESD workplace -VAS 6613-.

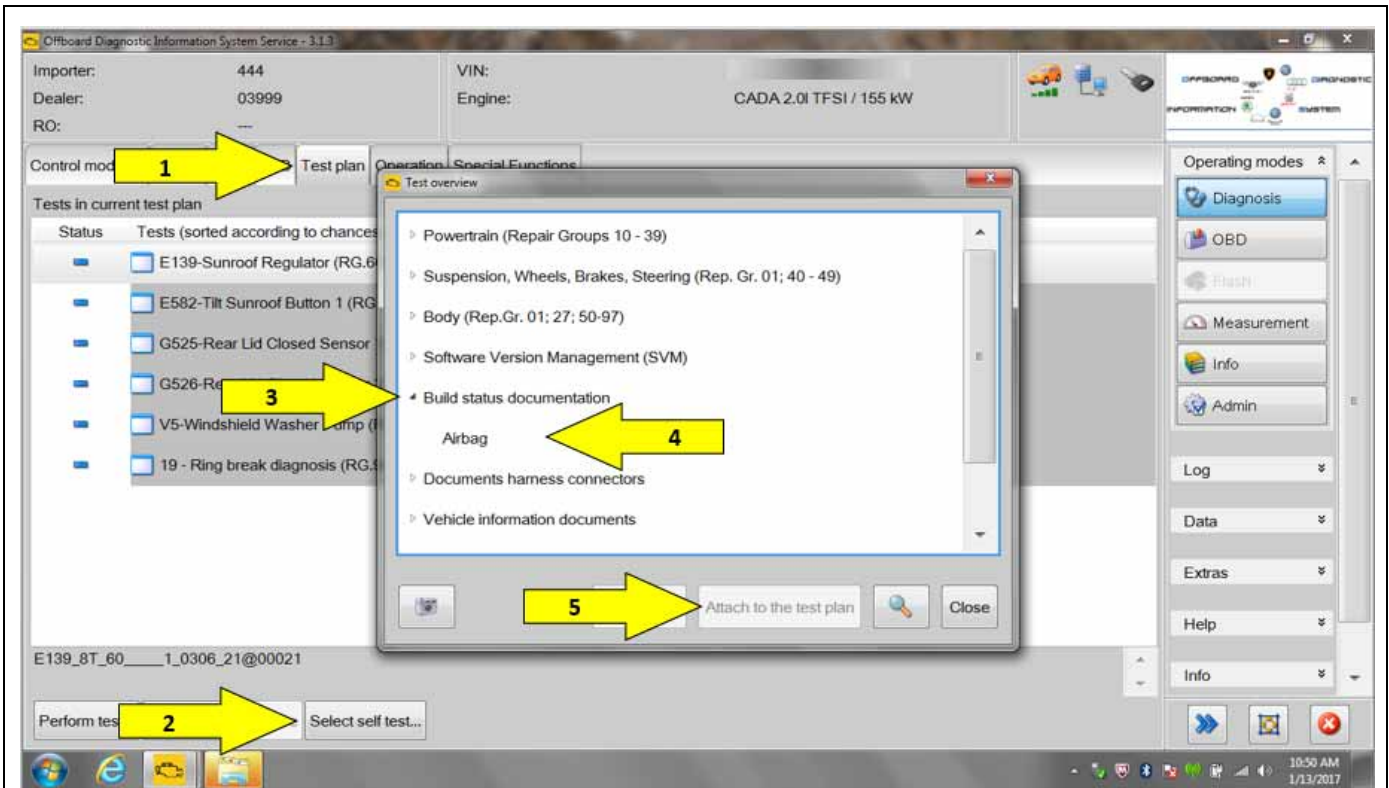
- Select the “Test plan” tab <1>.
- Select “Select self test...” <2>.
- Open the “Build status documentation” dropdown <3>.
- Highlight “Airbag” <4>.
- Select “Attach to the test plan <5>.

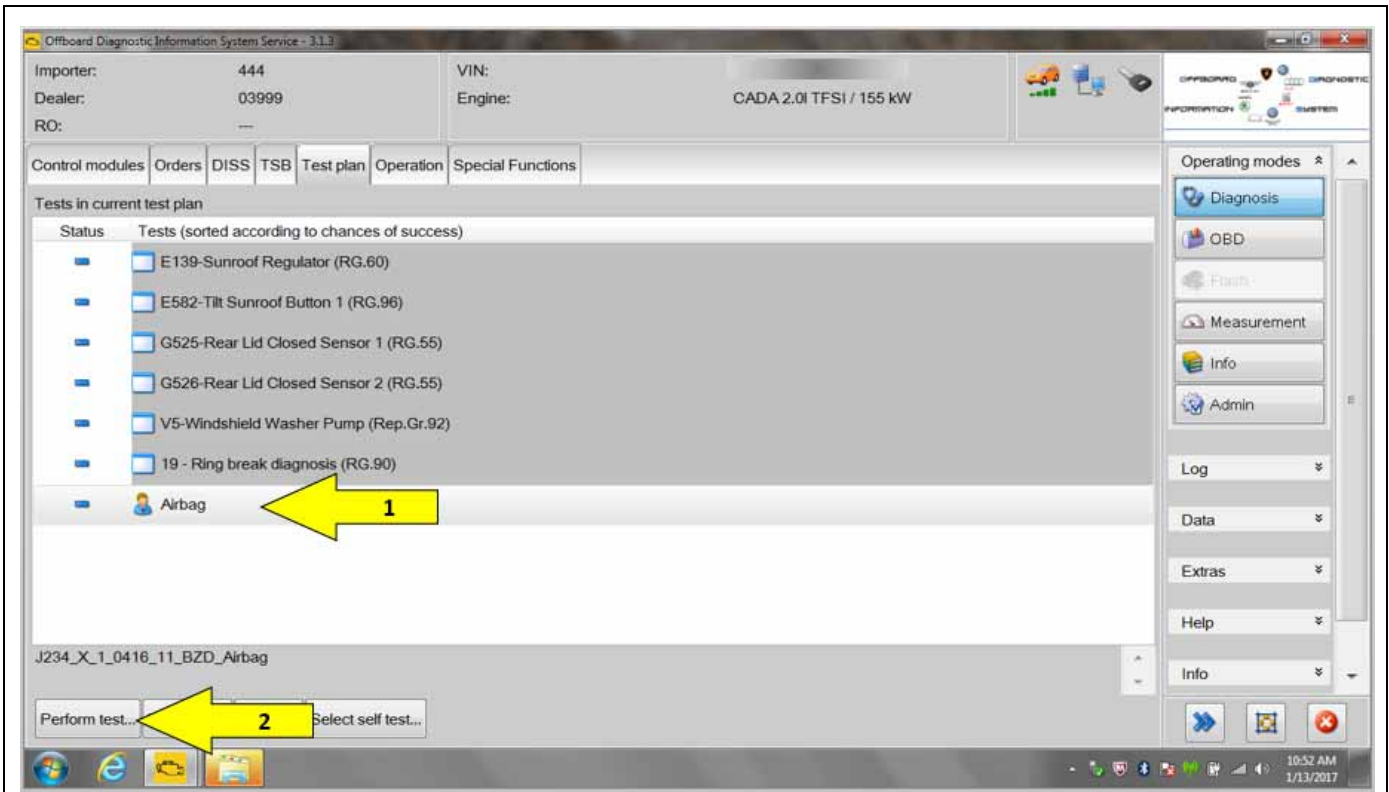
- Highlight the “Airbag” test plan <1>.
- Select “Perform test...” <2>.

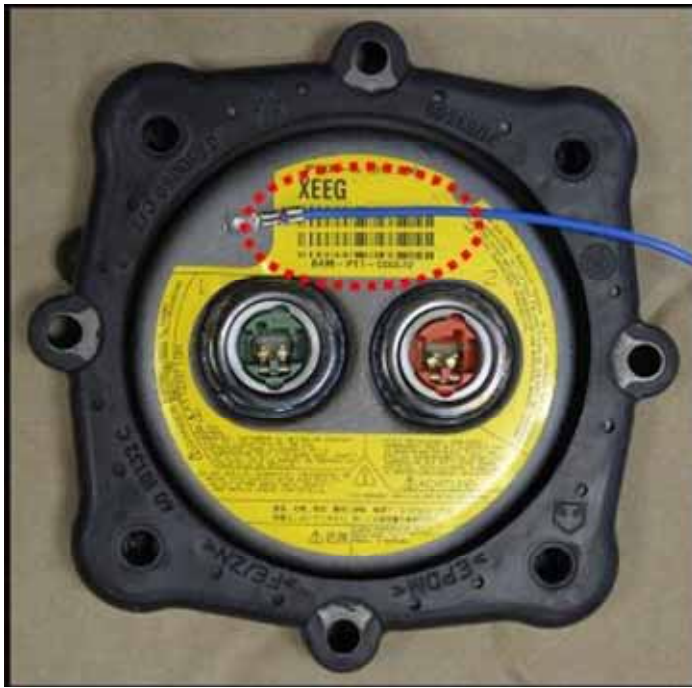
- Place the new inflator on the ESD mat.
- Scan the bar code of the new inflator at a distance of about 15 cm.

The photo is for reference only. The inflator that is installed may be either a single stage or dual stage inflator.

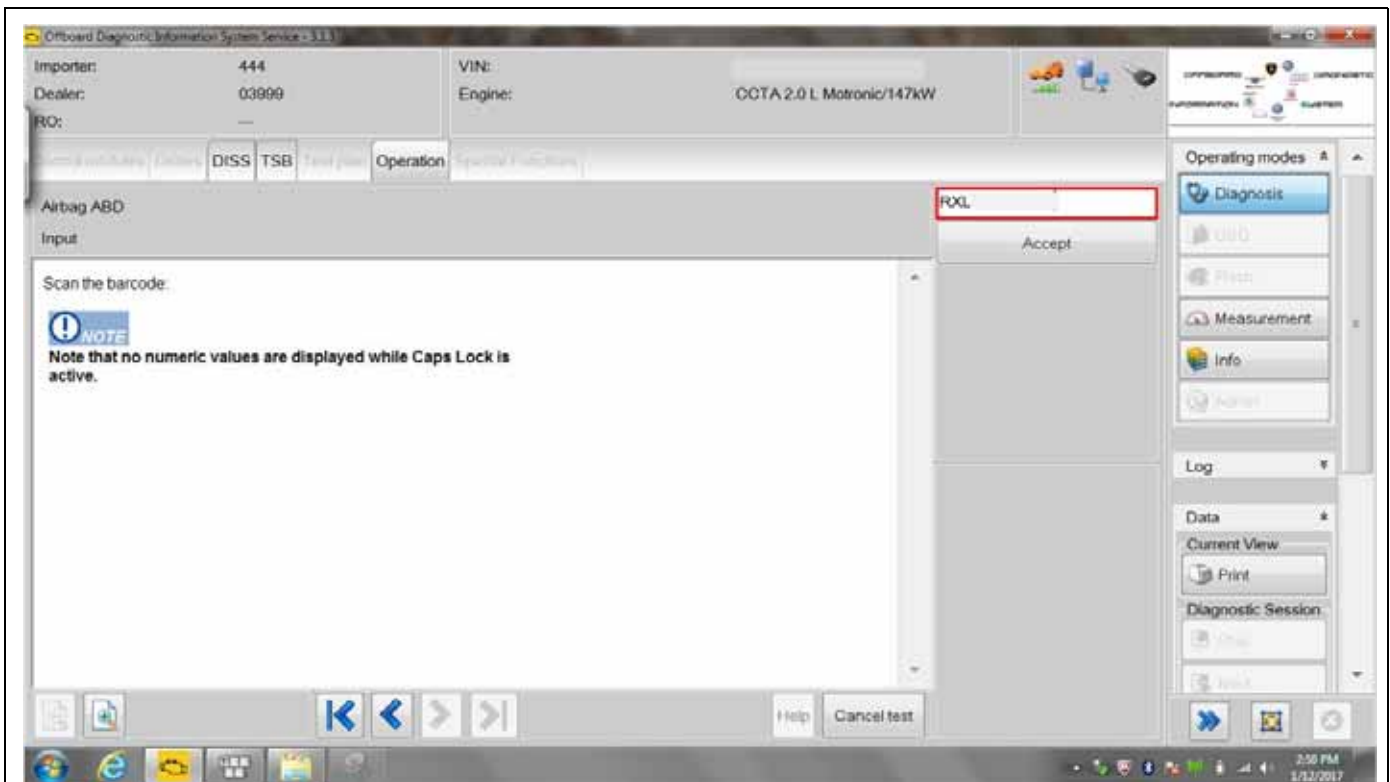
- Once the new inflator has been successfully scanned, press **“Accept”**

- Compare the scanned value with the value shown above the bar code on the new inflator.
- If there is a discrepancy, manually enter the value from the new inflator in the input field.
- If no value appears, recalibrate the scanner.

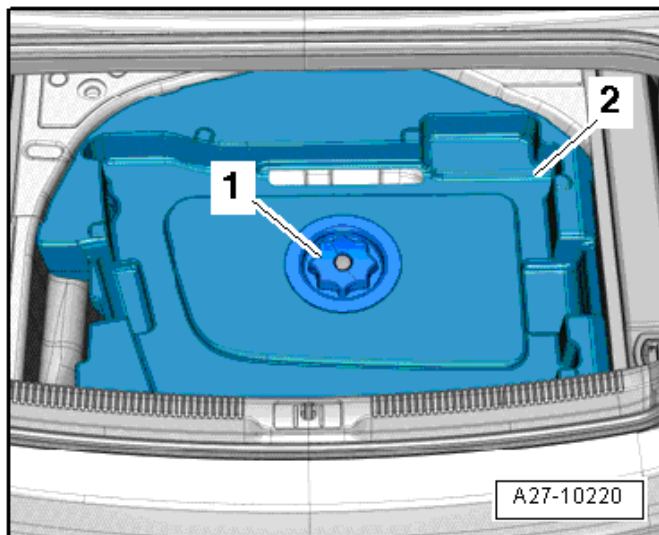
- Lift the luggage compartment floor and engage it on the body.
- Remove the wind deflector from its mount.
- Remove the nut <1> and remove the wind deflector mount <2>.

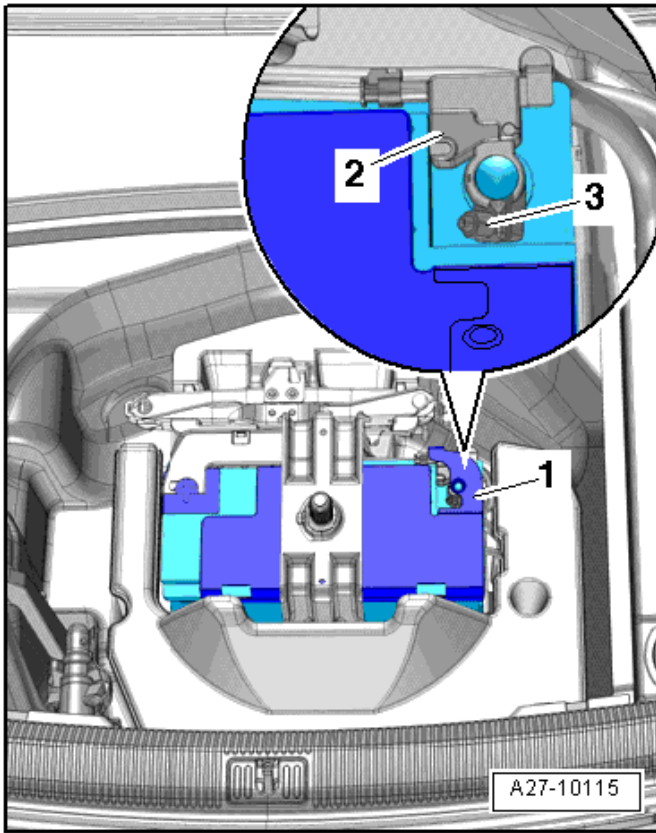
- Open the cover <1> over the battery negative terminal.
- Make sure the ignition is turned **ON**.
- Loosen the nut <3>.
- Remove and isolate the battery ground cable terminal <2> from the battery terminal.

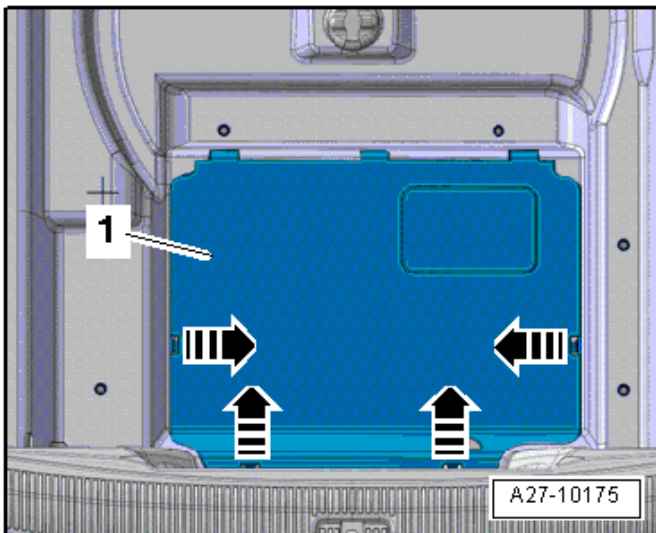
- Unlock the retaining tabs -arrows- and open the cover <1>.

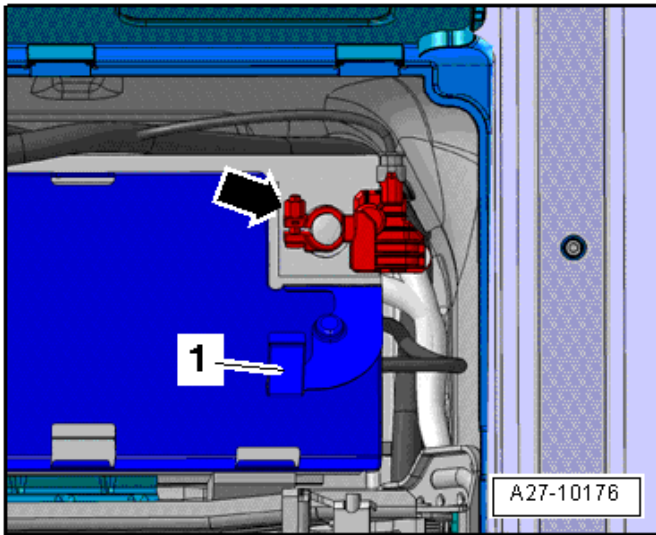
- Open the cover <1> over the battery negative terminal.
- Make sure the ignition is turned **ON**.
- Loosen the nut <arrow>.
- Remove and isolate the battery ground cable terminal from the battery pole.

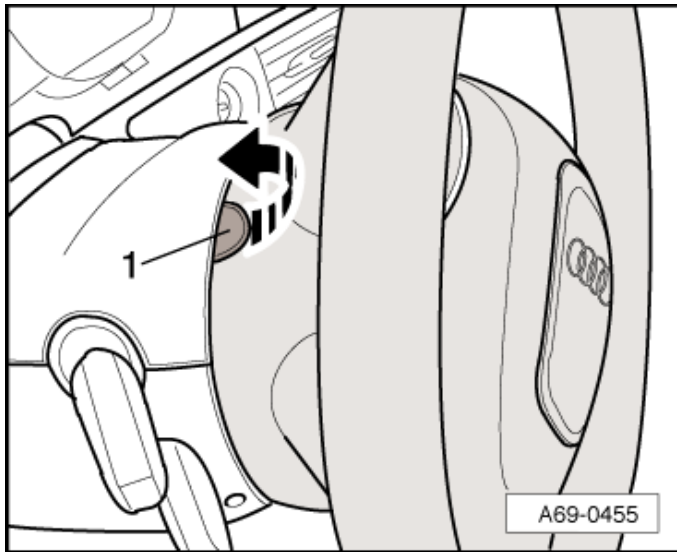
- Adjust the steering column as far down as possible.
- Turn the steering wheel so the cap <1> on the rear side of it faces upward. This is approximately the 12:00 position.
- Pry the cap off <arrow>.

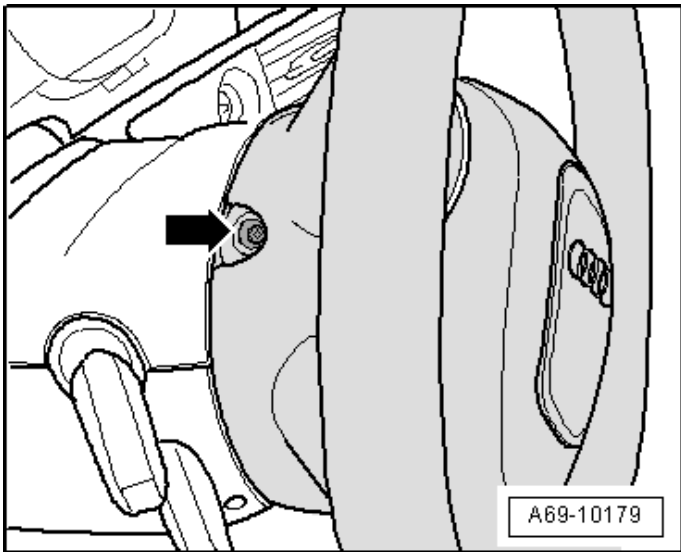
- Remove the driver airbag bolt <arrow>.
- Turn the steering wheel 180° and repeat the procedure on the opposite side.

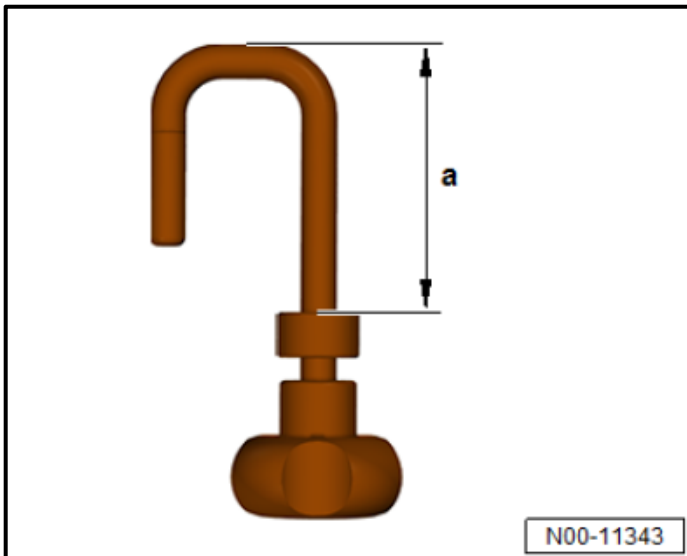
Tighten mounting by hand to prevent damage.

- Adjust three knurled nuts of securing hooks to <dimension a> 50mm.

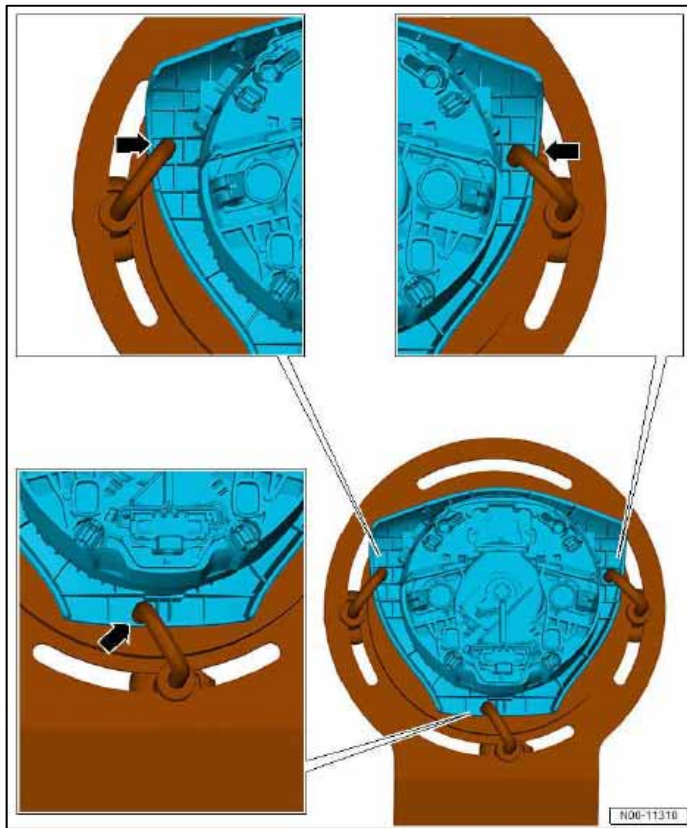
- Clamp airbag centrally in airbag support. There are securing points on the sides <arrows>, parallel opposite each other and below.

The clamps must be placed in the positions shown <arrows> to prevent damage to the airbag. Damage to the airbag is not covered under this action.

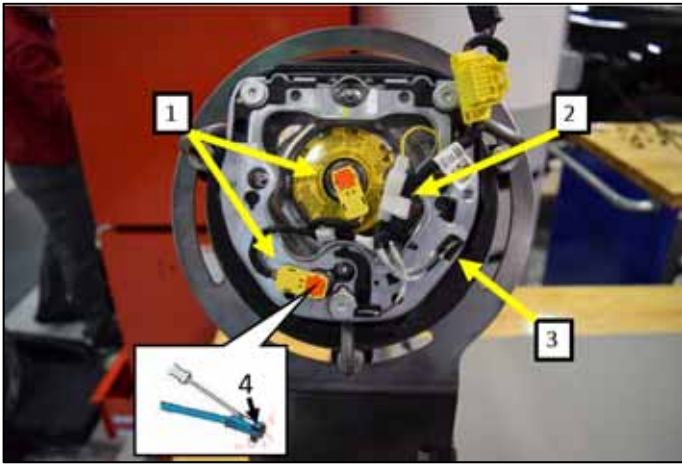
- Disconnect connector <1> using a small flat bladed screwdriver to disengage connector lock <4>.
- Disconnect connectors <2 and 3>.

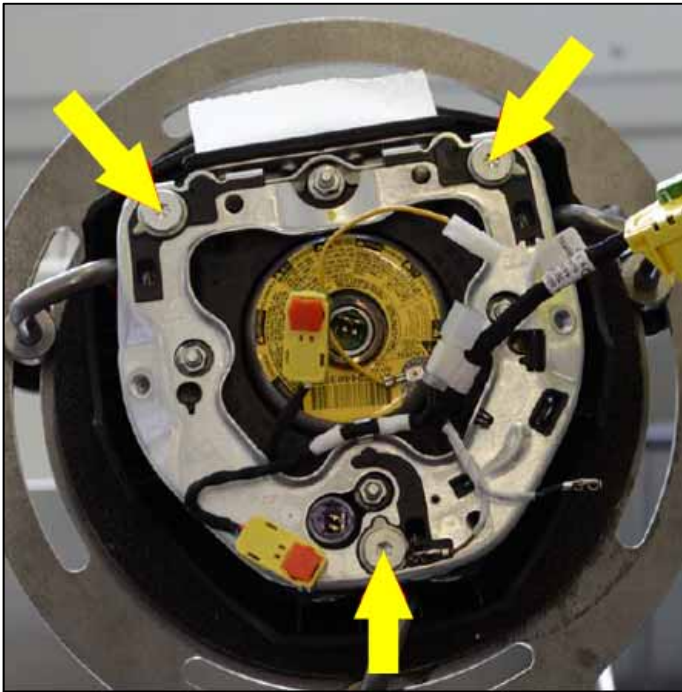
- Remove and discard the three horn ring bolts <arrows>.
- Remove the horn ring.

When removing the horn ring, take care that the springs are not lost as they are not available separately. Replacement of the airbag is required if a spring is lost and is not covered under this action.

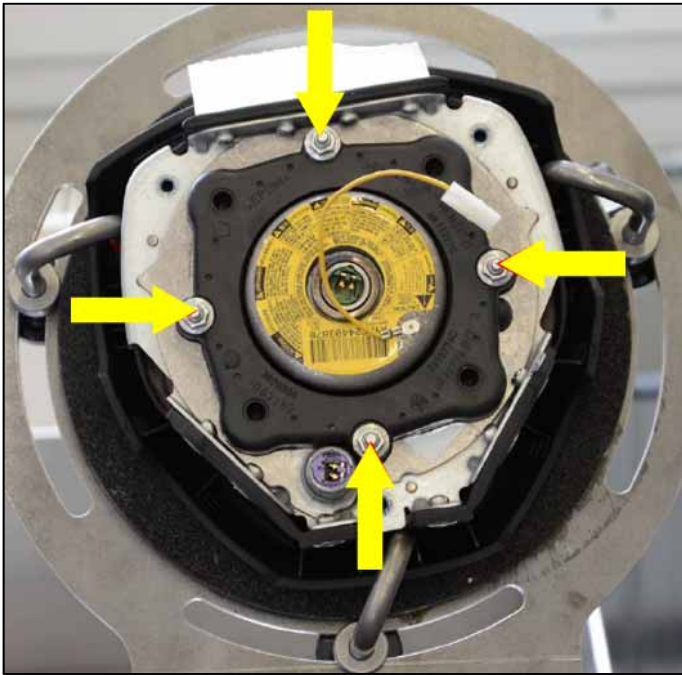
- Remove and discard the four nuts <arrows>.

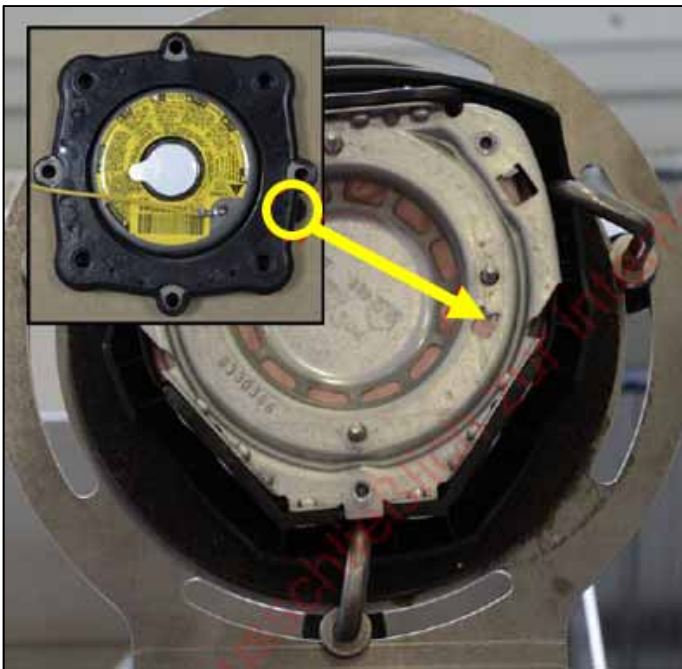
- Ensure the recess on the inflator lines up properly with the tab on the airbag <arrow>.

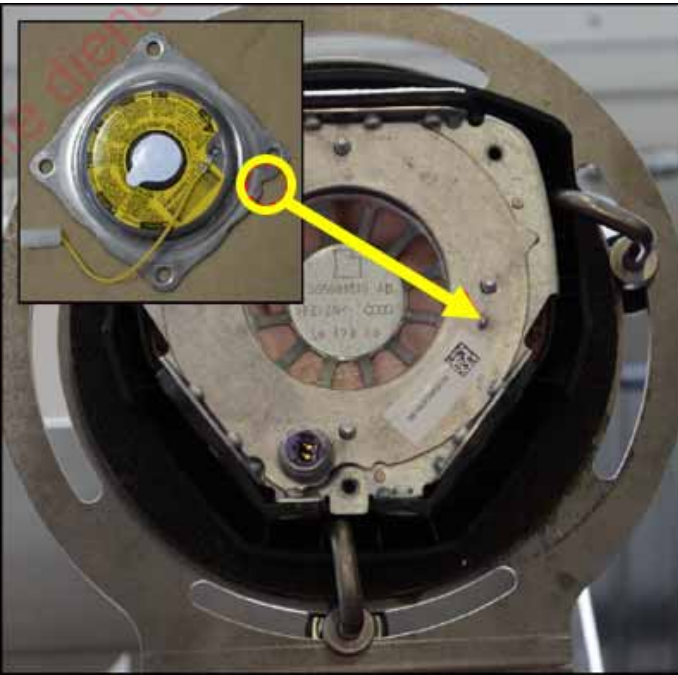
- Install the new inflator onto the studs.

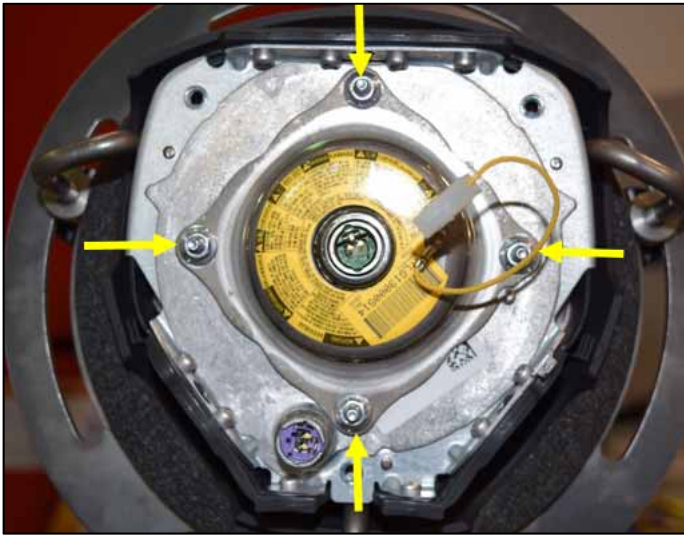
- Install the new inflator nuts <arrows> and torque to 4.5 Nm.

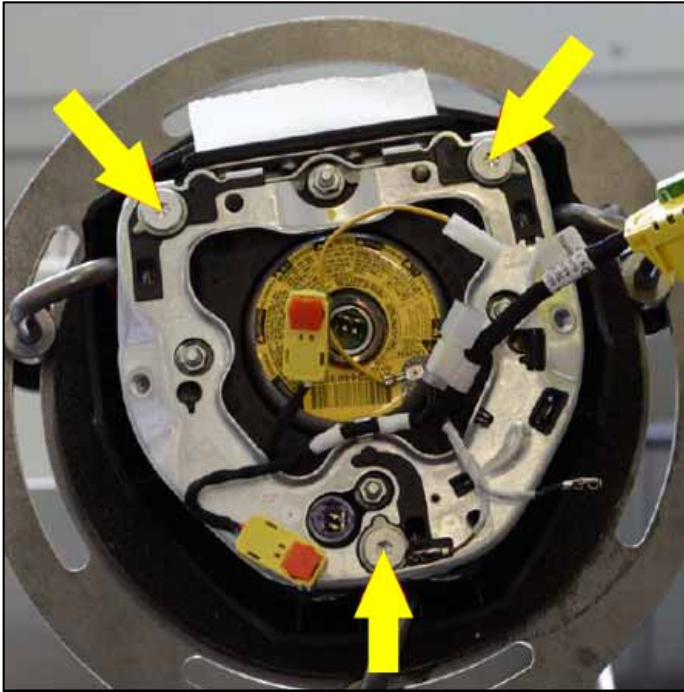
- Install the horn ring and tighten the bolts <arrows> to 6 Nm.

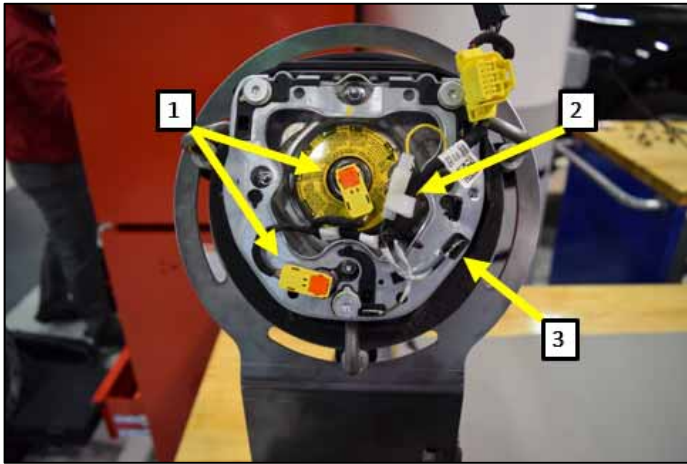
- Install connectors <1, 2 and 3>.

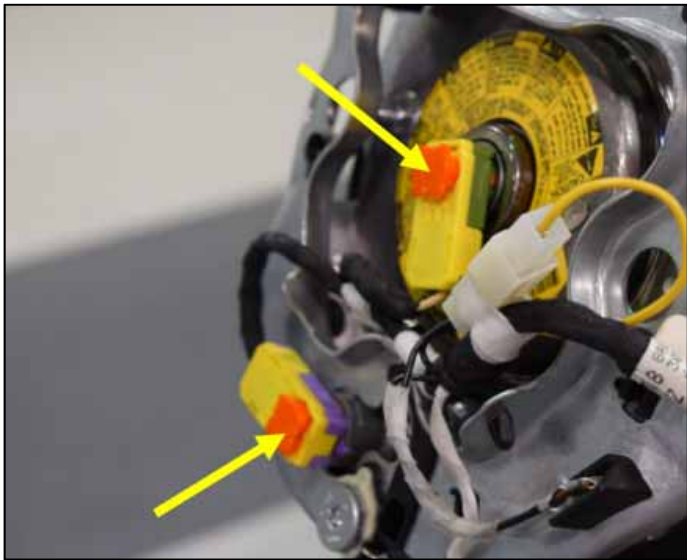
Ensure the connector locks <arrows> are fully opened as shown when installing the connectors.

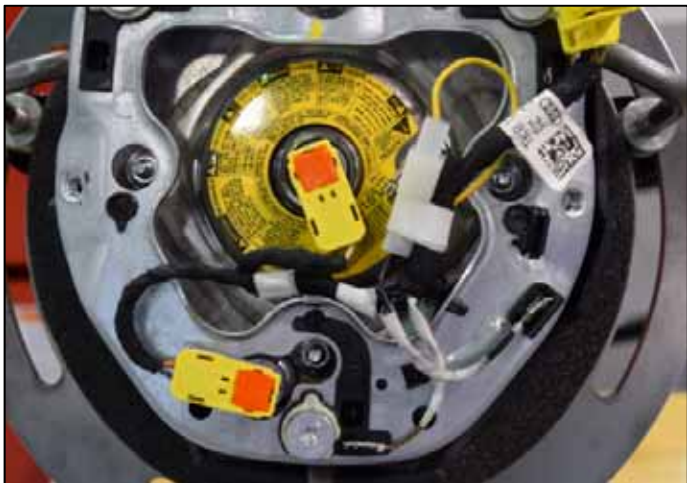
- Engage the connector locks.
- Ensure all wire connections are secure and the airbag harness is routed correctly.

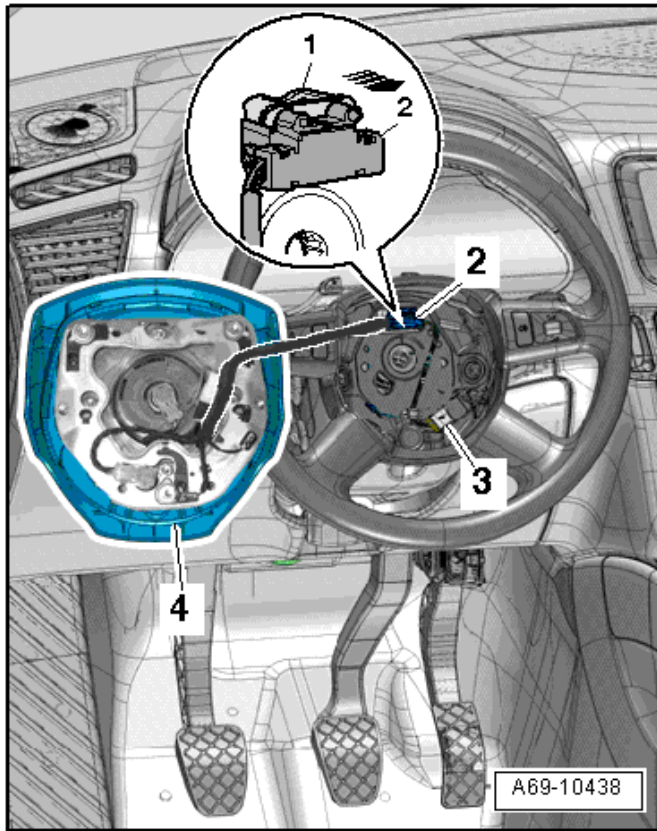
Bolted Airbag Version

- The battery must be disconnected before installing the airbag back into the vehicle.
- Before handling pyrotechnic components (for example, disconnecting the connector), the person handling it must “discharge static electricity”. This can be done by touching the door striker, for example.
- Connect the spiral spring electrical connector <2> with the airbag connector coupling on the coil connector with slip ring.
- Versions with Multi-function and Tiptronic steering wheel: Install the connector -3-.

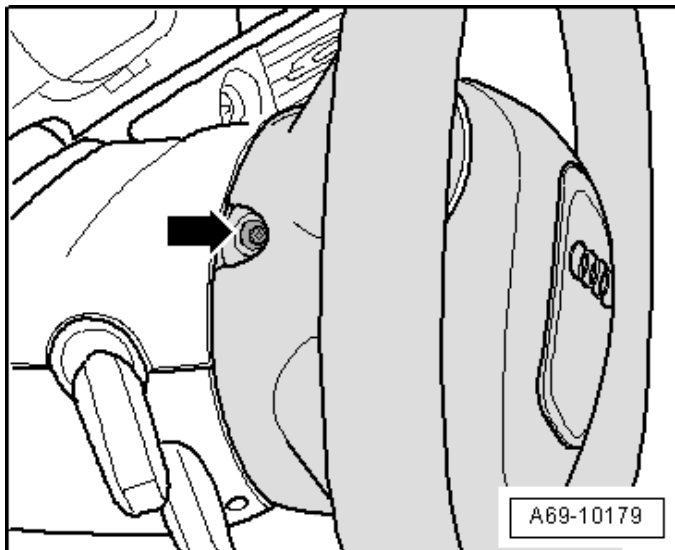
- Position the driver airbag in the steering wheel.
- Install the 2 bolts -arrow- for securing the driver airbag approximately 2 turns.
- Press horn about 3 times to achieve even gap dimension
- Torque the bolts <arrow> to 7 Nm.
- Install the bolt cover caps.

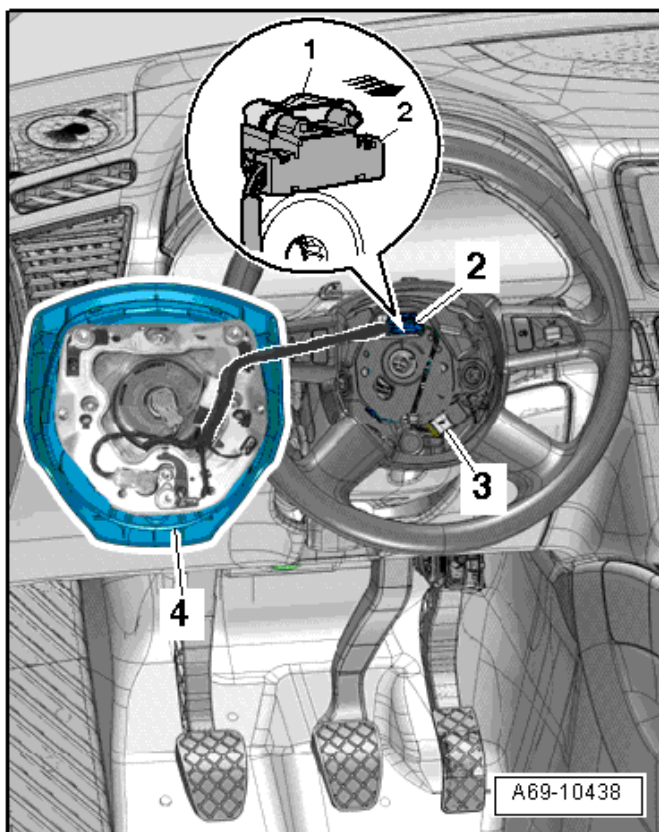
Attached Airbag Version

- The battery must be disconnected before installing the airbag back into the vehicle.
- Before handling pyrotechnic components (for example, disconnecting the connector), the person handling it must “discharge static electricity”. This can be done by touching the door striker, for example.
- Connect the spiral spring electrical connector <2> with the airbag connector coupling on the coil connector with slip ring.
- Press in harness connector to secure in the pockets on the steering wheel.
- Position driver airbag in the steering wheel and press on it until it audibly engages.

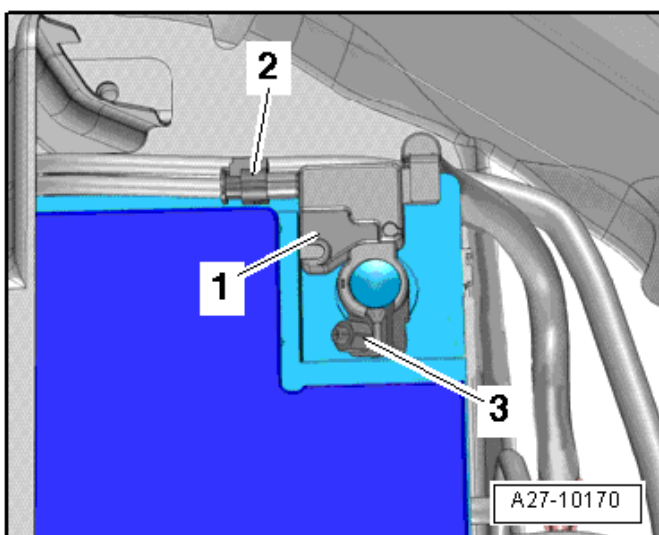
A5 Cabrio Procedure

Ignition must be ON when connecting battery. If pyrotechnic components (e.g. airbag, belt tensioner) are not repaired correctly, they may deploy unintentionally after connecting battery. There must not be anyone inside the vehicle when connecting the battery.

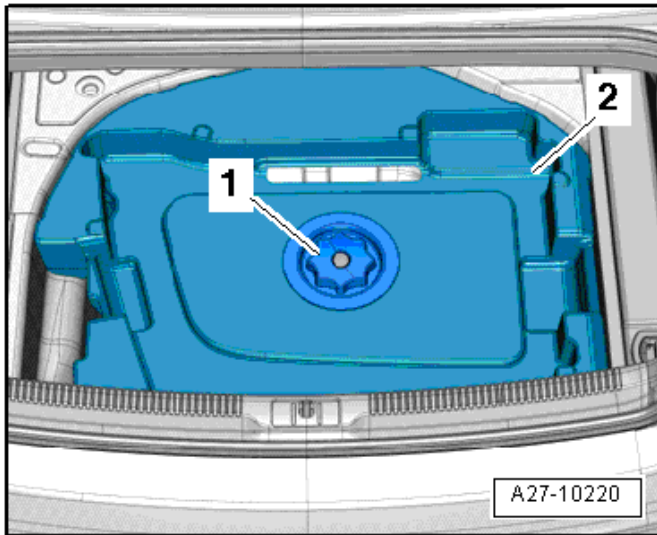
- Install the wind deflector mount <2>.
- Install the nut <1>.
- Install the luggage compartment floor.
- Cycle the ignition off and back on.
- Store previously recorded radio presets (if necessary).
- Set clock to local time.
- Activate the power window regulator one-touch up/down function.
- Check the DTC memories of all the control units and erase under-voltage faults if necessary.

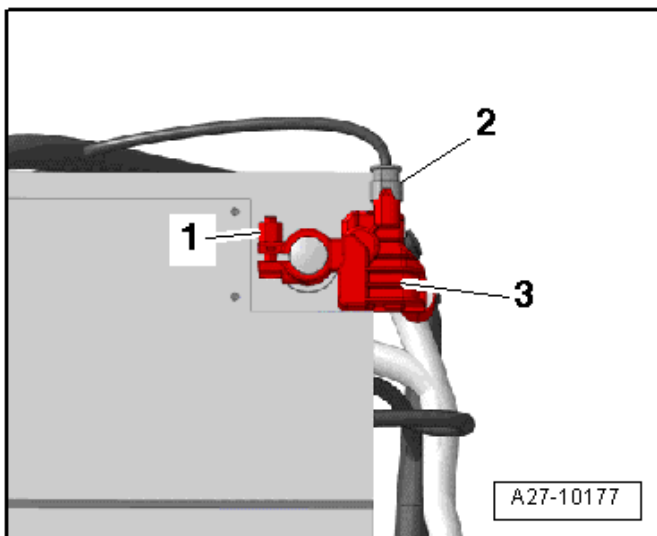
Q5 Procedure

- Ignition must be **ON** when connecting battery. If pyrotechnic components (e.g. airbag, belt tensioner) are not repaired correctly, they may deploy unintentionally after connecting battery. There must not be anyone inside the vehicle when connecting the battery.
- If the ignition is not switched on after reconnecting the battery (the indicator lamps in the instrument cluster do not illuminate), the ignition (key/button) may only be switched on while sitting in the driver's seat in the rearmost position.

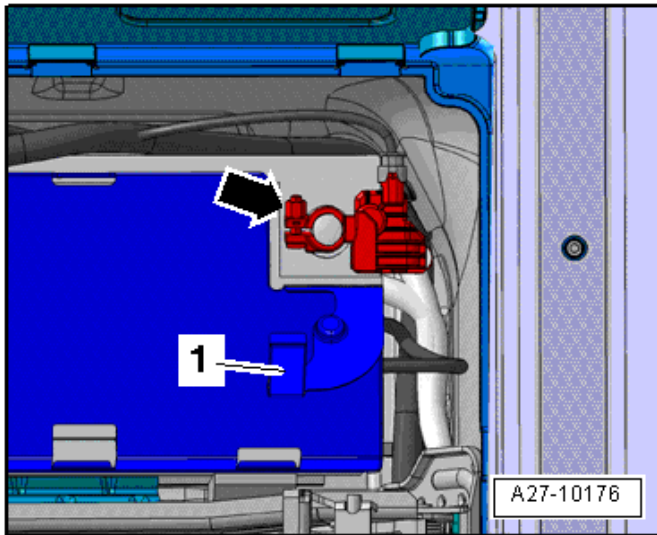
- Install battery terminal cover <1>.

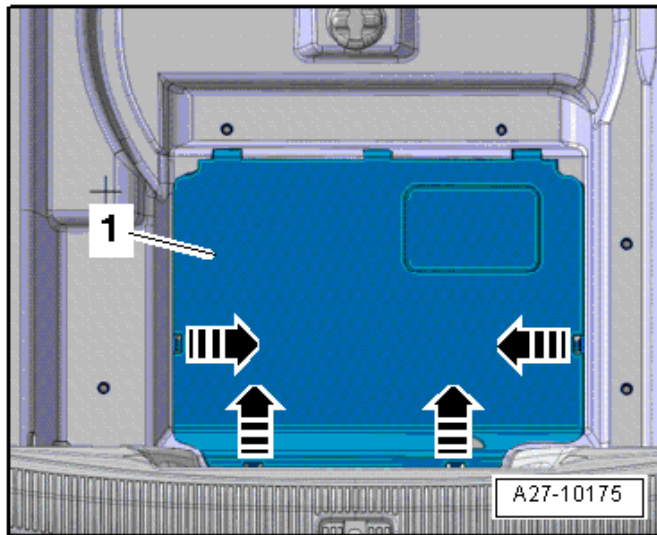
The cover is available with varying numbers of retaining clips.

- Install cover <1>.

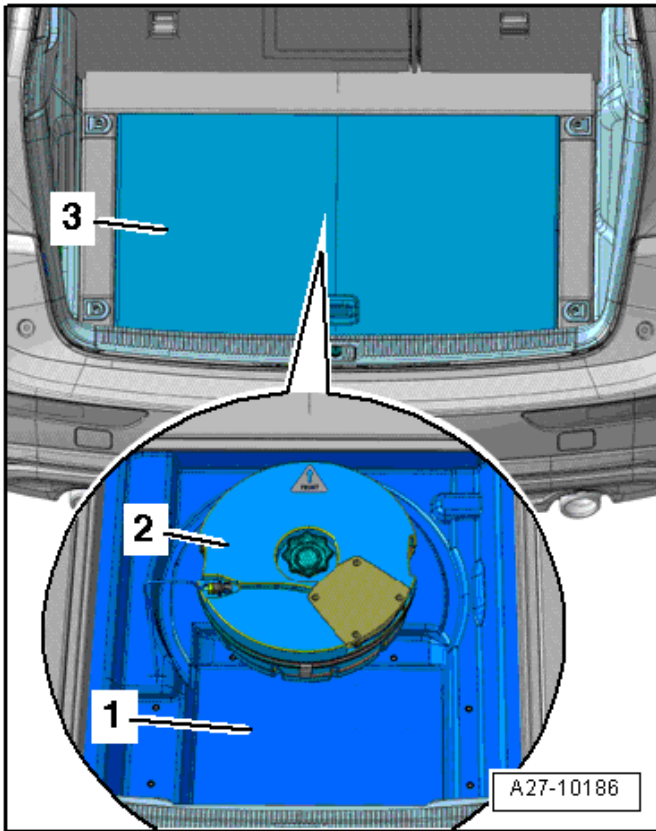
- Install the carpet <1> over the battery cover.
- If equipped, install the subwoofer <2>.
- Install the dirt tray, if applicable.
- Install the luggage compartment floor covering <3>.
- Cycle the ignition off and back on.
- Store previously recorded radio presets (if necessary).
- Set clock to local time.
- Activate the power window regulator one-touch up/down function.
- Check the DTC memories of all the control units and erase under-voltage faults if necessary.
