Safety Recall

Code: 69N1

Subject	TAKATA SDI Driver Frontal Airbag Inflator								
Release Date	March 20, 2017								
Revision Summary	Priority group P5 released for criteria 01.								
Affected Vehicles	U.S.A. & Canada: Certain 2009-2013 MY Audi vehicles equipped with a Takata SDI driver frontal airbag <i>Check Campaigns/Actions screen in Elsa on the day of repair to verify that a VIN qualifies for repair under this action. Elsa is the <u>only</u> valid campaign inquiry & verification source.</i> <ul style="list-style-type: none">✓ Campaign status must show "open."✓ If Elsa shows other open action(s), inform your customer so that the work can also be completed at the same time the vehicle is in the workshop for this campaign.								
Takata Recall Priority Groups and Repair Rollout	This recall is being managed according to the requirements mandated by the NHTSA in the Coordinated Remedy Order. Transport Canada is following the same requirements. Vehicles affected by this recall fall into the following priority groups established by the NHTSA as shown below:

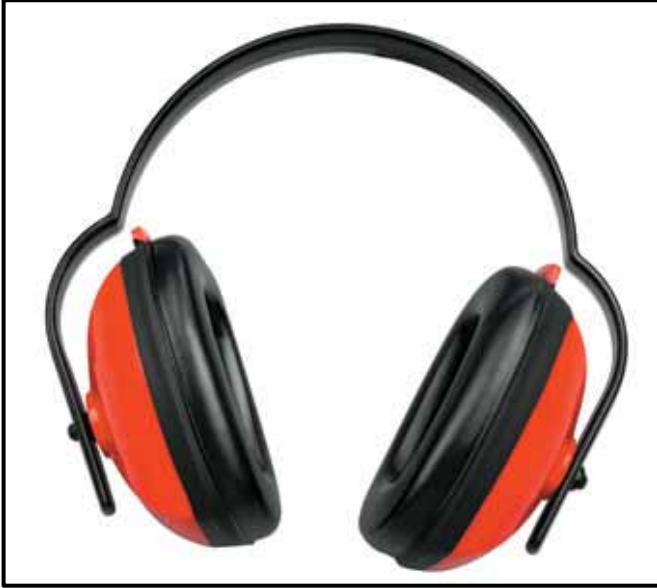
- Ear Protection (locally sourced).

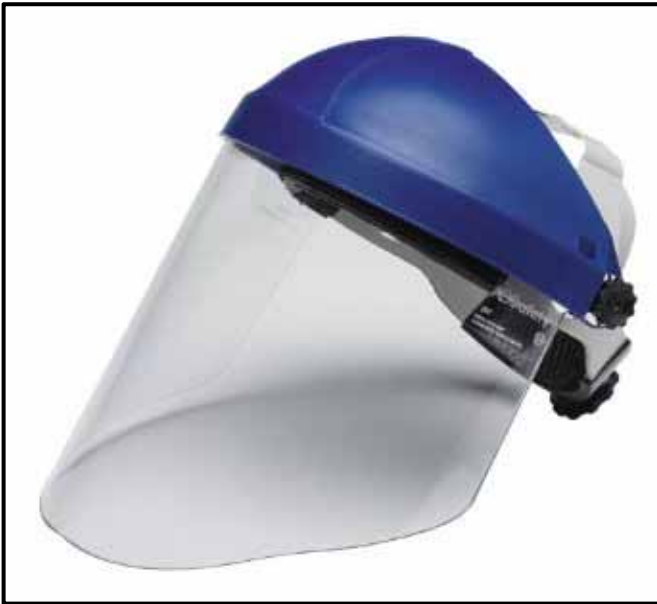
- Face Shield (locally sourced).

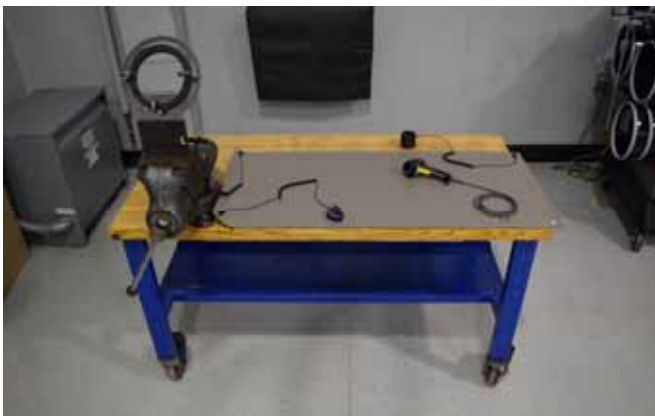
- Workbench that will support a vice.
- Work surface free of unnecessary tools, equipment and debris.

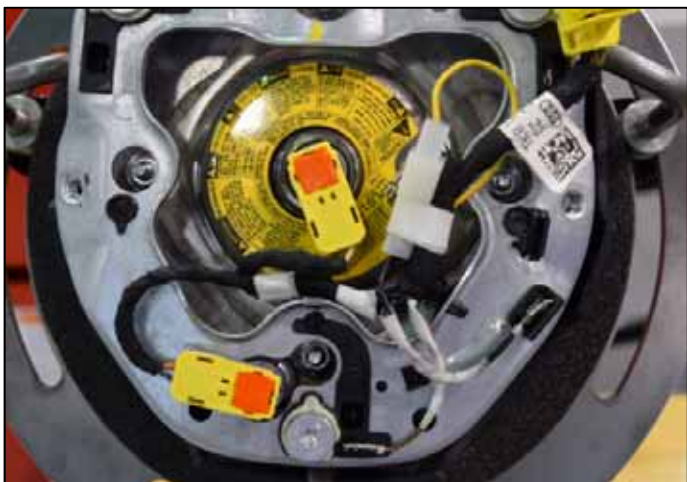
- Engage the connector locks.
- Ensure all wire connections are secure and the airbag harness is routed correctly.
