Safety Recall

Code: 69N2

Subject TAKATA PSDI-5 Driver Frontal Airbag Inflator

Release Date April 7, 2017

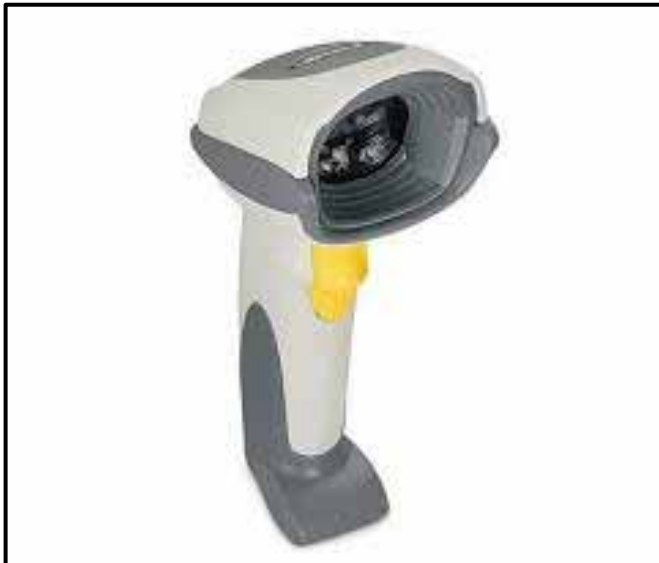
- Bar Code Scanner – VAS6161/1

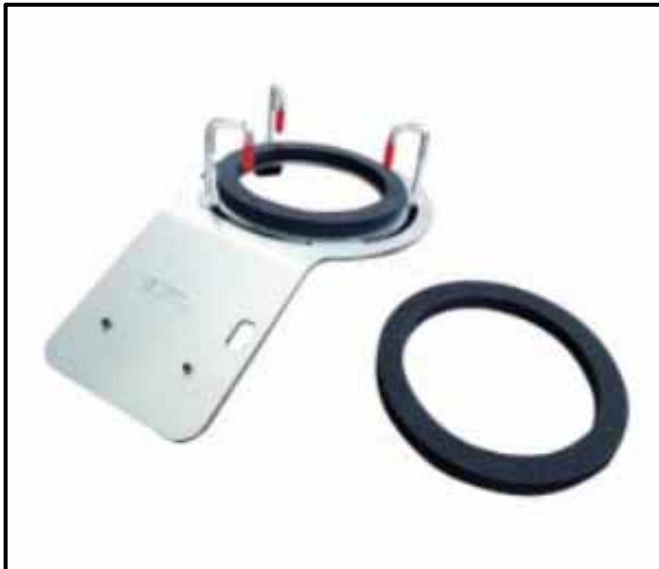
- Airbag Support - T10568

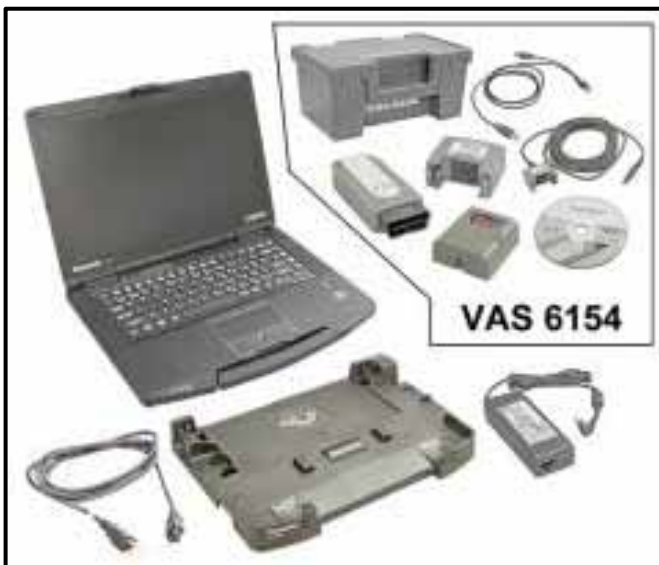
- VAS6150D - Diagnostic Tester (or equivalent)

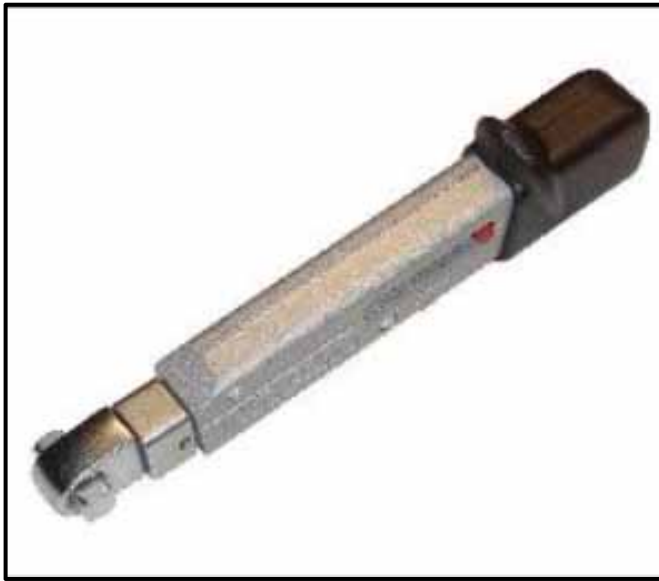
- VAG1410 – Torque Wrench (or equivalent)

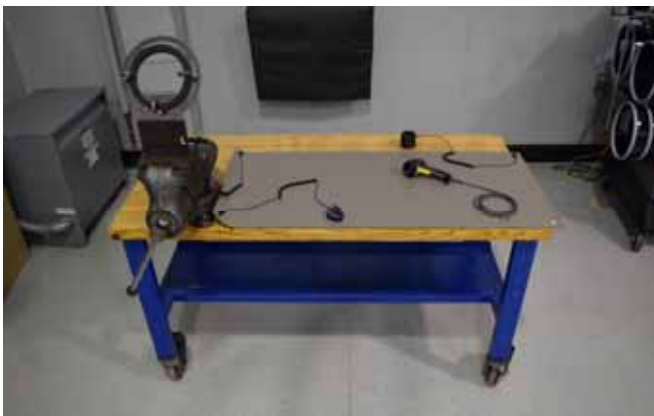
- Workbench that will support a vice.
- Work surface free of unnecessary tools, equipment and debris.

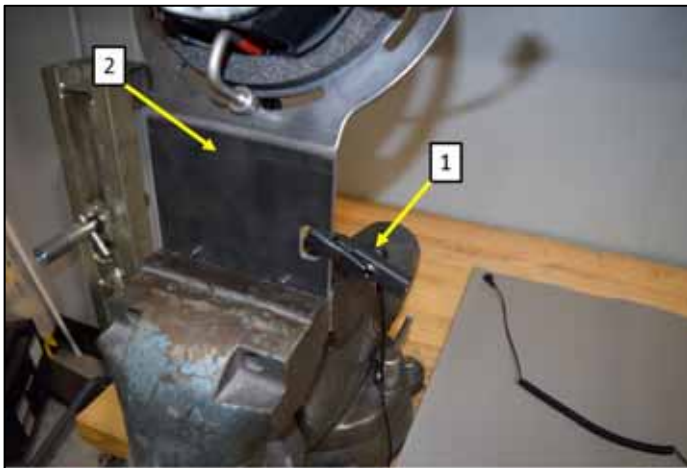
- Clamp Airbag Support T10568 <2> into the vice.
- Connect crocodile clip <1> to airbag support <2> and ESD workplace -VAS 6613-.

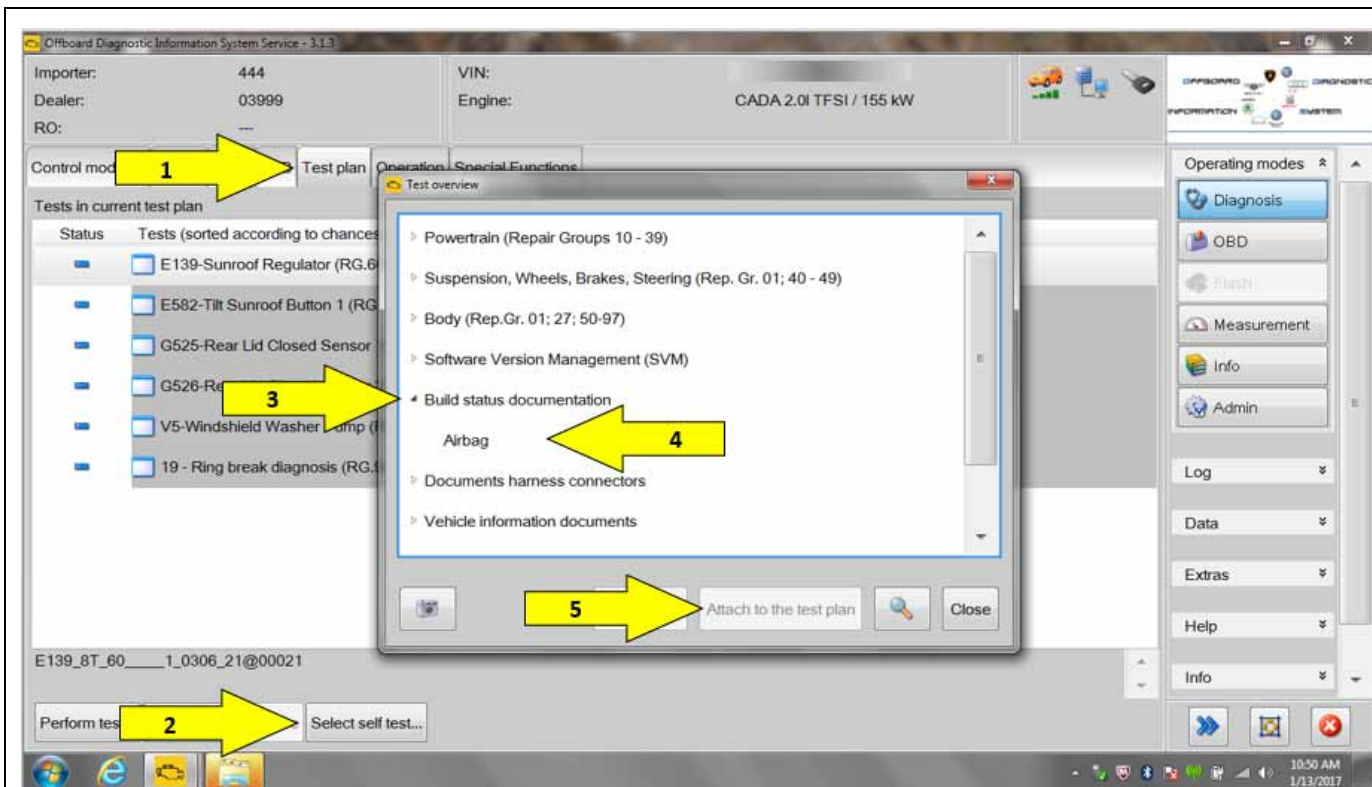
- Select the "Test plan" tab <1>.
- Select "Select self test..." <2>.
- Open the "Build status documentation" dropdown <3>.
- Highlight "Airbag" <4>.
- Select "Attach to the test plan" <5>.

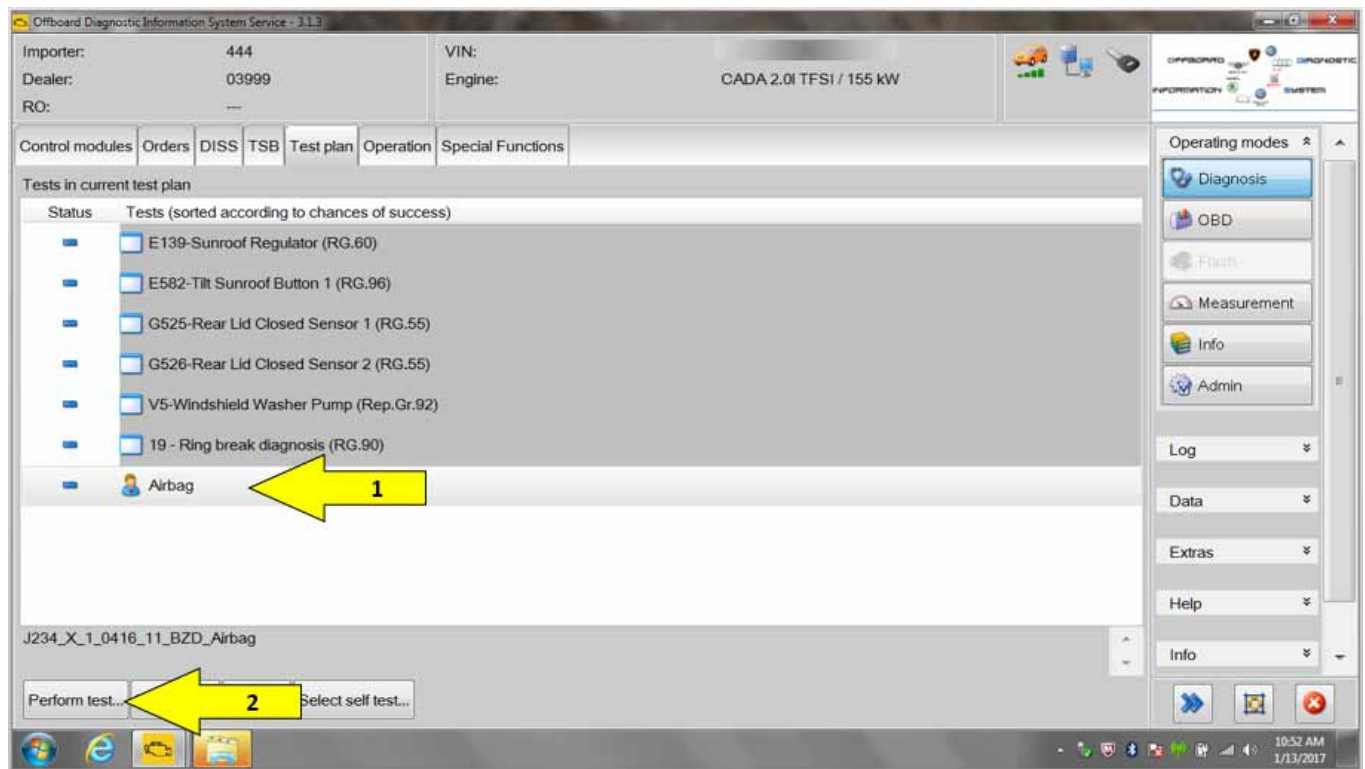
- Highlight the “Airbag” test plan <1>.
- Select “Perform test...” <2>.

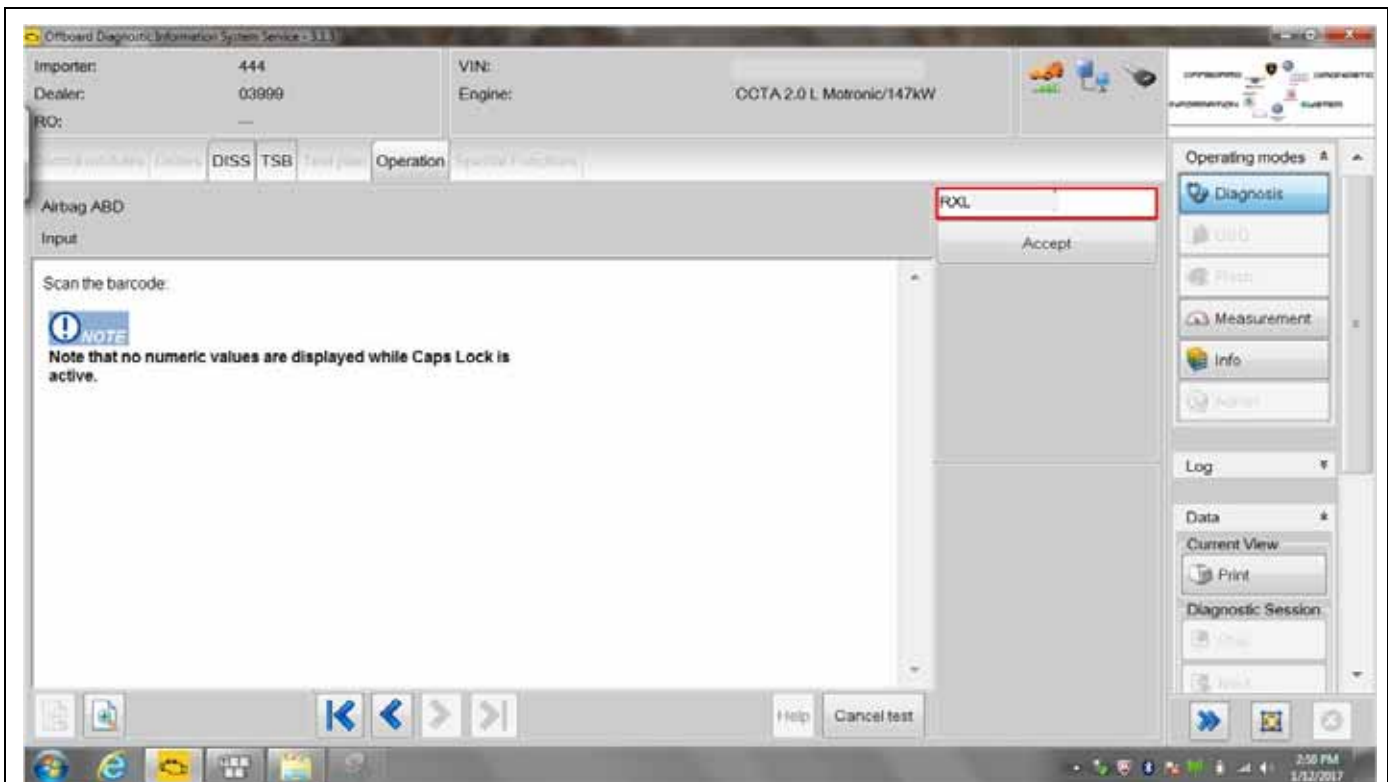
- Once the new inflator has been successfully scanned, press “Accept”

- Compare the scanned value with the value shown above the bar code on the new inflator.
- If there is a discrepancy, manually enter the value from the new inflator in the input field.
- If no value appears, recalibrate the scanner.

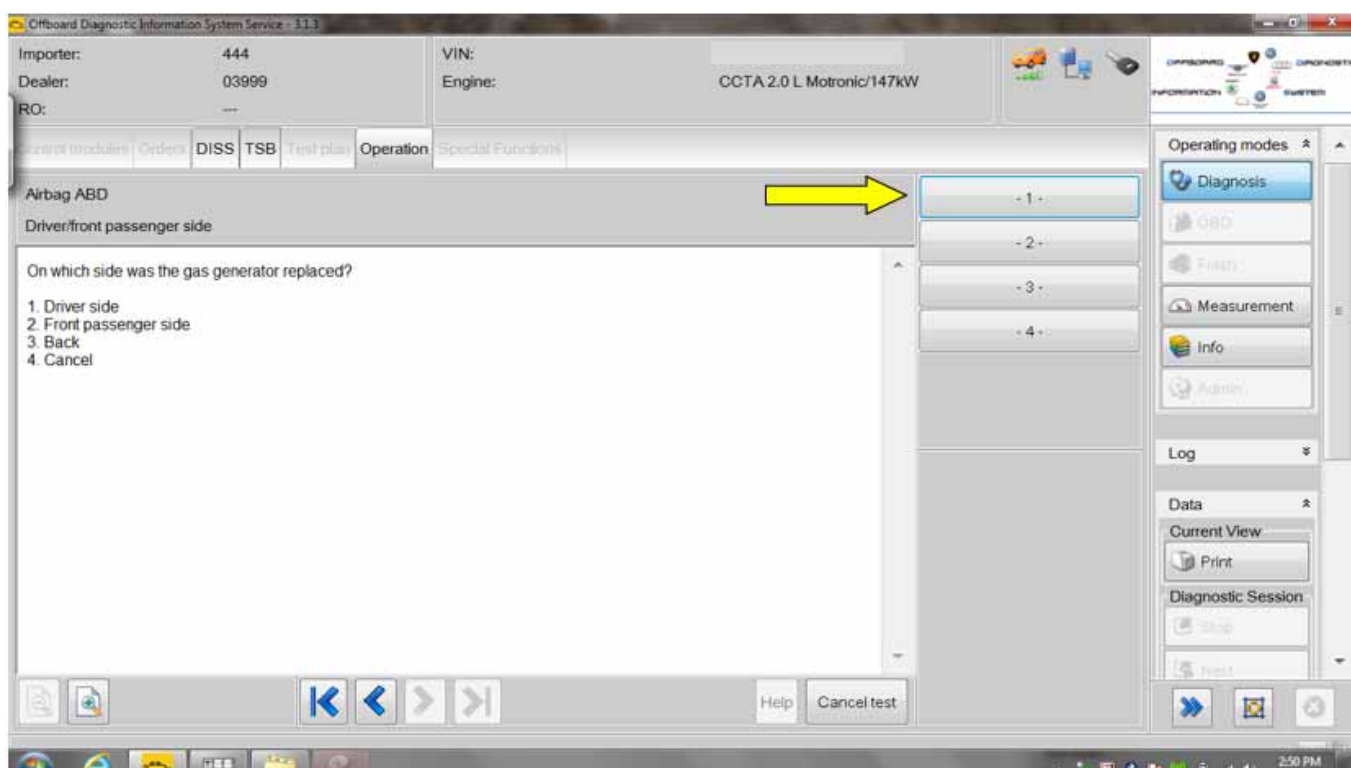
- Select option 1 indicating that the Driver side inflator was replaced.
- After selecting option 1, a valid GeKo ID will need to be entered in order to upload the new inflator identification.

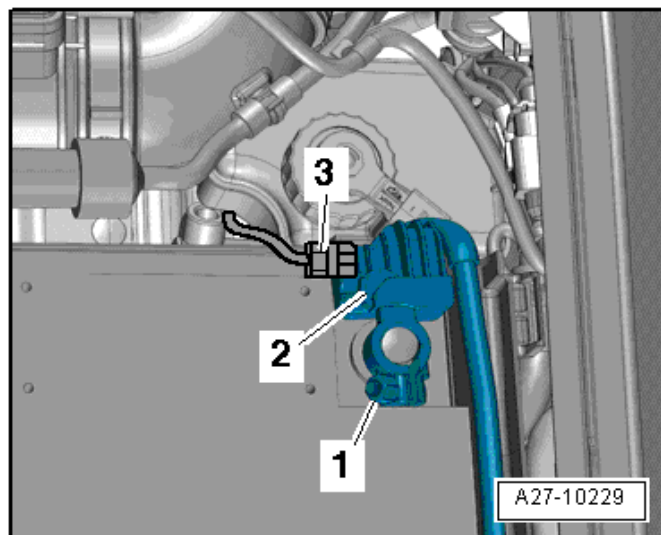
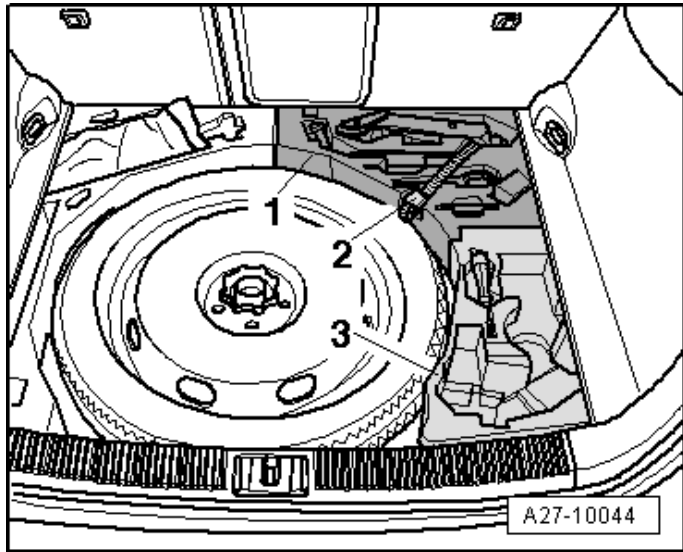
- Remove battery cover <1> by pressing release button in direction of <arrow>.
- Make sure the ignition is turned **ON**.
- Loosen the nut <1>.
- Remove and isolate the battery ground cable terminal <2> from the battery terminal.

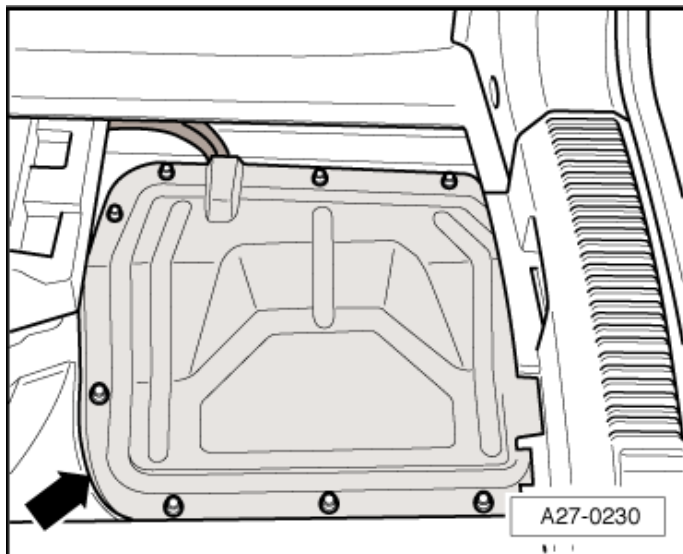
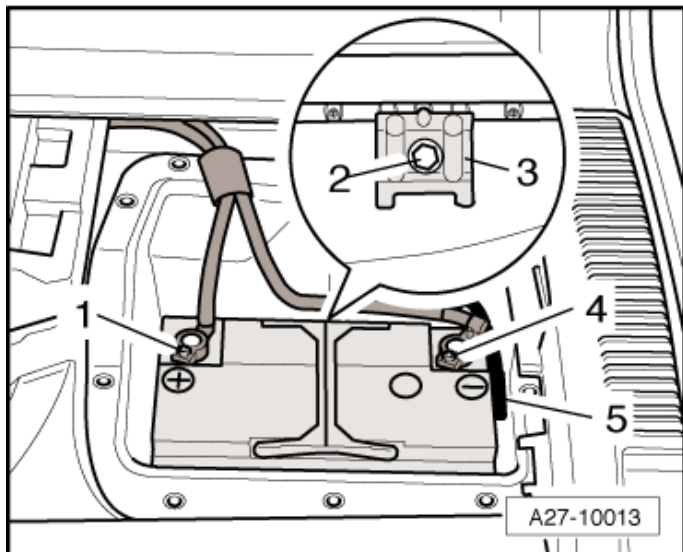
- Remove the rear molded insert <3>.
- Remove the battery cover <arrow>.
- Remove the molded insert on top of the battery.

- Make sure the ignition is turned **ON**.
- Loosen the nut <4>.
- Remove and isolate the battery ground cable terminal from the battery terminal.

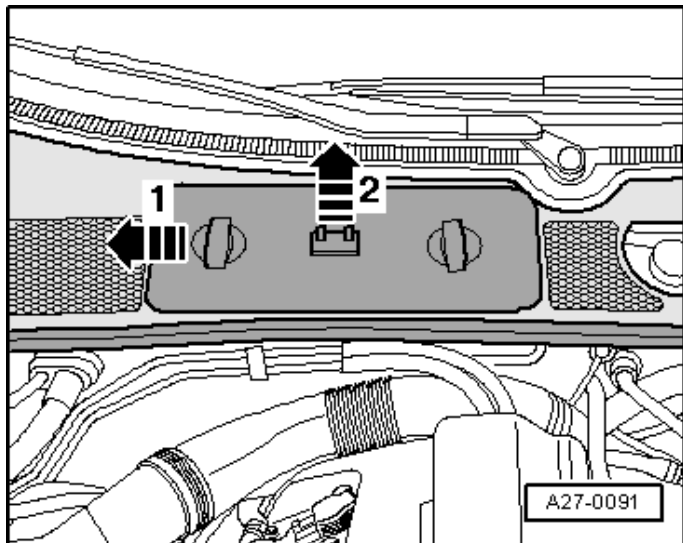
- Slide the cover over the battery to the right <arrow 1> and remove it <arrow 2>.

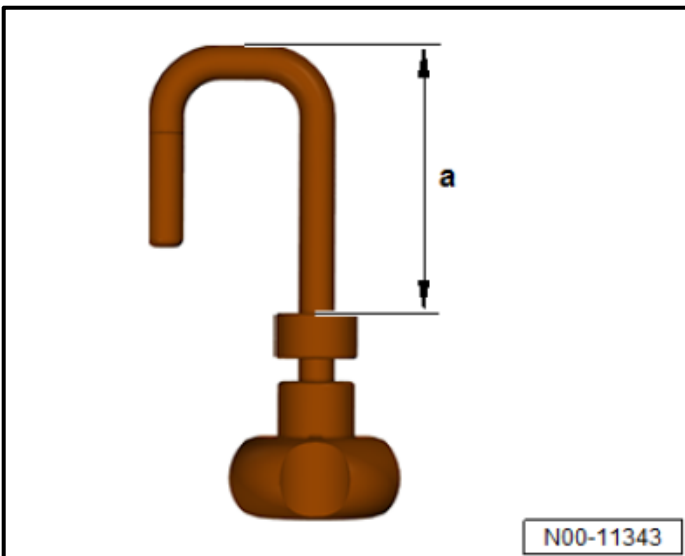
Tighten mounting by hand to prevent damage.

- Adjust three knurled nuts of securing hooks to <dimension a> 50mm.

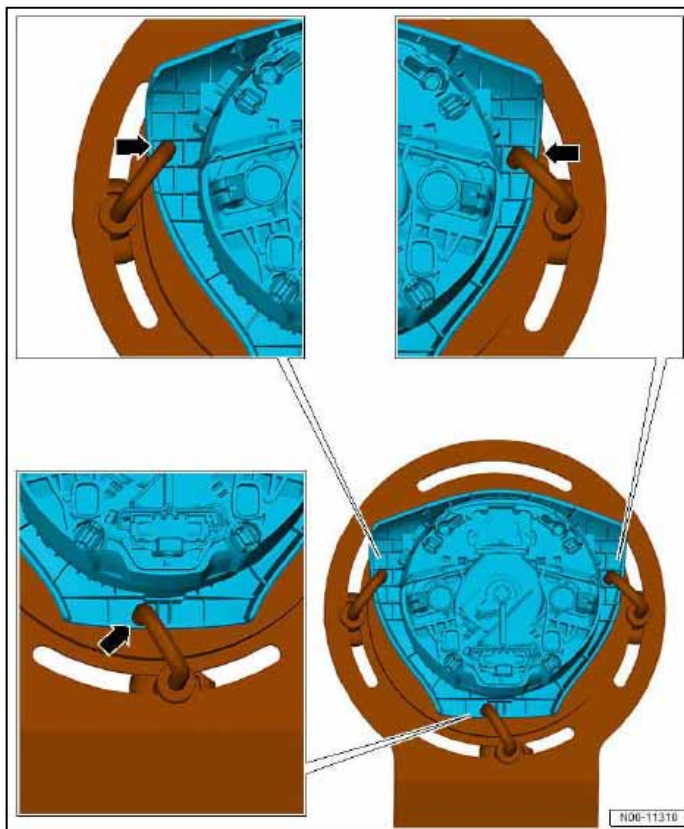
- Clamp airbag centrally in airbag support. There are securing points on the sides <arrows>, parallel opposite each other and below.

The clamps must be placed in the positions shown <arrows> to prevent damage to the airbag. Damage to the airbag is not covered under this action.

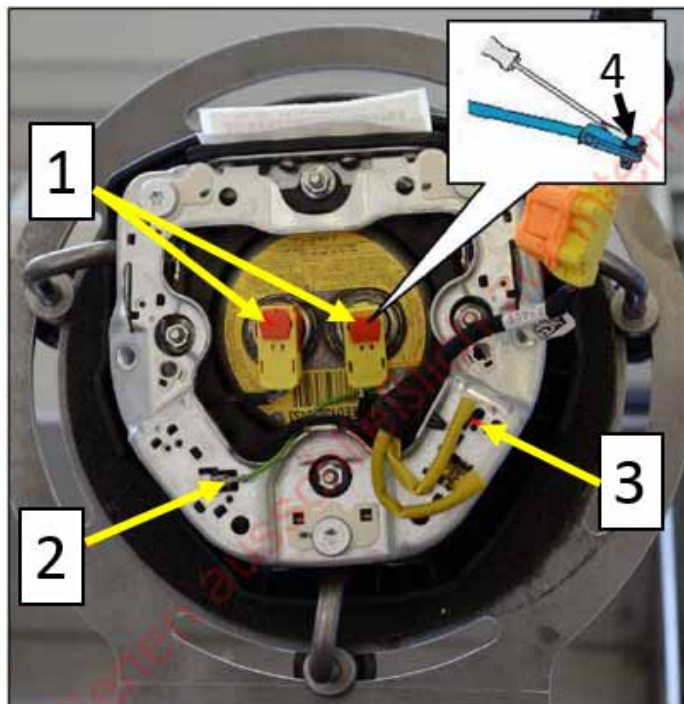
- Disconnect connectors <1> using a small flat bladed screwdriver to disengage connector lock <4>.
- Disconnect connectors <2 and 3>.

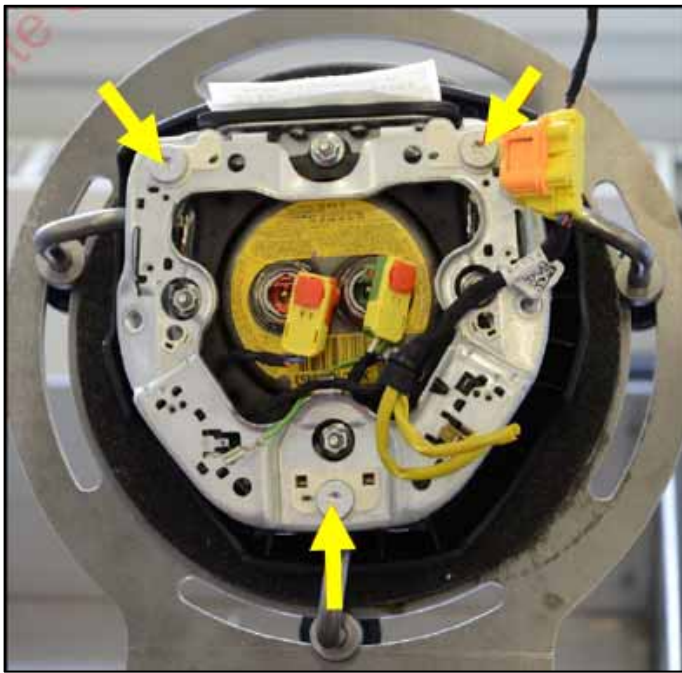
- Remove and discard the three horn ring bolts <arrows>.
- Remove the horn ring.

When removing the horn ring, take care that the springs are not lost as they are not available separately. Replacement of the airbag is required if a spring is lost and is not covered under this action.

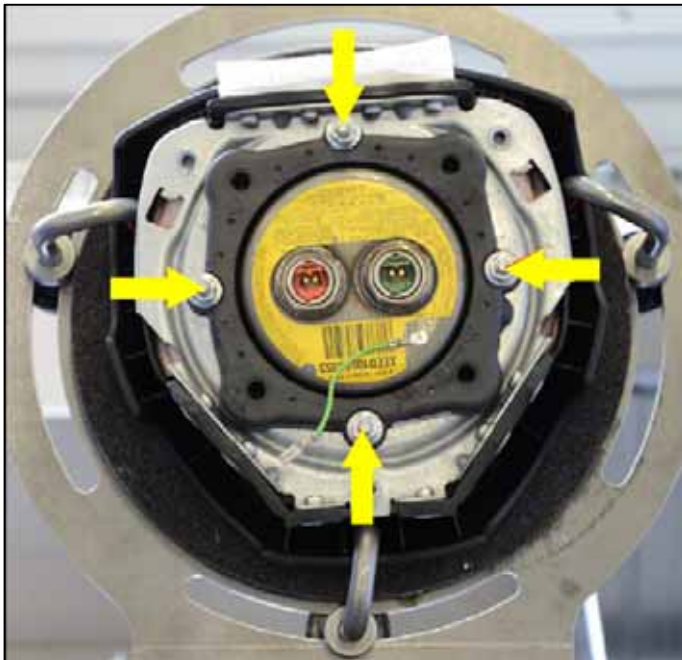
- Remove and discard the four nuts <arrows>.

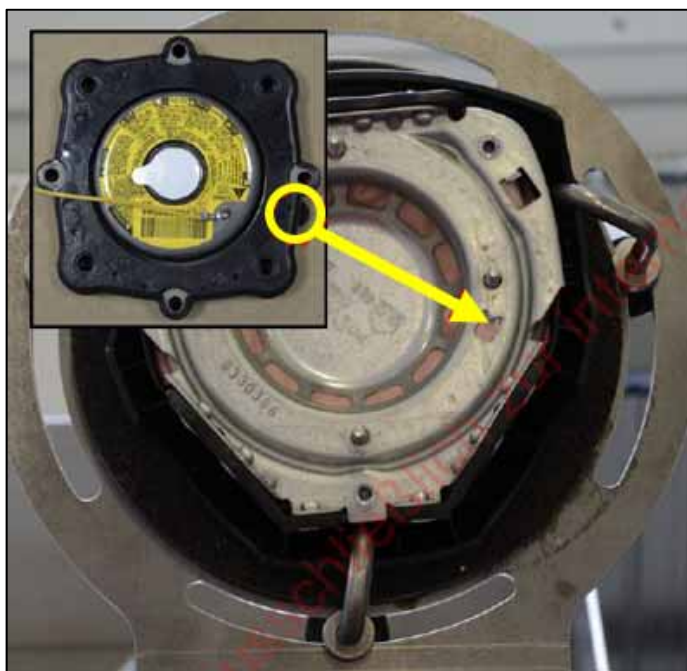
- Install the new inflator onto the studs.
- Ensure the recess on the inflator lines up properly with the tab on the airbag <arrow>.

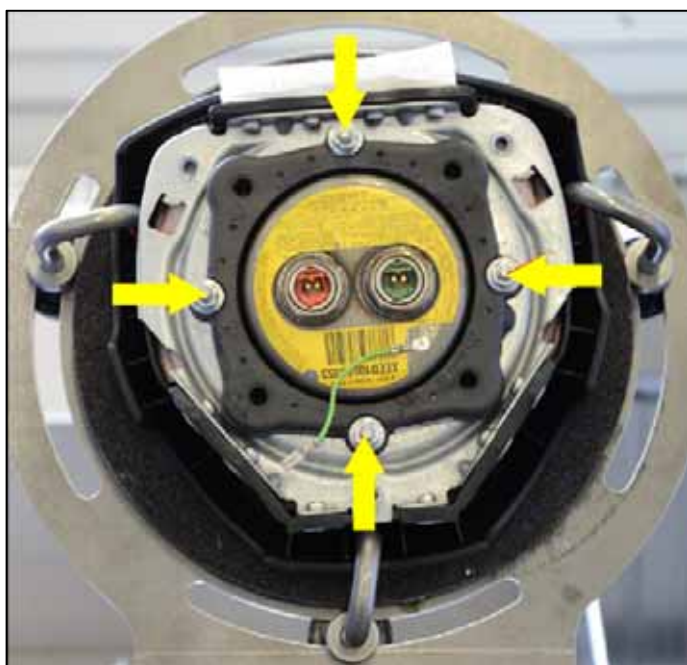
- Install the new inflator and torque nuts <arrows> to 4.5 Nm.

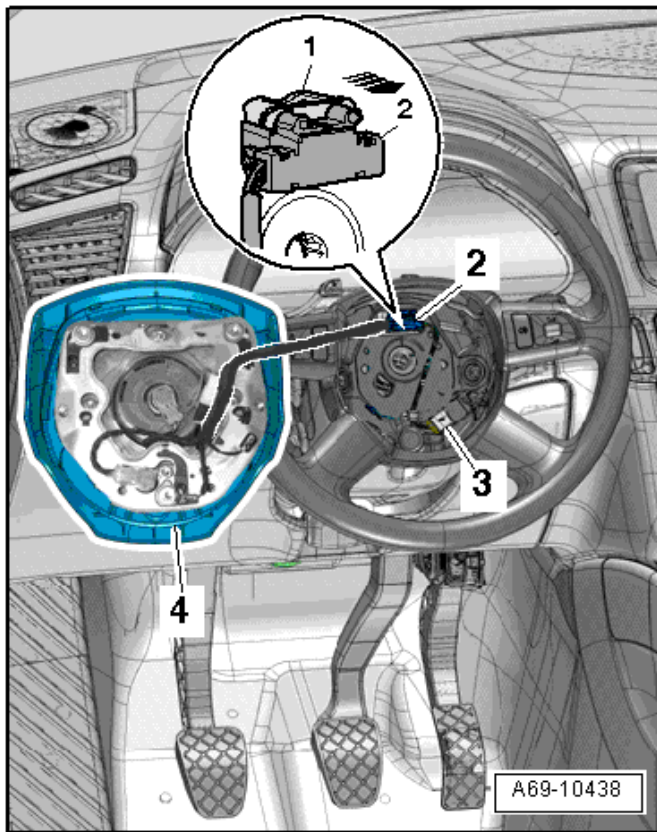
- The battery must be disconnected before installing the airbag back into the vehicle.
- Before handling pyrotechnic components (for example, disconnecting the connector), the person handling it must “discharge static electricity”. This can be done by touching the door striker, for example.
- Connect the spiral spring electrical connector <2> with the airbag connector coupling on the coil connector with slip ring.
- Versions with Multi-function and Tiptronic steering wheel: Install the connector <3>.

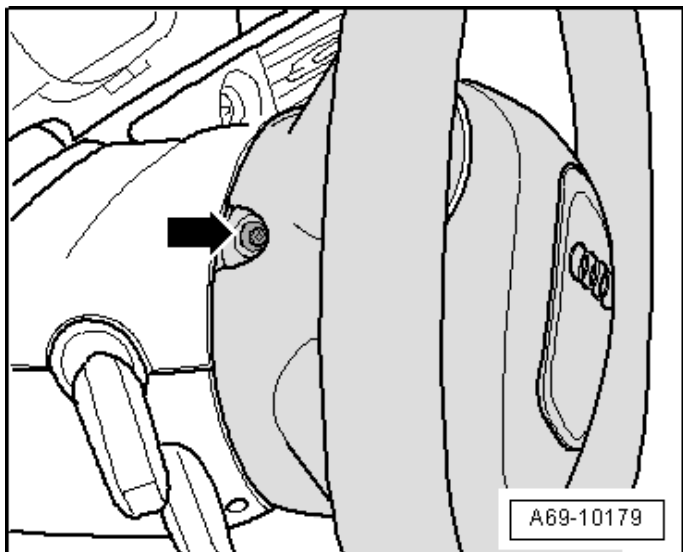
- Position the driver airbag in the steering wheel.
- Install the 2 bolts -arrow- for securing the driver airbag approximately 2 turns.
- Press horn about 3 times to achieve even gap dimension.
- Torque the bolts <arrow> to 7 Nm.
- Install the bolt cover caps.

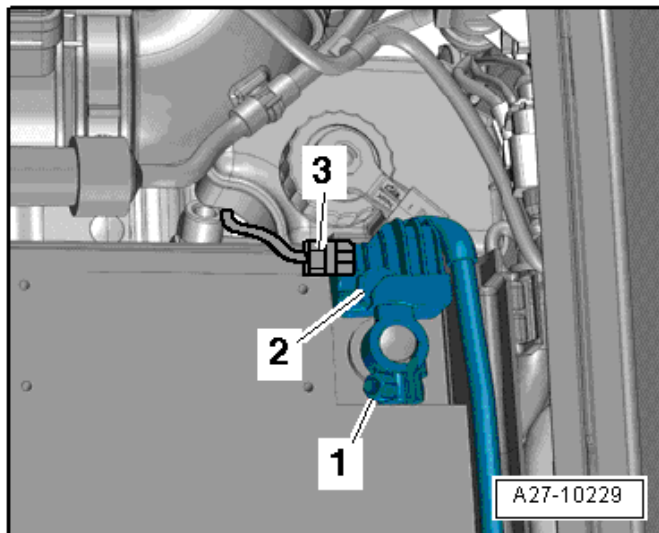
Battery in Engine Compartment:

Ignition must be ON when connecting battery. If pyrotechnic components (e.g. airbag, belt tensioner) are not repaired correctly, they may deploy unintentionally after connecting battery. There must not be anyone inside the vehicle when connecting the battery.

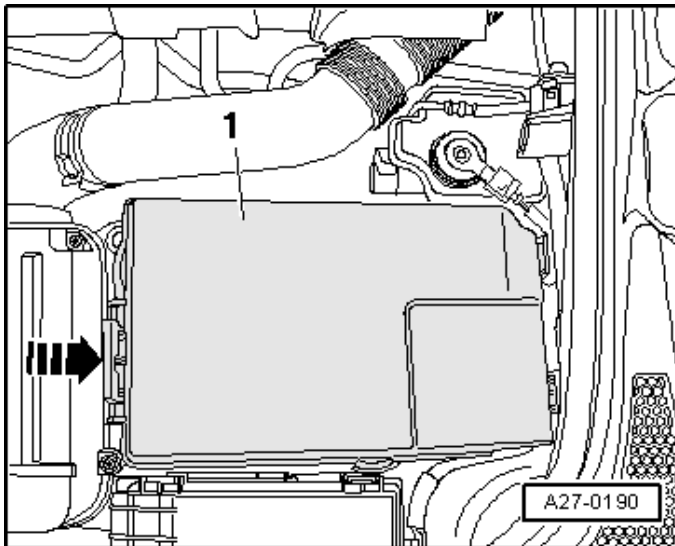
- Install battery cover <1>.
- Store previously recorded radio presets.
- Activate the power window regulator one-touch up/down function.
- Check the DTC memories of all the control units and erase Under-voltage faults if necessary.

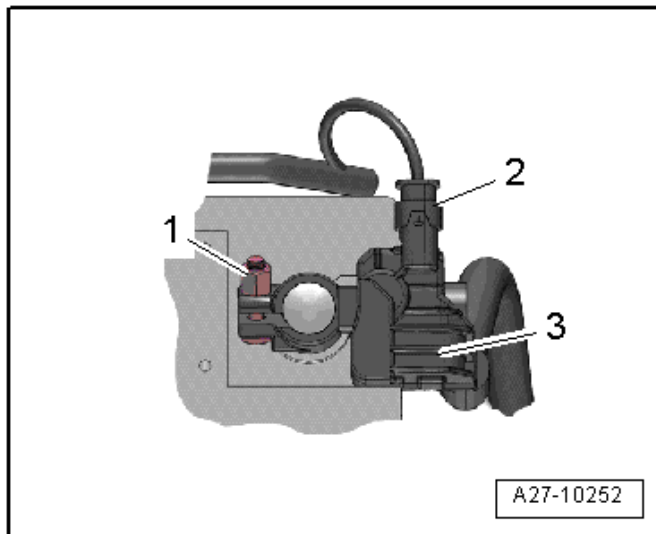
Battery in Luggage Compartment:

- If equipped, disconnect the connector <2> from the Battery Monitoring Control Module -J367-.
 - Connect the battery ground cable terminal by hand to the battery negative terminal.
 - Torque the nut <1> to 6 Nm.
 - If equipped, reconnect the connector to the Battery Monitoring Control Module -J367-.
-
- Install the molded insert on top of the battery.
 - Install the battery cover <arrow>.

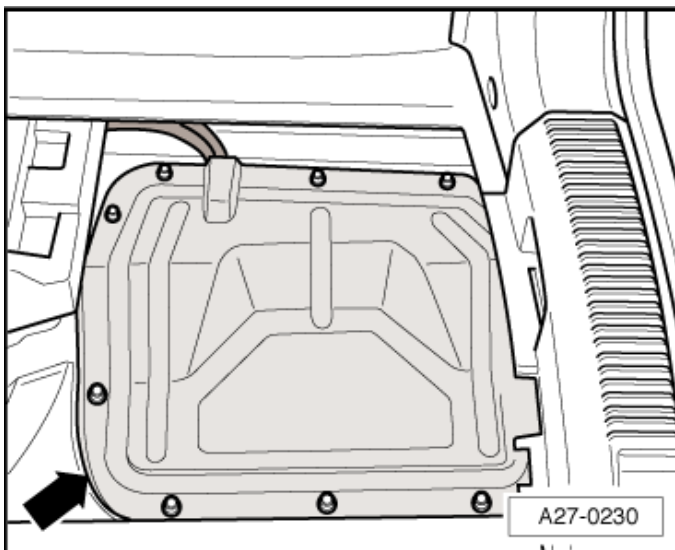
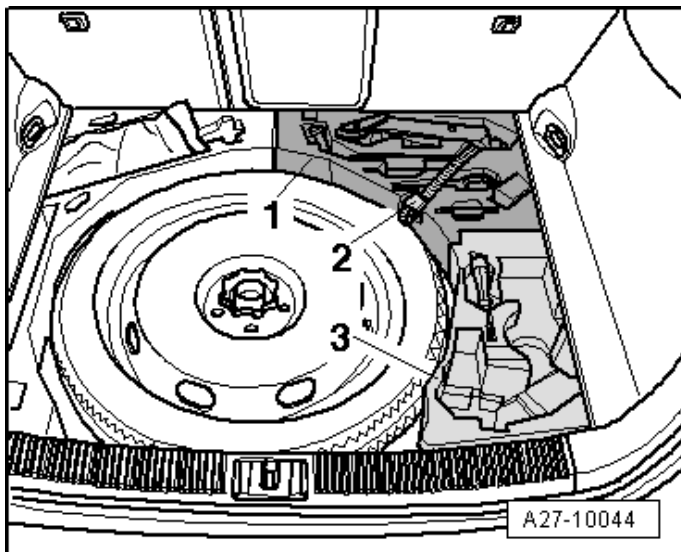
- Install the rear molded insert <3> which holds the vehicle tools.
- Install the luggage compartment floor.
- Cycle the ignition off and back on.
- Store previously recorded radio presets (if necessary).
- Set clock to local time.
- Activate the power window regulator one-touch up/down function.
- Check the DTC memories of all the control units and erase under-voltage faults if necessary.

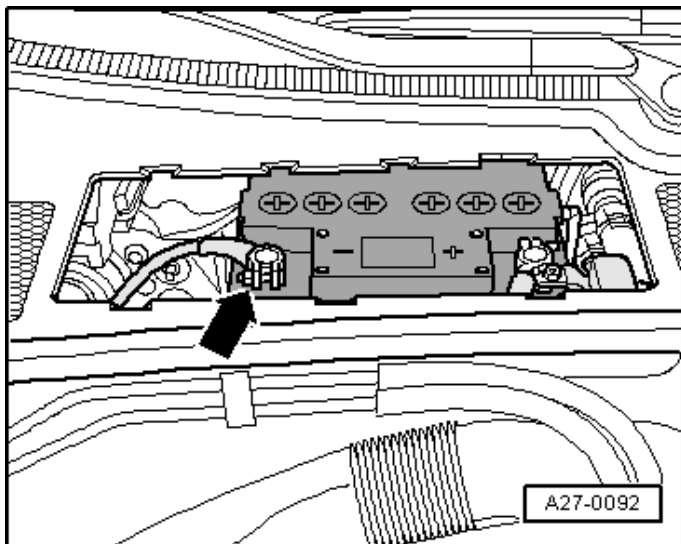
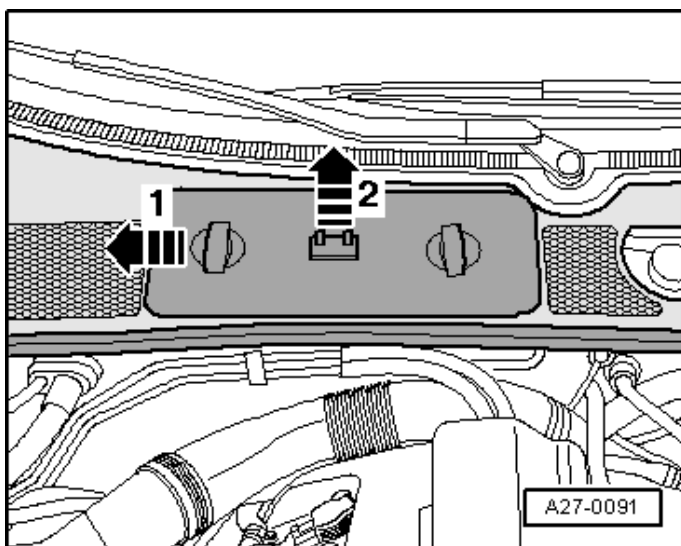
- Install battery cover.
- Cycle the ignition off and back on.
- Store previously recorded radio presets (if necessary).
- Set clock to local time.
- Activate the power window regulator one-touch up/down function.
- Check the DTC memories of all the control units and erase under-voltage faults if necessary.

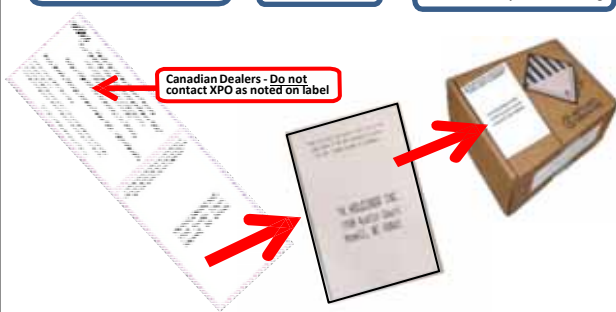
1. VW/Audi Inflator Kit will contain this two-part label:
2. Peel off 'Ship To' Label.
3. Affix Label to Box. Do not cover up Class 9 Marking.
