Safety Recall

Code: 69N2

Subject TAKATA PSDI-5 Driver Frontal Airbag Inflator

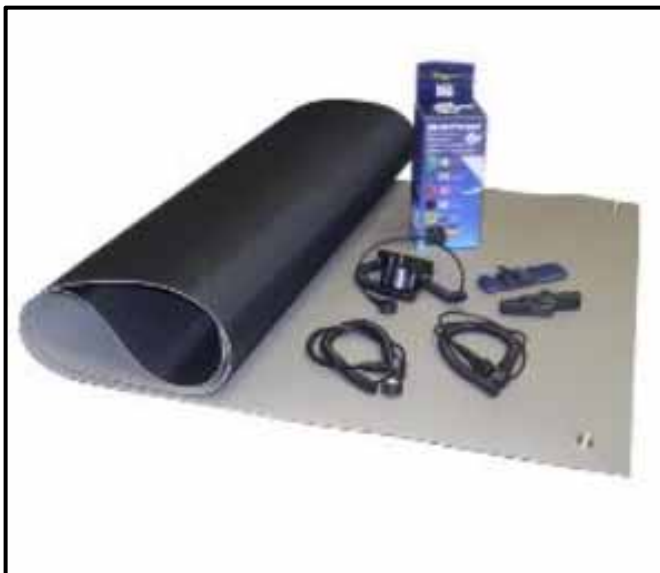
- ESD Worksurface - VAS 6613

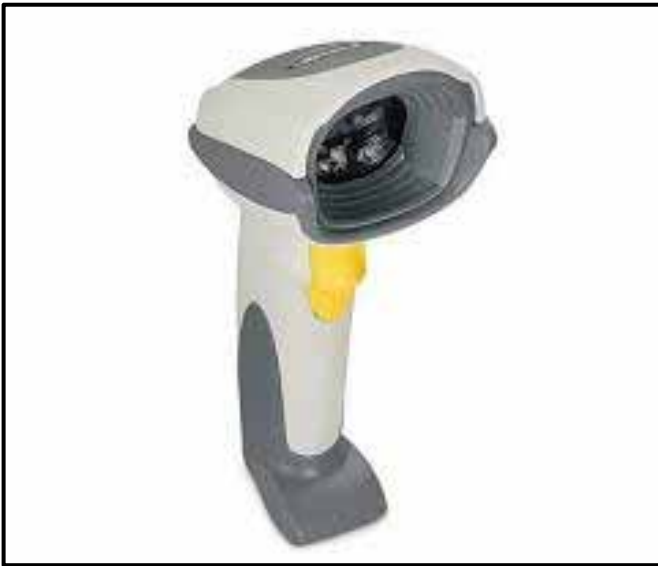
- Bar Code Scanner – VAS6161/1

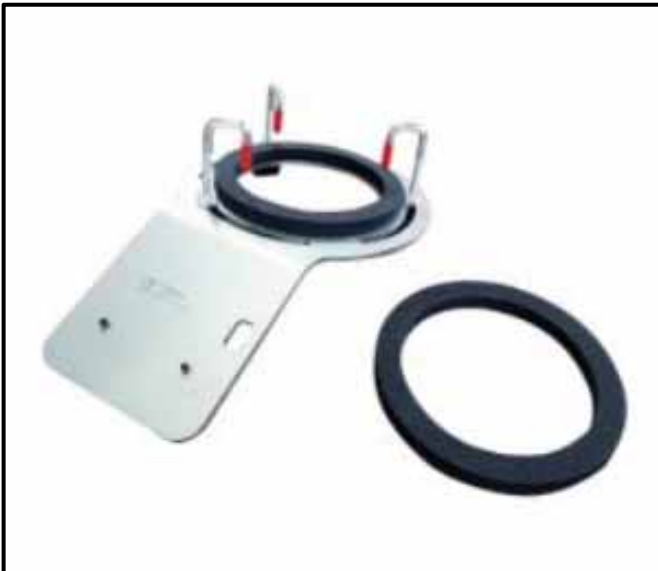
- Airbag Support - T10568

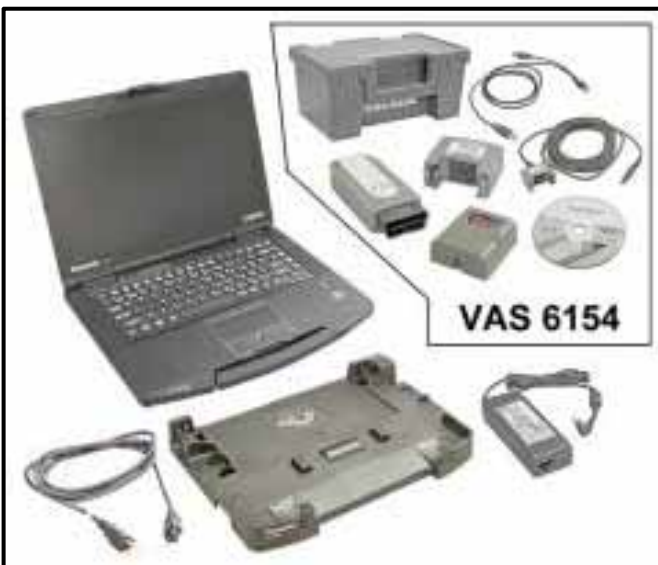
- VAS6150D - Diagnostic Tester (or equivalent)

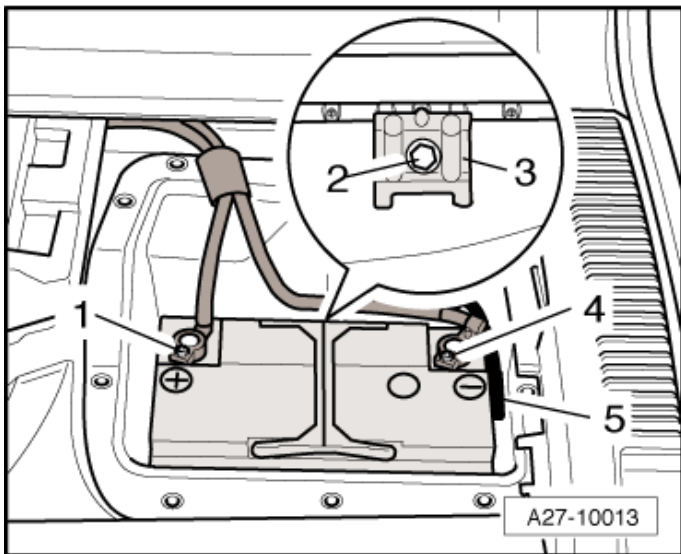
- Remove the rear molded insert <3>.
- Remove the battery cover <arrow>.
- Remove the molded insert on top of the battery.

- Make sure the ignition is turned **ON**.
- Loosen the nut <4>.
- Remove and isolate the battery ground cable terminal from the battery terminal.

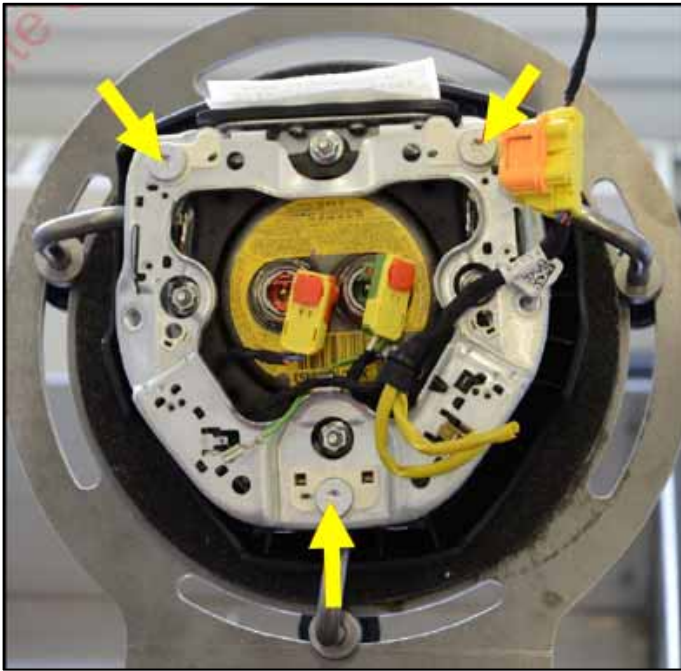
- Remove and discard the three horn ring bolts <arrows>.
- Remove the horn ring.

When removing the horn ring, take care that the springs are not lost as they are not available separately. Replacement of the airbag is required if a spring is lost and is not covered under this action.

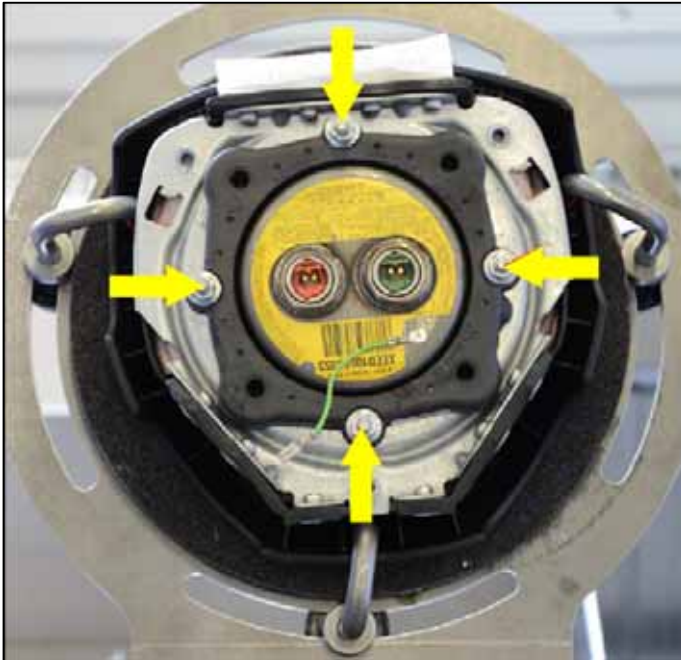
- Remove and discard the four nuts <arrows>.

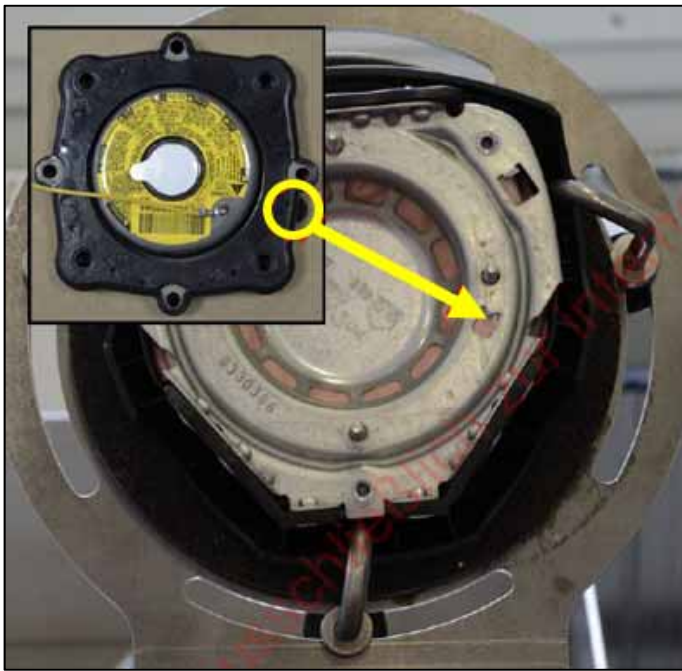
- Install the new inflator onto the studs.
- Ensure the recess on the inflator lines up properly with the tab on the airbag <arrow>.

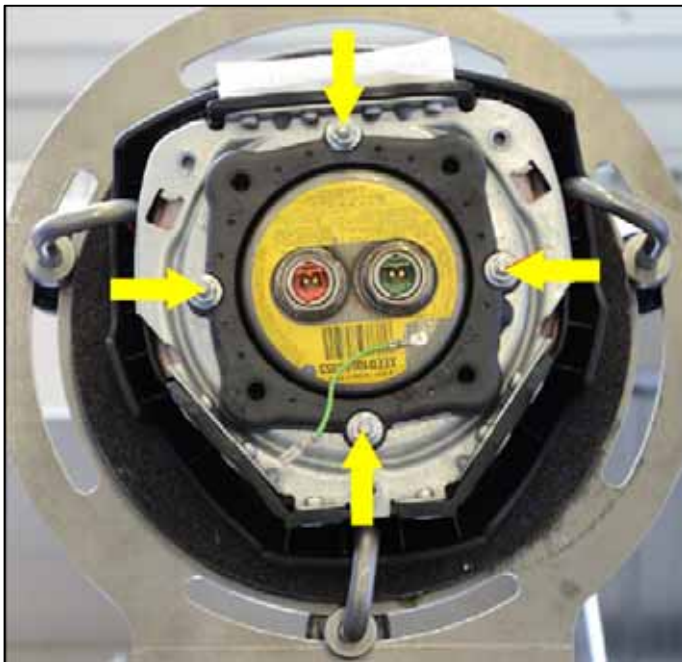
- Install the new inflator and torque nuts <arrows> to 4.5 Nm.

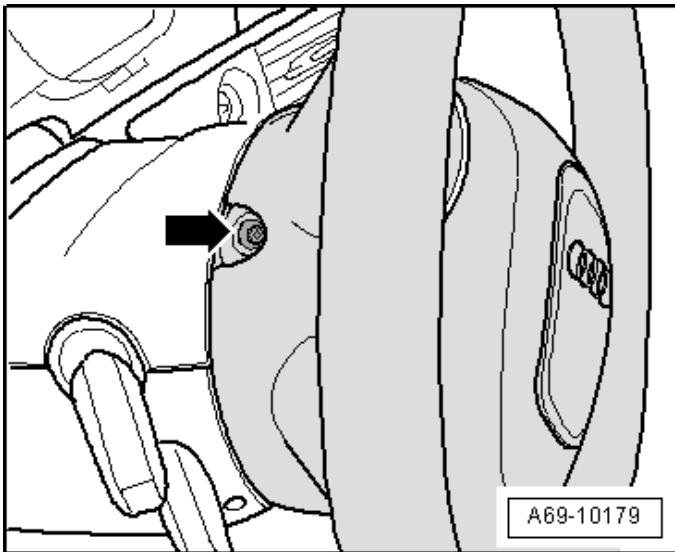
- The battery must be disconnected before installing the airbag back into the vehicle.
- Before handling pyrotechnic components (for example, disconnecting the connector), the person handling it must “discharge static electricity”. This can be done by touching the door striker, for example.
- Connect the spiral spring electrical connector <2> with the airbag connector coupling on the coil connector with slip ring.
- Versions with Multi-function and Tiptronic steering wheel: Install the connector <3>.
