Safety Recall

Code: 69N2

Subject TAKATA PSDI-5 Driver Frontal Airbag Inflator

Revision Summary Updated Criteria 02 Part Number, SAGA sheet and repair instructions

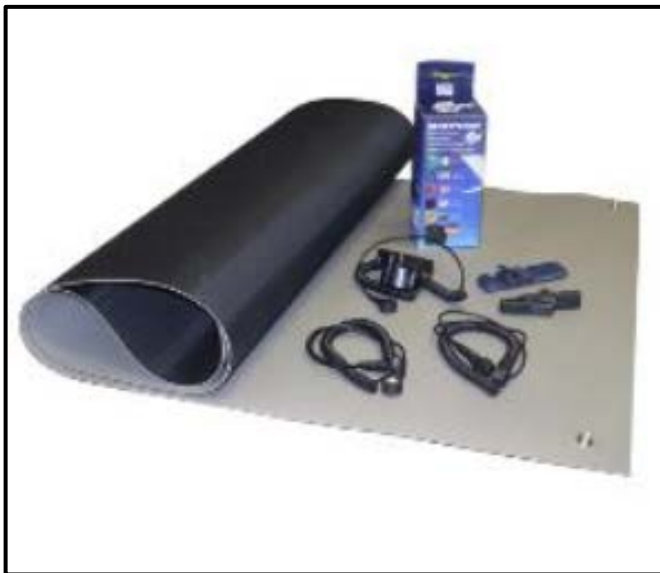
- ESD Worksurface - VAS 6613

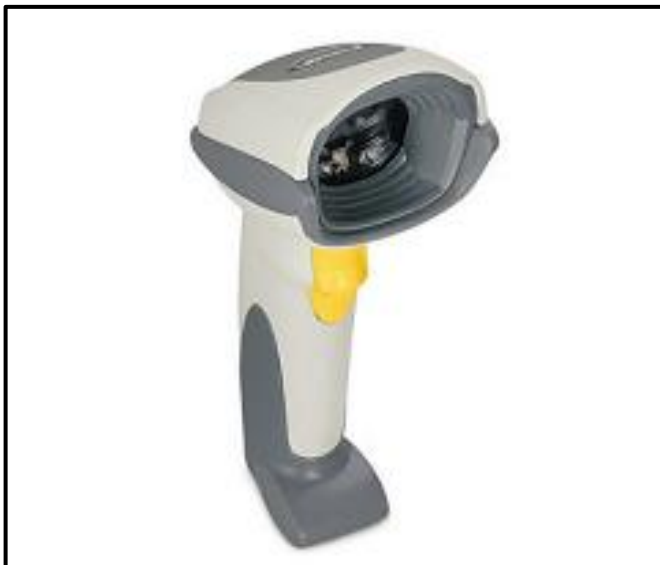
- Bar Code Scanner – VAS6161/1

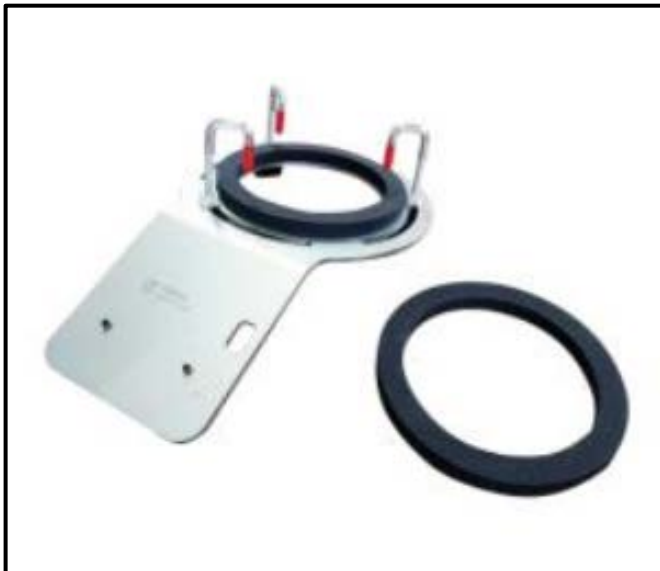
- Airbag Support - T10568

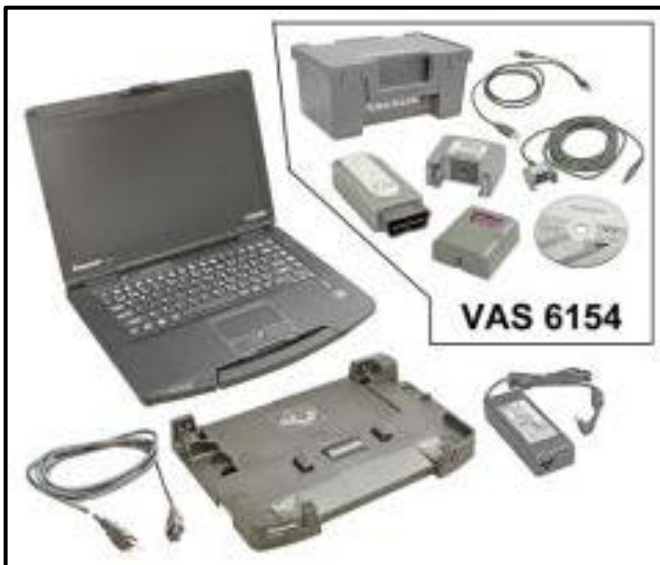
- VAS6150D - Diagnostic Tester (or equivalent)

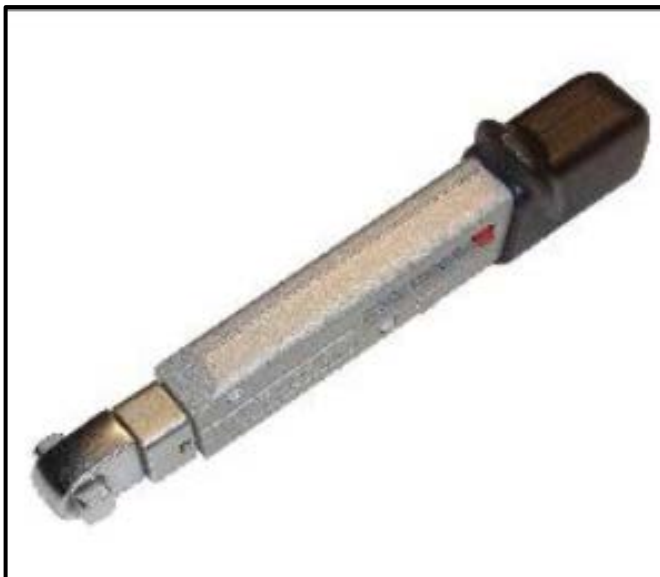
- VAG1410 – Torque Wrench (or equivalent)

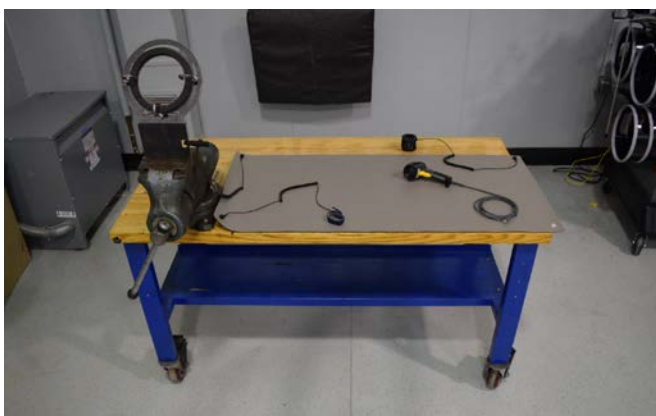
- Workbench that will support a vice.
- Work surface free of unnecessary tools, equipment and debris.

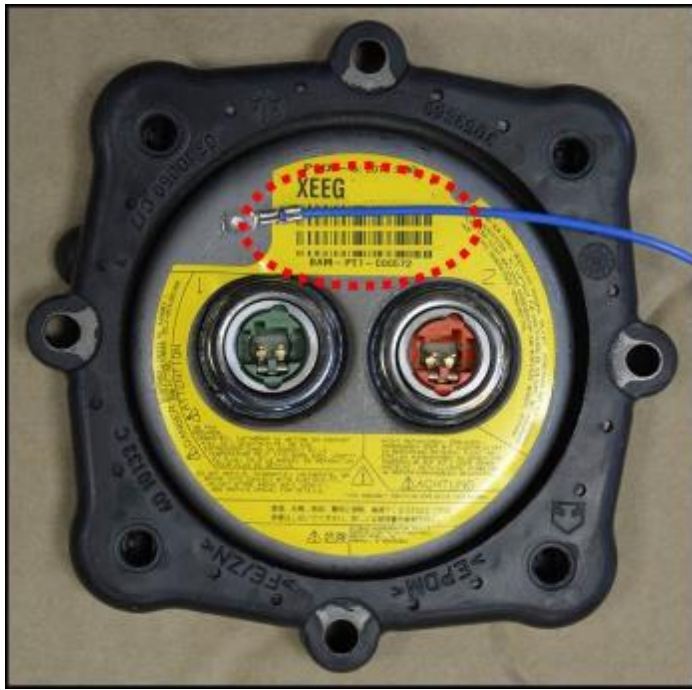
- Place the new inflator on the ESD mat.
- Scan the bar code of the new inflator at a distance of about 15 cm.

The photo is for reference only. The inflator that is installed may be either a single stage or dual stage inflator.
