Safety Recall

Code: 69N2

Subject TAKATA PSDI-5 Driver Frontal Airbag Inflator

Affected Vehicles **U.S.A. & CANADA: Certain 2006-2013 MY Audi Vehicles equipped with a Takata PSDI-5 driver frontal airbag**

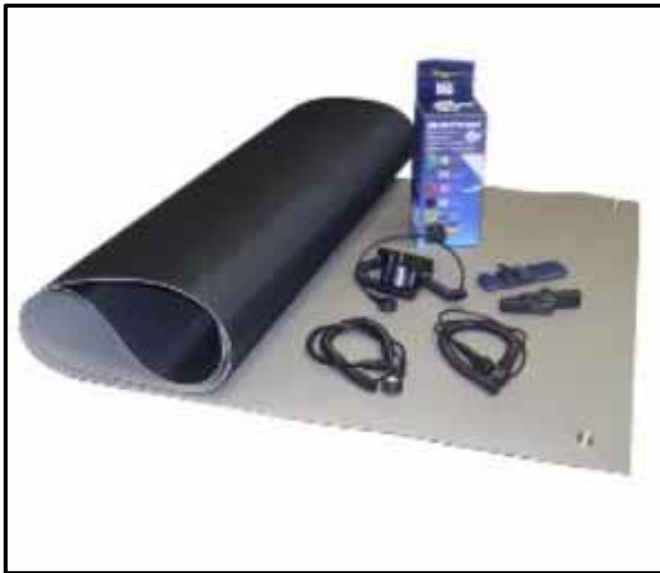
- ESD Worksurface - VAS 6613

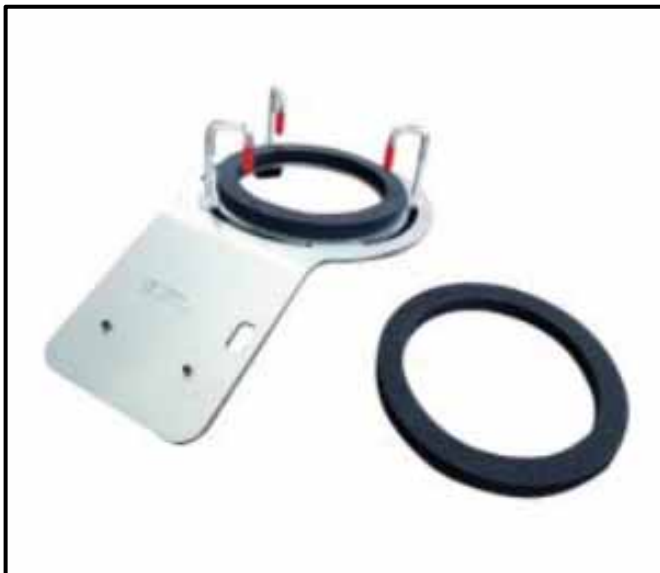
- Airbag Support - T10568

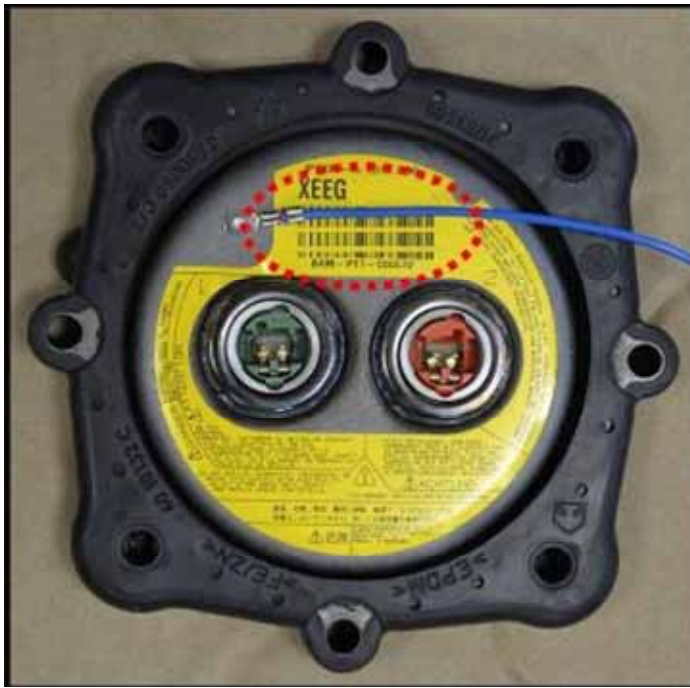
- Place the new inflator on the ESD mat.
- Scan the bar code of the new inflator at a distance of about 15 cm.

The photo is for reference only. The inflator that is installed may be either a single stage or dual stage inflator.
