# Safety Recall

## Code: 69M5

Subject	Airbag Control Unit (Occupant Restraint Controller (ORC Module))
Release Date	December 20, 2016
Affected Vehicles	<b>U.S.A. &amp; CANADA: 2009 MY Volkswagen Routan</b> <i>Check Campaigns/Actions screen in Elsa on the day of repair to verify that a VIN qualifies for repair under this action. Elsa is the <u>only</u> valid campaign inquiry &amp; verification source.</i> <ul style="list-style-type: none"><li>✓ Campaign status must show "open."</li><li>✓ If Elsa shows other open action(s), inform your customer so that the work can also be completed at the same time the vehicle is in the workshop for this campaign.</li></ul>
Problem Description	The airbag control unit (Occupant Restraint Controller/ORC module) in certain vehicles may corrode and fail. If the airbag control unit fails, the airbags may not deploy in the event of a crash, increasing the risk of occupant injury. Additionally, the airbags may inadvertently deploy, increasing the risk of a crash.

## Section B – Removal of Occupant Restraint Controller (ORC Module)

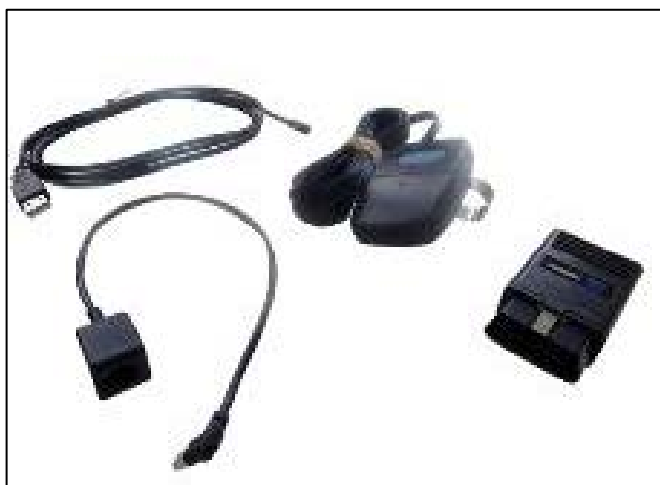
- VWMICROPOD – Volkswagen microPod II kit (or equivalent).
- wiTECH™ desktop client.

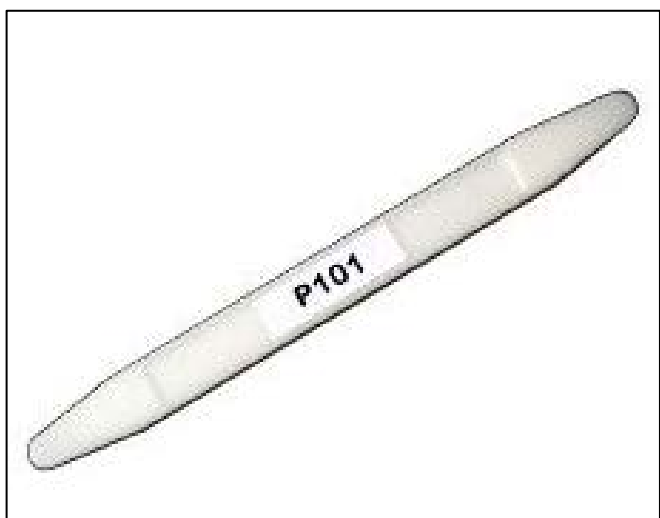
- RMCP 101 – Trim Removal Wedge (or equivalent).

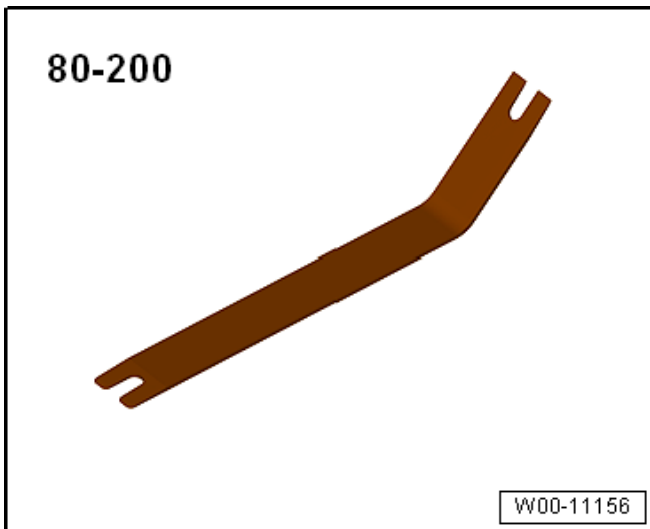
- Pry Lever -80-200- (or equivalent)

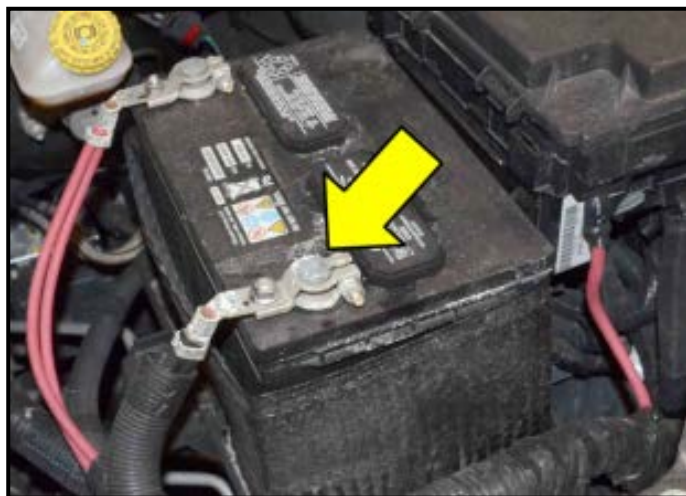
- Record all radio presets.
- Loosen the negative battery cable clamp nut <arrow>.
- Remove the negative battery cable clamp <arrow> from the negative battery post.
- Wait two minutes for the system capacitor to discharge before further service.

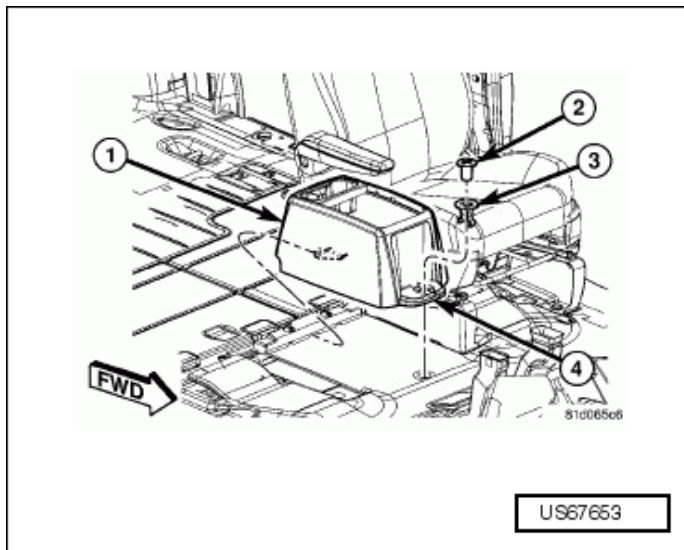
#### Removal of Floor Console, Base Model:

- Remove the front plug <2> and clip <3>.
- Slide the console <1> forward while lifting slightly to clear the rear load floor hook.
- Remove the floor console <1>.

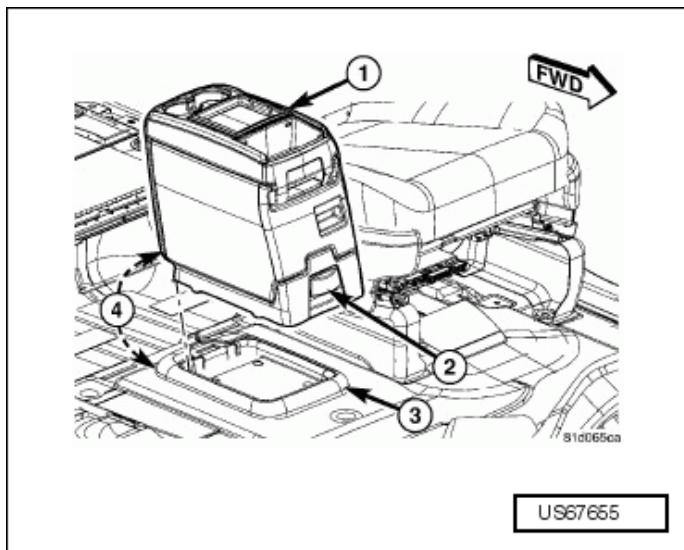
#### Removal of Floor Console, Premium Model:

- Pull up on the bottom release handle <2> in the front of the console <1>.
- Lift the rear of the console <4>.
- Pull rearward to disengage the console from floor and remove console.

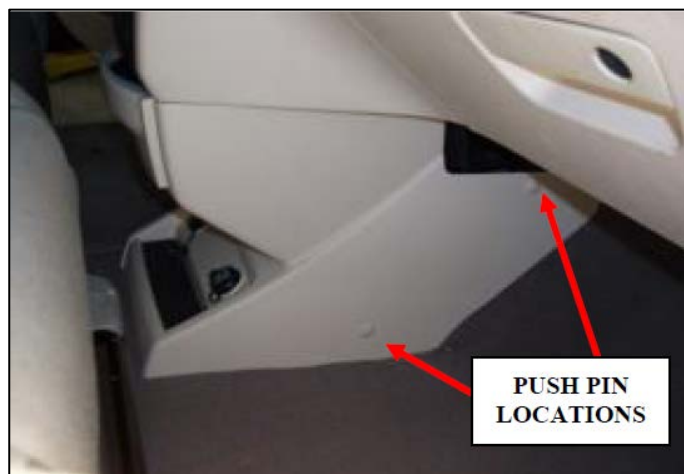
- Remove the four push pin retainers <arrows>, two on each side.
- Slide instrument panel console rearward and disconnect electrical connectors.
- Remove the instrument panel console.

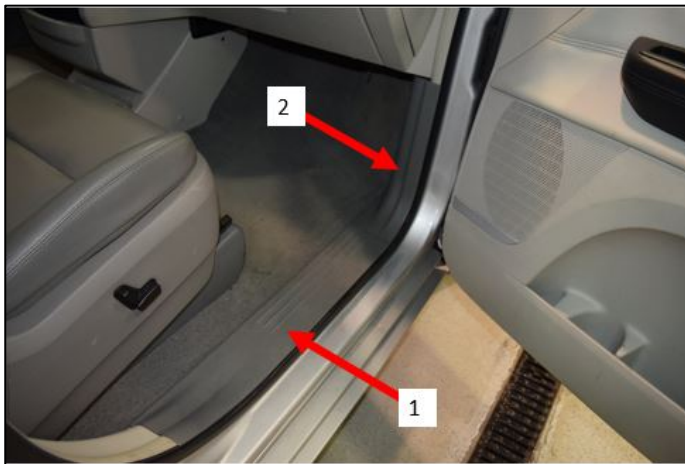
- Remove passenger side rocker trim <1> and A-pillar trim <2> using RMCP 101 – Trim Removal Wedge (or equivalent).
- Move passenger side front seat to the most rearward position.

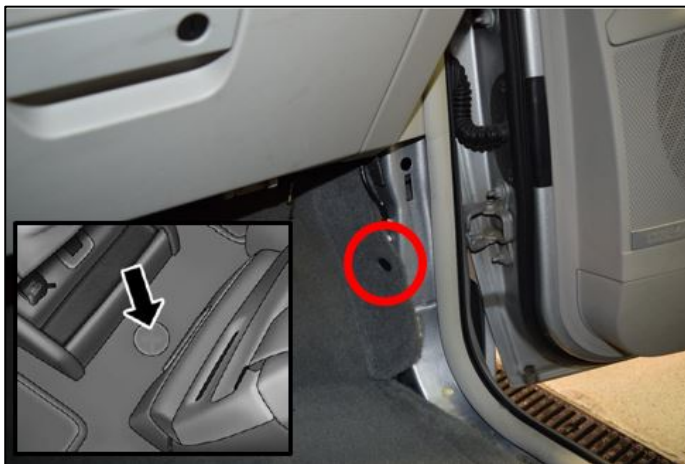
- Remove push pin <circle> using Pry Lever - 80-200- (or equivalent).
- Remove spare tire lowering bolt cover <arrow>.
- Pull passenger side carpet back to access the floor duct and instrument panel support bracket.

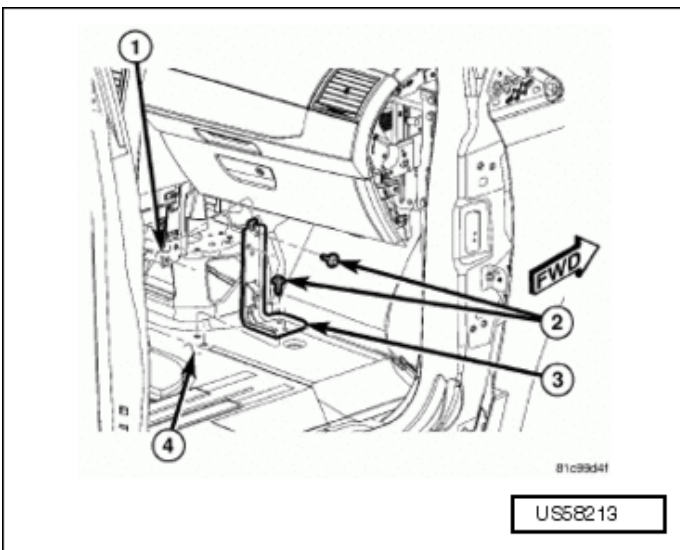
- Remove the bolts <2> from passenger side instrument panel center support bracket <3>.
- Remove the bracket.

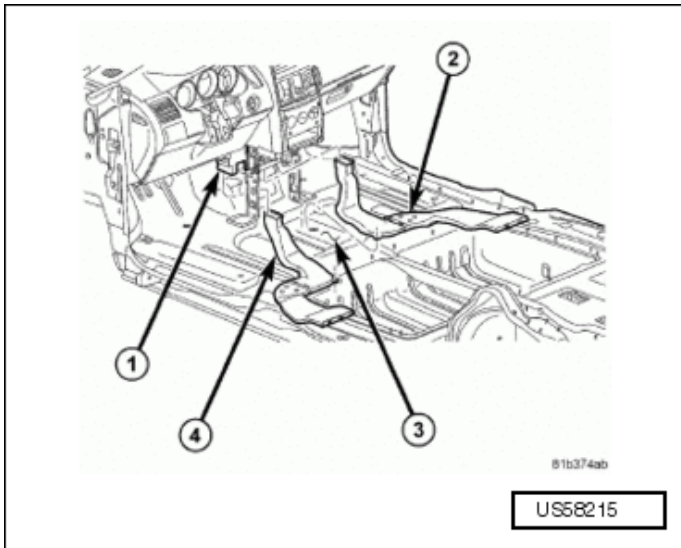
- Disengage the front section of duct <2> from the stud located on the floor.

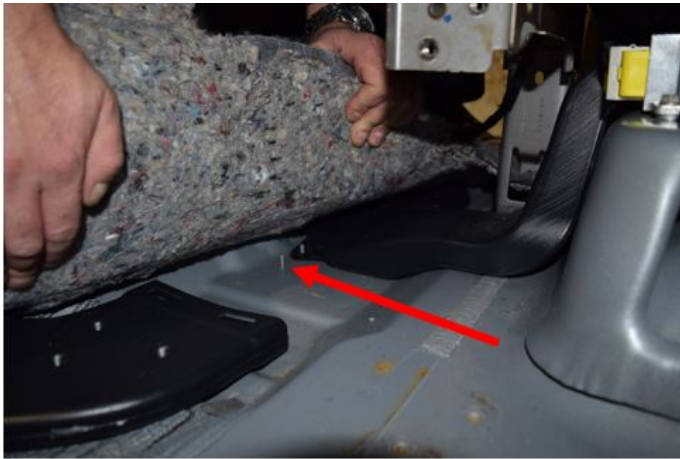
- Location of duct retaining stud <arrow>.

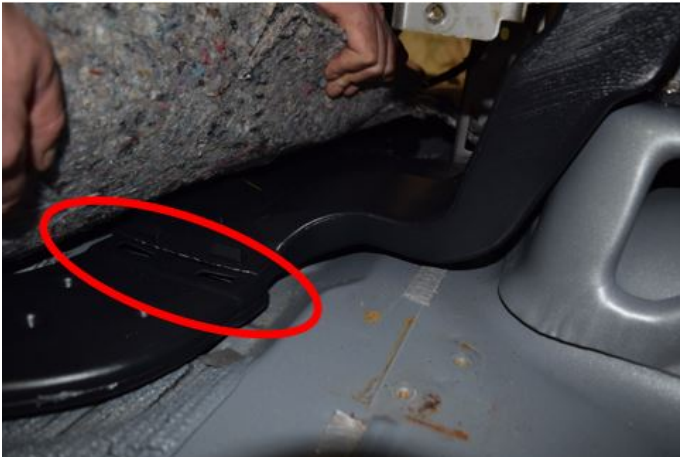
- Separate the duct sections <circle>.
- Lift up on the front duct section at the stud mounting point, slide the duct slightly toward the driver's side, and rotate the duct until it can be removed from the vehicle.

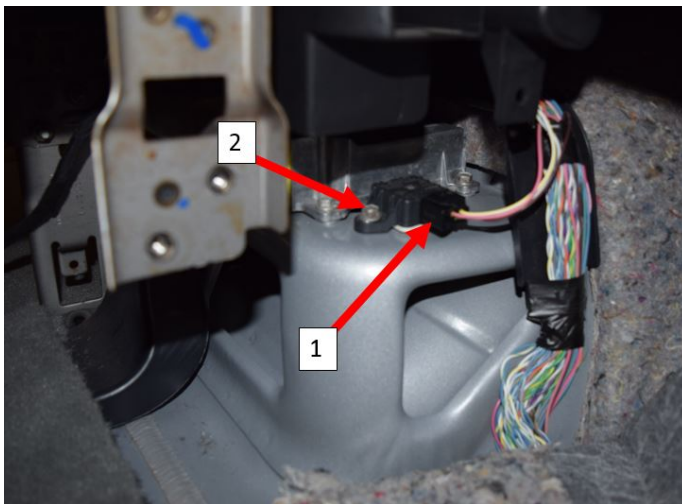
- Disconnect connector <1> at the dynamics sensor.
- Remove the screws <2>.
- Remove the dynamics sensor.

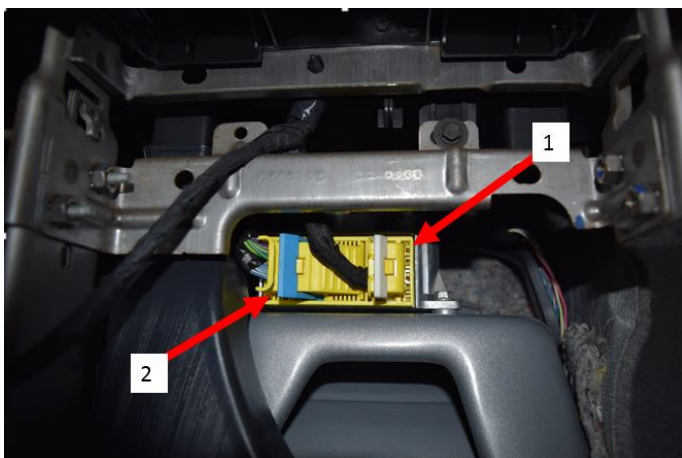
- Disconnect the wire harness connectors from the ORC Module.
  - Depress the release tab on the connectors <1 and 2> and lift the lever arm to the fully open position on each connector.

Disconnecting the 36 pin connector <1> first will allow for an easier access when disconnecting the 72 pin connector <2>.

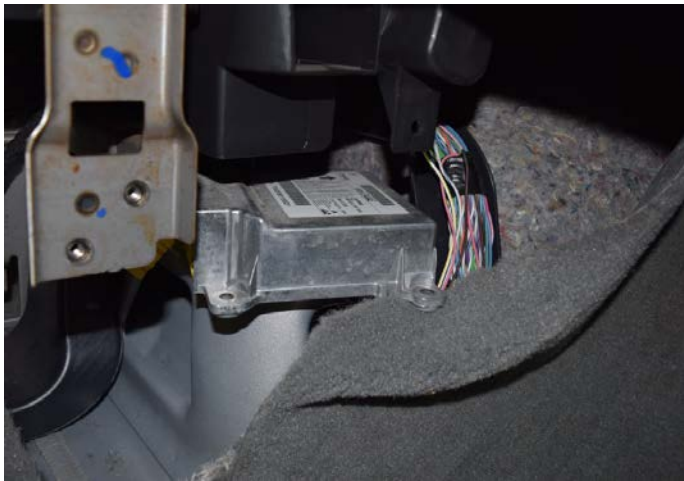
- Remove the three ORC Module bolts and slide the module out toward the passenger side of the vehicle.

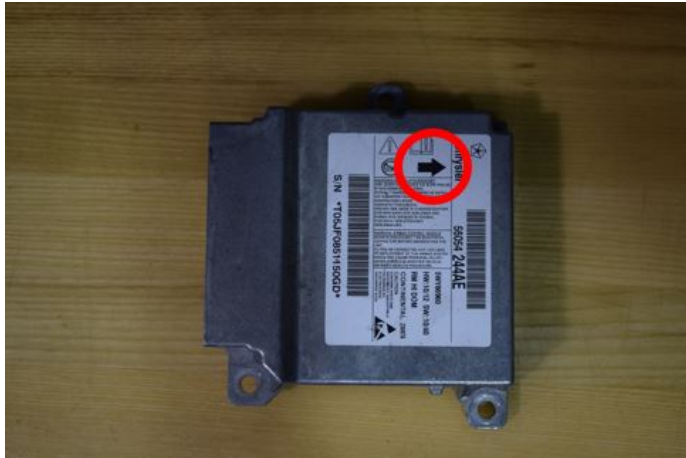
When installing the ORC Module, the arrow on the parts label <circle> must point toward the front of the vehicle.

- Install the ORC Module, part #, and verify the locating pins are correctly inserted into their locating holes.

- Install and torque the three bolts to 10 Nm

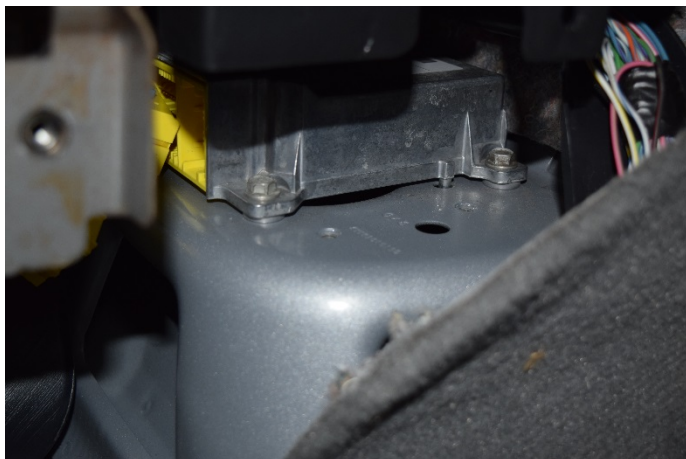
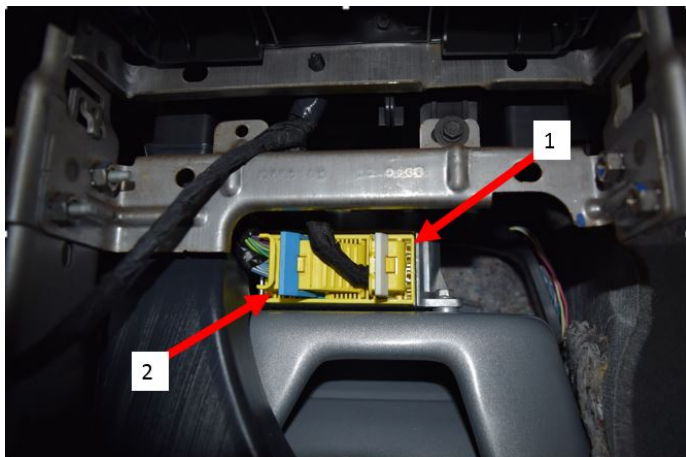
- Connect the connectors <1 and 2> to the ORC Module.

Connecting the 72 pin connector <2> first will allow for an easier access when connecting the 36 pin connector <1>.

- Be certain that the latches on both connectors are each fully engaged and locked.

The lever arms of the wire harness connectors for the ORC Module must be in the unlatched position before they are inserted into their connector receptacles on the ORC Module or they may become damaged.

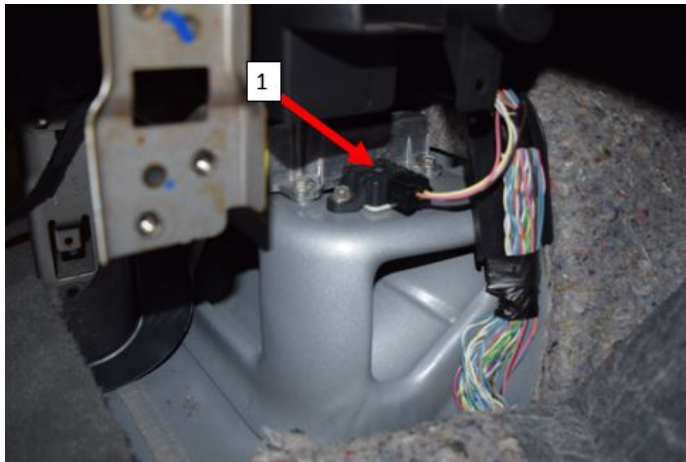
- Install the dynamics sensor <1> and torque the two bolts to 9 Nm.
- Reconnect the dynamics sensor connector.

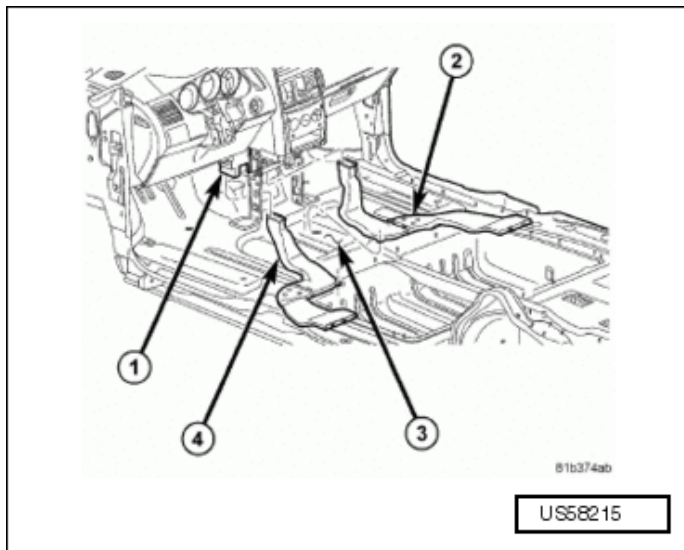
- Reinstall the front section of duct <2>.

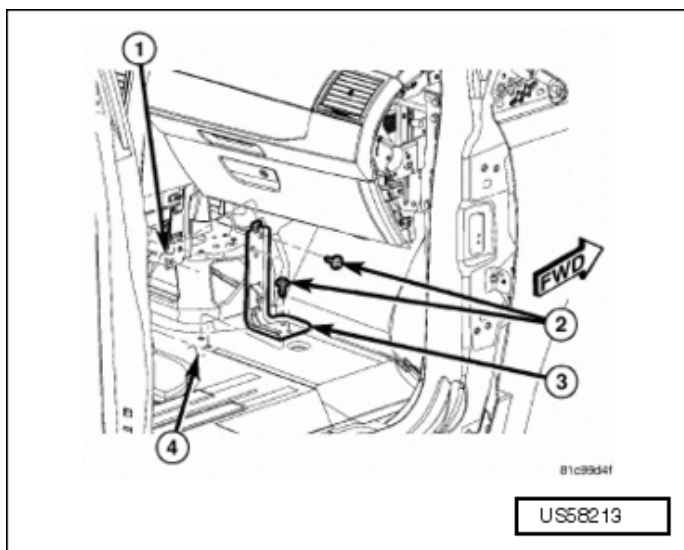
- Reinstall the instrument panel center support bracket <3> and torque the mounting screws to 9 Nm.

Install the bolts into the floor first.

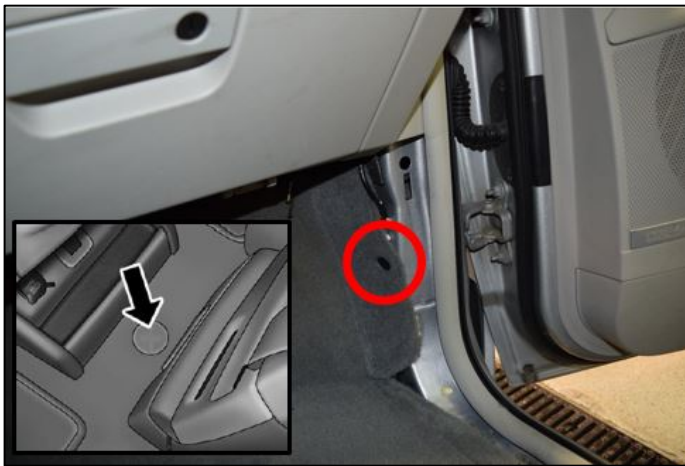
- Reposition carpet.
- Install push pin <circle>.
- Install spare tire lowering bolt cover <arrow>.

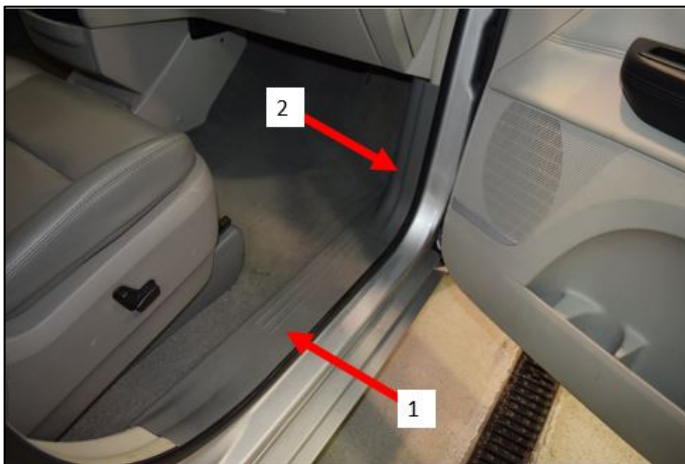
- Install A-pillar trim <2>.
- Install rocker trim <1>.

The A-pillar trim must be installed first before installing the rocker trim.

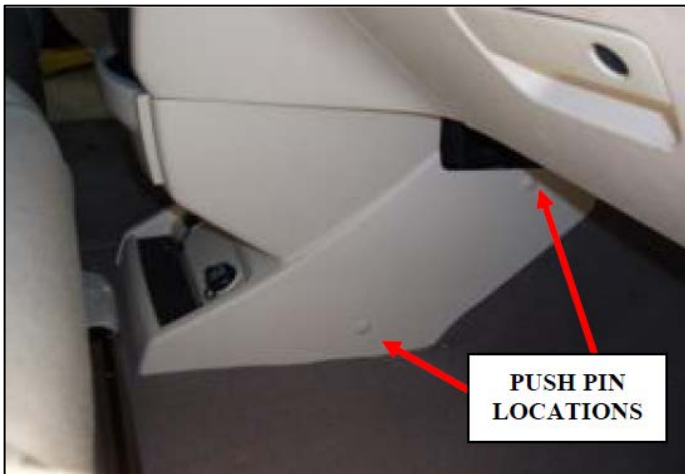
- Connect electrical connectors.
- Install instrument panel console.
- Install the four push pin retainers <arrows>, two on each side.

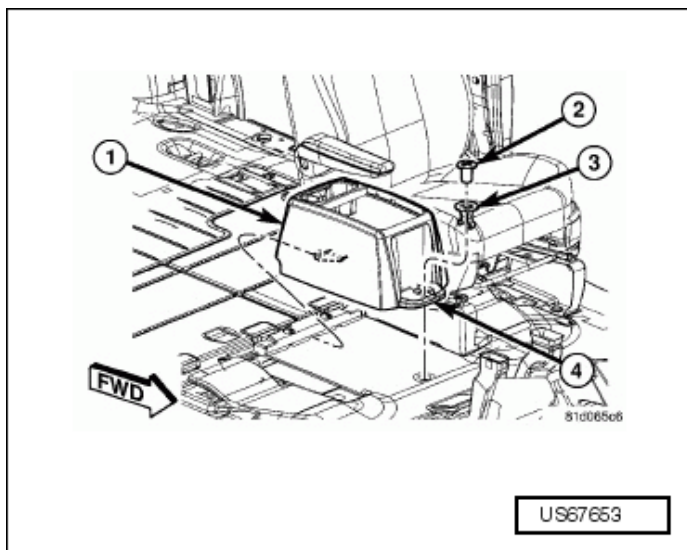
#### Reinstallation of Floor Console, Base Model:

- Reinstall the floor console <1>.
- Slide the console <1> rearward while setting the console <1> into the floor hook <4>.
- Reinstall the front clip <3> and plug <2>.

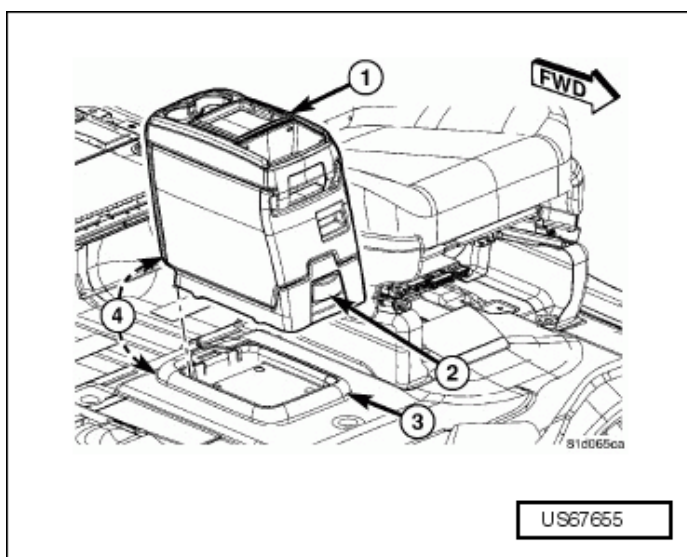
#### Reinstallation of Floor Console, Premium Model:

- Set the console <1> in position, and push rearward to engage the floor hook.
- Make sure the release handle catch <2> securely catches on the front release mechanism <3> of the console <1>.

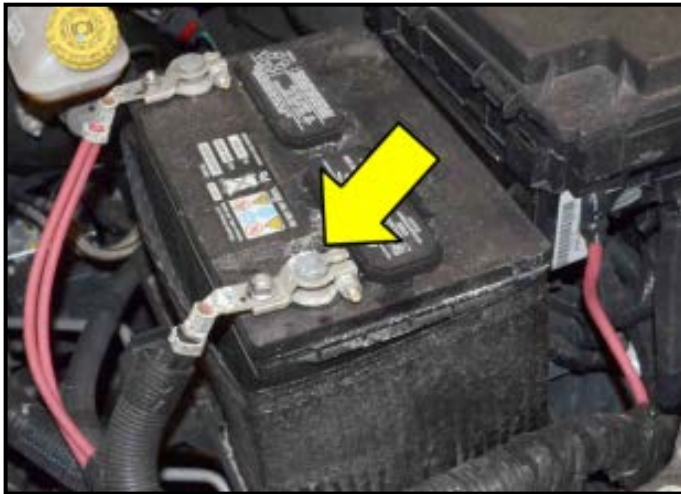
- Install and torque the negative battery clamp <arrow> to 5 Nm.
- Using the scan tool, read and record the active DTC data.
- Use the scan tool to read and record any stored DTC data.

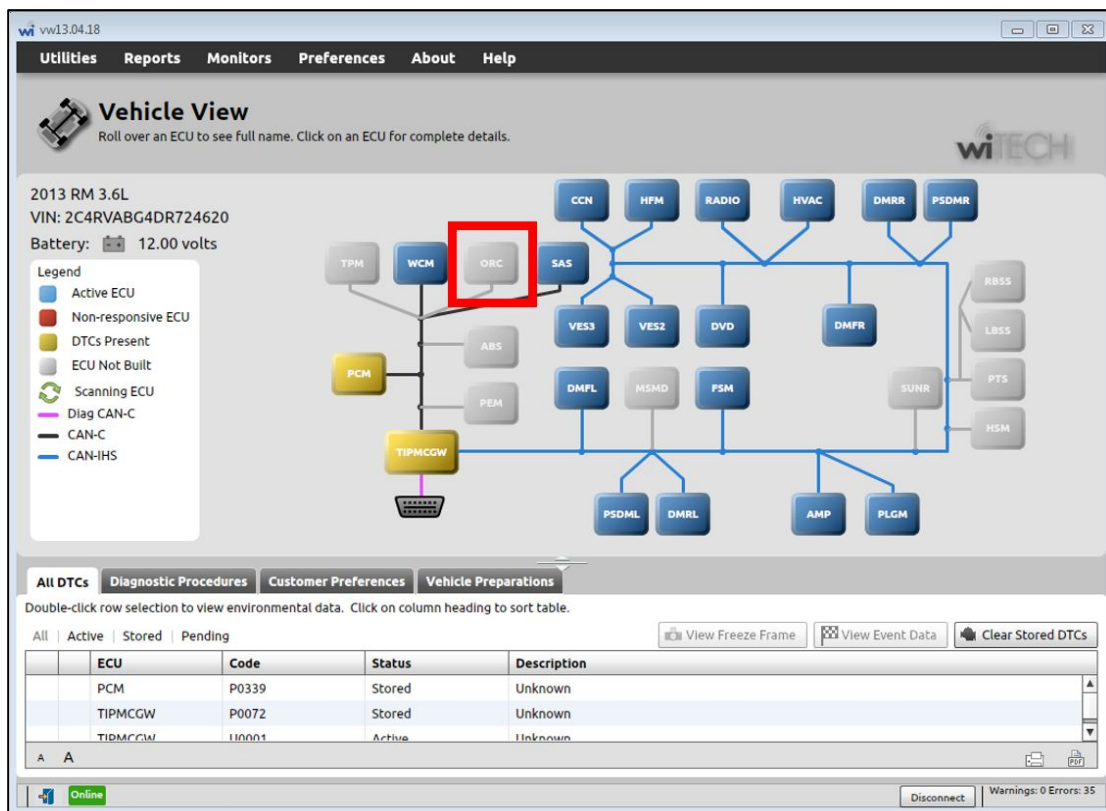
- Select the occupant restraint controller (ORC) from the main topology screen.

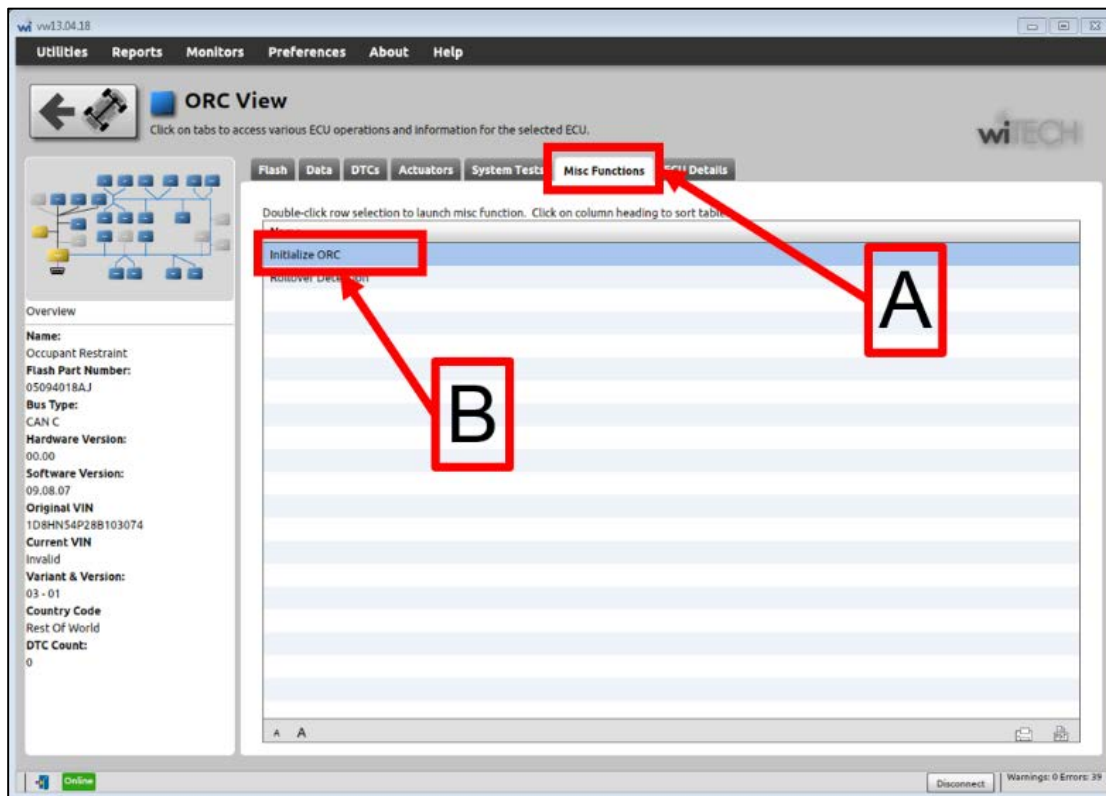
- Select the “Misc Functions” tab <A> under the ORC View screen.
- Select “Initialize ORC” <B> from the Misc Functions list.
- Follow the screen prompts on the wiTECH screen.
- Turn the ignition switch to the “OFF” position for 15 seconds, and then back to the “ON” position. Observe the airbag indicator in the instrument cluster. The airbag indicator lamp should illuminate for four to six seconds, and then go out. This indicates that the SRS is functioning normally.

Service occupant restraint control modules are shipped in a “Locked Out” state and when replaced will set a “B2722 - ORC Unlocked-All Deployment Disabled” fault code. Once the occupant restraint module has been initialized, this DTC should erase.

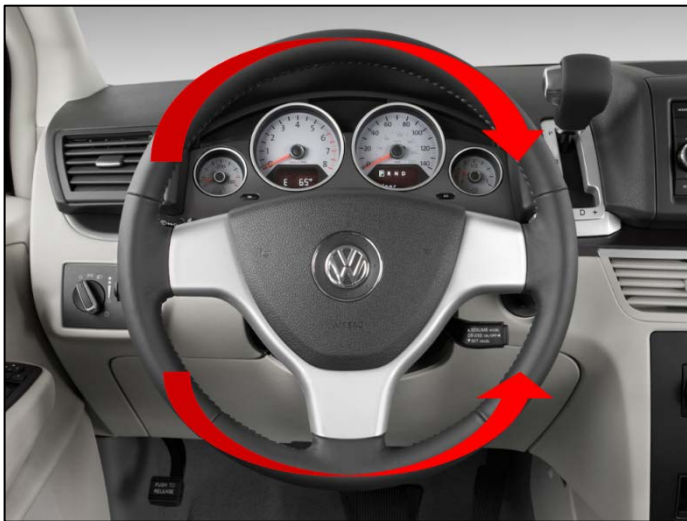
- To calibrate the ABS/ESP, perform the following:
  - Start the engine.
  - Center the steering wheel.
  - Turn the steering wheel all the way to the left until the internal stop in the steering gear is met, then turn the wheel all the way to the right until the opposite internal stop in the steering gear is met.
  - Center the steering wheel.
  - Turn off the engine.

If the vehicle is equipped with electronic stability program, once the battery is reconnected, the steering angle sensor in the clockspring needs to be calibrated. The SAS requires calibration anytime the battery or an ABS/ESP component has been disconnected for any length of time. If the SAS is not calibrated following battery reconnecting, the ESP/BAS indicator lamp is illuminated following five ignition cycles indicating the need for calibration.
