RECALL CAMPAIGN BULLETIN

NTB16-052b

VOLUNTARY SAFETY RECALL CAMPAIGN OCCUPANT CLASSIFICATION SYSTEM REPROGRAMMING

APPLIED VEHICLE: 2016 Maxima (A36)
2013-2016 Altima (L33)
2014-2016 Rogue (T32)
2015-2016 Murano (Z52)
2015-2016 Murano Hybrid (Z52)

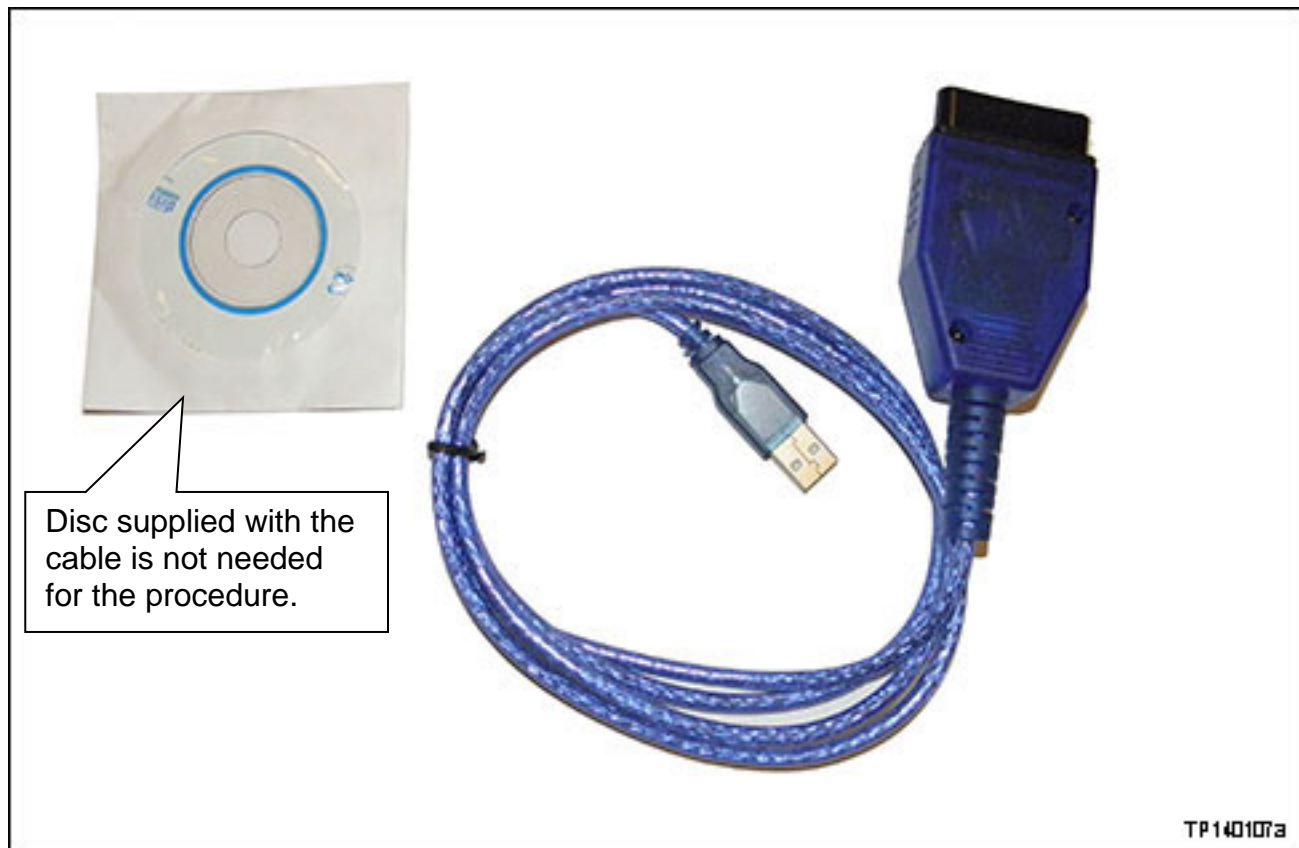
REQUIRED SPECIAL TOOL J-51594 (OCS Reprogramming Cable)

- One J-51594 OCS reprogramming cable has been supplied to each dealer. Additional cables can be obtained from Tech-Mate at 1-800-662-2001.
