RECALL CAMPAIGN BULLETIN

NTB16-052

VOLUNTARY SAFETY RECALL CAMPAIGN OCCUPANT CLASSIFICATION SYSTEM REPROGRAMMING

CAMPAIGN ID #: R1609
NHTSA #: 16V-244
APPLIED VEHICLE: 2016 Maxima (A36)
2013-2016 Altima (L33)
2014-2016 Rogue (T32)
2015-2016 Murano (Z52)
2015-2016 Murano Hybrid (Z52)

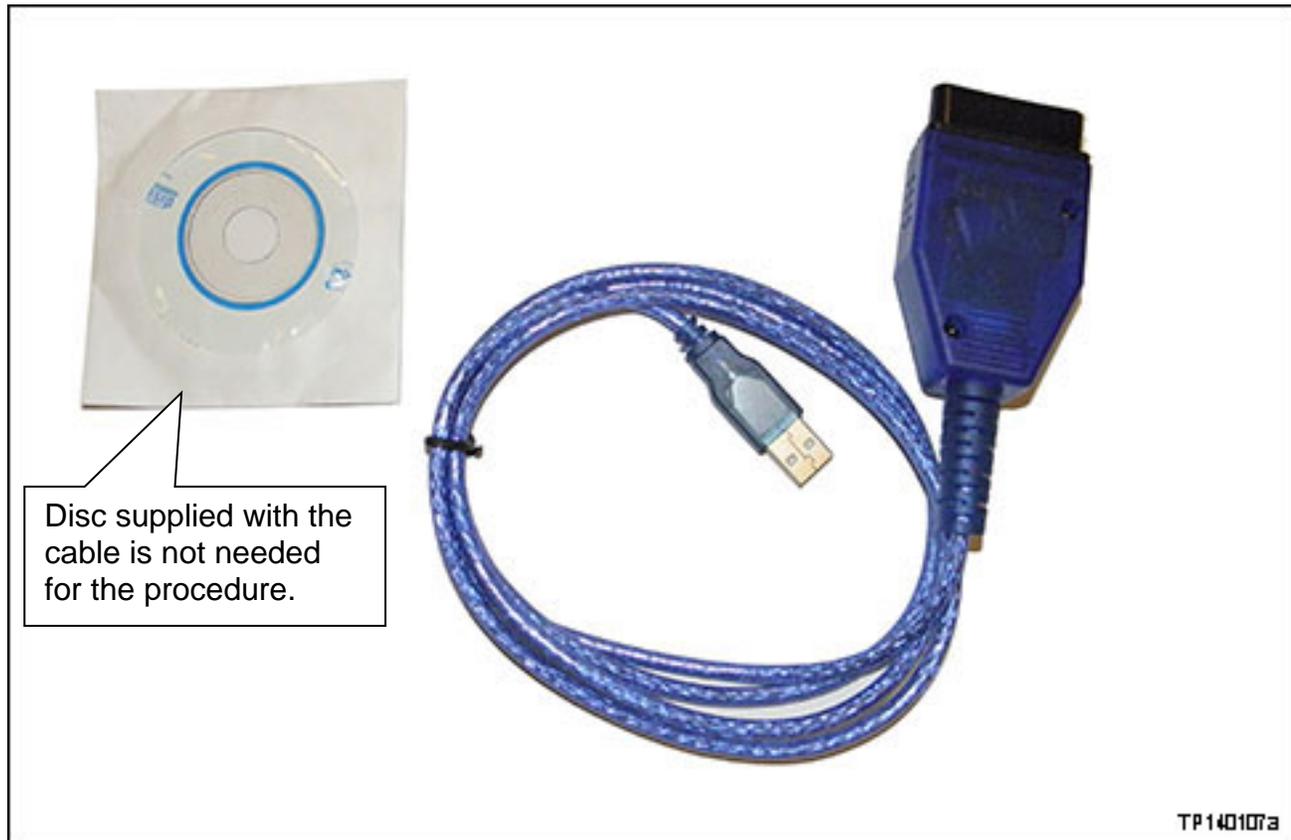
REQUIRED SPECIAL TOOL J-51594 (OCS Reprogramming Cable)

- One J-51594 OCS reprogramming cable has been supplied to each dealer. Additional cables can be obtained from Tech-Mate at 1-800-662-2001.

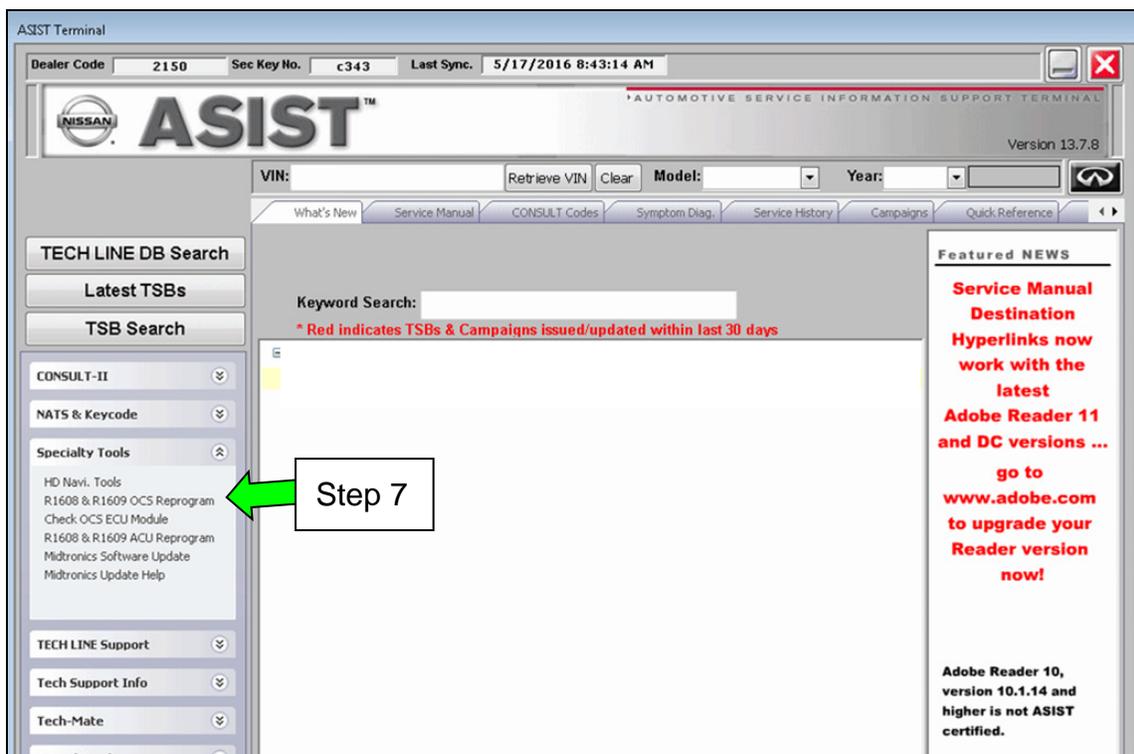
Figure 1

2. Open the vehicle hood, connect GR8 and set to ECM Power Supply Mode.
3. Turn the ignition ON, engine OFF / not Ready.
4. Turn hazards ON.
5. Connect the CONSULT-III plus VI (C-III plus) to the vehicle.
6. Connect the VI to the CONSULT PC with a USB cable.
7. Start the CONSULT PC, open ASIST and then select “**R1608 & R1609 OCS Reprogram**” on ASIST under Specialty Tools (Figure 1).

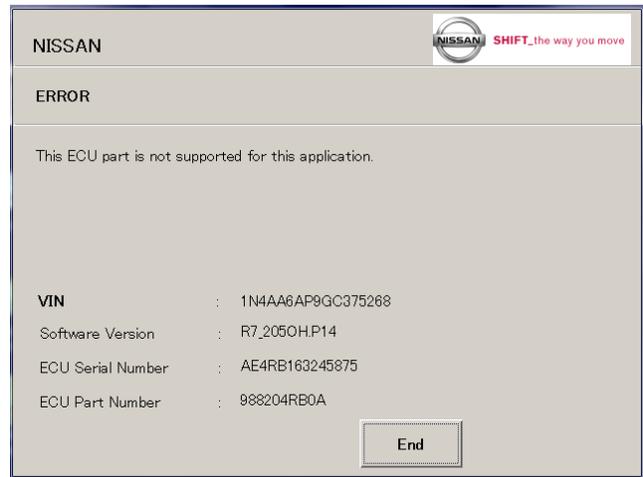
13. Is the screen in Figure 6 displayed?

- a. Select **End** and discontinue airbag reprogramming.
- b. Proceed to **OCS Control Unit Reprogram**.

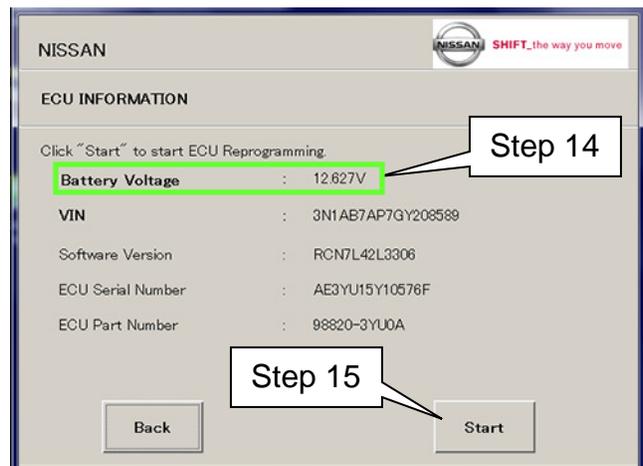
Figure 7

14. Confirm that the Battery Voltage is between 12.0V and 15.5V.

15. Select **Start** and then proceed to page 7.

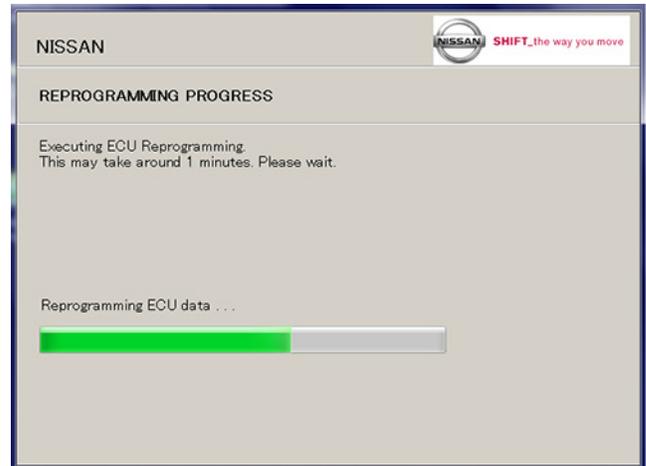
Figure 8

- **REPROGRAMMING PROGRESS** screen will be displayed (Figure 8).
- Reprogram will take approximately 3 minutes.
- Once the reprogramming has finished the screen in Figure 9 will be displayed.
- **WARNING:** Airbag control unit damage may occur if reprogramming is interrupted.

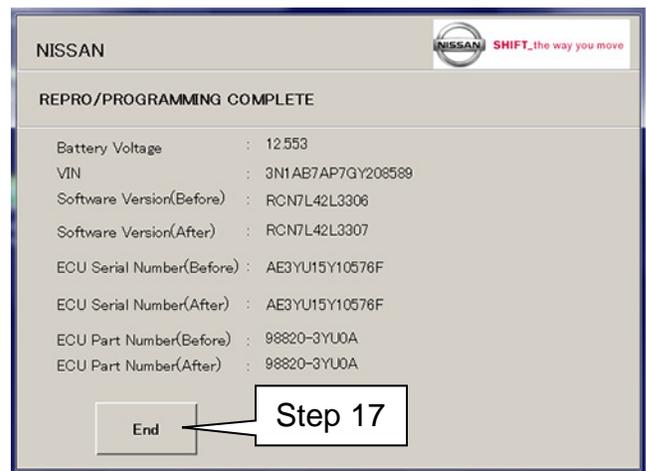
Figure 9

16. Confirm that the “Software Version(Before)” and “Software Version(After)” are different.

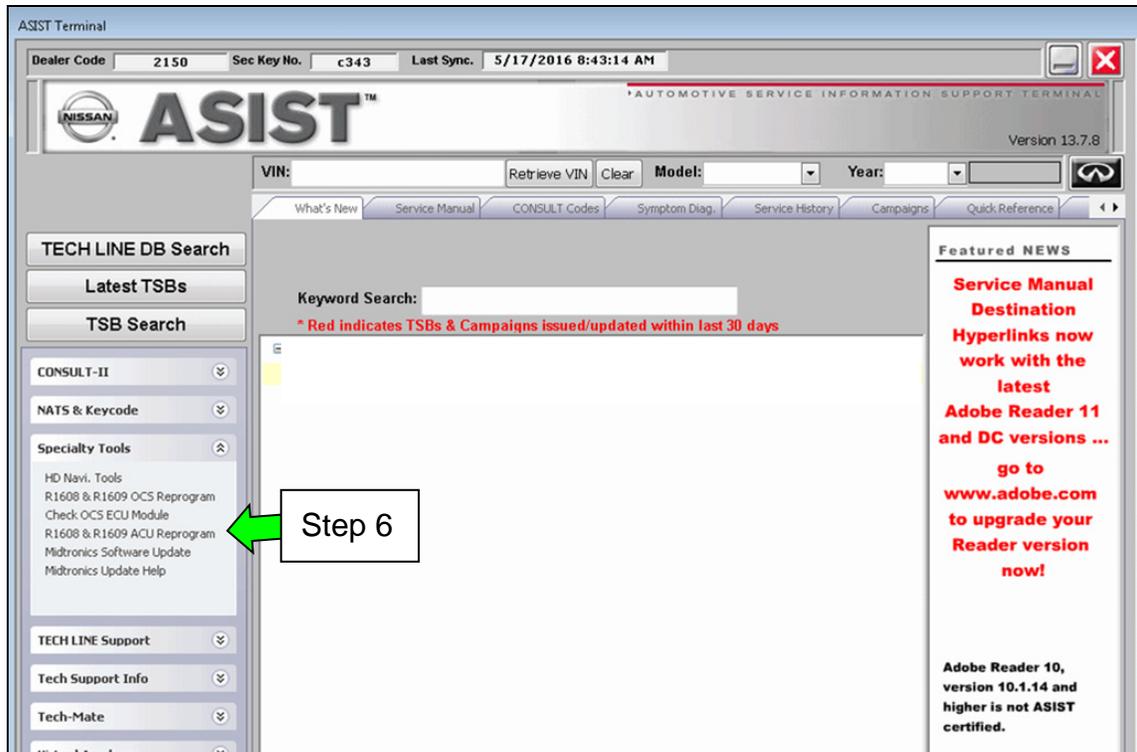
Figure 11

6. Select “R1608 & R1609 ACU Reprogram” on ASIST under Specialty Tools (Figure 11).

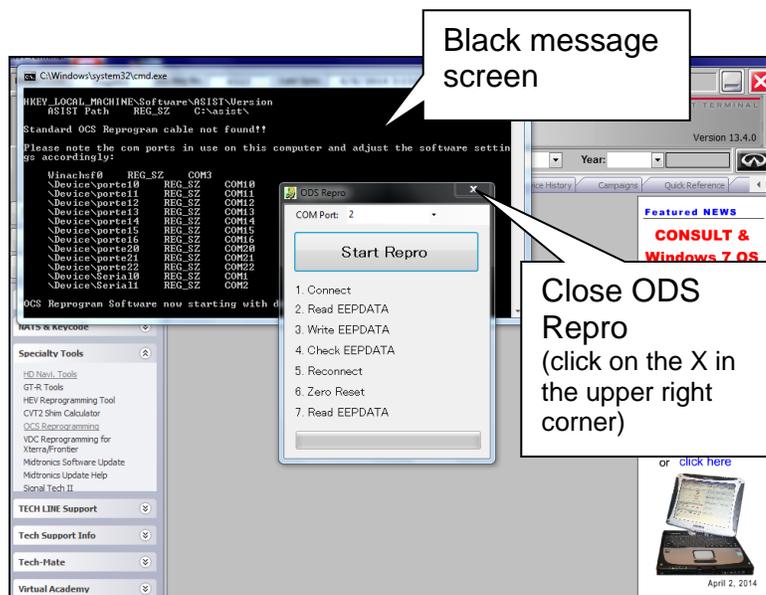
Figure 12

NOTE: If you get a black message screen as shown in Figure 12, this indicates that the reprogramming cable is not connected, or the cable driver did not install correctly.

- Close ODS Repro.
- Close ASIST.
- Start over from step 1 on page 8.

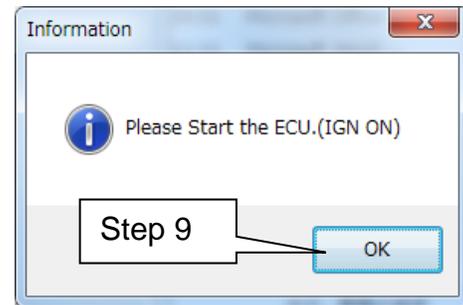
Figure 14

- After selecting OK in Figure 14, the OCS reprogramming will start.

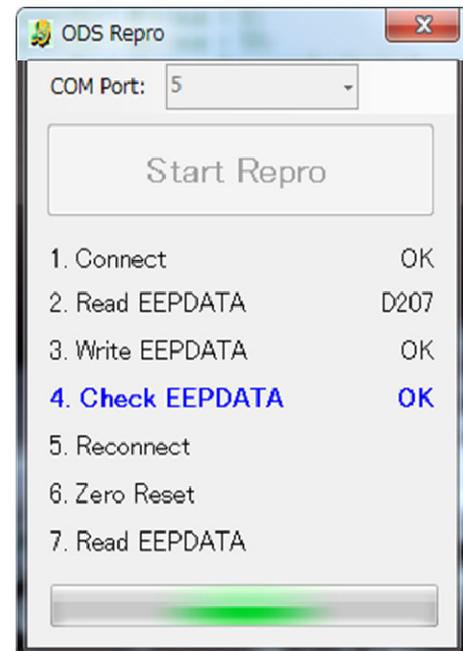
Figure 15

- Items 1 through 4 (Figure 15) will likely complete quickly.
- If the OCS reprogramming stops (displays NG) at item 1, 2, 3 or 4, refer to Figures 20 through 23 on pages 13 and 14.

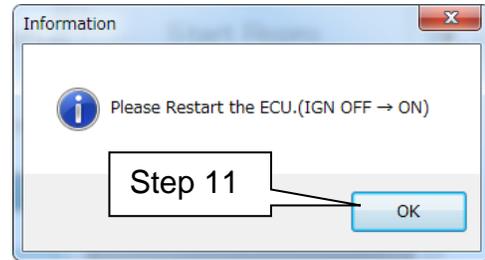
Figure 16

- After selecting OK in Figure 16, the OCS reprogramming will likely complete items 5 through 7 quickly (see "Complete" screen, Figure 18 below).
- If the OCS reprogramming stops (displays NG) at item 5, 6 or 7, refer to Figures 24 through 26 on pages 15 and 16.

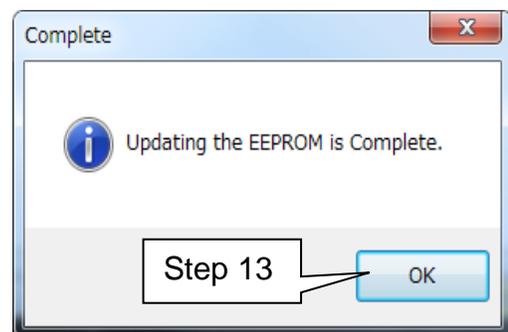
Figure 18

12 When this screen displays (Figure 18), OCS reprogramming is complete.

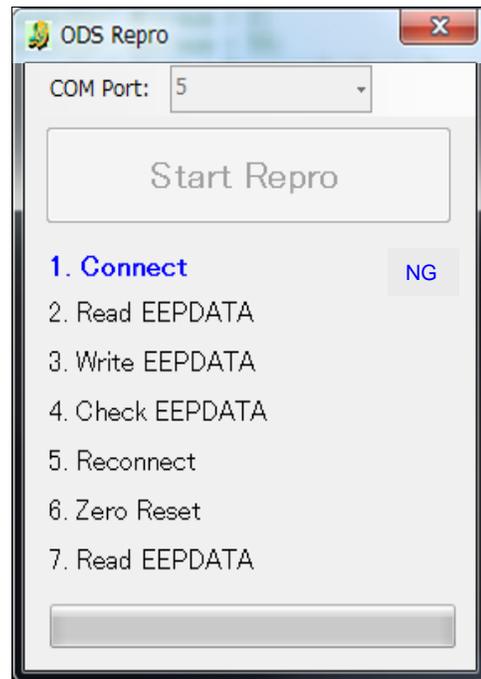
Figure 20

- #1 - If Connect indicates NG:
 - a. Click OK on the accompanying error message.
 - b. Turn the ignition OFF.
 - c. Close ODS Repro (click on the red X in the upper right corner).
 - d. Restart from step 1 on page 8.

- Zero Point Reset was included in the reprogramming – it is not necessary to perform as a separate step.
- Figures 20 through 26 on pages 13 through 16 are provided as reference if the OCS reprogramming stops (displays NG) at one of the items (1-7).

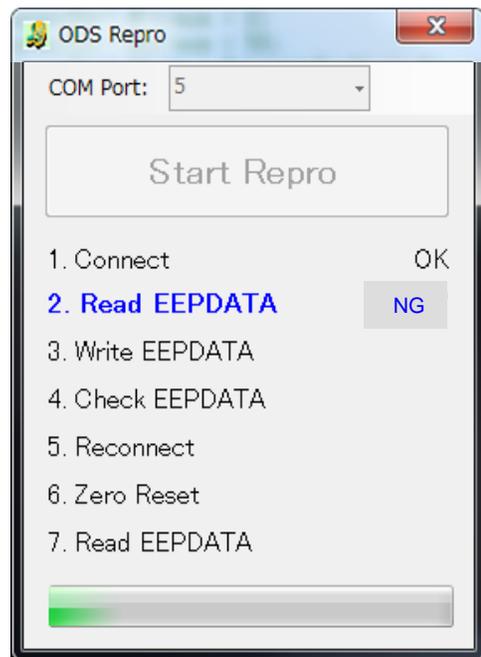
Figure 21

- #2 - If Read EEPROMDATA indicates NG:
 - a. Click OK on the accompanying error message.
 - b. Turn the ignition OFF.
 - c. Close ODS Repro (click on the red X in the upper right corner).
 - d. Restart from step 1 on page 8.

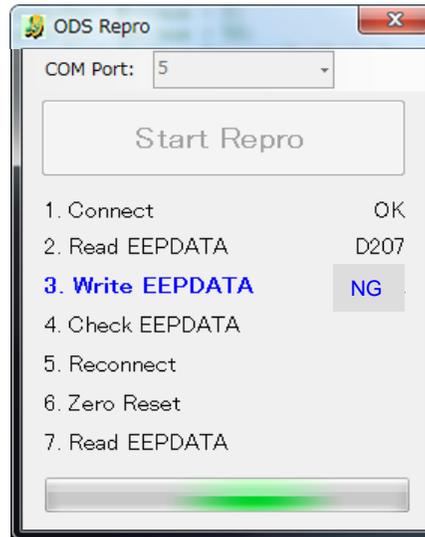
Figure 22

- #3 - If Write EEPROMDATA indicates NG:
 - a. Click OK on the accompanying error message.
 - b. Turn the ignition OFF.
 - c. Close ODS Repro (click on the red X in the upper right corner).
 - d. Restart from step 1 on page 8.

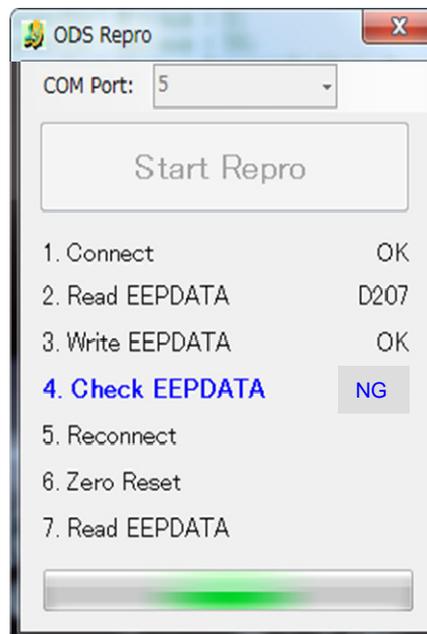
Figure 23

- #4 - If Check EEPROMDATA indicates NG:
 - a. Click OK on the accompanying error message.
 - b. Turn the ignition OFF.
 - c. Close ODS Repro (click on the red X in the upper right corner).
 - d. Restart from step 1 on page 8.

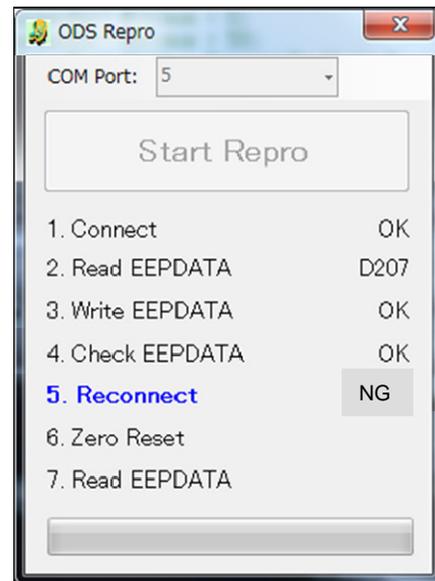
Figure 24

- #5 - If Reconnect indicates NG:
 - a. Click OK on the accompanying error message.
 - b. Turn the ignition OFF.
 - c. Close ODS Repro (click on the red X in the upper right corner).
 - d. Restart from step 1 on page 8.

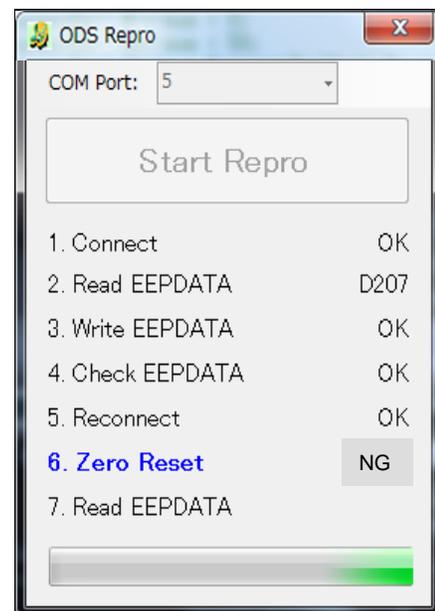
Figure 25

- #6 - If Zero Reset indicates NG:
 - a. Click OK on the accompanying error message.
 - b. Cycle the ignition OFF > ON.
 - If needed, retry ignition OFF > ON 5 times.
 - c. If Zero Reset still indicates NG, close ODS Repro (click on the red X in the upper right corner), and restart from step 1 on page 8.

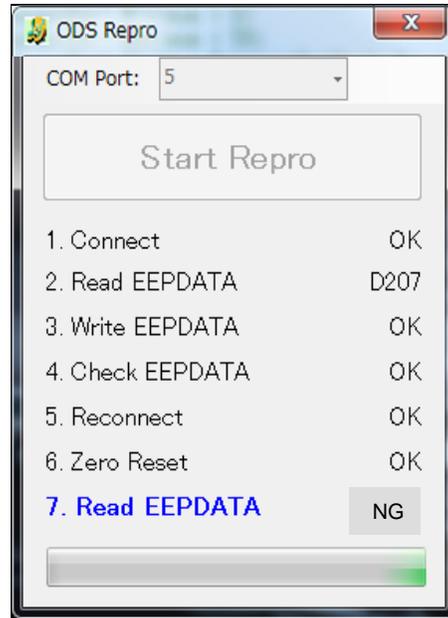
Figure 26

- #7 - If Read EEPROMDATA indicates NG:
 - a. Click OK on the accompanying error message.
 - b. Turn the ignition OFF.
 - c. Close ODS Repro (click on the red X in the upper right corner).
 - d. Restart from step 1 on page 8.
