LANCER PASSENGER SIDE FRONTAL AIR BAG **INFLATOR – SAFETY RECALL CAMPAIGN**

No: SR-16-002 DATE: July, 2016 MODEL: 2006-07 Lancer [X] TECHNICIAN [X] WARRANTY PROCESSOR [X] SALES MANAGER

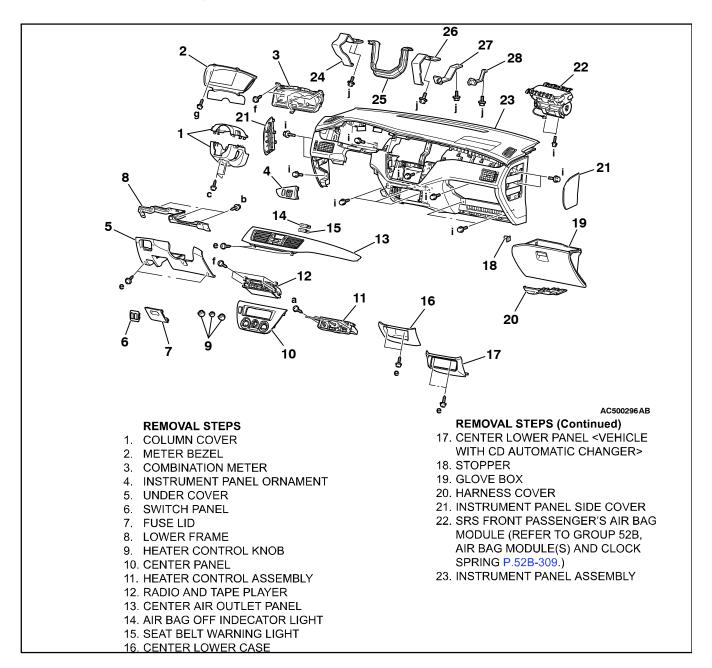
3. Remove the instrument panel.

NOTE: Make sure the left and right wire harness clips, behind the radio, are disconnected prior to dash removal.

NOTE: Unbolt the ECM/PCM prior to dash removal.

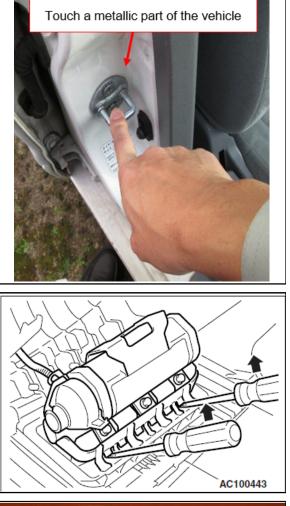
1. The front passenger side air bag module is secured to the instrument panel in a flexible plastic enclosure. Insert a flat head screwdriver and disengage the mounting hooks to dislodge the module from the enclosure.

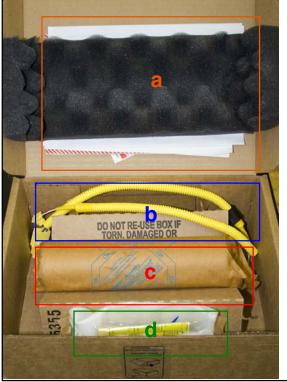
Air bag Inflator Kit Part No.: 7030A844

- a. Return shipping label and instructions for old inflator
- b. Wire harness
- c. Replacement inflator
- d. Electro tap and replacement nuts

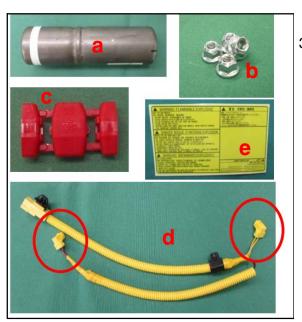
- 3. Confirm that the following contents are included in the Air bag Inflator Kit:
 - a. (1) Replacement dessicated inflator with white tape
 - b. (4) Replacement Nuts
 - c. (1) Electro tap
 - d. (1) Replacement Wiring Harness
 - e. (1) Caution Label

Connector shape of original harness

NOTE: The replacement wiring harness' connector is different from the original connector. However, the two are compatible. The replacement wiring harness has the same function and performance as the original.

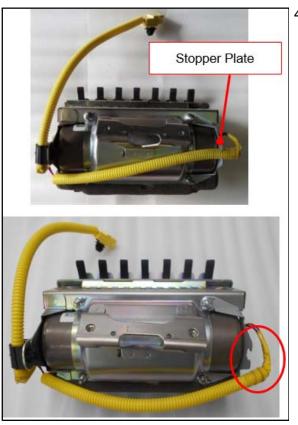
4. Unhook the corrugated tube from the Stopper Plate.

5. Insert the tip of a flat head screwdriver and open the clip.

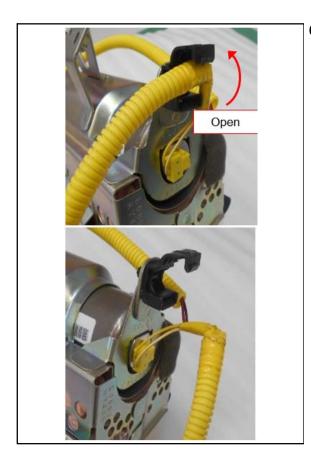
6. Open the clip and remove the harness.

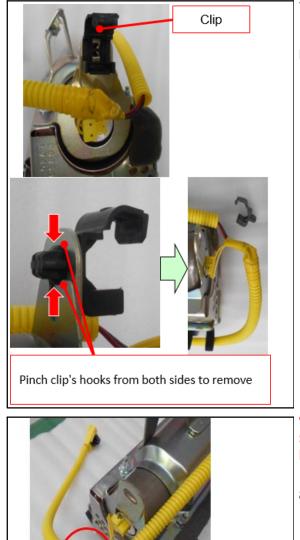
- 7. Use a pliers to remove wiring clip from the bracket.
- **NOTE:** Since the wiring will not be reused, the clip is not required to be undamaged during removal.

8. Remove the harness tape as illustrated.

Harness Tape

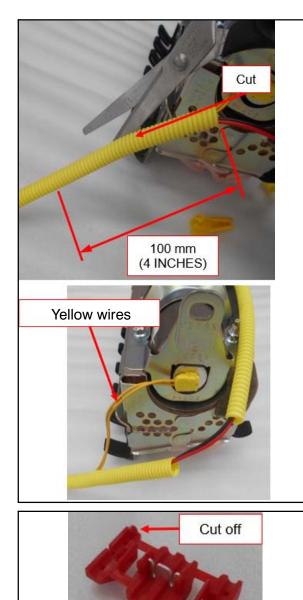
9. Use an appropriately-sized scissor to cut approximately 4 inches (100 mm) of the corrugated tube from one end as illustrated.

10. Take the yellow wires out of the corrugated tube. Do not damage the yellow wires during this process.

11. Using a nipper or pliers, cut the tab off of the Electro tap as illustrated.

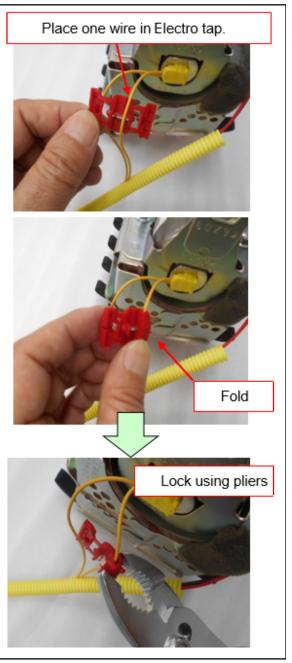
12. Place one yellow wire in the Electro tap.

13. Hold the wire by folding the Electro tap.

14. Lock the wire in the Electro tap with a pliers.

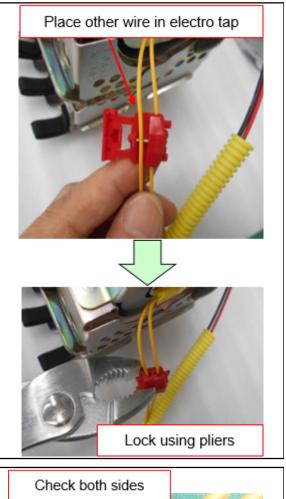
15. Lock the other yellow wire using the same procedures.

- Check both sides
- 16. Confirm that both yellow wires are locked.

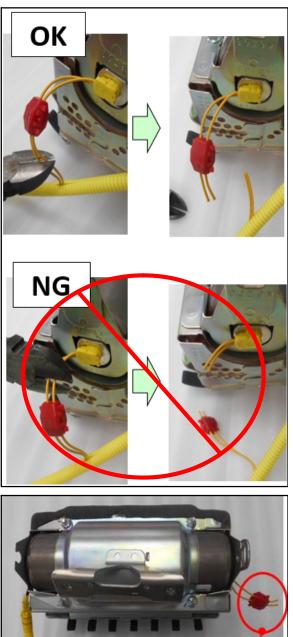
Red And Black

Yellow

17. Cut the yellow wires on the side opposite of the inflator, as illustrated.

WARNING: Do not cut the side closest to the inflator. Do not cut the red and black wire.

18. Confirm that the yellow wires have been shorted and cut.

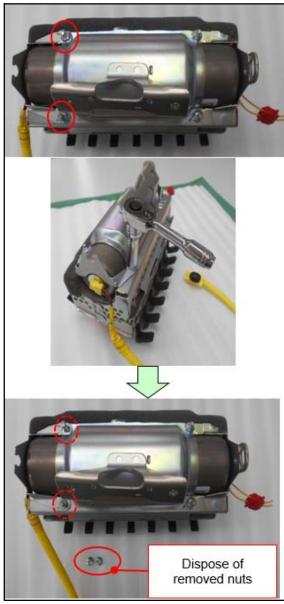
19. Loosen, remove, and dispose the (2) nuts as illustrated.

Do NOT remove any other nuts at this time, to avoid risk of dropping the air bag. Do NOT reuse the removed nuts.

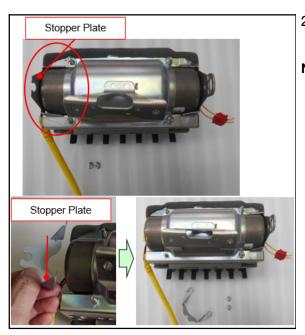
20. Remove the Stopper Plate.

NOTE: The Stopper Plate will be reused. Do not dispose.

21. Loosen, **but do not remove**, the (2) nuts as illustrated.

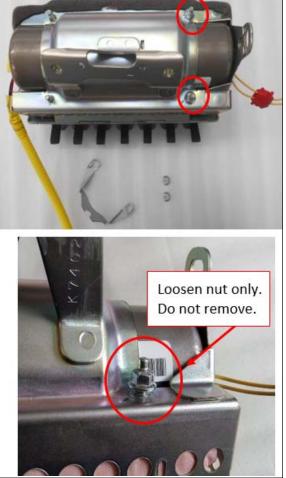
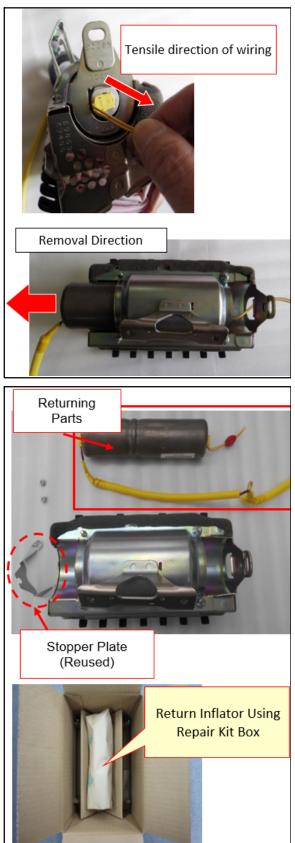
- 22. **Gently** pull on and straighten the yellow wires so that it is in line with the inflator. This will prevent the wire from contacting the edges of the inflator housing during removal.
- 23. Continue pulling on the harness while gently pushing the inflator with your finger in the illustrated direction until the inflator is completely separated from the housing.

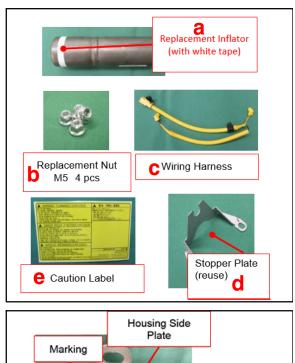
25mm (1 INCH)

11mm (7/16 INCH)

Marking

Center Line

- 1. Verify that you have all of the following parts:
 - a. (1) Replacement dessicated inflator with white tape
 - b. (4) Replacement Nut M5
 - c. (1) Replacement Wiring Harness
 - d. (1) Removed Stopper Plate
 - e. (1) Caution Label
- **NOTE:** In order to install a desiccated inflator, markings must be made on the center of the air bag module. Follow the procedures to mark and align the inflator.
- 2. Before starting, prepare a permanent marker with diameter less than 0.1 In. (2 mm).
 - a. As shown in the photo, measure the center of the Housing Side Plate and make a mark on it.
 - b. Also make a mark on the harness bracket, as illustrated.
 - c. Connect the two marks by drawing a Center Line between them.

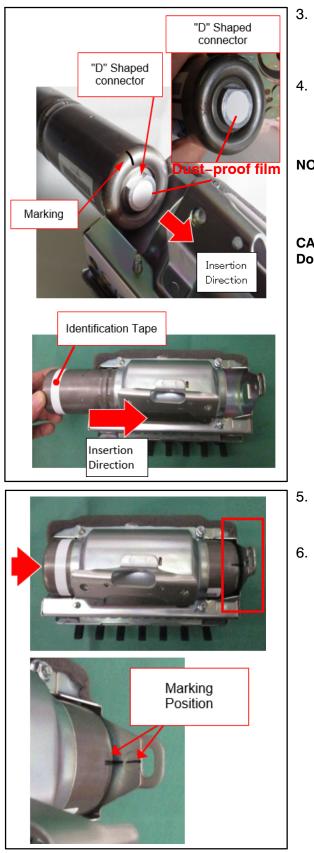
- 3. Confirm that the inflator has the white identification tape.
- 4. Insert inflator into the housing, with the "D" shape side facing in.
- **NOTE:** The marking on the replacement inflator may be faint or slightly rubbed off during shipping and handling.

- 5. Rotate the inflator until the two markings are aligned.
- 6. Push the inflator in until it contacts the Housing Side Plate.

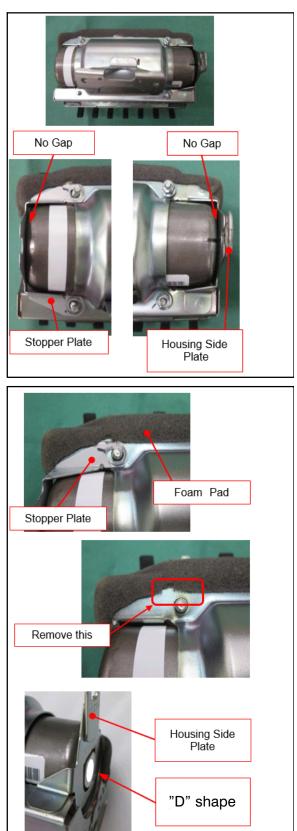
- 7. Ensure that there are **no gaps** between the inflator and the Housing Side Plate, and that the inflator is fully seated.
- 8. Install, and if necessary, adjust the Stopper Plate, and confirm there are **no gaps** between the inflator and the Housing Side Plate, and there **no gaps** between the inflator and the Stopper Plate.

9. If the foam pad interferes with the installation of the Stopper Plate, a small portion of the foam pad may be removed as illustrated.

10. Confirm that the "D" shape side of the inflator is on the same side as the Housing Side Plate.

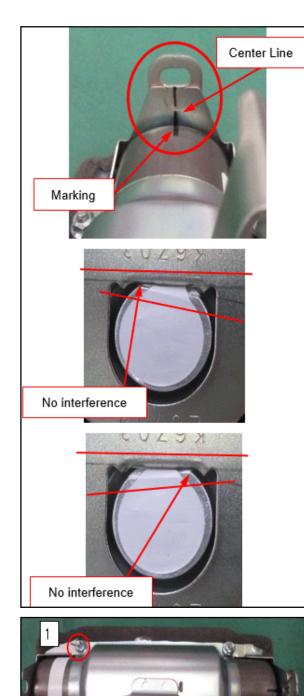
Housing Side Plate

- 11. Confirm that the Center Line and marking are still aligned. If they are not, rotate the inflator until they are aligned.
- **NOTE:** Inflator may appear to be misaligned, as illustrated in the left photographs; however, this is acceptable as long as the Center Line and markings are aligned. After temporary fitting of the Stopper Plate in next step, make sure that the "D" shape side of the inflator is not interfering with the Housing Side Plate.

12. Attach the Stopper Plate using the (2) new nuts. Do not tighten the nuts yet.

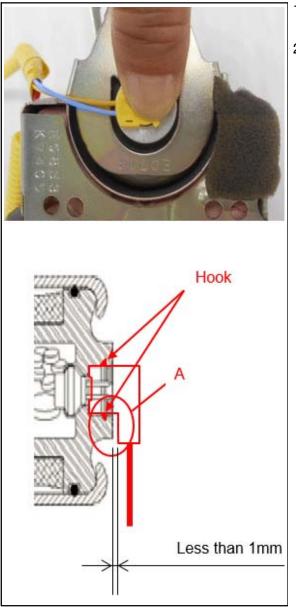
- 19. Push the connector into position, until the space between the connector and inflator is less than 1mm.
- 20. Lightly pull on the connector and confirm that it is locked into position.

- 21. Position the harness as illustrated.
 - 22. Insert the harness clip into the Housing Side Plate.

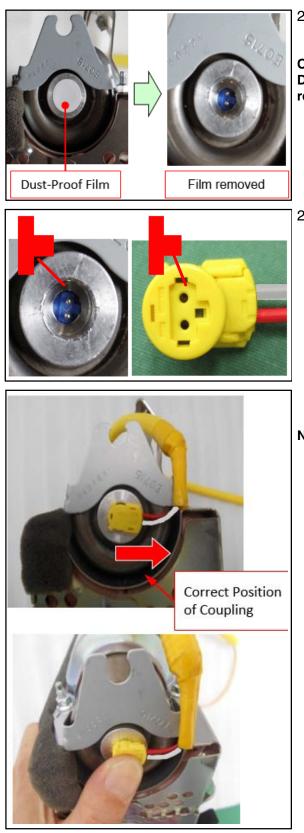
23. Peel the dust-proof film, on the Stopper Plate side, off.

- 24. Connect the red and white wire to the inflator's Stopper Plate side.
 - a. Align the "T" shape on the connector and inflator.

- b. Confirm connector and harness position is as illustrated.
- **NOTE:** If coupling orientation is incorrect, the connector will not securely lock into position. Reorient the coupling and try again.

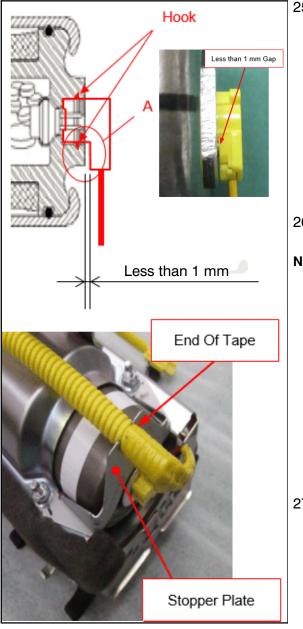
25. Push the connector into position until the space between connector and inflator is less than 1mm.

- 26. Lightly pull on the connector and confirm that it is locked into position.
- **NOTE:** If the coupling orientation is incorrect, the connector will not securely lock into position. Reorient the coupling and try again.

27. Set the end of the corrugated tube onto the Stopper Plate.

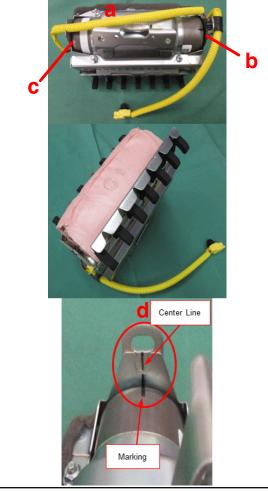
- 29. Paste the new Caution Label directly on top of the original Caution Label
- 30. Wipe and press with a dry, clean rag or cloth.

- 31. Final verification:
 - a. Have you assembled the inflator with white tape?
 - b. Are there no gaps between inflator and Housing Side Plate?
 - c. Are there no gaps between inflator and Stopper Plate?
 - d. Is the inflator positioned correctly? Check the Center Line and marking.
 - e. Are all nuts tightened to specified torque?
 - f. Are harness connectors securely locked?
 - g. Is the harness assembled as illustrated?
 - h. Are there no scratches or dirt on the air bag?
 - i. Is the new Caution Label attached?
