SIB 65 19 16

**RECALL 16V-364: PASSENGER'S FRONT AIR BAG MODULE**

This Service Information bulletin (Revision 9) replaces SI B65 19 16 dated September 2019.

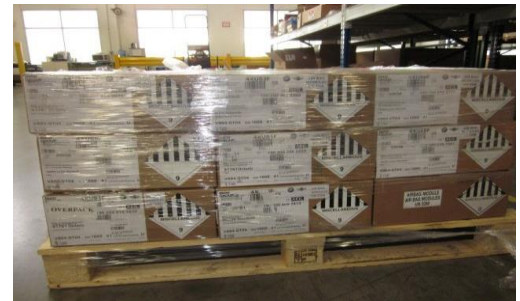
Place the recall airbag components neatly on a pallet, and securely shrink-wrap them to the pallet.

**Note:** The total height of the pallet and boxes cannot exceed 60 inches.
