November 1, 2016

05148 Version 2

## Safety Recall: 2015 TLX V6 A/T Sensor Cluster Crimp Failure

Supersedes 16-075, dated September 3, 2016 to include WARRANTY CLAIM INFORMATION, SOFTWARE INFORMATION, and REPAIR PROCEDURE

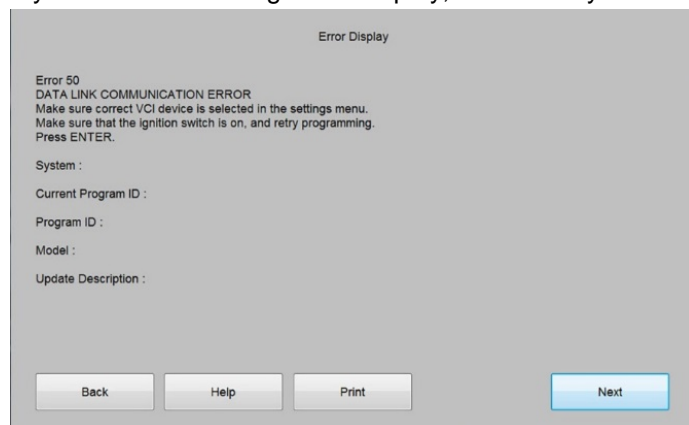
- You can't update the vehicle using the MVCI as a standalone tool.
- **Do not** use the MongoosePro VCI tool.
- Make sure the 12 volt battery is fully charged before starting an update.
- Connect a fully charged jumper battery to the vehicle and leave it connected during the entire procedure to maintain steady voltage.
- Never turn the ignition to OFF or ACCESSORY during the update. If there is a problem with the update, leave the ignition turned to ON.
- To prevent transmission control unit damage, do not operate anything electrical (headlights, audio system, brakes, A/C, power windows, door locks, etc.) during the update.
- If you see the following Error Display, check that you are using the correct tool (MVCI or DST-i) with the i-HDS.

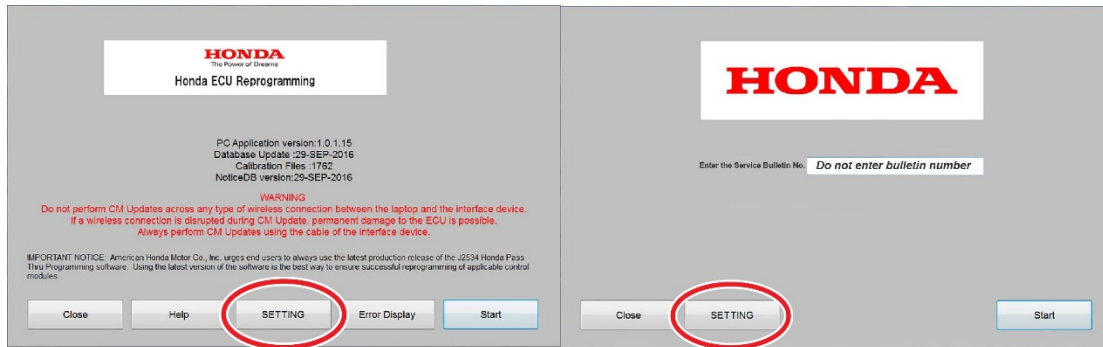
To change this, click on either of the SETTING selection buttons at the bottom of the J2534 initial screens as shown.

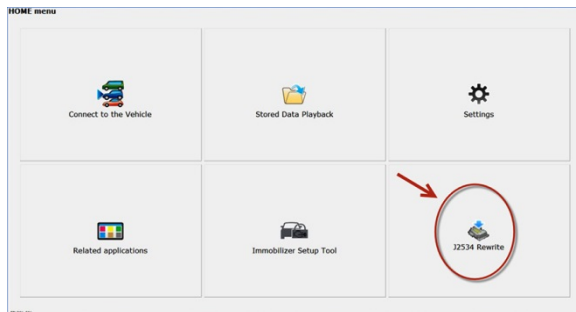
3. Select **J2534 Rewrite**.

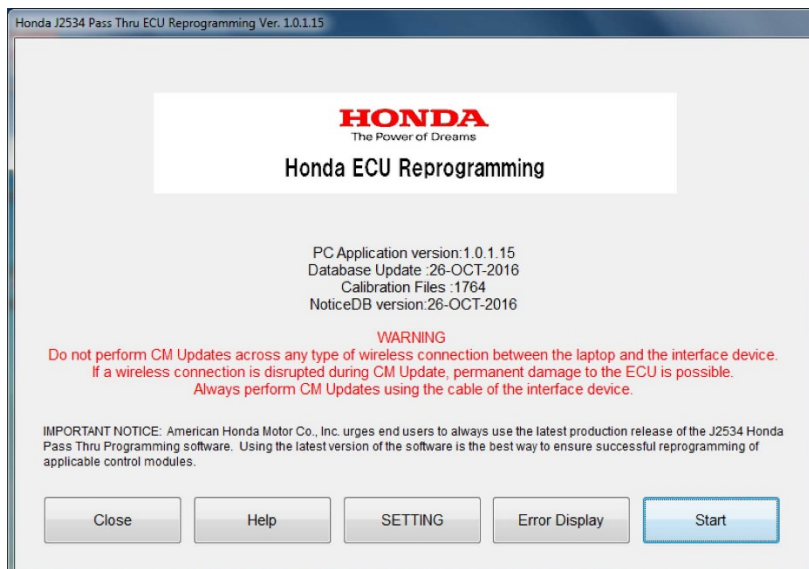
4. Confirm the software is the same **or later** as listed in SOFTWARE INFORMATION.

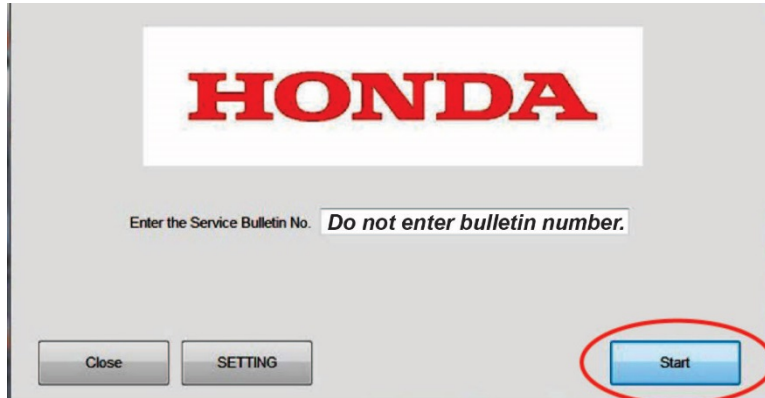
5. Select **Start**, then follow the screen prompts.

- **Don't enter a bulletin number.**
- If you receive a message that the vehicle has been already updated or that no update is available, check the transmission data list. The header should indicate one of the following numbers (or later).
