Safety Recall

Code: 20Y5

Subject	Suction Pump
Release Date	December 21, 2016
Revision Summary	Certain work instruction steps have been modified to help technicians avoid consequential damage during this repair.
Affected Vehicles	U.S.A.: Certain 2015-2016 MY Audi A3 Sedan & A3 Cabriolet Canada: Certain 2015-2016 MY Audi A3 Sedan <i>Check Campaigns/Actions screen in Elsa on the day of repair to verify that a VIN qualifies for repair under this action. Elsa is the <u>only</u> valid campaign inquiry & verification source.</i> <ul style="list-style-type: none">✓ Campaign status must show "open."✓ If Elsa shows other open action(s), inform your customer so that the work can also be completed at the same time the vehicle is in the workshop for this campaign.
Problem Description	The suction pump inside the fuel tank designed to purge fuel from the evaporative emissions (EVAP) system may have been damaged during assembly. This could cause fuel to flow directly into the EVAP system which could, over time, accumulate and cause a leak through the charcoal canister filter element. Leaking fuel, in the presence of an ignition source, may result in a fire.

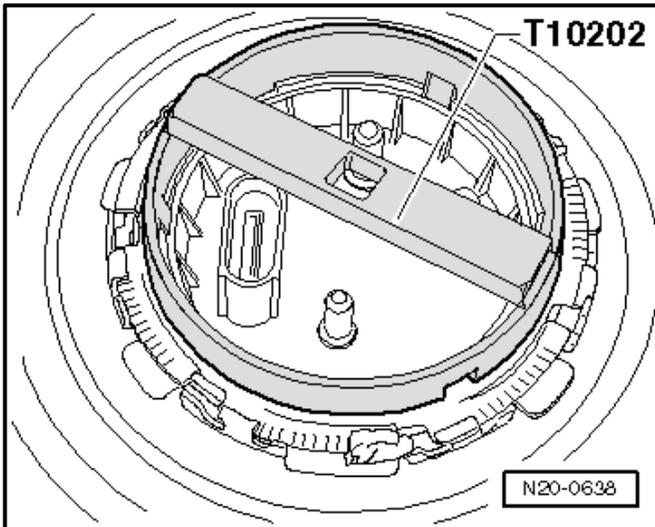
- Wrench - Fuel Sending Unit -T10202-

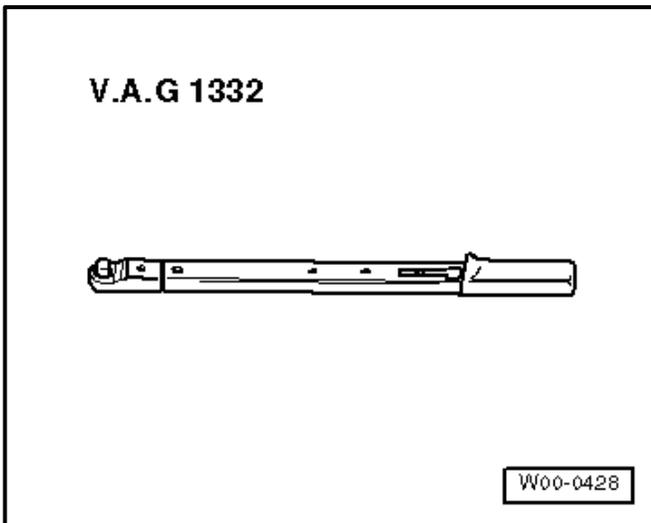
- Torque Wrench 1332 40-200Nm -VAG1332- (or equivalent)

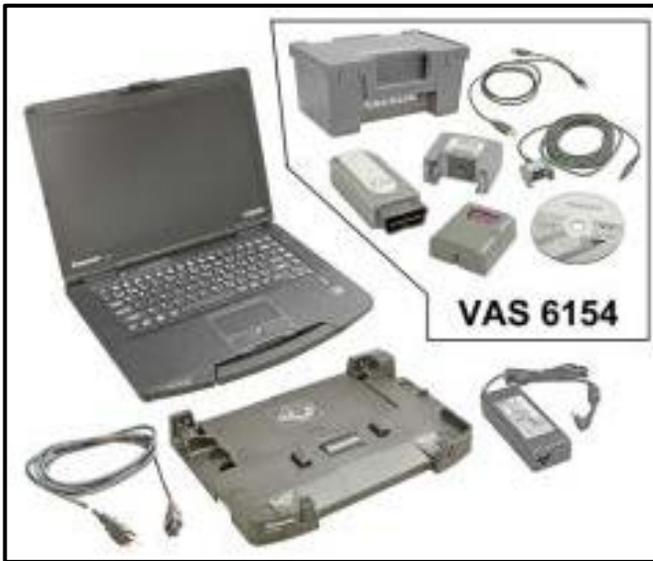
- VAS6150D – Diagnostic Tester (or equivalent)
- VAS 6154 – Vehicle Communication Interface (or equivalent)

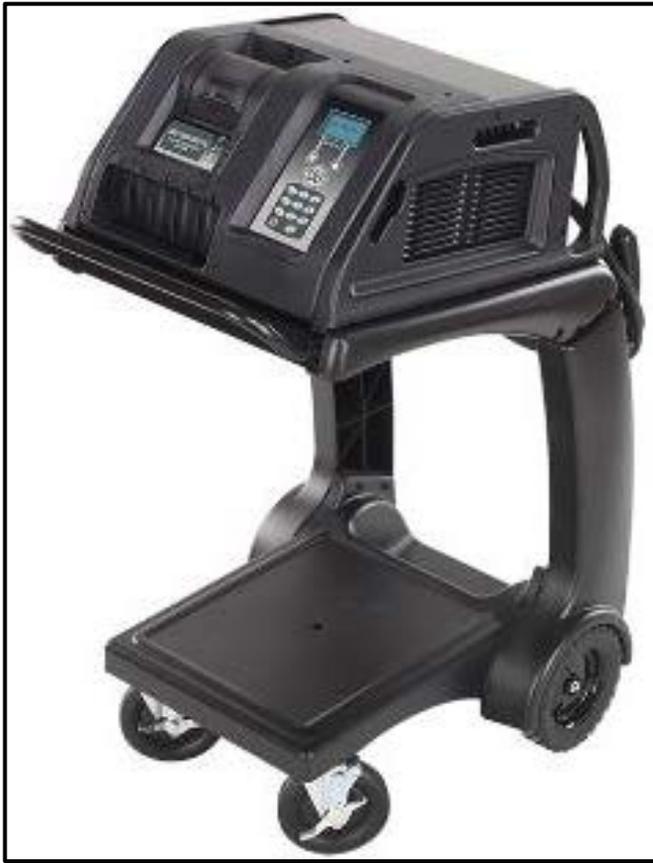
- GRX300VAS – Battery Tester/Charger (or equivalent)

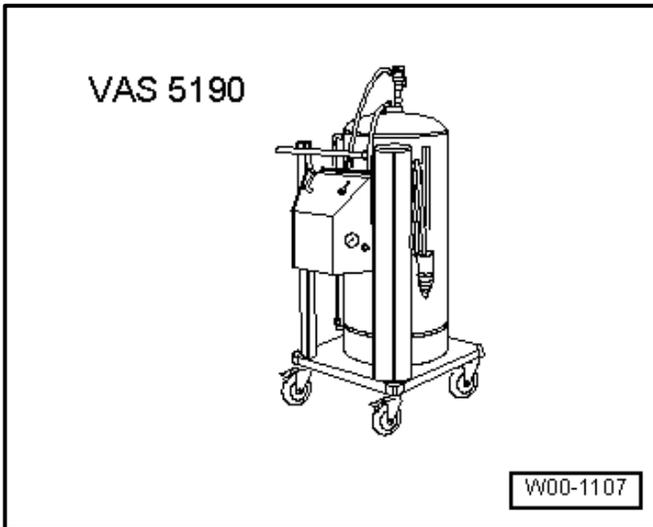
- Fuel Extractor VAS5190A -VAS5190- (or equivalent)

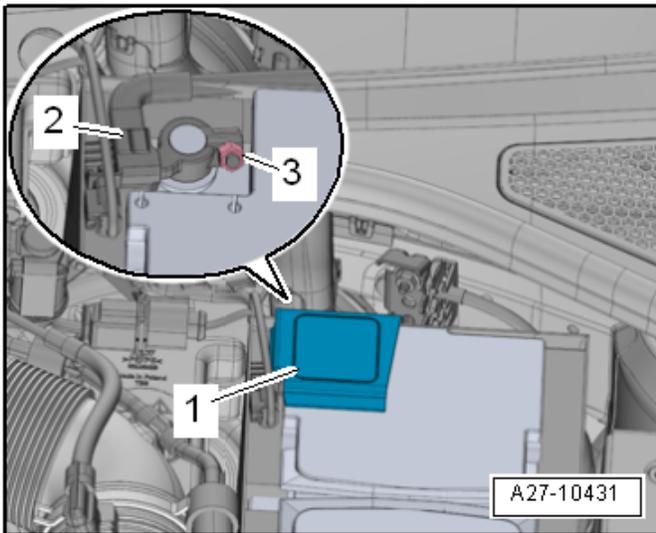
- Open the vehicle hood.
- Open the battery heat protection sleeve cover to access the cover <1> on the battery ground terminal <2>.
- Loosen the nut <3> several turns and remove the battery ground terminal <2> from the negative battery post and isolate the terminal.

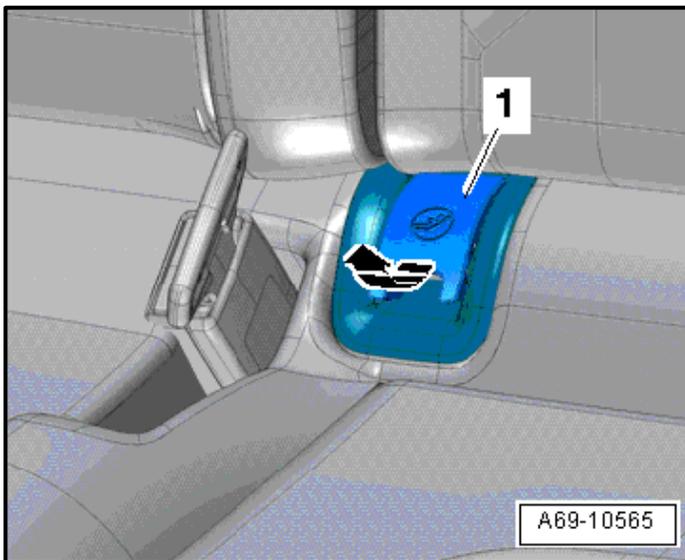
- Unclip and remove the covers <1> from the LATCH child seat anchors <arrow>.

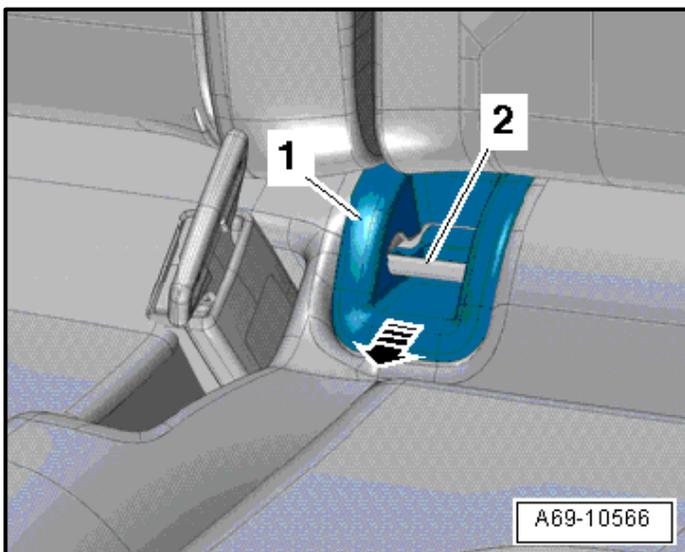
- Push the guides <1>, corresponding to cut-out, downward and disengage them from the LATCH child seat anchors <2>.

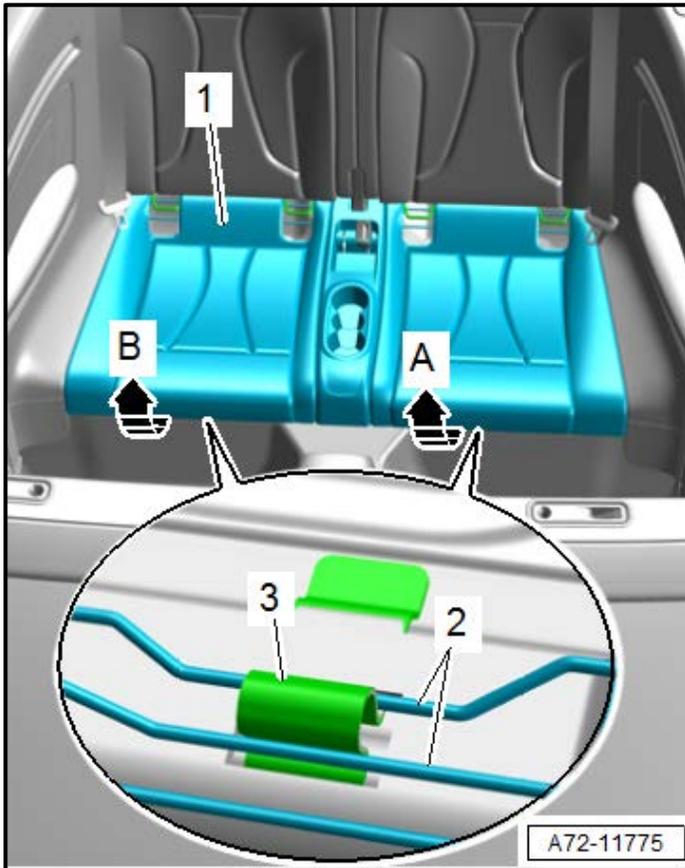
- With both hands, grasp the rear bench seat under the seat frame.
- Pull the rear bench seat <1> up forcefully with both hands <arrow A> so the so the seat frame <2> on the bench seat disengages from the mounting <3>.
- Repeat the procedure on the other side of the rear bench seat <arrow B>.
- Disengage the bench seat from the backrest frame and remove from the vehicle.

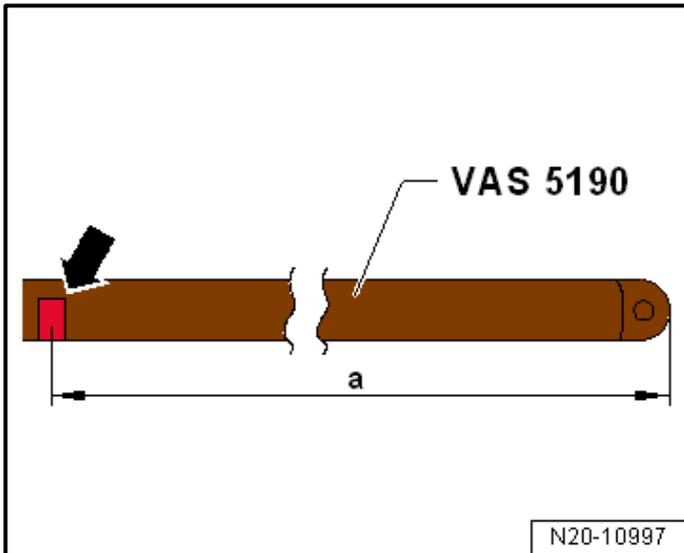
- Use insulating tape to mark the hose <arrow> at the distance <a> from the end of the suction hose on the -VAS5190-.

Application	Distance of <a>
A3/Sportback with Multi-link	960 mm
A3/Sportback with Torsion Beam	1010 mm
A3 Cabriolet	765mm

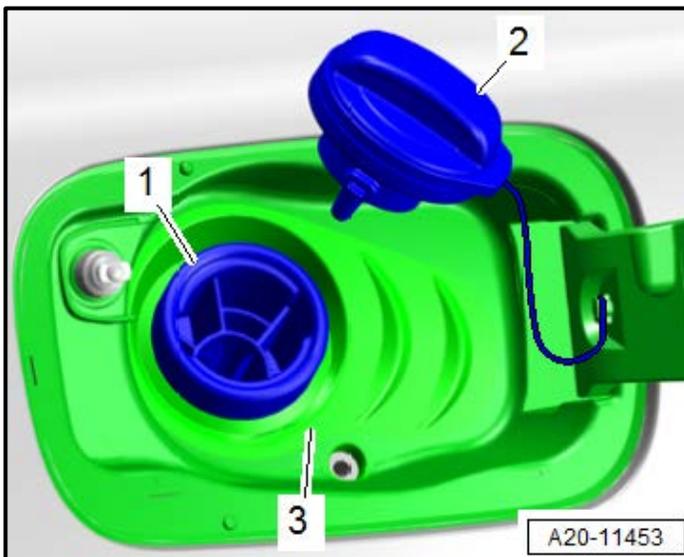
- Open the fuel filler door unit.
- Clean the area around the fuel filler neck <3>.
- Remove the cap <2> for the fuel filler neck <1>.
- Attach the ground wire from the -VAS5190A- to a bare area on the body.

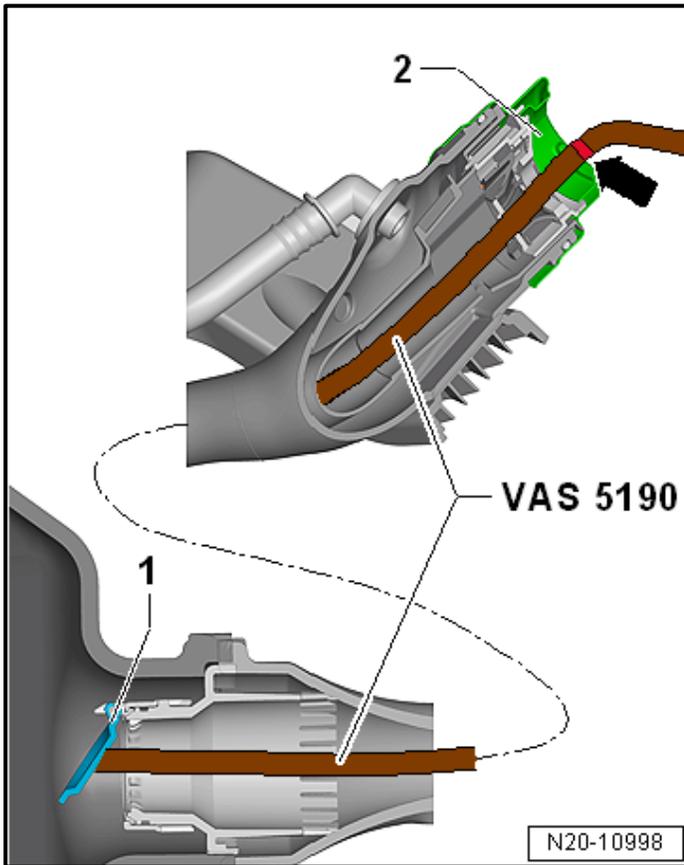
- Slide the suction hose from the -VAS5190A- into the fuel tank until the previously made mark -arrow- meets the filler neck <2>.
- Drain the fuel tank as much as possible through the filler neck.

- A valve <1> is located in the fuel tank on the lower end of the filler neck. It must not be damaged by the suction hose. Only slide the hose in as far as the mark that was made earlier <arrow>.
- When no more fuel can be extracted, the fuel tank has been emptied enough so that the sensor flange can be opened safely.

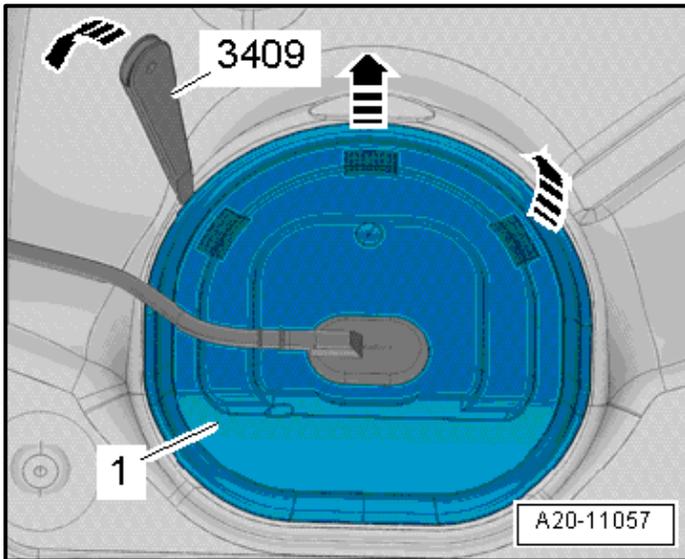
- In the rear seat, unclip the sealing flange cover <1> at the tabs <arrows> using the Trim Removal Wedge -3409- (or equivalent).

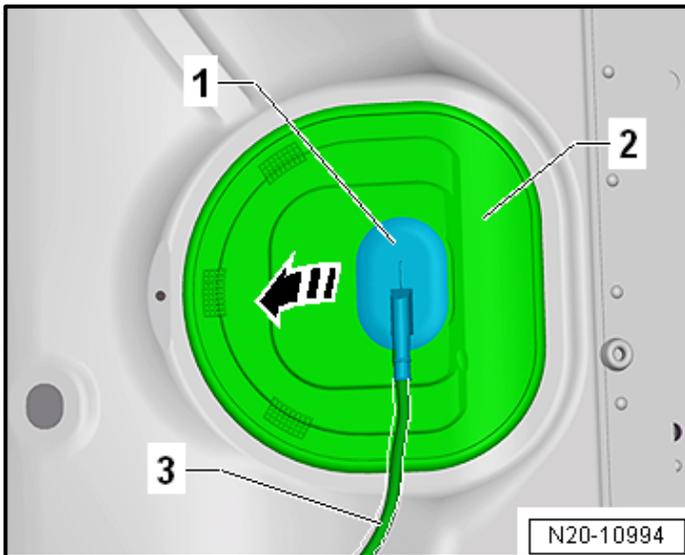
- Unclip the grommet <1> downward out of the cover <2>.

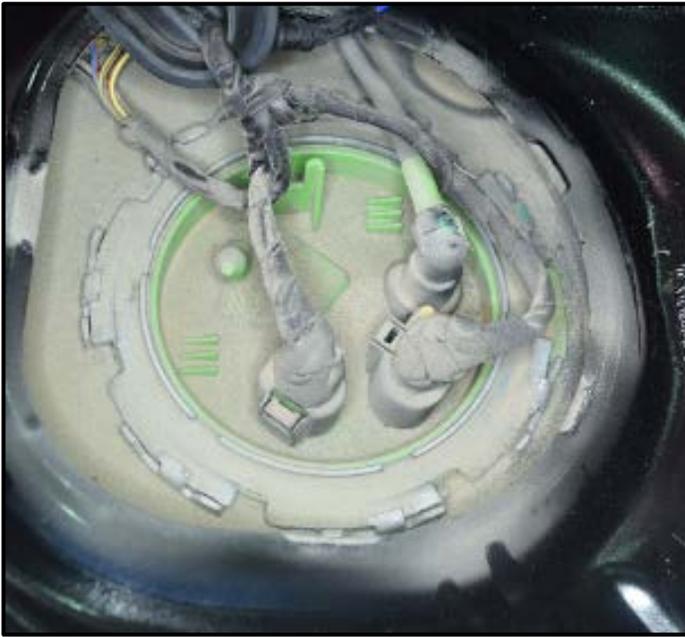
- Prior to disassembly, the fuel delivery unit **MUST** be clean. If excessive dirt or debris is present <as shown>, clean and dry the fuel delivery unit and surrounding areas as necessary.

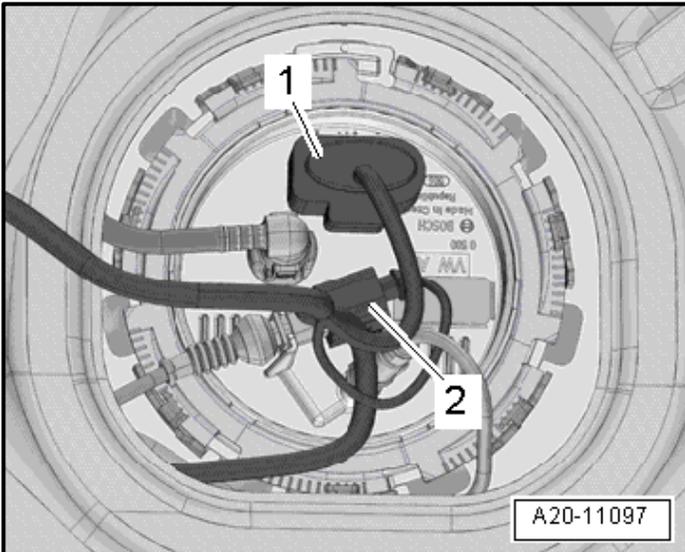
- Unlock and disconnect the connector <1> from the sealing flange.
- If equipped, disengage the connector <2> for the parking heater Metering Pump -V54- on the sealing flange and move it to the side.

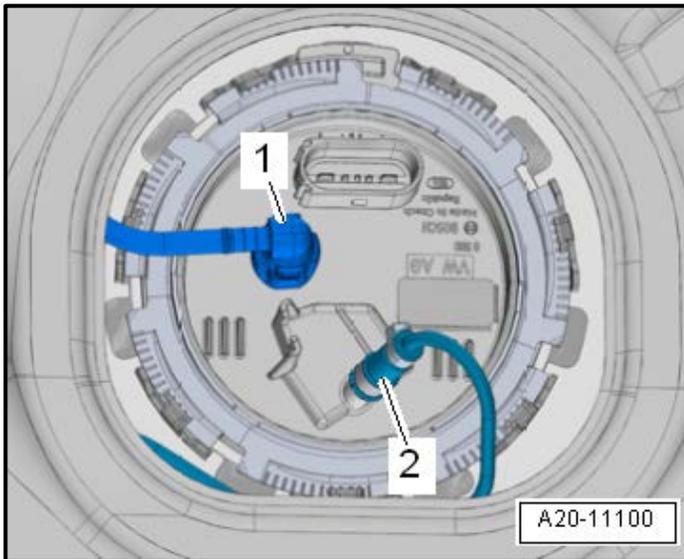
- Remove the fuel line connector <1> from the locking flange by pushing down on the connector, squeezing the release tab between the finger and thumb, then lifting up.
- If equipped, remove the fuel line <2> to the Metering Pump -V54- for the parking heater on the sealing flange by loosening the lower hose clamp.

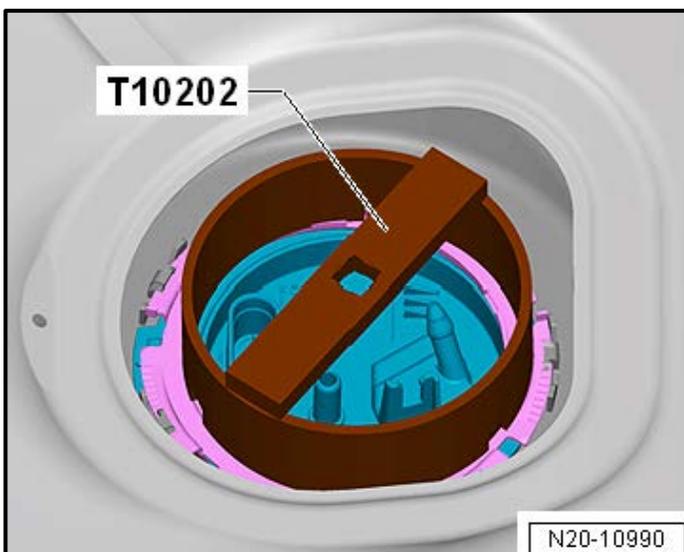
- Remove the locking ring using the Wrench - Fuel Sending Unit -T10202-.
- Carefully lift the fuel delivery unit flange.

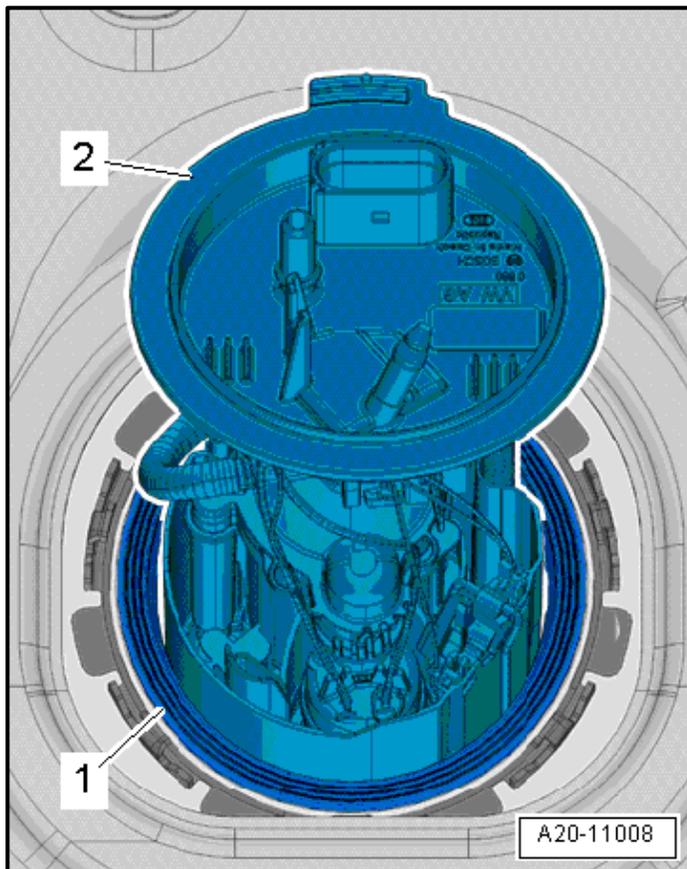
- Pull the sealing flange <2> out of the opening in the fuel tank slightly.
- Remove the seal <1> and slightly lift the fuel delivery unit flange again carefully.

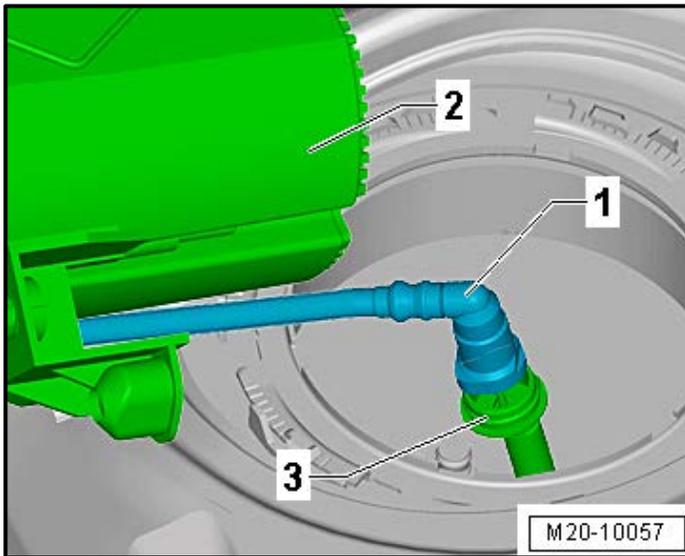
- Place a cloth underneath to catch the residual fuel, since the fuel delivery unit may still be partially filled.
- Carefully pull the fuel delivery unit <2> out of the fuel tank, release the fuel line <1> and disconnect it from the front suction line <3>.
- Lay a cloth inside the vehicle to absorb any residual fuel.

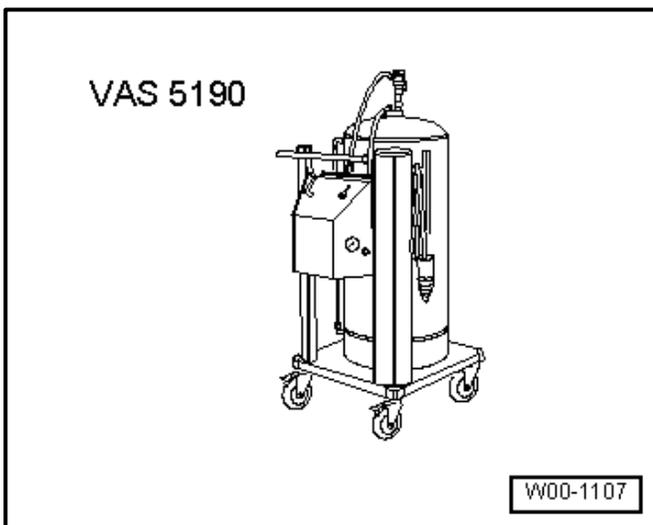
- After the fuel delivery unit is removed from the fuel tank opening and the suction pump line is disconnected, insert the suction hose from the -VAS 5190- Fuel Extraction Unit to remove as much additional fuel as necessary to perform the remaining operations safely and comfortably.
- Add any additional fuel removed from the fuel delivery unit and/or the bottom of the tank to the fuel volume previously recorded on the repair order.

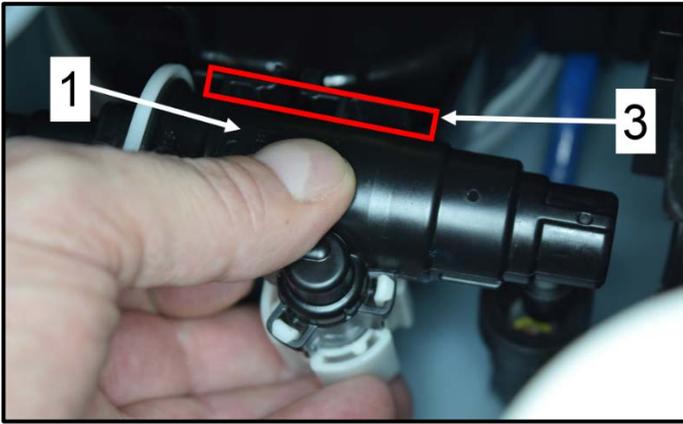
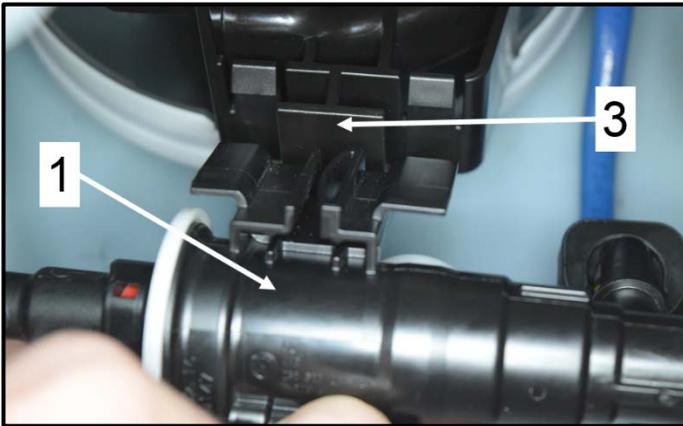
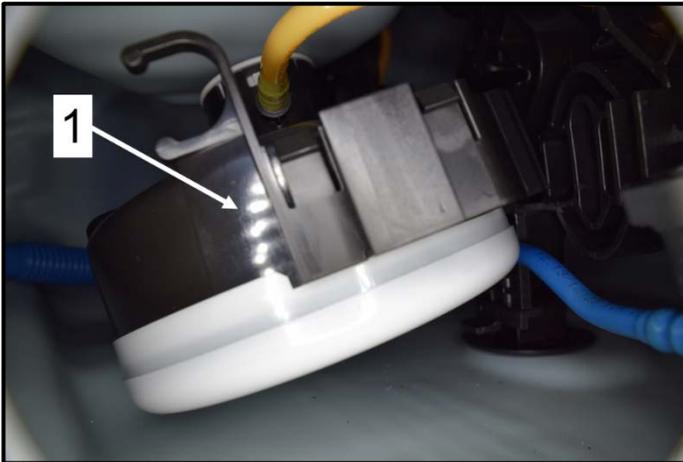
- Remove the suction pump <1> off the retainer bracket <3>:
 - Slightly rotate suction pump <1> away from the bracket <3>
 - Remove the pump <1> from the fuel tank by gently rocking it back and forth between the fingers and thumb.
 - Use caution not to damage the attached front suction line.

- Take care that the Liquid-Vapor Separator Assembly <1> does not come off of its attachment bracket when removing the Suction Jet Pump.

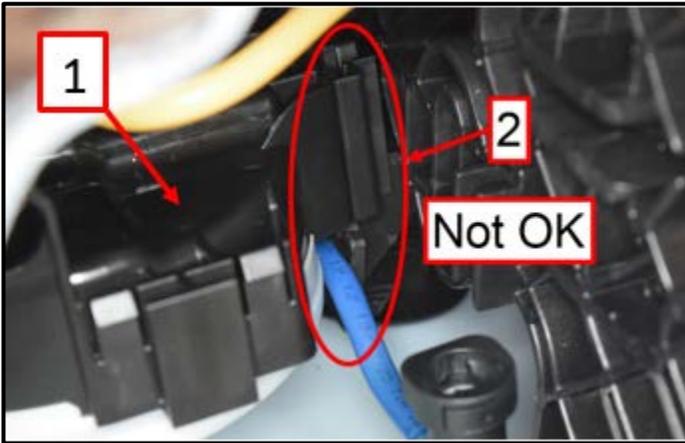
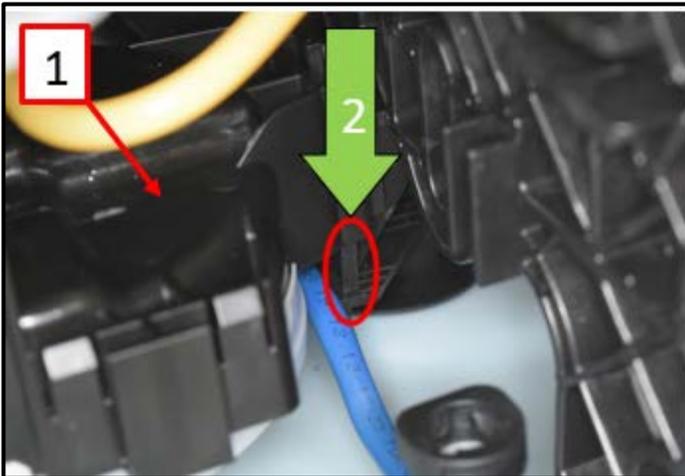
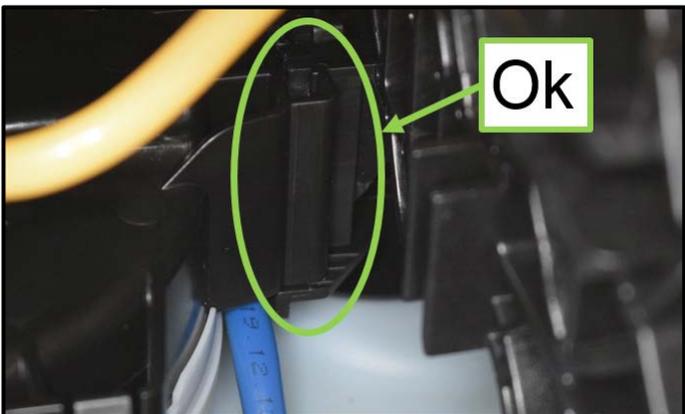
- If the Liquid-Vapor Separator <1> comes loose and is not reinstalled onto the mounting bracket, a customer comeback for rattling in the fuel tank, or EVAP system faults may occur.
- The Liquid-Vapor Separator <1> can be reinstalled onto its mounting bracket <2>.
- Replacement of the fuel tank for the Liquid-Vapor Separator dislodging from the mounting bracket is not covered under this campaign.

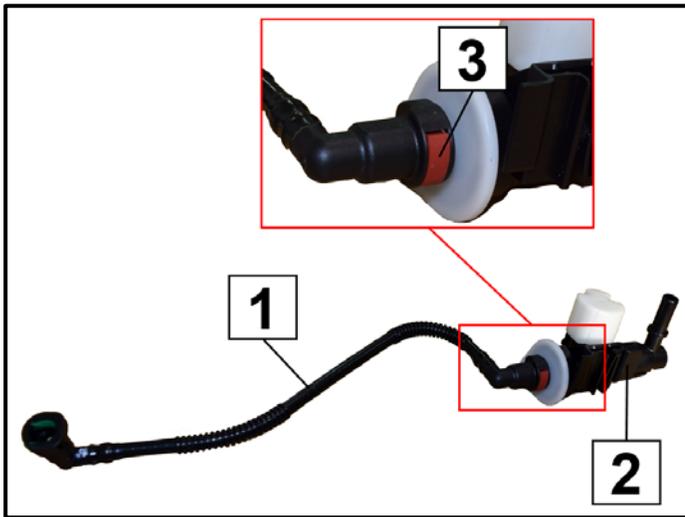
- Disconnect the front suction line <1> from the suction pump:
 - Push the front suction line <1> further onto the suction pump <2>.
 - Press the release <3> with the thumb, then pull the front suction line <3> off of the suction pump <2>.
- Transfer the front suction line <1> from the old suction pump <2> to the new suction pump, ensuring that the locking of the retention clip <3> is felt and/or heard.

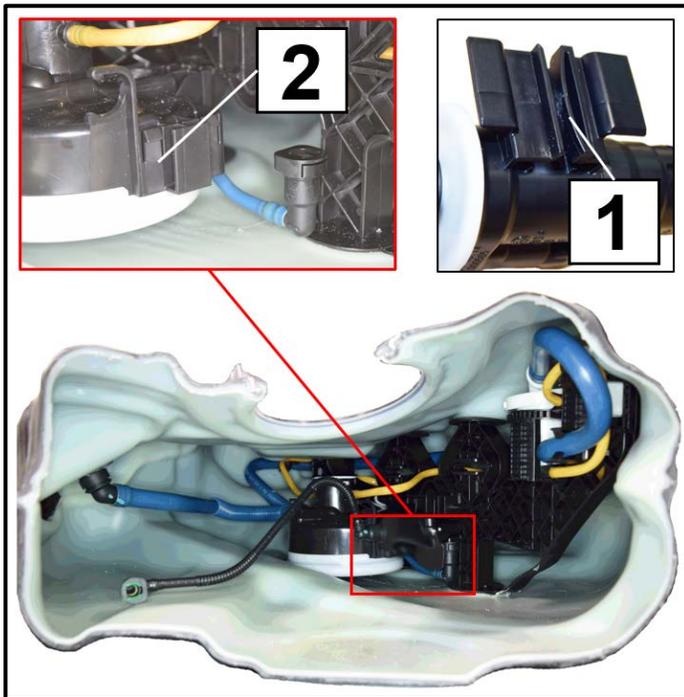
- Insert the new suction pump <1> into the fuel tank.
- Align the retention clip on the new suction pump <1> to the bracket <2> on the liquid-vapor separator.
- Slide the new suction pump <1> downward onto the bracket <2>.
- Ensure that the pump is secured firmly on the bracket <2>.

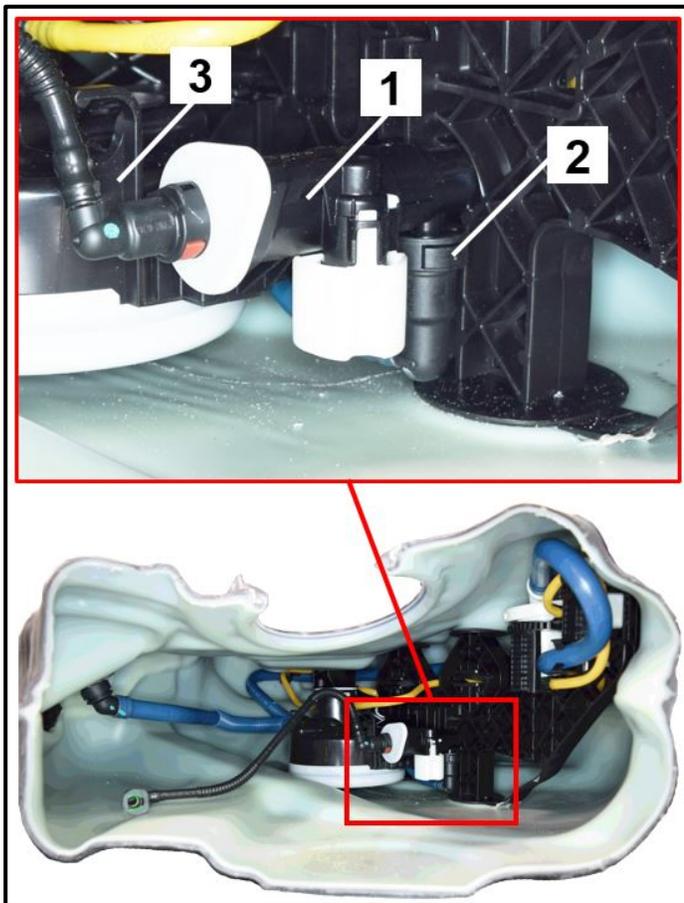
- Reconnect the rear suction line <2> to the suction pump <1>, ensuring that the locking of the retention clip is felt and/or heard.
- Ensure that the front suction line <3> and rear suction line <2> are firmly seated and secure by gently pulling the lines away from the suction pump.

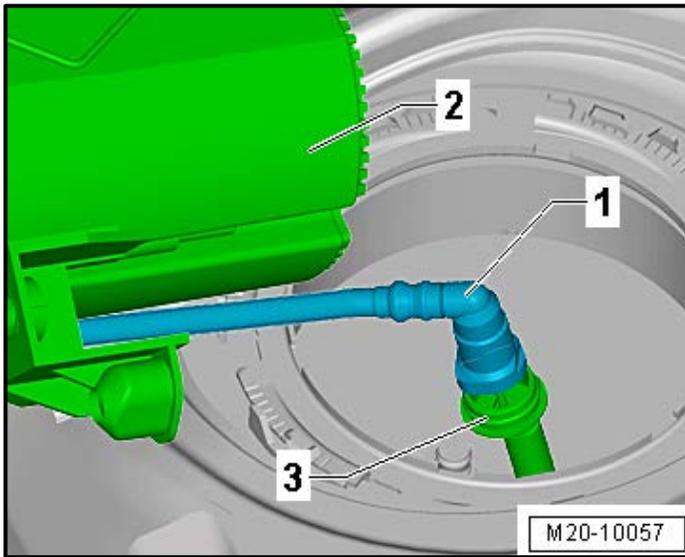
- Carefully align the fuel delivery unit <2> to the fuel tank and reconnect the fuel line <1> to the front suction line <3>.

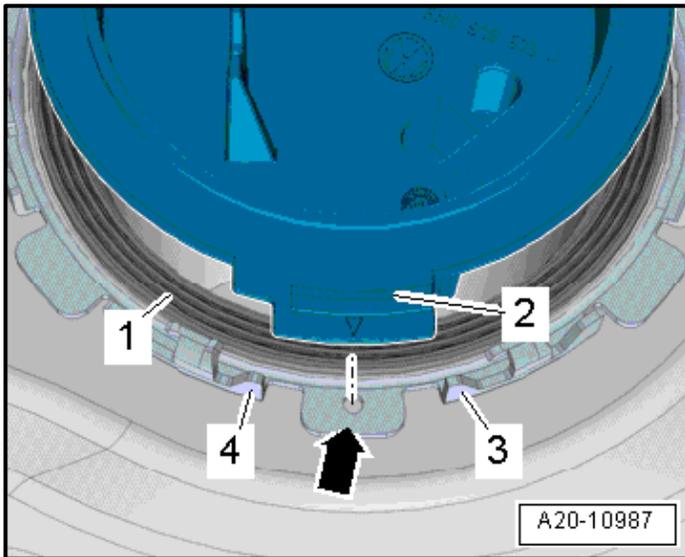
When inserting the sealing flange, the seal must not be damaged or crushed.

- Push the sealing flange <2> down against the spring force.
- Bring the sealing flange into its installation position.

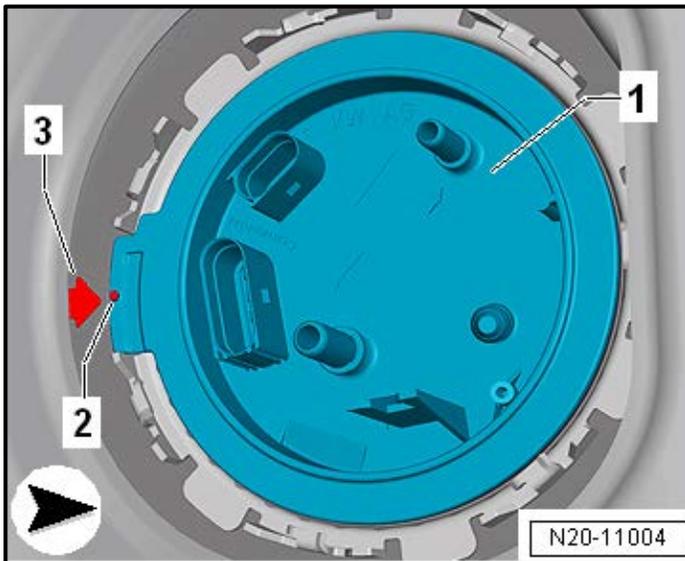
- The arrow <3> on the fuel tank must point to the mark <2> on the sealing flange <1>.

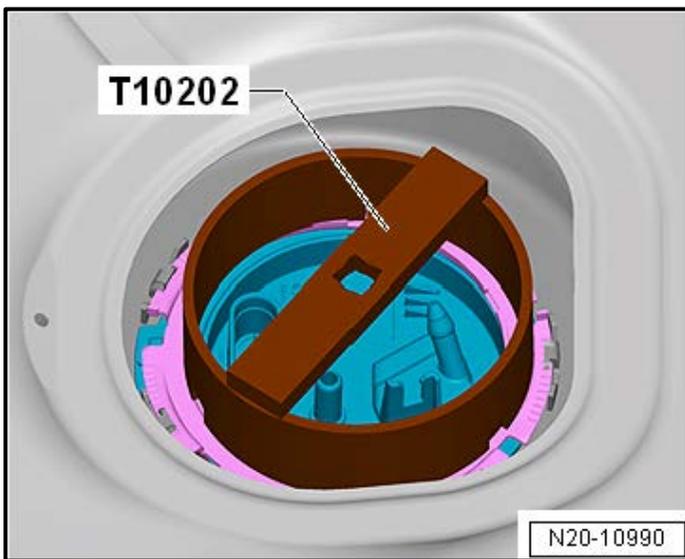
- Using the -T10202-, tighten the locking ring to 110 Nm.

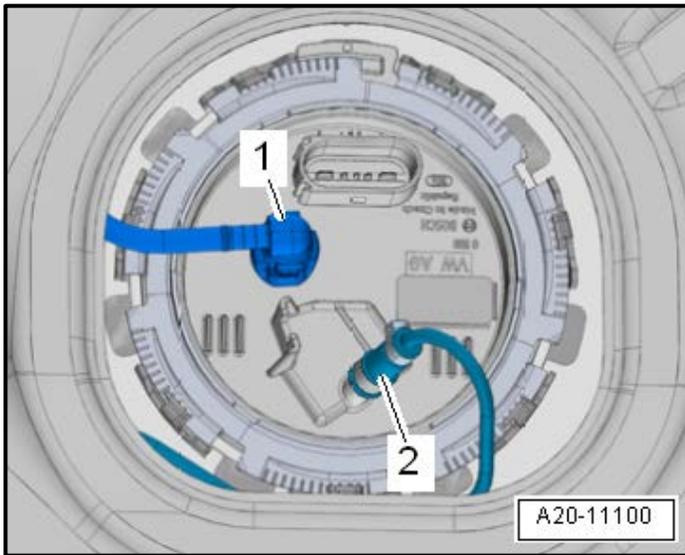
- Attach the fuel line <1> to the sealing flange until it clicks into place.
- If equipped, install the fuel line <2> to the Metering Pump -V54- for the parking heater on the sealing flange.

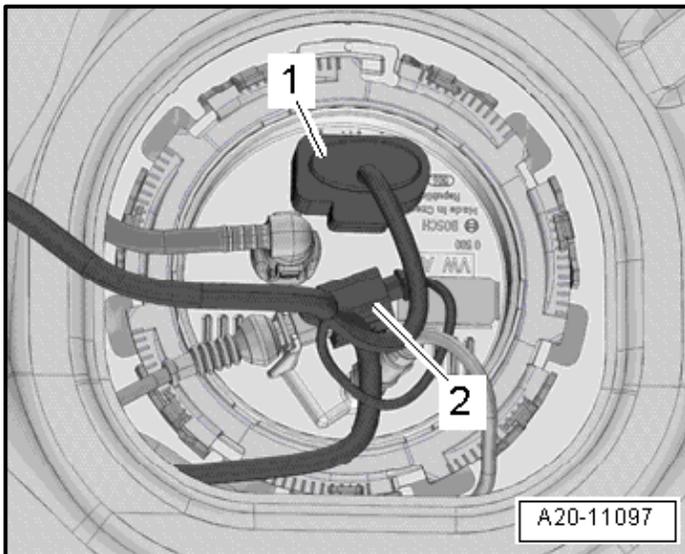
- Connect the connector <1>.
- If equipped, engage the connector <2> for the parking heater Metering Pump -V54- on the sealing flange.
- Gently pull on the connectors to make sure they are secure.

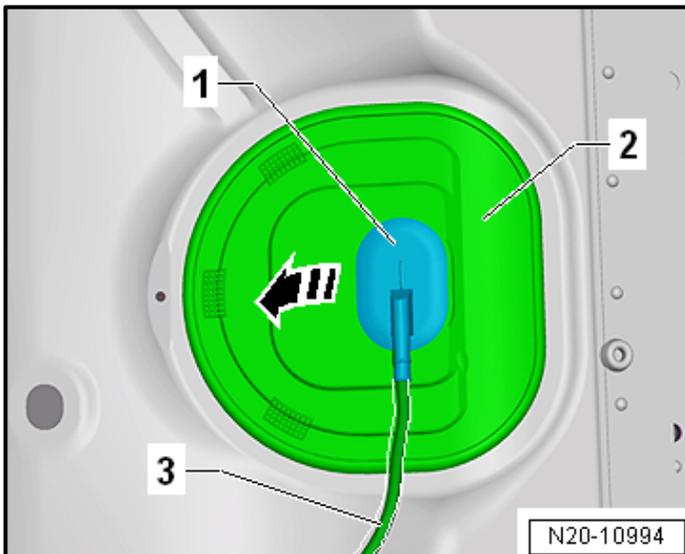
- Reattach the grommet <1> into the cover <2>.

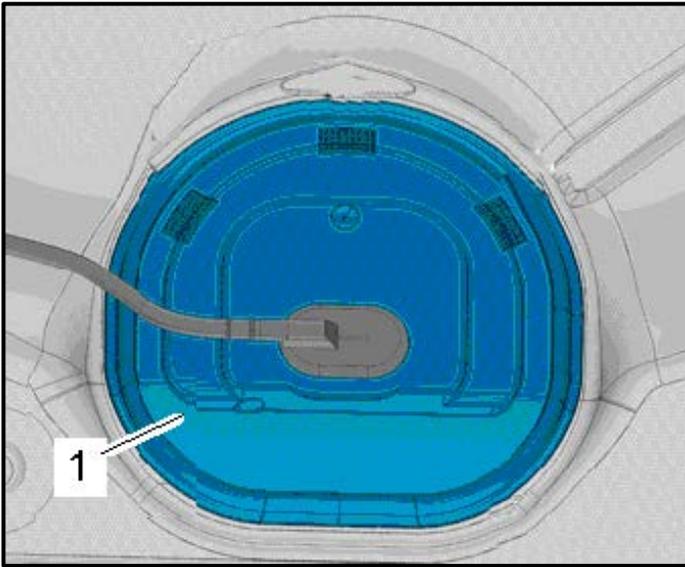
- Reattach the sealing flange cover <1>.

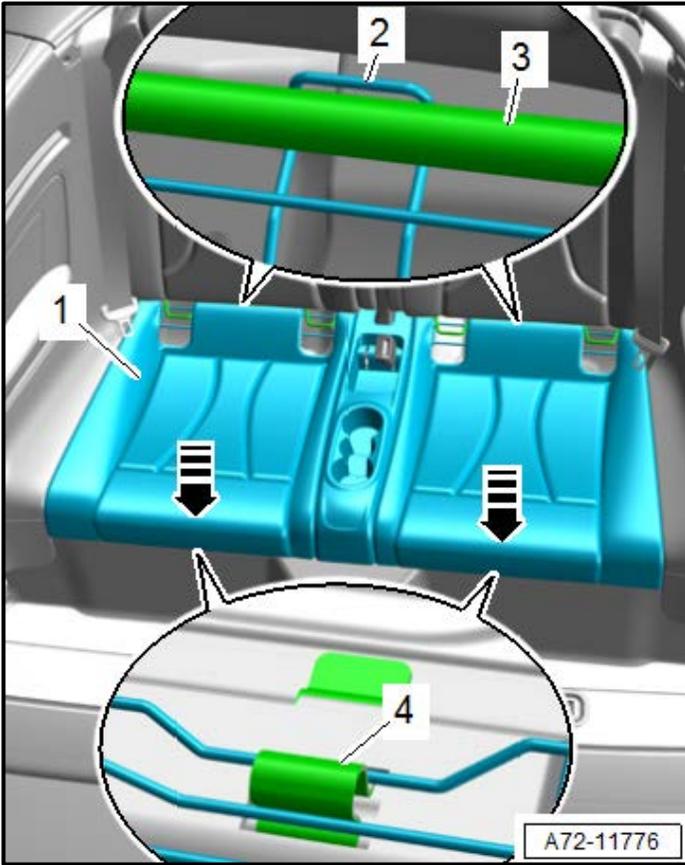
- Install the bench seat <1> and engage the seat frame <2> on the backrest frame <3>.
- Push the rear bench seat down until it engages audibly <arrows> in the mount <4>.

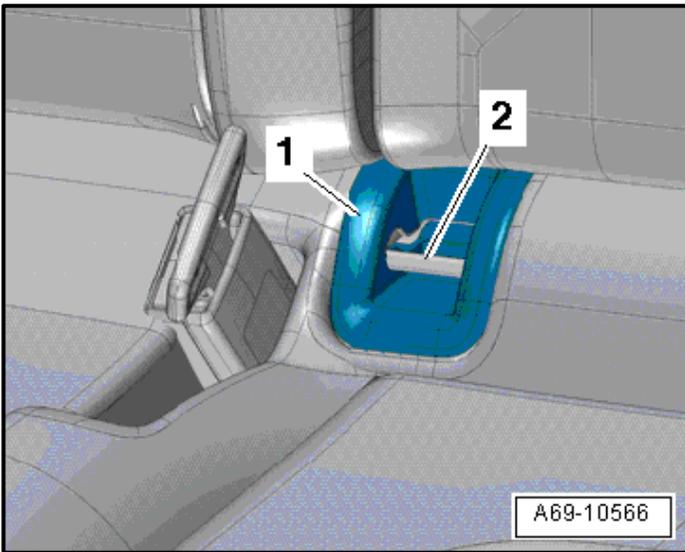
- Reinstall the guides <1> to the LATCH child seat anchors <2>.

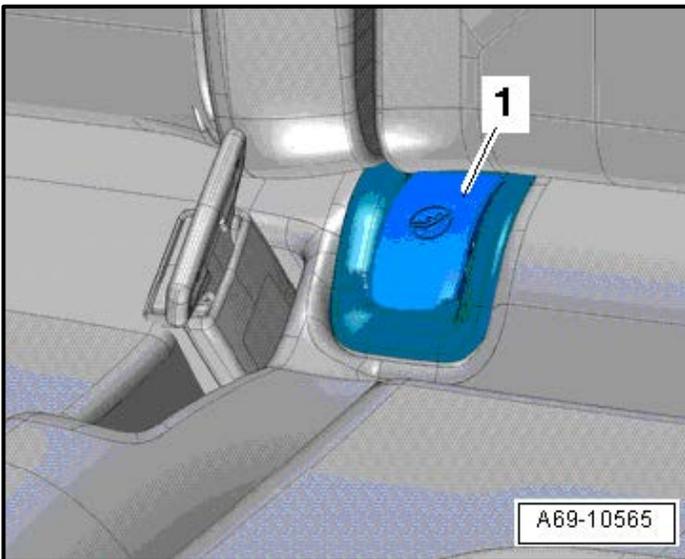
- Reinstall the covers <1> to the LATCH child seat anchors <arrow>.

⚠ CAUTION
Edges on the child seat anchor cover may be sharp.

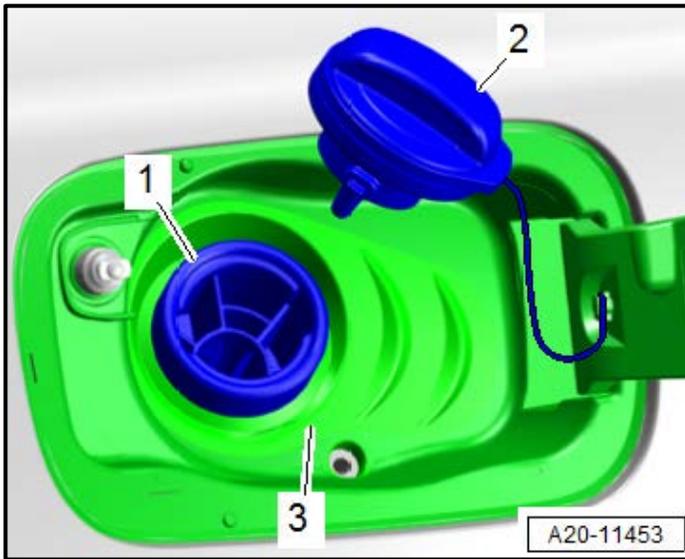
- Open the fuel door and remove the fuel cap <2>.
- Refill the fuel tank with the same amount of fuel removed prior with the -VAS 5190- Fuel Extraction Unit.
- Verify using the sightglass on the side of the -VAS 5190- Fuel Extraction Unit that the fuel tank was filled with the same amount of fuel that was extracted before reconnecting the battery.

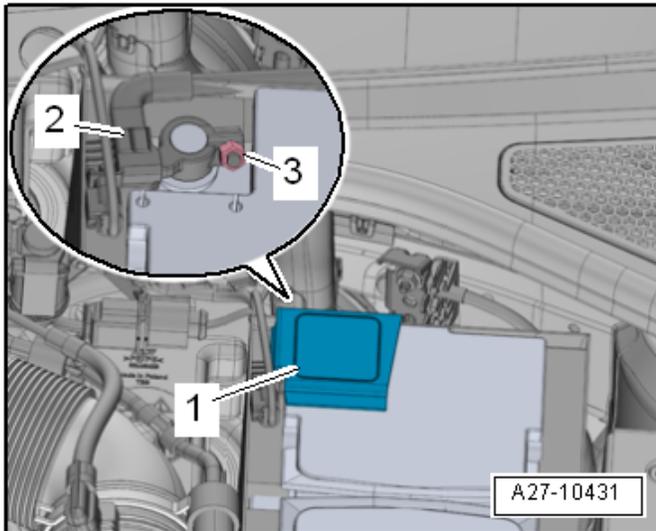
- Reconnect the negative battery terminal <2> to the negative battery post and tighten the nut <3> to 6 Nm.
