Dealer Service Instructions for:

Safety Recall S61 / NHTSA 16V-668 Occupant Restraint Controller

2010	(JS) Chrysler Sebring
2011-2014	(JS) Chrysler 200
2010-2014	(JS) Dodge Avenger
2010-2012	(PM) Dodge Caliber
2010-2014	(MK49) Jeep® Compass
2010-2014	(MK74) Jeep® Patriot

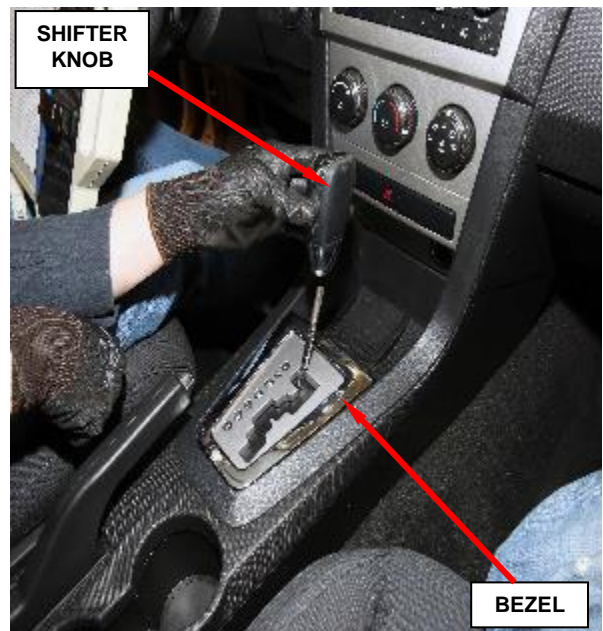
Figure 1 – Shifter Knob and Bezel

2. Remove the center console.
 - a. Pull up on shifter knob and remove (Figure 1).
 - b. Using trim stick C-4755 or equivalent, pry up on bezel and remove from shifter pod (Figure 1).
 - c. Using trim stick C-4755, remove center console bezel and storage bin (Figure 2).

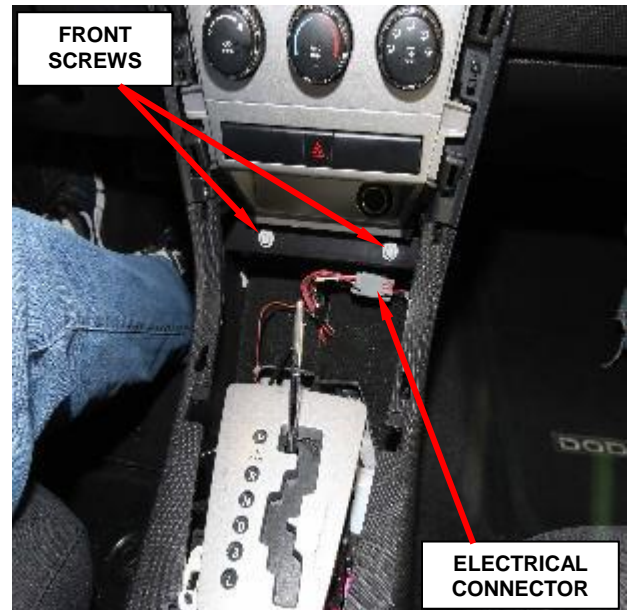
Figure 3 – Center Console Front Screws (Avenger Shown, Sebring Similar)

- d. Remove and save the two screws in the front of the console (Figure 3).
- e. Remove and save the four screws inside the console compartment (Figure 4).
- f. Disconnect the center console electrical connector (Figure 3).
- g. Pull the parking brake lever rearward.
- h. Remove the center console from the vehicle.

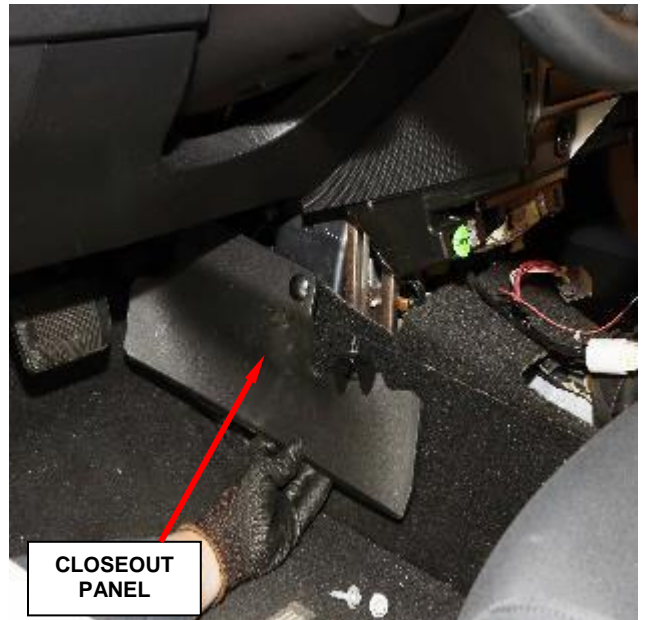
Figure 5 – Closeout Panel

3. Remove the left-side instrument panel closeout panel (Figure 4).

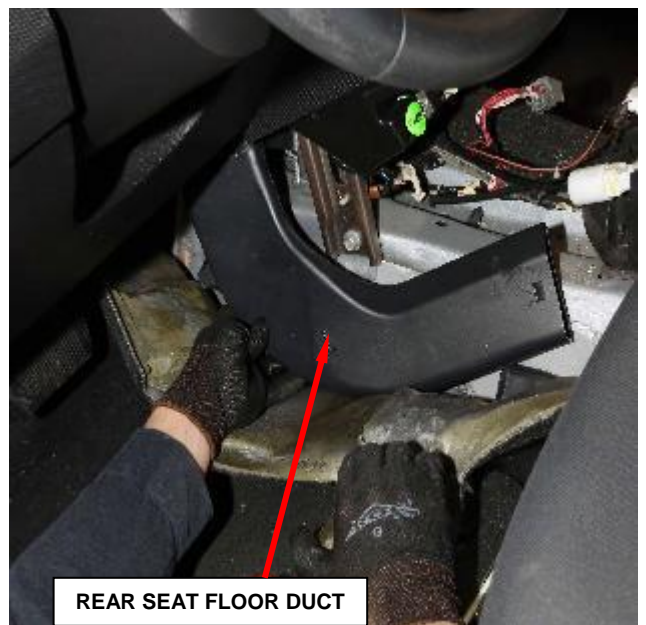
**Figure 6 – Rear Seat Floor Duct
(Left-Side Shown, Right-Side Similar)**

4. Remove the left-side rear seat floor duct (Figure 6).

5. Remove the right-side hush panel (Figure 7).
6. Remove the right-side rear seat floor duct (Figure 6).
7. Remove the three Occupant Restraint Controller (ORC) mounting nuts (Figure 8).

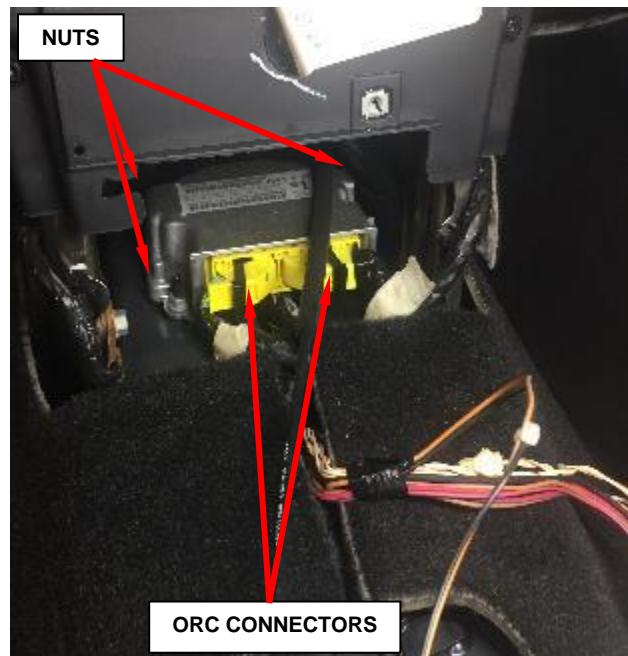
**Figure 8 – ORC Connectors
(Sebring Shown, Avenger Similar)**

8. Disconnect the two ORC connectors (Figure 8).
9. Remove ORC from vehicle.

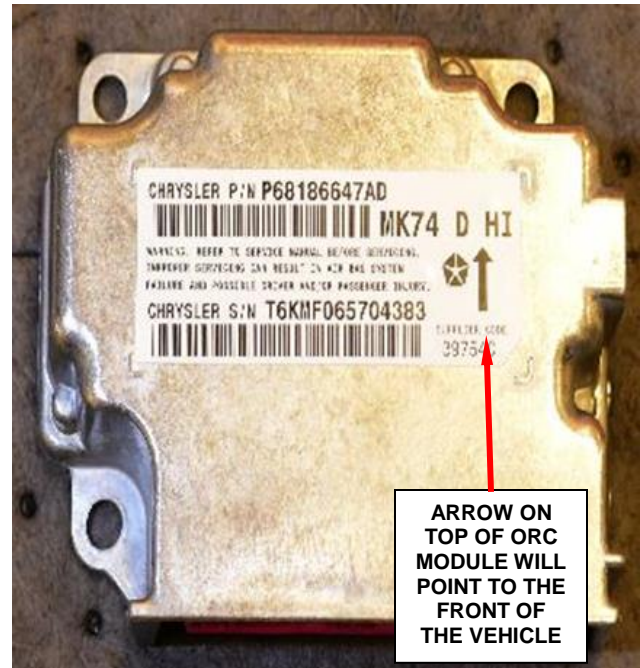
**Figure 9 – Arrow Orientation**

10. Connect the two ORC connectors to the **NEW** ORC and ensure that the connectors are engaged.
11. Position the **NEW** ORC (arrow pointing forward) on the console floor bracket and mounting studs (Figure 9).
12. Install the three ORC retaining nuts and tighten to 80 in. lbs. (9 N·m).
13. Install the right-side rear seat floor duct.
14. Install the right-side hush panel.

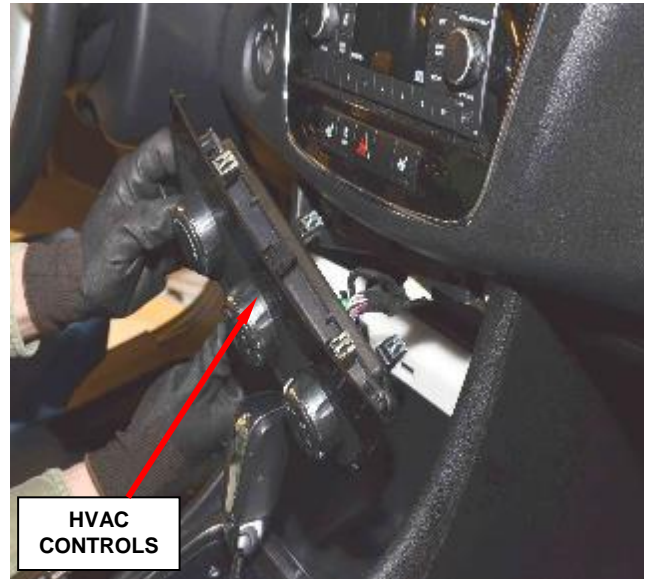
Figure 10 – HVAC Controls

NOTE: Chrysler 200 shown, Dodge Avenger similar

2. Remove the center console.
 - a. Using trim stick C-4755 or equivalent, remove and disconnect the HVAC controls (Figure 10).
 - b. Using trim stick C-4755 or equivalent, remove the shifter trim bezel.
 - c. Using trim stick C-4755 or equivalent, remove the console front storage bin and disconnect the USB connector from the bin if equipped (Figure 11).

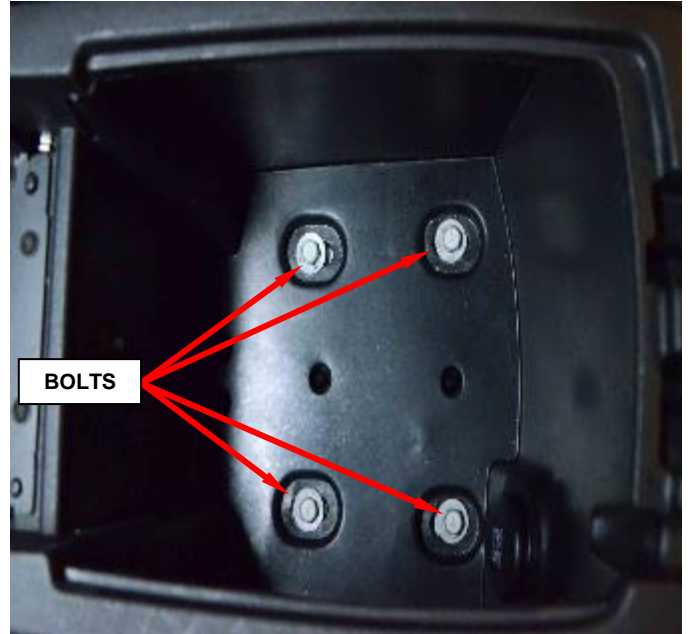
Figure 12 – Console Bin Bolts

e. Remove the four bolts located inside the console bin (Figure 12).

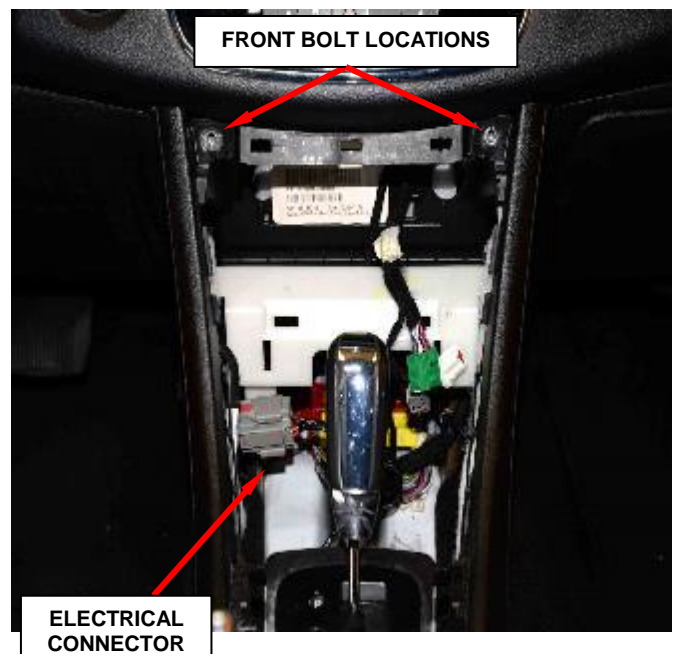
Figure 13 - Front Console Bolts

f. Remove the two front console bolts (Figure 13).

h. Disconnect the electrical connector then lift up on the rear of the center console, and remove the center console (Figure 13).

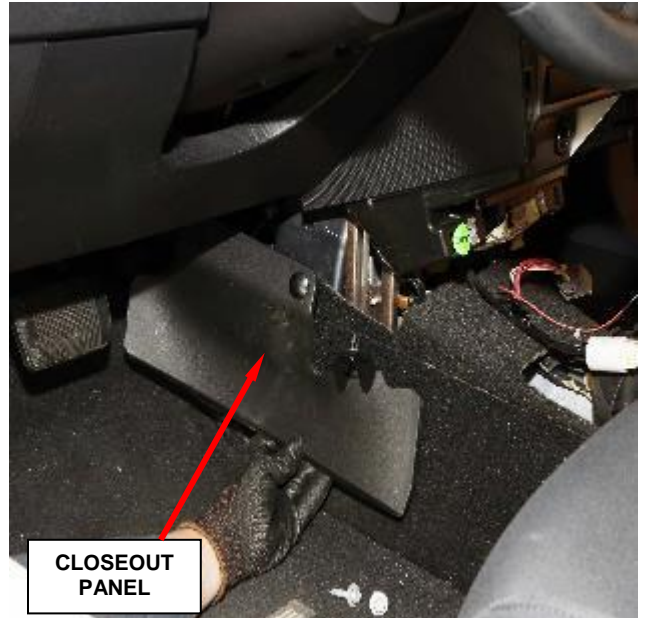
Figure 14 – Closeout Panel

3. Remove the left-side instrument panel closeout panel (Figure 14).

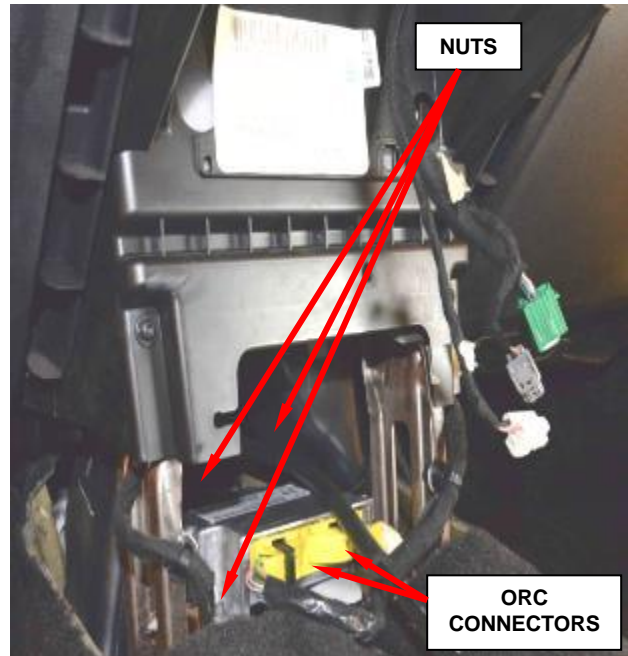
**Figure 17 – ORC Connectors
(Sebring Shown, Avenger Similar)**

5. Remove the right-side hush panel (Figure 16).
6. Remove the right-side rear seat floor duct (Figure 15).
7. Remove the three Occupant Restraint Controller (ORC) mounting nuts (Figure 17).
8. Disconnect the two ORC connectors (Figure 17).
9. Remove ORC from vehicle.

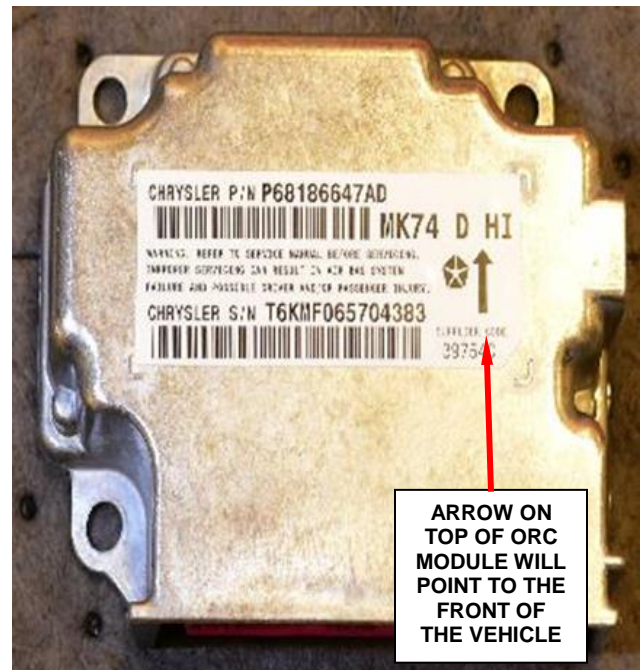
**Figure 18 – Arrow Orientation**

10. Connect the two ORC connectors to the **NEW** ORC and ensure that the connectors are engaged.
11. Position the **NEW** ORC (arrow pointing forward) on the console floor bracket and mounting studs (Figure 18).

12. Install the three ORC retaining nuts and tighten to 80 in. lbs. (9 N·m).
13. Install the right-side rear seat floor duct.
14. Install the right-side hush panel.

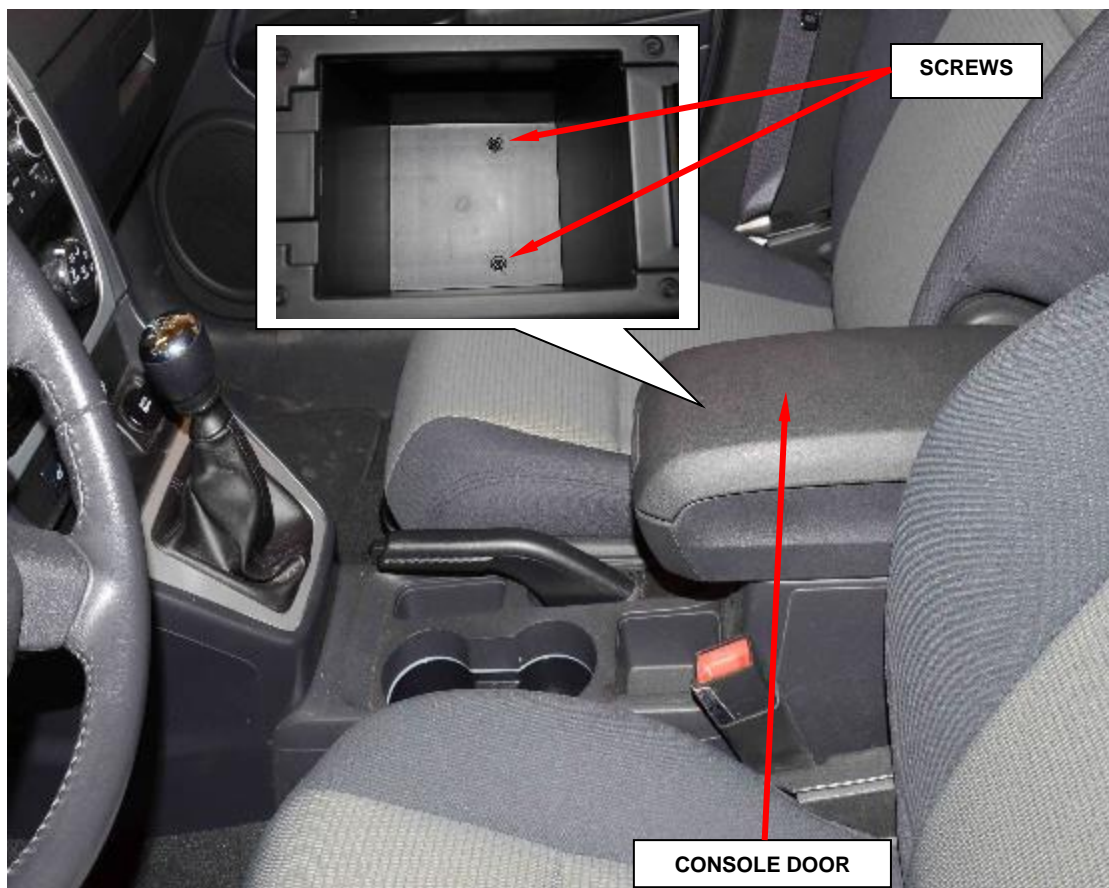
**Figure 19 – Center Console**

1. Disconnect and isolate the negative cable from the battery. Wait two minutes for the system capacitor to discharge before further service.
2. Pull back on parking brake lever to the upright position.
3. Open the console door and remove the two screws fastening the console to the rear floor bracket (Figure 19).
4. Carefully pry up on the rear of the center console until the retainers disengage from the center console to front floor bracket.
5. Disconnect center console wire connector to instrument panel connector.
6. Remove the console from vehicle.

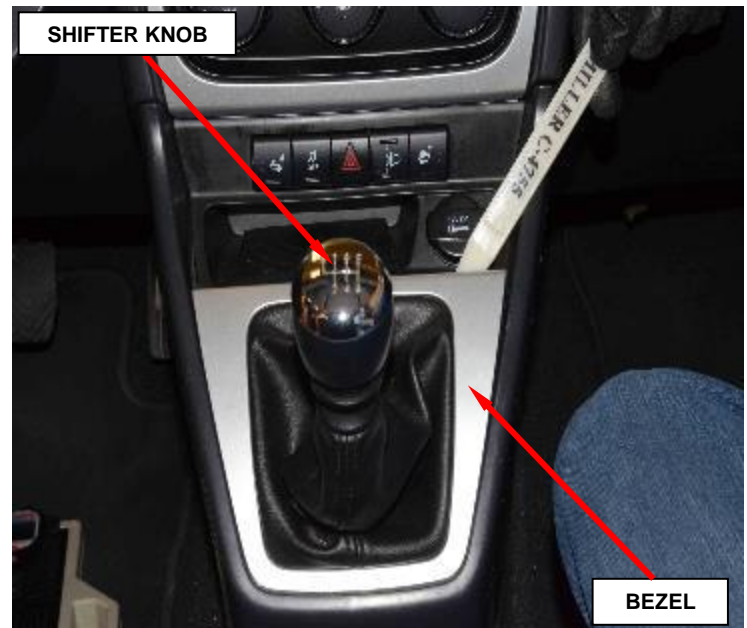
**Figure 20 – Shifter Knob and Bezel
(Manual Transmission Shown)**

- a. For automatic transmission vehicles, pull up on shifter knob and remove (Figure 20).

- b. If equipped with a manual transmission, using trim stick C-4755 or equivalent, pry up on the shifter boot bezel and position the bezel to the side.
 - c. If equipped with an automatic transmission, using trim stick C-4755 or equivalent, pry up on bezel and remove from shifter pod.

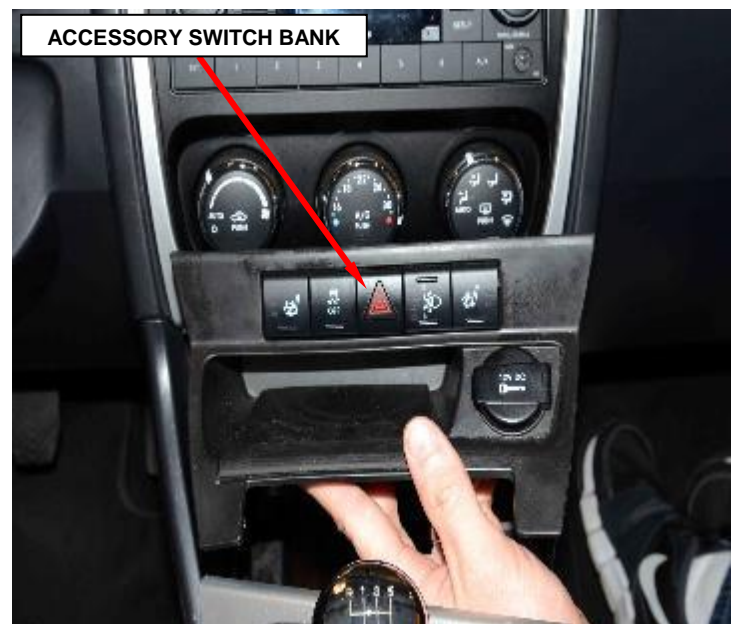
Figure 21 – Switch Bank

8. Using trim stick C-4755 or equivalent, release the retaining clips and separate the accessory switch bank assembly from the console (Figure 21).
9. Disconnect the electrical connectors.

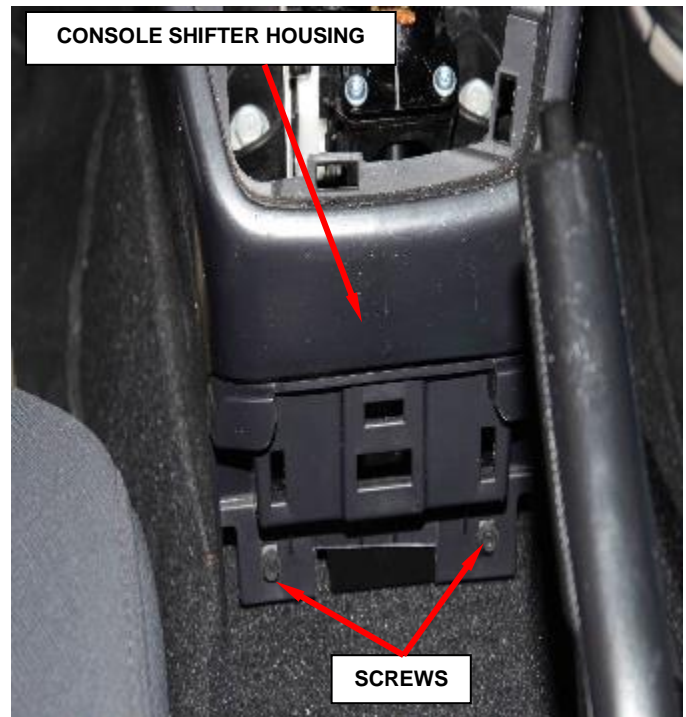
**Figure 22 – Shifter Housing**

10. Remove the two rear screws and remove the front console shifter housing (Figure 22).
11. If equipped, lift, but do not remove, the jute covered panel over the Occupant Restraint Controller (ORC) between the dash panel and the gearshift mechanism as necessary to access the ORC connections and fasteners.

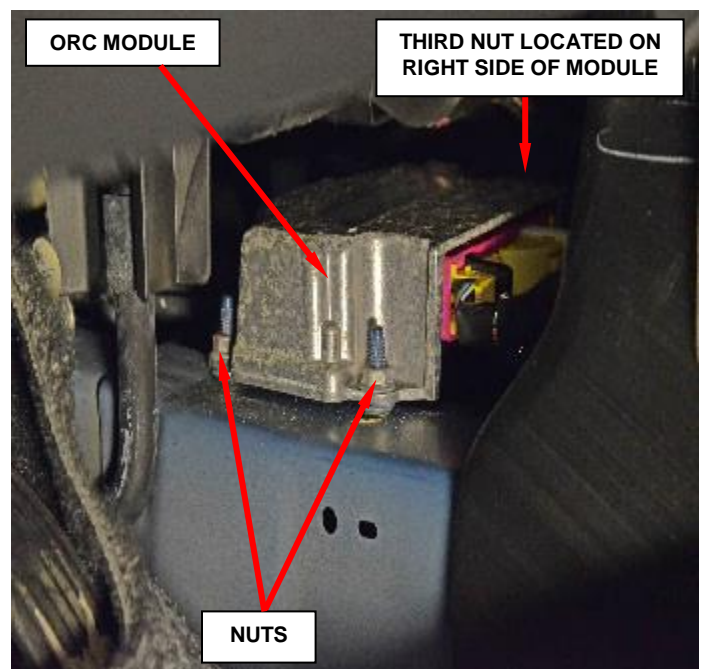
**Figure 23 – Mounting Nuts**

12. Remove the three nuts that secure the ORC to the three studs on the ORC mount welded onto the top of the floor panel transmission tunnel (Figure 23).

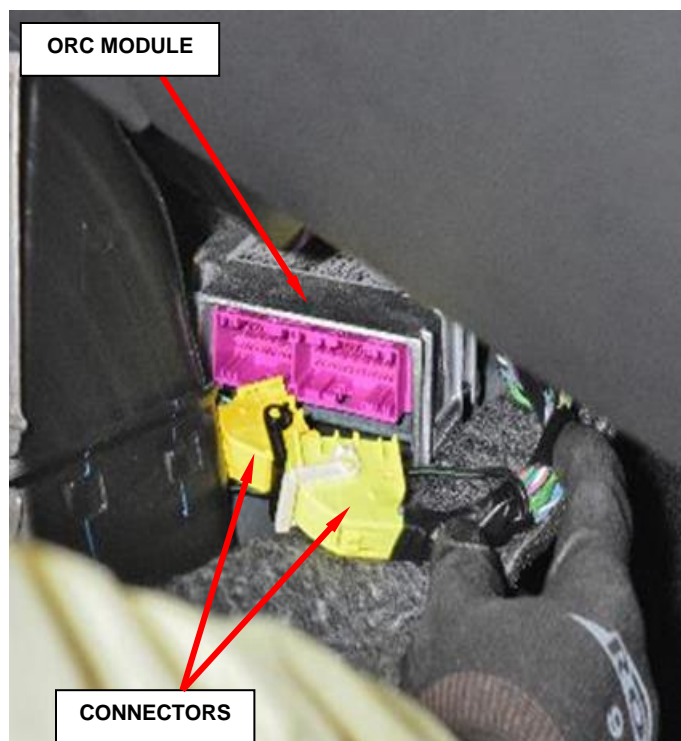
**Figure 24 – ORC Module Connectors**

13. Unlatch and disconnect the two instrument panel wire harness connectors from the ORC connector receptacles located on the rearward facing side of the module. To disconnect the wire harness connectors from the ORC, depress the release tab and lift the lever arm on each connector (Figure 24).
14. Remove the ORC from the ORC mount.
15. If equipped, lift, but do not remove, the jute covered panel over the ORC mount between the dash panel and the gearshift mechanism as necessary to install the **NEW** ORC, its connections and fasteners.

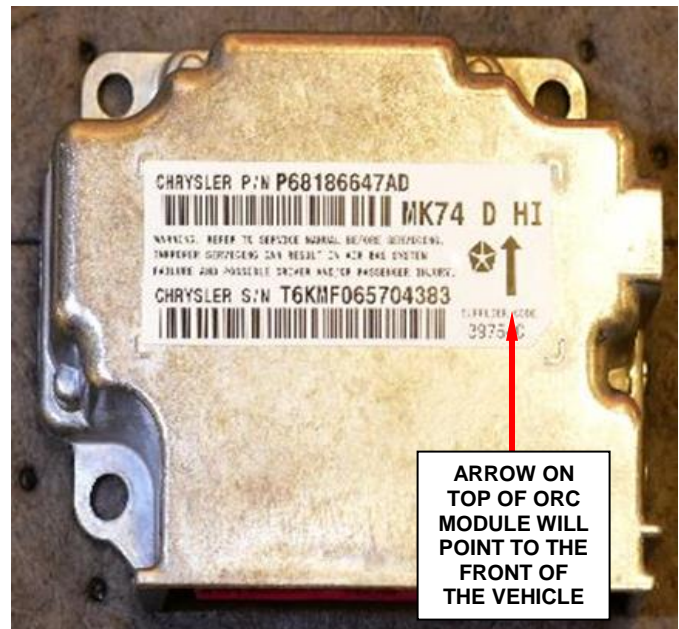
**Figure 25 – Arrow Orientation**

16. Carefully position the **NEW** Occupant Restraint Controller (ORC) onto the three studs of the ORC mount on the floor panel transmission tunnel. When the ORC is correctly positioned, the bottom of the housing will fit flush with the mount and the orientation arrow on the label on top of the housing will be pointed forward in the vehicle (Figure 25 on next page).

18. Install and tighten the three nuts that secure the ORC to the studs of the ORC mount. Tighten the nuts to 80 in. lbs. (9 N·m).
19. If equipped, restore the jute covered panel to its proper position over the ORC between the dash panel and the gearshift mechanism.

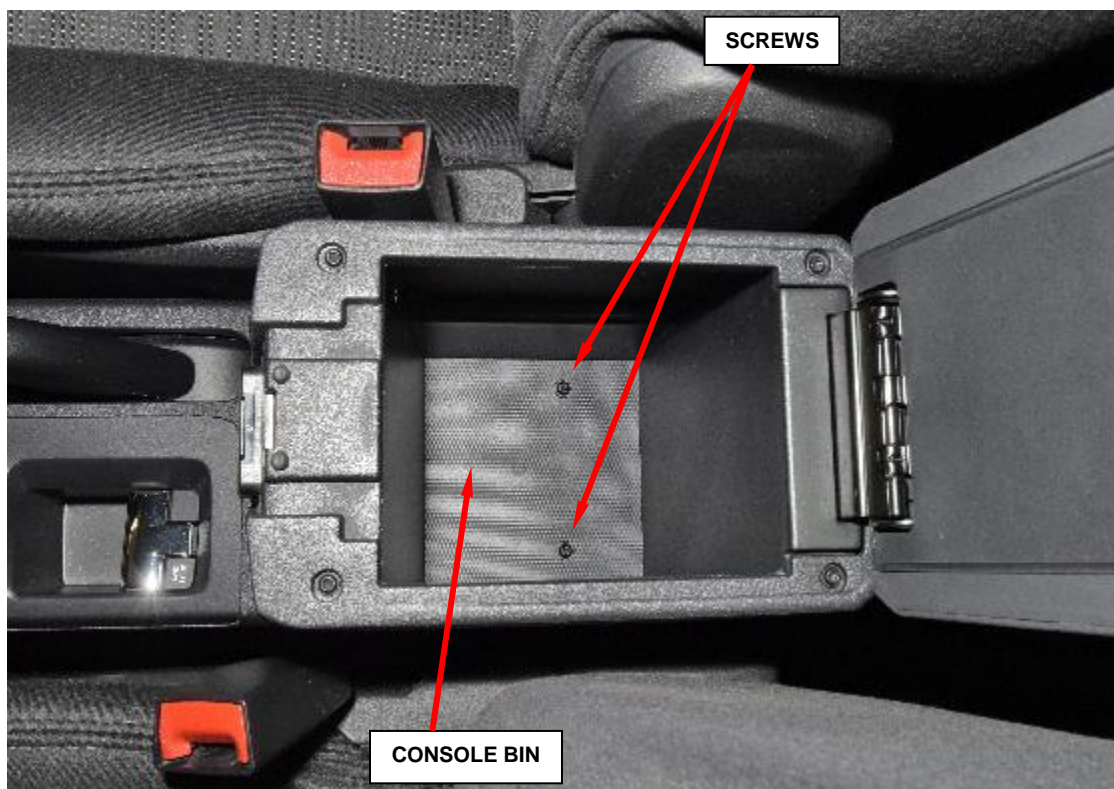
**Figure 26 - Center Console**

1. Disconnect and isolate the negative cable from the battery. Wait two minutes for the system capacitor to discharge before further service.
2. Pull back on parking brake lever to the upright position.
3. Remove the two screws from the console bin (Figure 26).
4. Lift the console up at the front from underneath right hand and left hand sides of console base at the same time and release the front clips.
5. Lift console from rear and release the rear clips.
6. Disconnect the electrical connector.
7. Remove the console from vehicle.

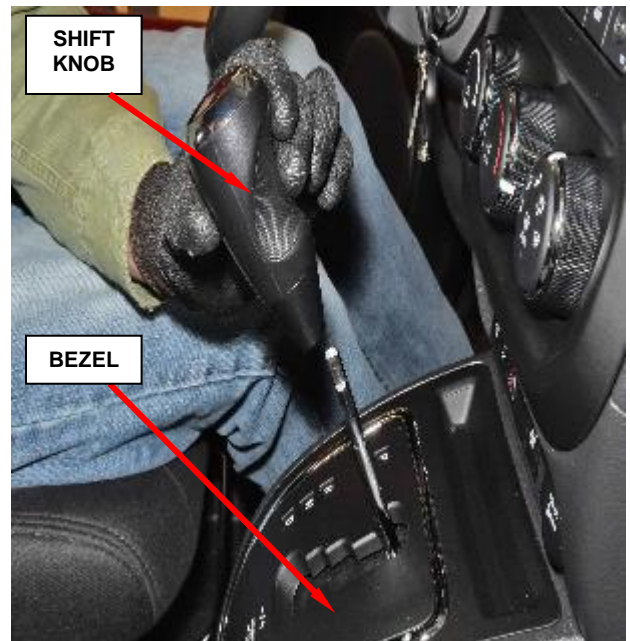
Figure 27 – Shifter Knob and Bezel

a. Pull up on the shifter knob and remove (Figure 27).

c. Using trim stick C-4755 or equivalent, pry up on bezel and remove from the shifter pod (Figure 27).

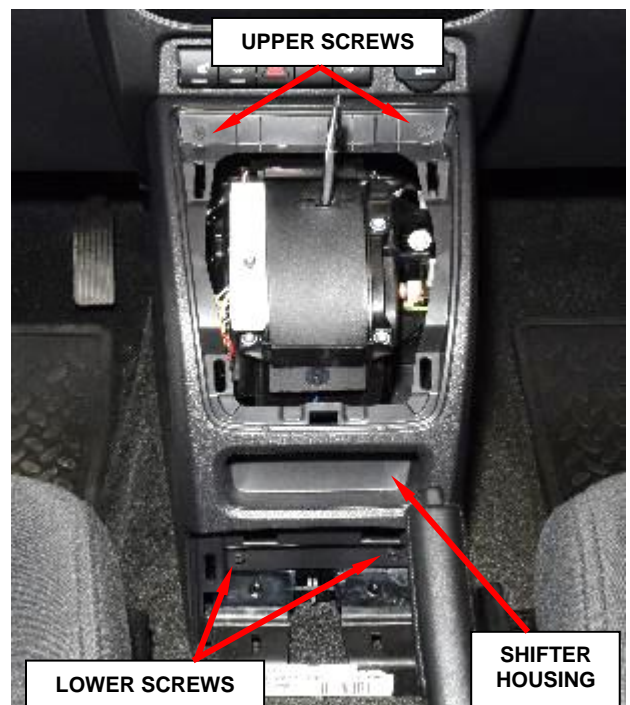
Figure 28 – Shifter Housing Screws

9. Remove the shifter housing lower screws (Figure 28).

10. Remove the shifter housing upper screws and remove the shifter housing (Figure 28).

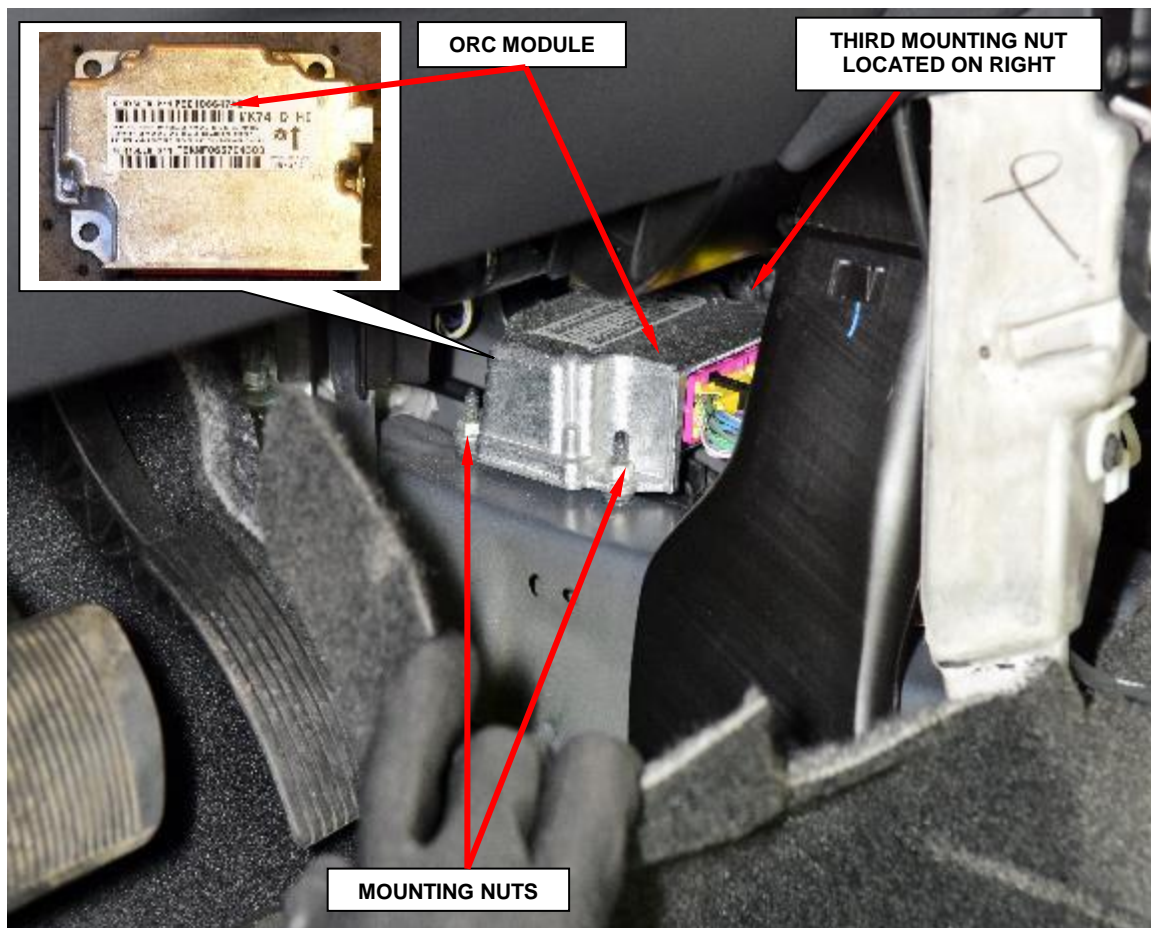
**Figure 29 – Mounting Nuts**

11. If equipped, lift but do not remove, the jute covered panel over the Occupant Restraint Controller (ORC) between the dash panel and the gearshift mechanism as necessary to access the ORC connections and fasteners.
12. Remove the three nuts that secure the ORC to the three studs on the ORC mount welded onto the top of the floor panel transmission tunnel (Figure 29).

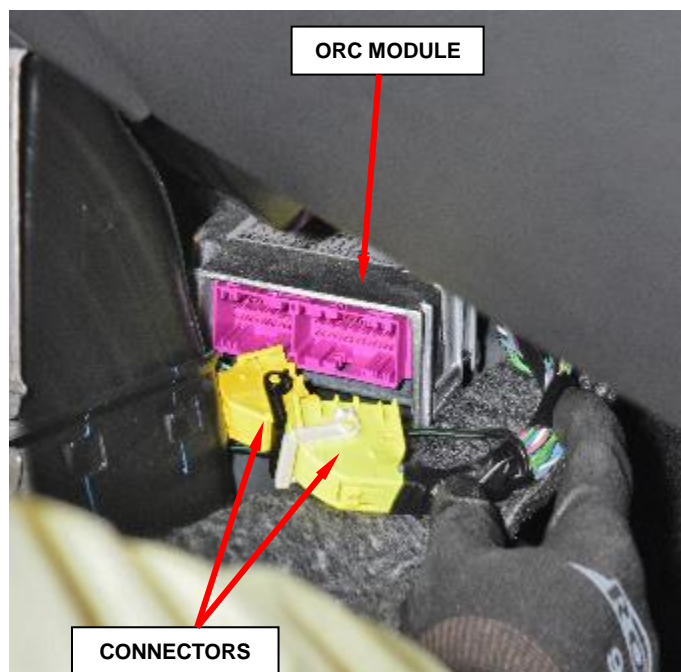
**Figure 30 – ORC Module**

13. Unlatch and disconnect the two instrument panel wire harness connectors from the ORC connector receptacles located on the rearward facing side of the module. To disconnect the wire harness connectors from the ORC, depress the release tab and lift the lever arm on each connector (Figure 30).

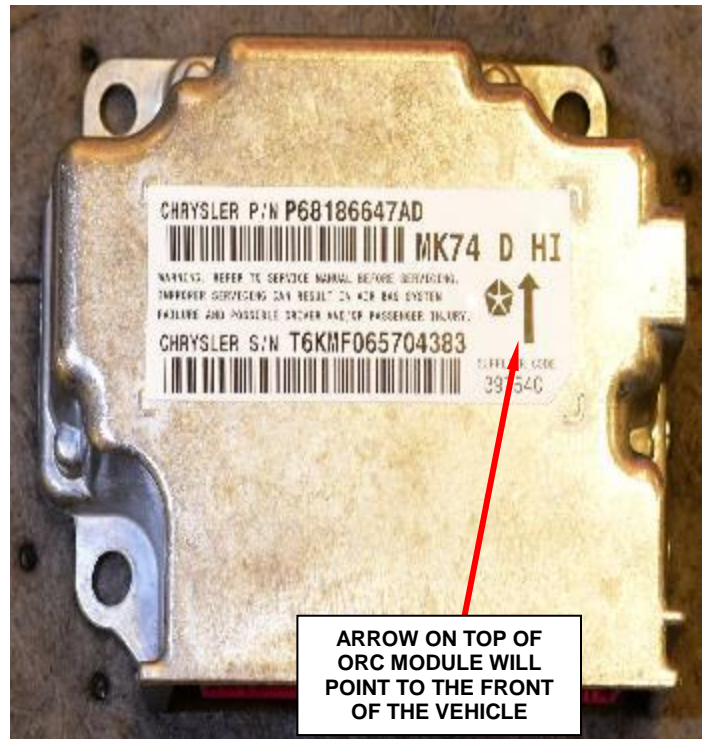
**Figure 31 – Orientation Arrow**

16. Carefully position the **NEW** Occupant Restraint Controller (ORC) onto the three studs of the ORC mount on the floor panel transmission tunnel. When the ORC is correctly positioned, the bottom of the housing will fit flush with the mount and the orientation arrow on the label on top of the housing will be pointed forward in the vehicle (Figure 31).

18. Install and tighten the three nuts that secure the ORC to the studs of the ORC mount. Tighten the nuts to 80 in. lbs. (9 N·m).
19. If equipped, restore the jute covered panel to its proper position over the ORC between the dash panel and the gearshift mechanism.
20. Install the front console shifter housing.
