SI B65 22 16
Audio, Navigation, Monitors, Alarms, SRS

Recall Campaign 16V-683: Driver's Air Bag Module F15 F25 F26

BMW AG is conducting a Voluntary Safety Recall involving certain Model Year 2014 – 2015 vehicles. This involves the replacement of the driver's air bag module.

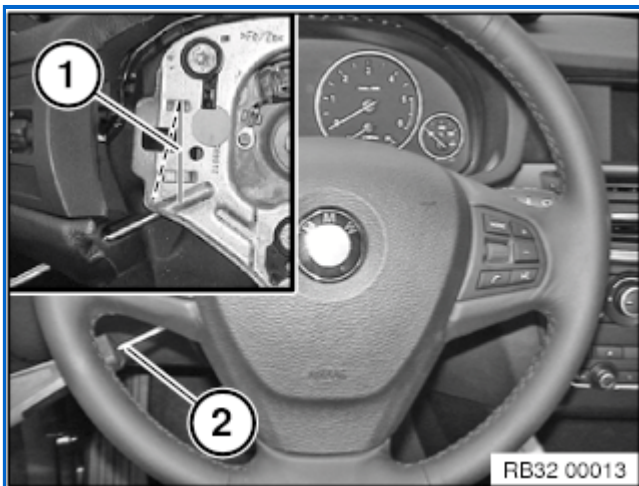
Insert Torx screwdriver T25 (2) at an angle into concealed opening on reverse side of steering wheel until a spring resistance is felt (approx. 1.5 cm).

Press spring leg (1) inward until airbag is unlocked.

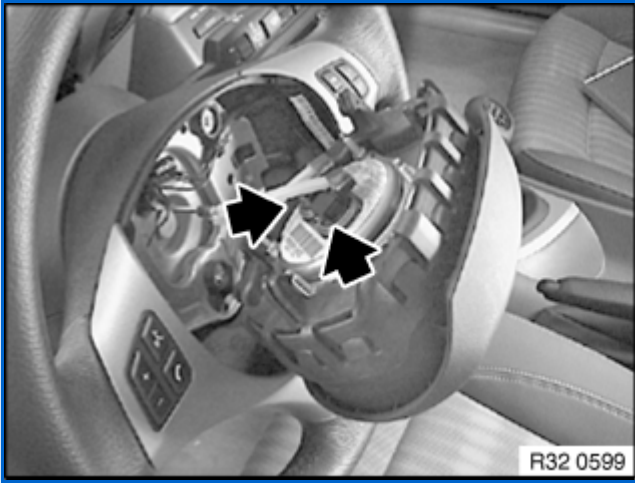
Connect plugs to connections of same colour on airbag unit.

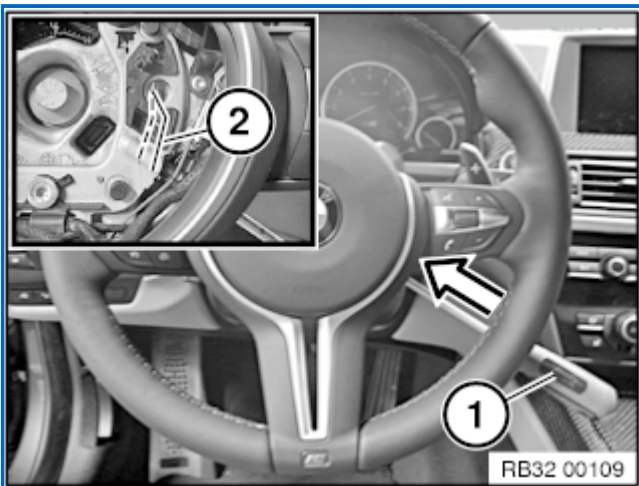
Insert Torx screwdriver T27 (1) straight into concealed opening until a spring resistance can be felt.

Press in wire spring clip (2) with Torx screwdriver T27 (1) in direction of arrow until the airbag unit is unlocked.

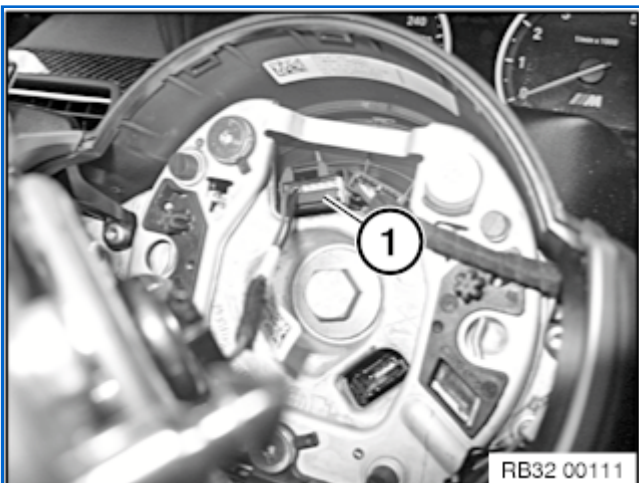
Raise airbag unit towards rear.

Disconnect plug connections(1) and remove airbag unit.

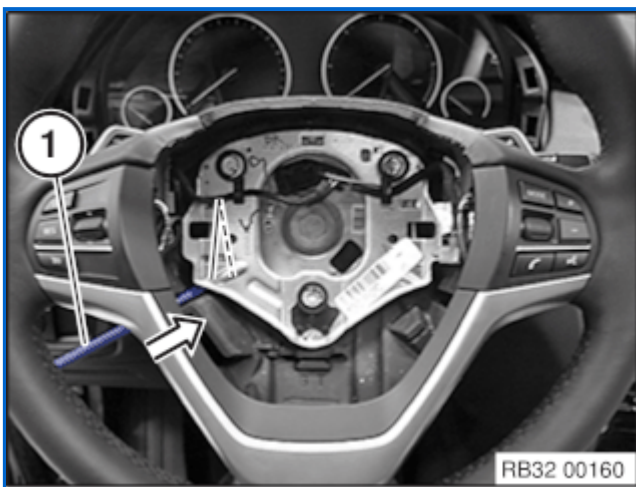
Insert Torx screwdriver T30 (1) at an angle into concealed opening on reverse side of steering wheel until a spring resistance is felt (approx. 2 cm).

Increase pressure on spring leg using Torx screwdriver T30 (1) until airbag unit is released.
