SI B65 22 16
Audio, Navigation, Monitors, Alarms, SRS

RECALL CAMPAIGN 16V-683: DRIVER'S AIR BAG MODULE F15 F25 F26

BMW AG is conducting a Voluntary Safety Recall involving certain Model Year 2014 – 2015 vehicles. This involves the replacement of the driver's air bag module.

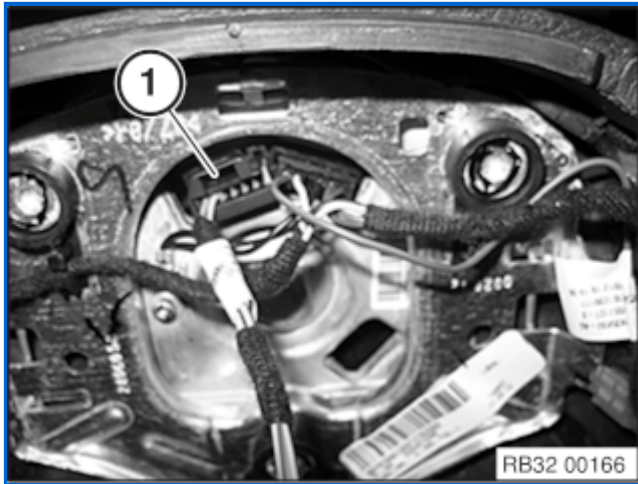
Tilt airbag unit towards rear.

Disconnect electrical connectors (1) and remove airbag unit.
