Safety Recall S77 / NHTSA 16V-750

Passenger Airbag Door

2016 (ZD) Dodge Viper

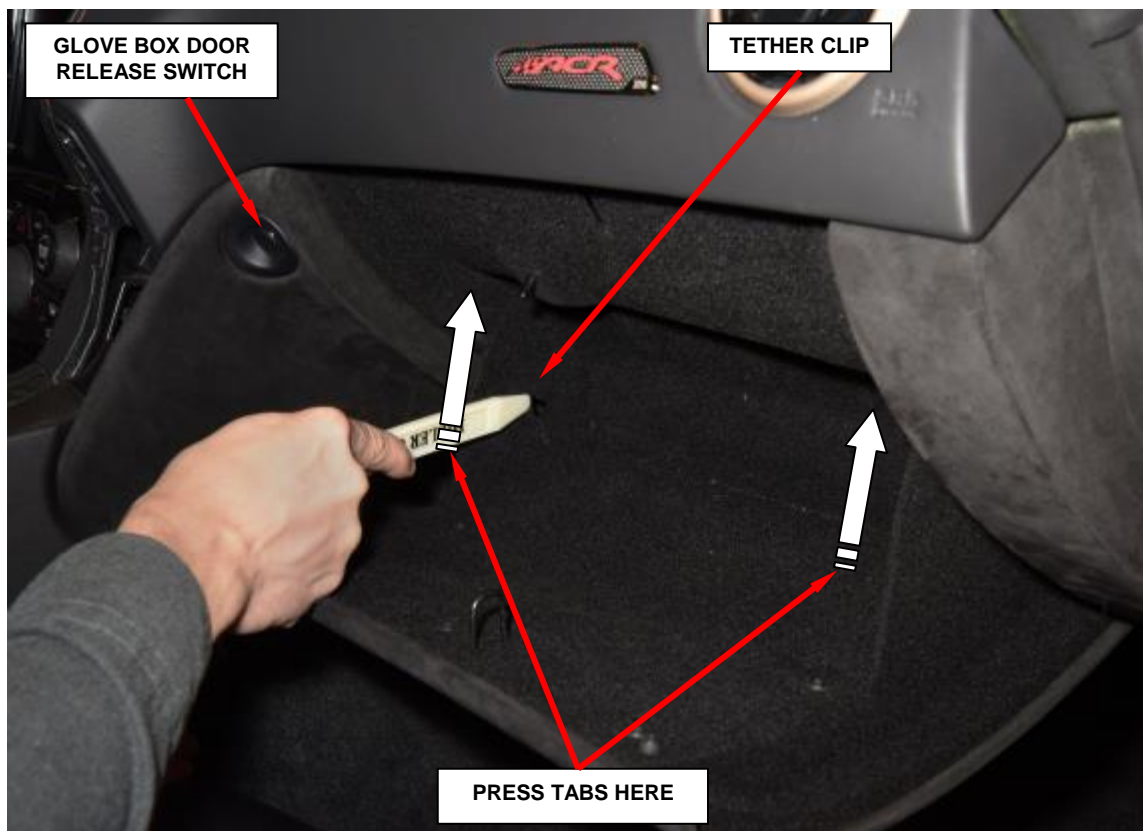
1. Remove the glove box.
 - a. Open the glove box door.
 - b. Lower the glove box door and disconnect tether clip (Figure 1).
 - c. Press the tab on the glove box trim panel and lower the glove box door fully (Figure 1).

Figure 1 - Glove Box

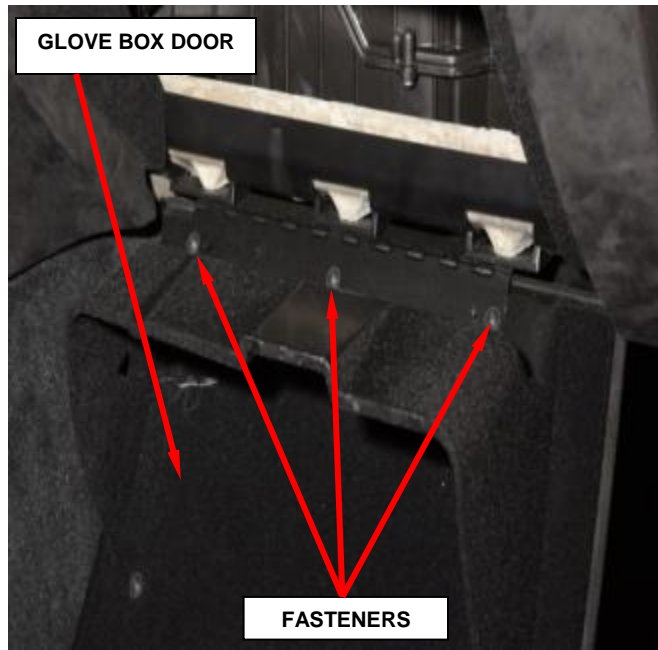
d. While holding the glove box door, remove the three glove box fasteners (Figure 2).

e. Remove glove box door from the vehicle (Figure 2).

Figure 2 – Glove Box Door

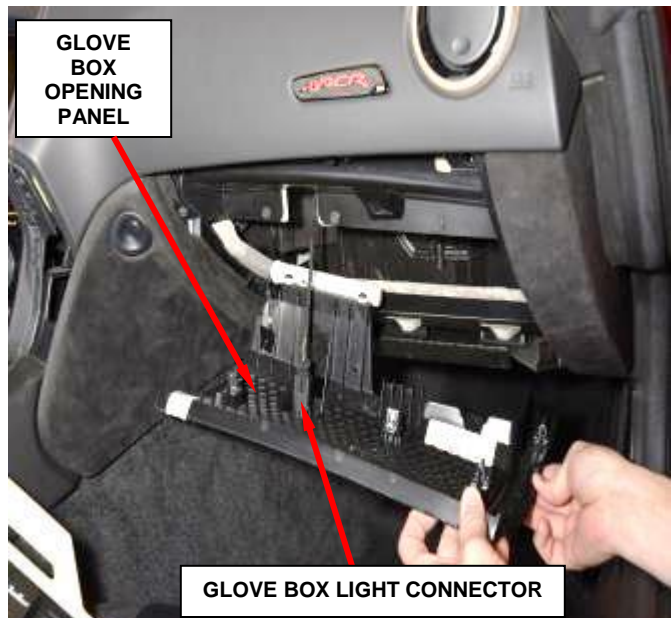
f. With the use of C-4755 or equivalent, release the retaining clips on the glove box opening panel (Figure 3).

g. Disconnect the glove box light wiring connector (Figure 3).

h. Remove the glove box opening panel from the vehicle (Figure 3).

Figure 3 – Glove Box Opening Panel

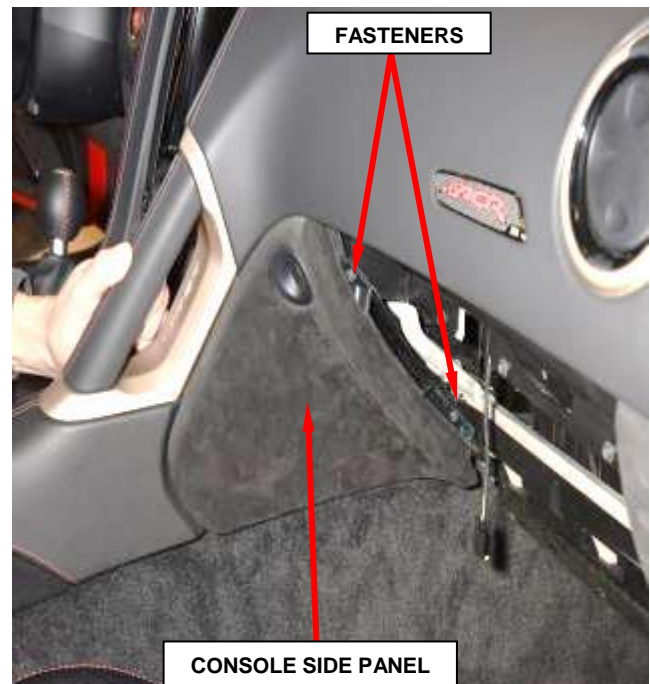
2. Disconnect and isolate the negative battery cable. If equipped with an Intelligent Battery Sensor (IBS), disconnect the IBS connector first before disconnecting the negative battery cable. Wait two minutes for the system capacitor to discharge before further service.
3. Remove the two fasteners from the console side panel (Figure 4).
4. Use C-4755 or equivalent, to release the console side panel clips from the instrument panel and console (Figure 4).
5. Disconnect the glove box release switch wiring connector.
6. Remove the right console side panel from the vehicle (Figure 4).

Figure 4 – Right Console Side Panel

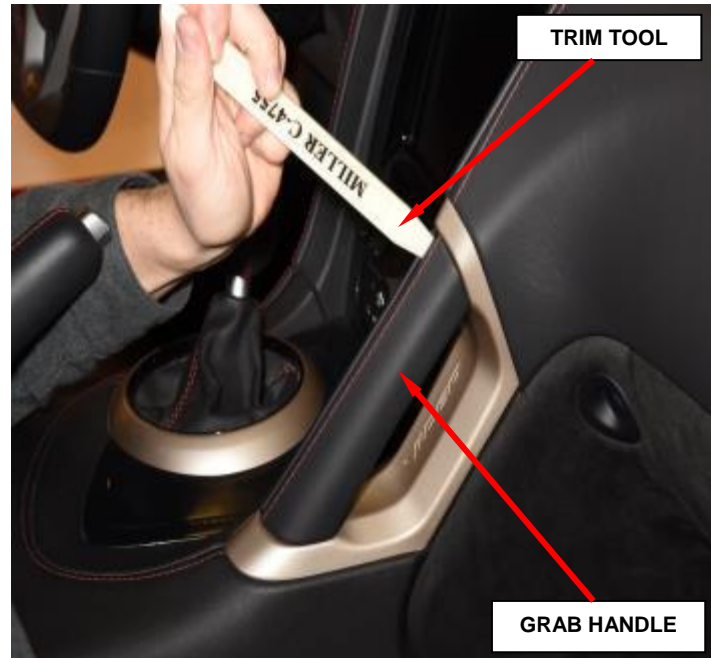
- a. Insert C-4755 trim tool or equivalent, between the right side of the grab handle and the left side of the grab handle (Figure 5).
- b. Gently pry to release the clips on the right side of the handle (Figure 5).
- c. Remove the two fasteners securing the left side of the handle.

Figure 5 –Grab Handle

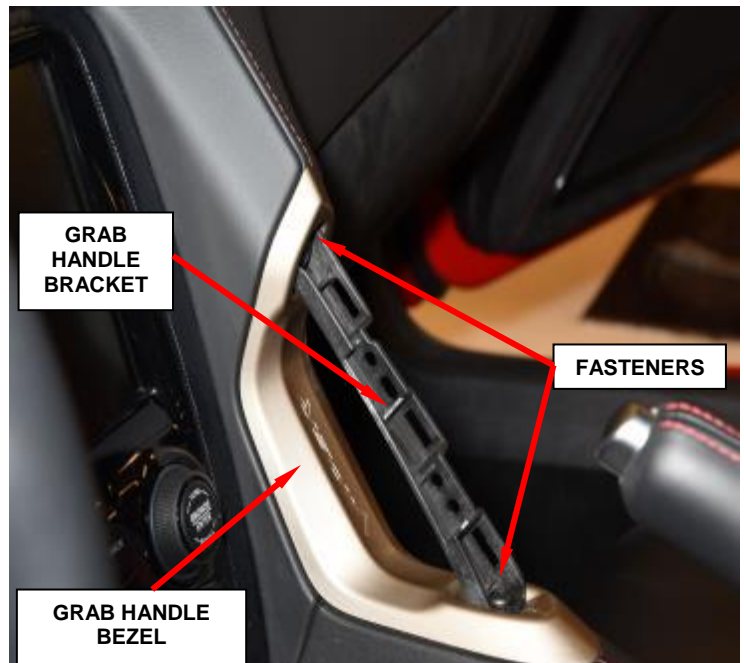
- d. Remove the two fasteners from the grab handle bracket (Figure 6).
- e. Use C-4755 or equivalent, to release the clips on the grab handle bezel and remove from the vehicle (Figure 6).

Figure 6 – Grab Handle Bezel

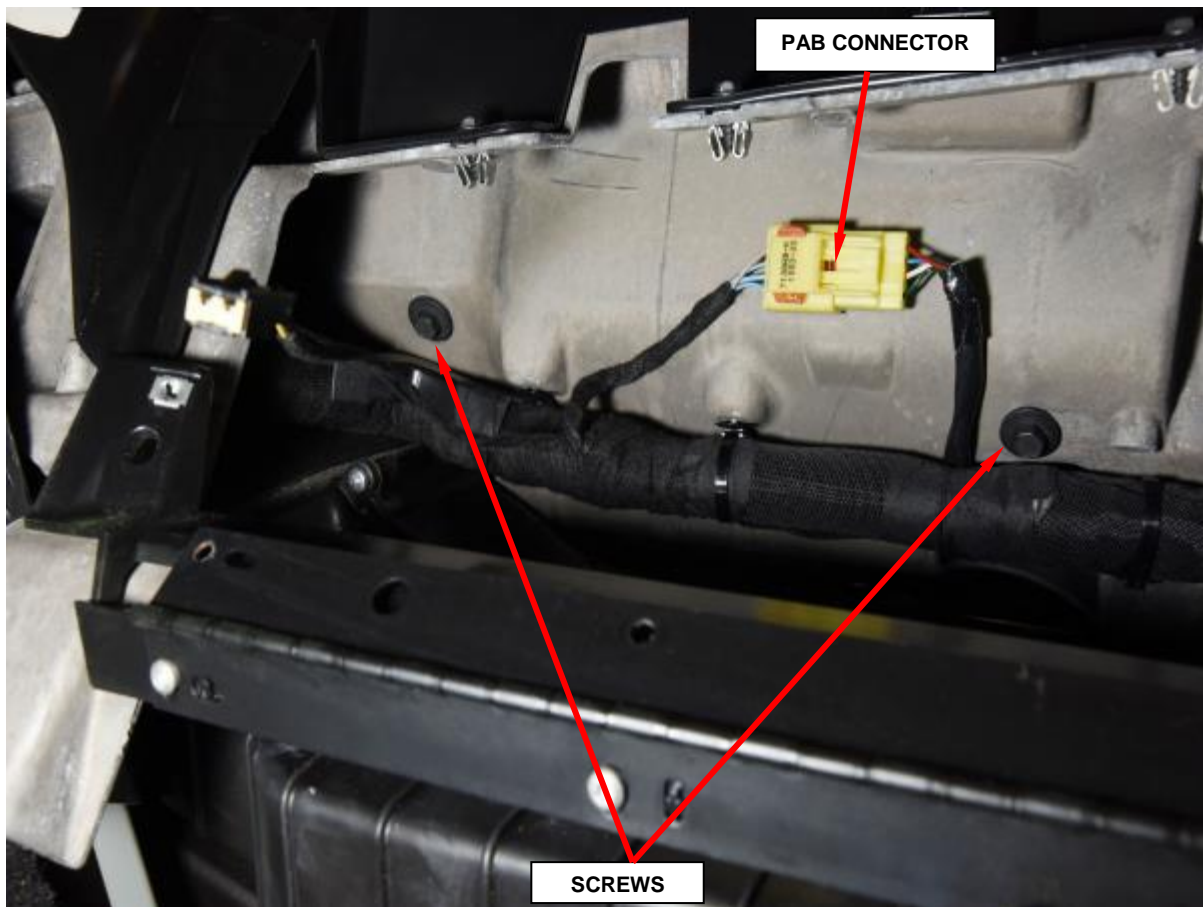
8. Disconnect the instrument panel wire harness connector from the PAB pigtail wire harness connector located above the glove box area of the instrument panel (Figure 7).

9. Remove the two screws that secure the lower PAB bracket to the instrument panel structural support above the glove box area of the instrument panel (Figure 7).

Figure 7 – PAB Bracket to Instrument Panel Support Structure

- 21. Install and tighten the two screws that secure the PAB lower mounting bracket to the instrument panel structural support above the glove box area of the instrument panel. Tighten the screws to 80 in. lbs. (9 N·m) (Figure 7).

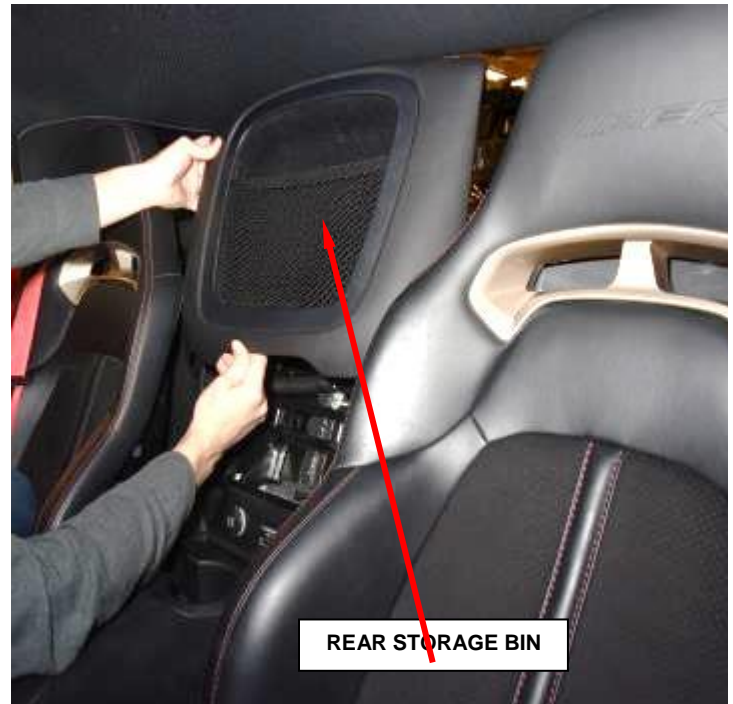
10. Use the following steps to remove the center bezel and related components to allow top pad removal.
 - a. Remove and save the rear storage bin (Figure 8).

Figure 8 – Rear Storage Bin

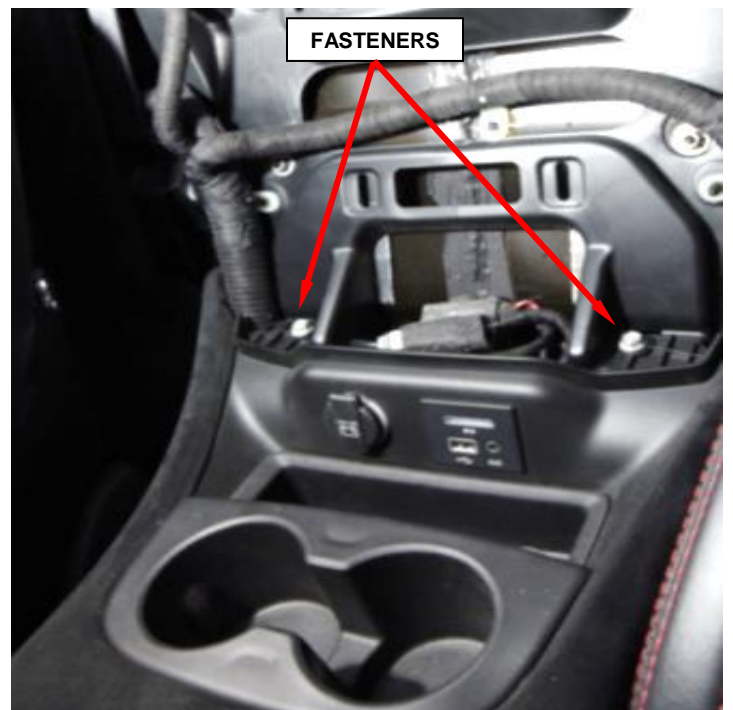
- b. Remove and save the two rear center console fasteners (Figure 9).

Figure 9 – Rear Console Fasteners

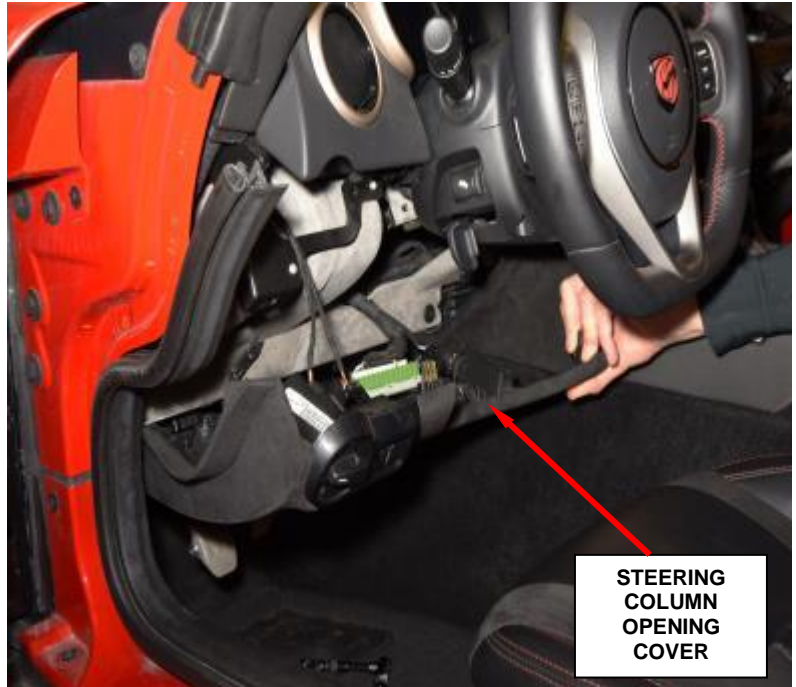
- c. Remove and save the two steering column opening cover fasteners (Figure 10).
- d. Remove and position the steering column opening cover to the side.
- e. Remove the left console side panel from the vehicle.

Figure 10 – Steering Column Opening Cover

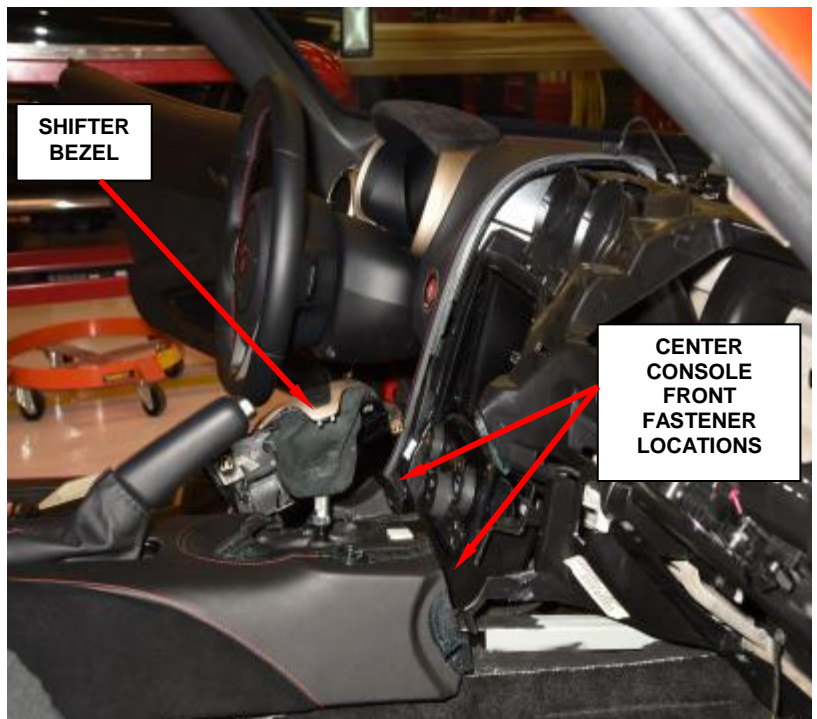
- f. Remove and save the two front center console fasteners (Figure 11).
- g. Release the shifter bezel from the console and position to the side (Figure 11).
- h. Position the floor center console rearward.

Figure 11 – Center Console

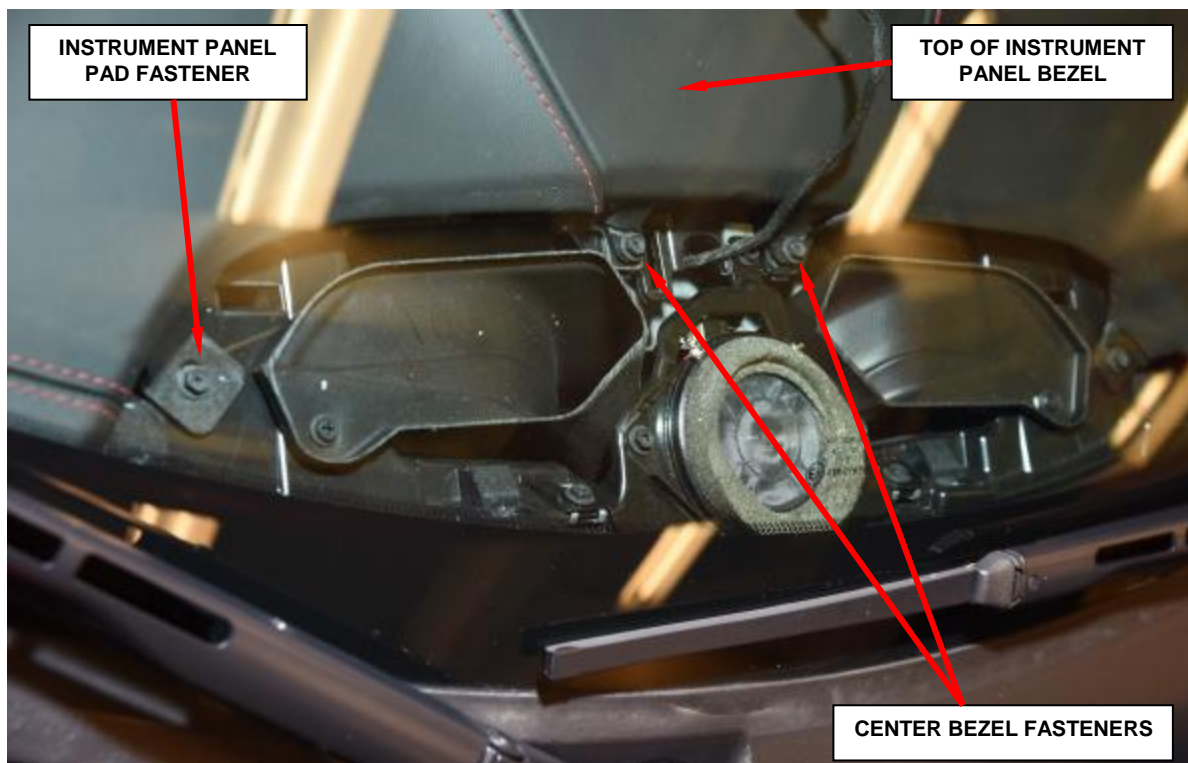
- i. Using C-4755 or equivalent, release the clips along the rear of the rear of the defroster grill.
- j. Slide the defroster grill rearward to release the front tabs from the dash.
- k. Disconnect the sun sensor wiring connector.
- l. Remove and save the defroster grill from the vehicle.
- m. Remove the two instrument panel center bezel fasteners and the right side instrument panel pad fastener (Figure 12).
- n. Use C-4755 or equivalent, to release the instrument panel center bezel retaining clips.
- o. Remove instrument panel center bezel.

**Figure 12 - Center Bezel Fasteners**

- f. Install the two lower instrument panel pad screws and tighten securely (Figure 14).
 - g. Install the dash pad fastener in the defroster grill area and tighten securely (Figure 12).

- k. Install the two instrument panel center bezel fasteners and tighten securely (Figure 12).
 - l. Position the defroster grill.
 - m. Connect the sun sensor wiring connector.

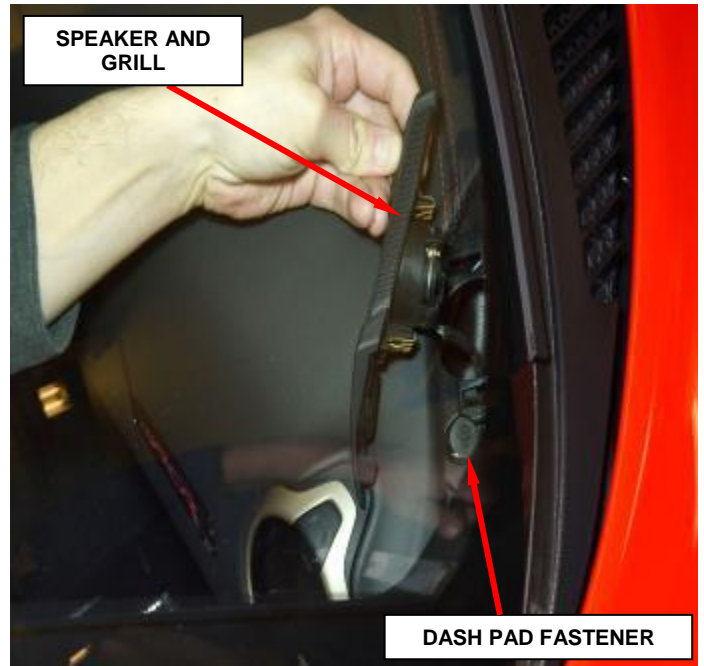
- p. Remove and save the right side speaker and grill assembly (Figure 13).

- q. Remove the dash pad fastener (Figure 13).

Figure 13 – Right Side Speaker

- d. Install the dash pad fastener into the speaker and grill area and tighten securely (Figure 13).
 - e. Install the right speaker and grill assembly.

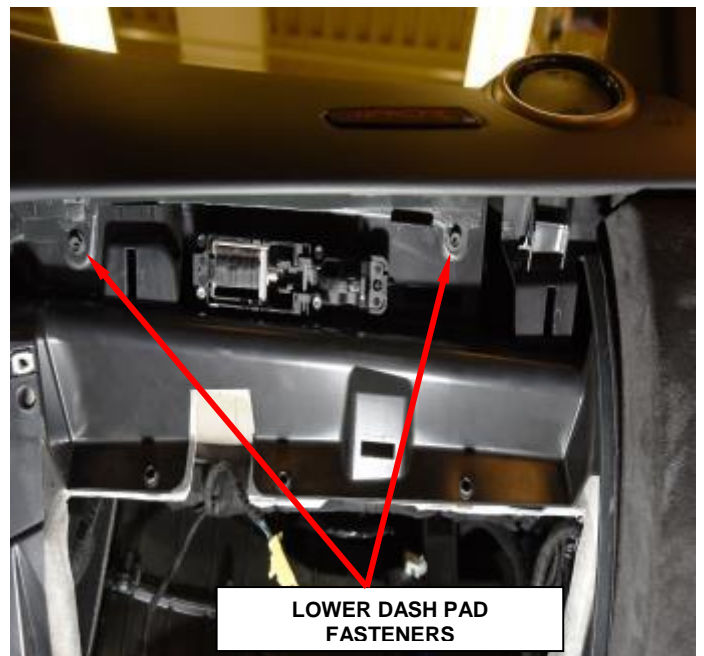
- r. From within the glove box opening, remove the two dash pad fastener (Figure 14).

Figure 14 – Lower Dash Pad Fasteners

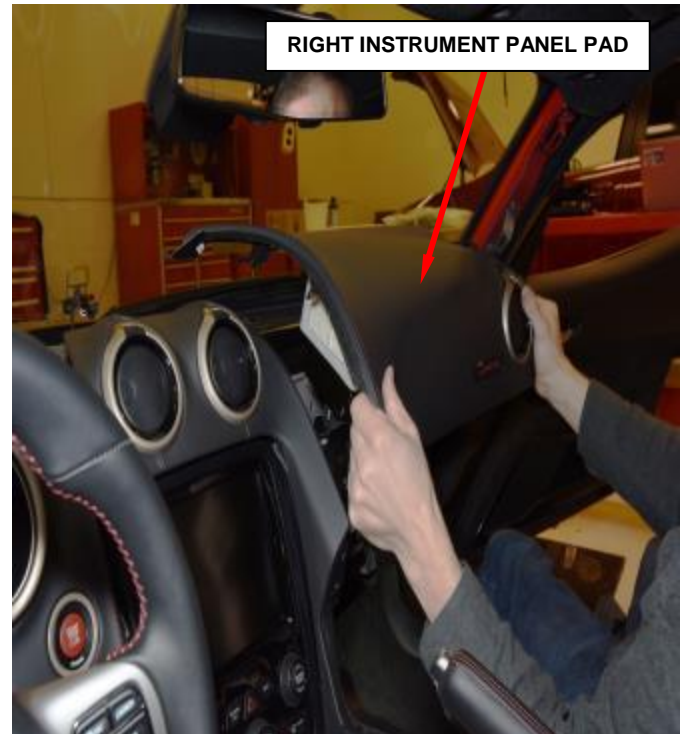
- t. Use C-4755 or equivalent, to release the retaining clips on the right instrument panel pad (Figure 15).
 - u. Remove the right instrument panel pad from the vehicle (Figure 15).
11. Place the top pad on a suitable work surface with the top facing down.
 12. Disengage each of the hooks on one side of the PAB housing from the windows in the forward and rearward vertical walls of the PAB retainer or chute on the underside of the top pad. To disengage the hooks, use hand pressure to pull the adjacent edge of the PAB housing firmly and evenly upward out of the retainer receptacle, while at the same time pulling the upper edge of the PAB receptacle wall outward far enough to disengage the hooks (Figure 16).

Figure 15 - Remove Instrument Panel Pad

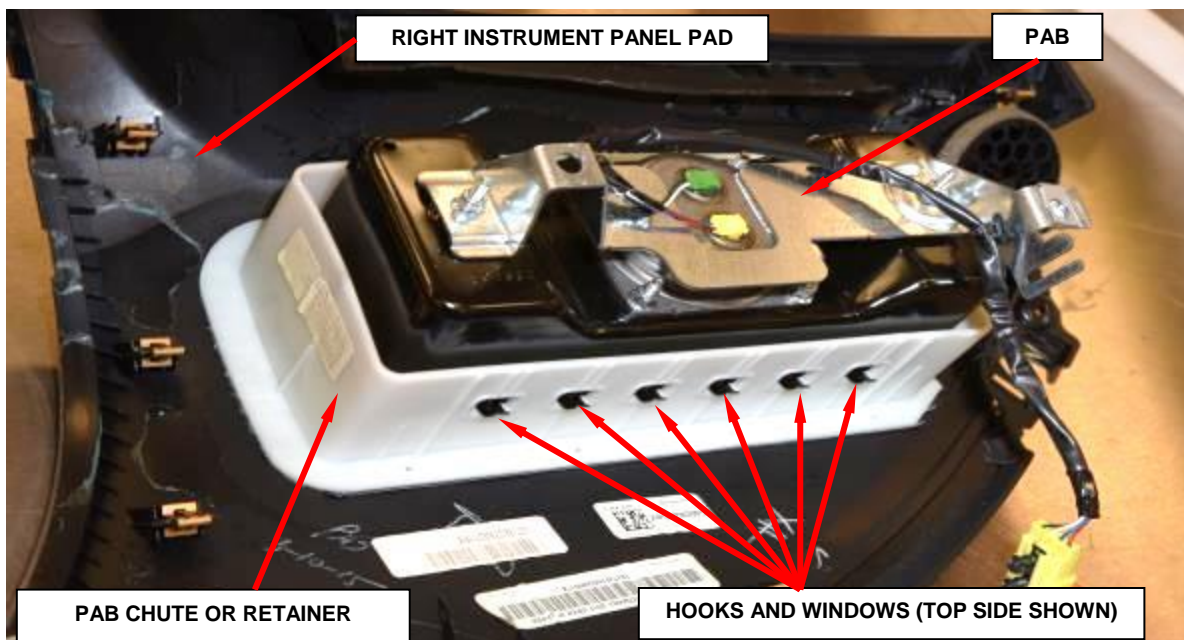
Figure 16 – Passenger Airbag Removal
