# Safety Recall

## Code: 45F2

<b>Subject</b>	<b>ABS Control Module Software</b>
<b>Release Date</b>	February 24, 2017
<b>Revision Summary</b>	<b>Work procedure updated.</b>
<b>Affected Vehicles</b>	<b>Certain 2009-2010 MY Volkswagen Vehicles</b>  <i>Check Campaigns/Actions screen in Elsa on the day of repair to verify that a VIN qualifies for repair under this action. Elsa is the <u>only</u> valid campaign inquiry &amp; verification source.</i> <ul style="list-style-type: none"><li>✓ Campaign status must show "open."</li><li>✓ If Elsa shows other open action(s), inform your customer so that the work can also be completed at the same time the vehicle is in the workshop for this campaign.</li></ul>
<b>Problem Description</b>	On certain vehicles, a fault within the antilock brake system (ABS) may cause the module to fail during ABS and/or electronic stability control (ESC) activation. This will cause warning lights for ABS, brake and the ESC systems to illuminate. If this happens, the brake system related vehicle stabilizing functions (ABS/ESC) may not be available, increasing the risk of a loss of vehicle control and could lead to a crash causing injury and/or property damage.

<b>

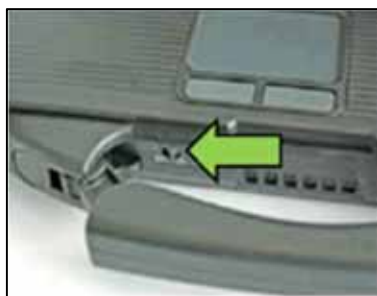
**VAS 6150 & VAS 6150A**  
(Front panel behind handle)

- Performing a software update using a Bluetooth connection increases the risk of losing connection during the update, which could result in damage to the control module. It also greatly increases the time required to perform the update. Requests for additional time or parts will be denied if the GFF log shows the update was performed using Bluetooth.
- ✓ **The Bluetooth function of the scan tool is physically switched off <see pictures below>.**

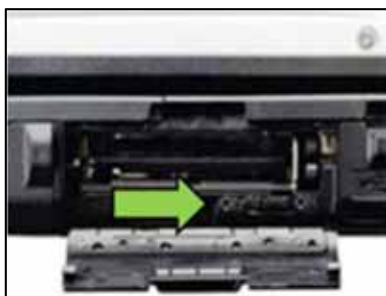
**VAS 6150B**  
(Right side behind WIRELESS door)

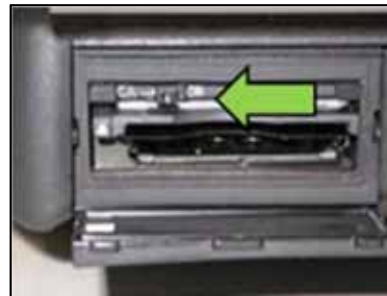
**VAS 6150C/D**  
(Left side behind SC/EX door)

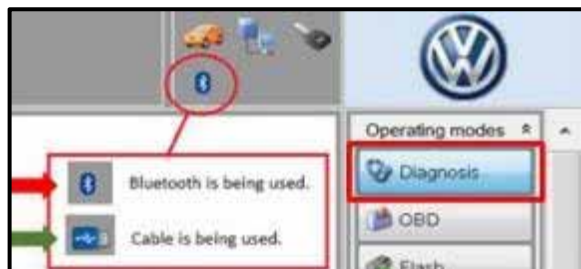
- Open the hood.
- Open the battery cover.
- Attach the GRX3000VAS Tester/Charger (or equivalent) to the vehicle battery.
- Switch the ignition on.
- Apply the parking brake.
- Turn off all consumers; headlights heated seats, etc.
- Connect the VAS6150D Diagnostic Tester (or equivalent) to the vehicle.
- Start the ODIS program.
- Confirm that scan tool is communicating with the diagnostic head by USB <Green Arrow>.
- If the Bluetooth symbol is shown <Red Arrow> then disconnect the diagnostic head from the vehicle and reconnect the USB cable to the diagnostic head and then reattach to the vehicle.
- Upon ODIS startup, verify the "Diagnosis" operating mode is selected <as shown>.
- Select "Starting Diagnosis" and perform a GFF scan of the vehicle.

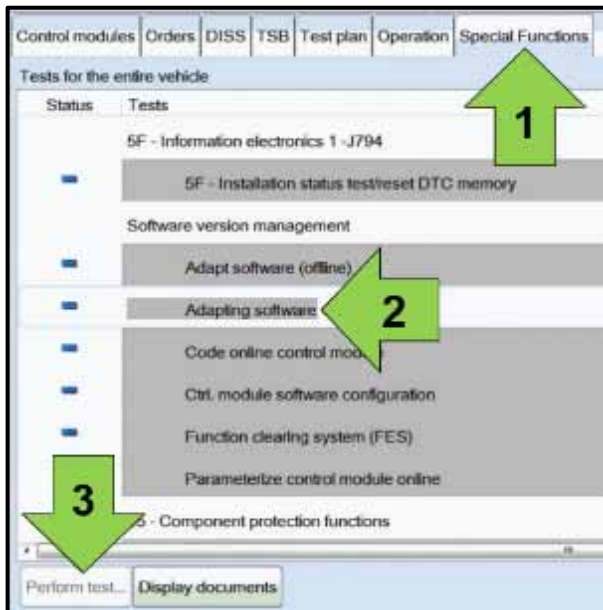
- Once the GFF scan is complete:
  - Record any faults that may be stored.
  - Select "Special functions" <arrow 1>, then "Adapting software" <arrow 2>, then select "Perform test" <arrow 3>.

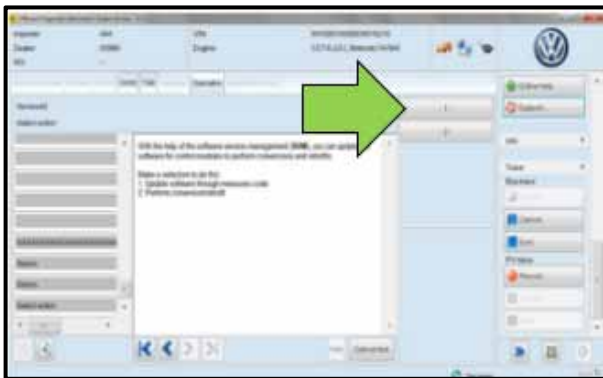
- Select the appropriate option to update "**through measures code**" <arrow>.

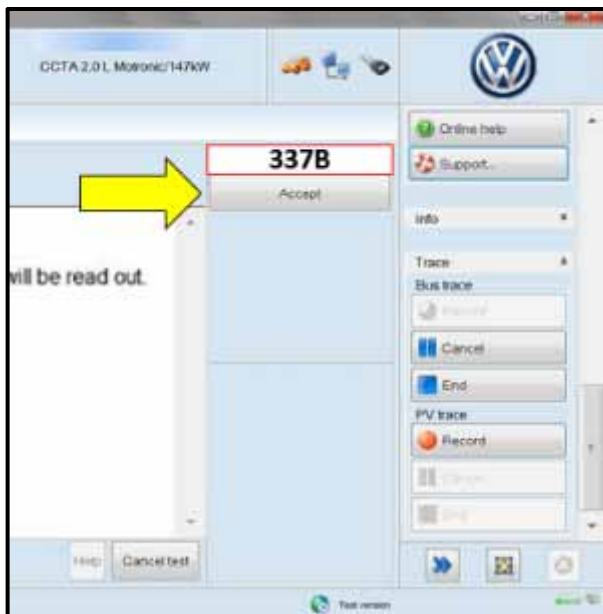
- Enter "**337B**" <as shown>.
- Select "Accept" <arrow> and follow on screen instructions.

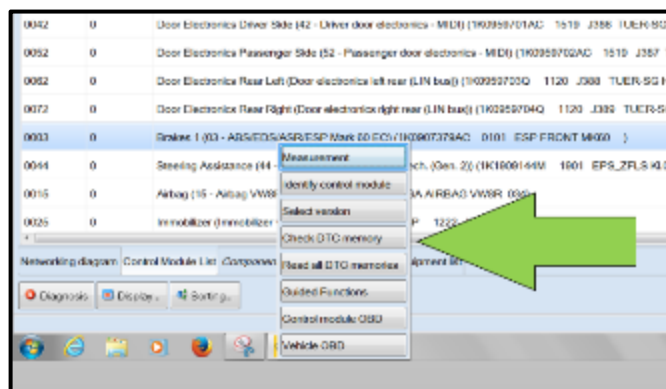
- After the short road test, turn off the ignition and cycle ignition back on.
- Select the “Control Module” tab.
- Scroll down and right click on Address Word 0003/ABS Control Module.
- Select Check DTC Memory <arrow>.

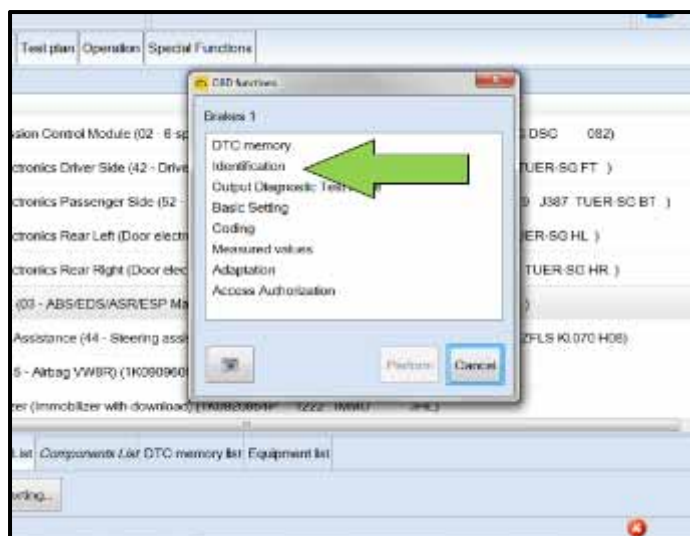
- Right click on Address 0003 (ABS Control Module), select "Control Module OBD" and then select "Identification" <arrow>.

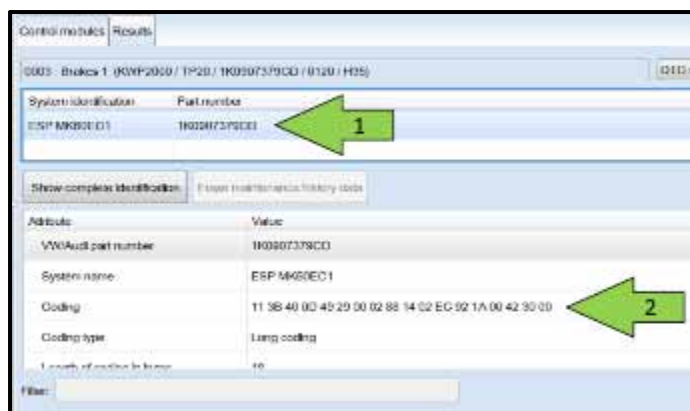
- Record the ABS Control Module part # <arrow 1> and the coding of the ABS Control Module <arrow 2> on the repair order. ABS Control Module coding may need to be entered manually after the ABS Control Module is replaced.
- Exit ODIS, send the Diagnostic Protocol online to GFF paperless.

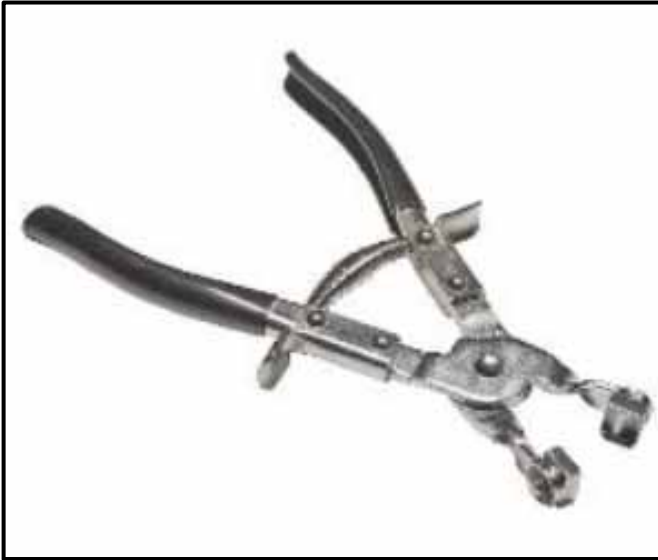
- Hose Clip Pliers -VAS6362- (or equivalent)

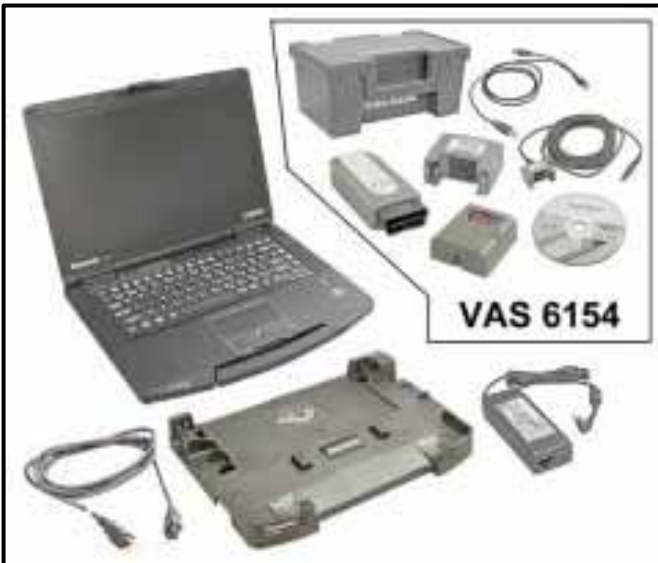
- VAS6150D - Diagnostic Tester (or equivalent)
- VAS6154 - Vehicle Communication Interface (or equivalent)

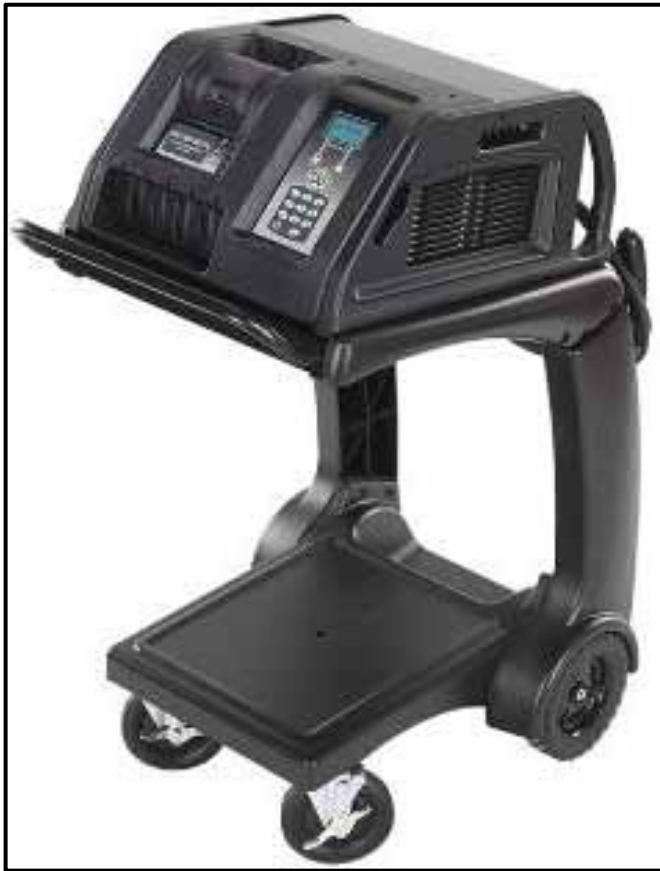
- GRX3000VAS – Battery Tester/Charger (or equivalent)

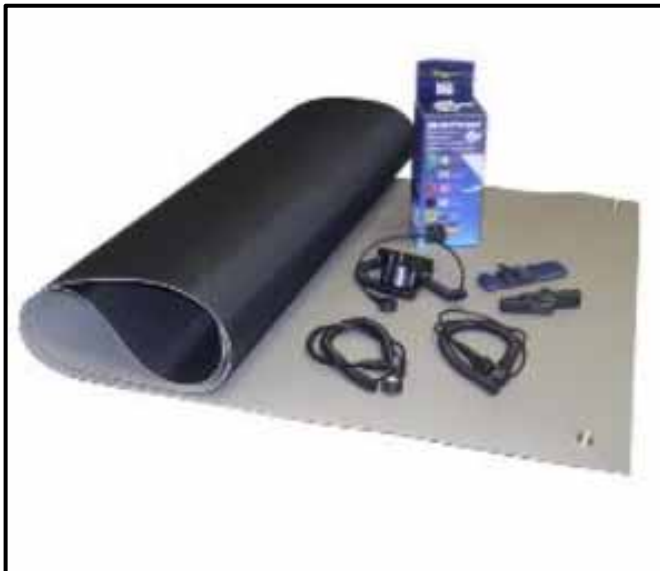
- ESD Worksurface - VAS 6613

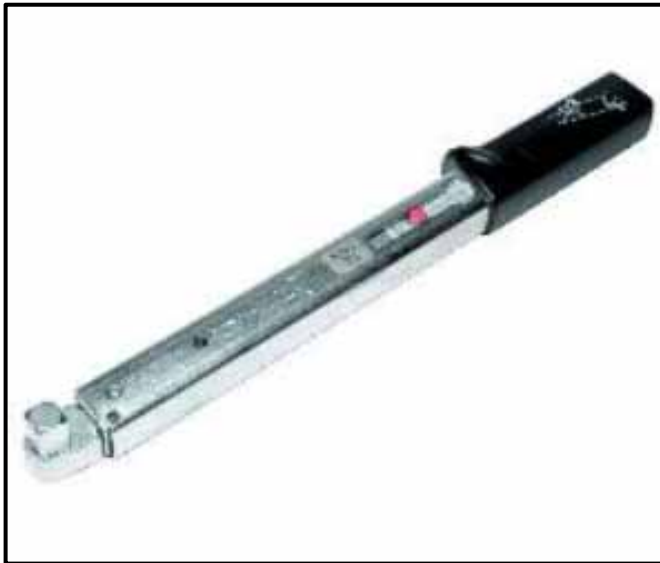
- Torque Wrench 5–50Nm -V.A.G 1331- (or equivalent)

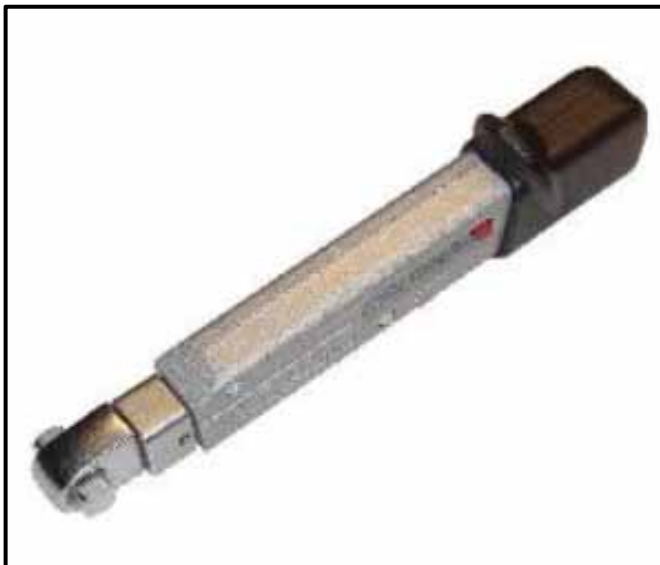
- Torque Wrench -V.A.G 1410- (or equivalent)

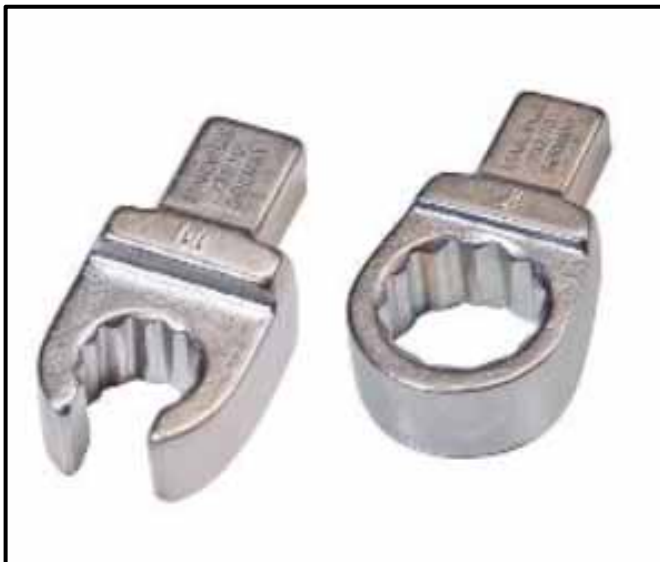
- Torque Wrench 1331 Insert - Ring Wrench - 11mm & 17mm -VAG1331/2- (or equivalent)

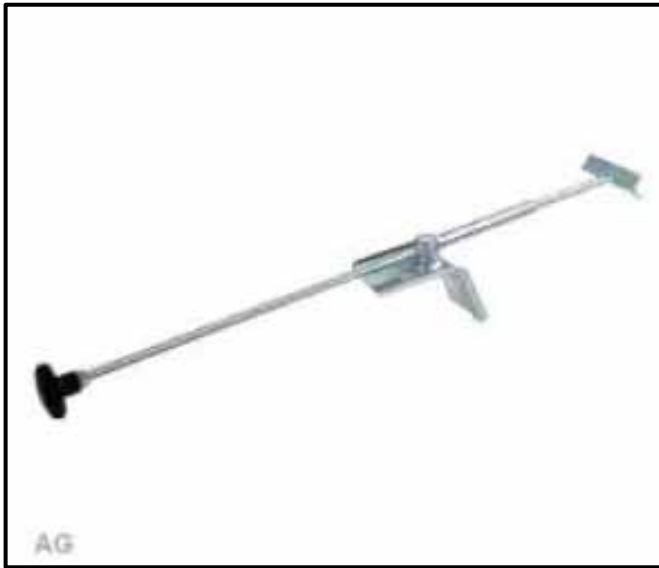
- Brake Pedal Actuator -V.A.G 1869/2-

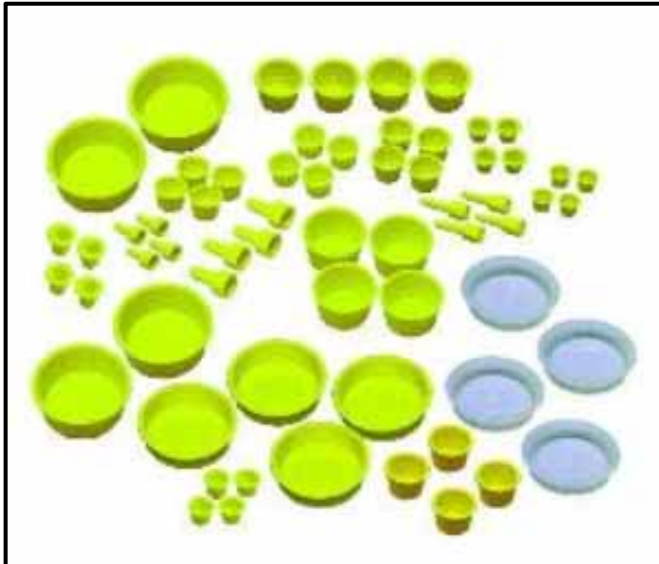
- Engine Bung Set –VAS6122- (or equivalent)

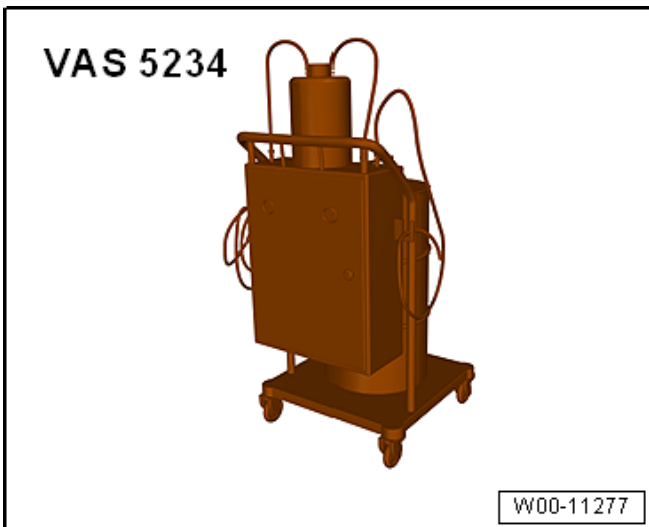
- Brake Charger/Bleeder Unit -VAS 5234-

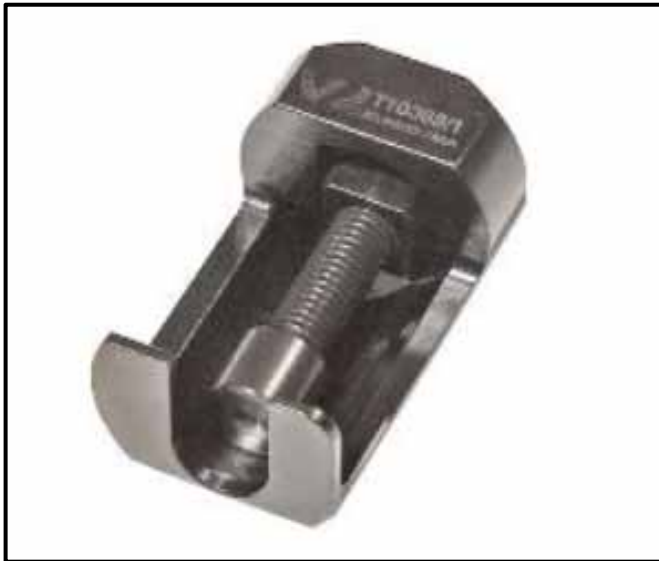
- Puller - Wiper Arm Kit - Puller 1 -T10369/1-

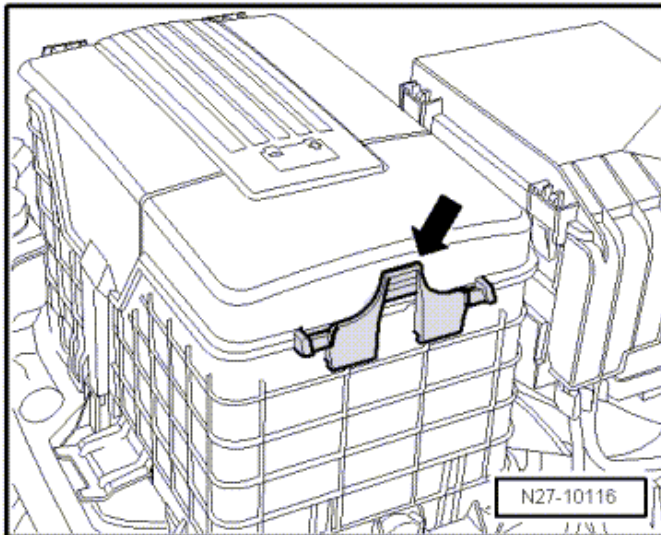
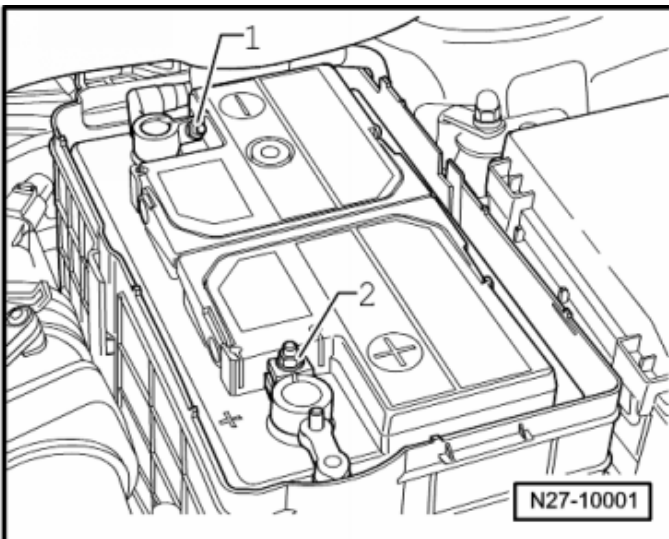
- Loosen the nut <1>.
- Remove and isolate the battery ground cable terminal from the battery terminal.

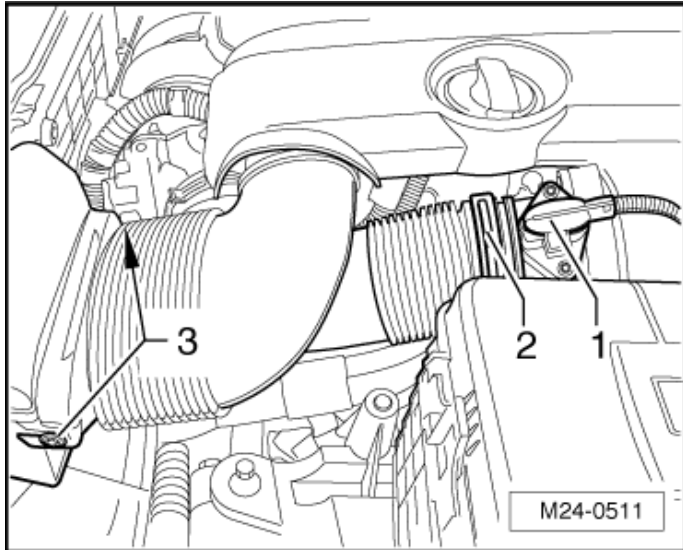
- **For 5 cylinder gas engines:**
  - Open clamp <2> and disconnect intake hose.
  - If equipped, disconnect the connector <1> and remove.
  - Remove the screws <3> and the intake hose.

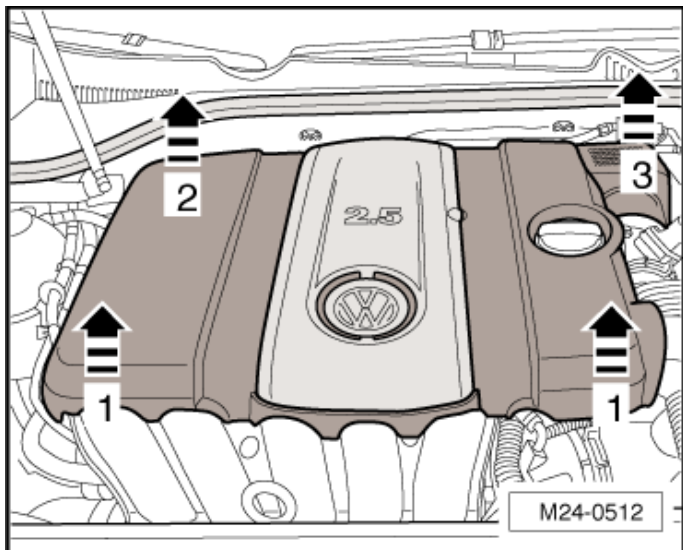
- Pull the cover out first at the front in direction of <arrow 1>, then at the right rear in direction of <arrow 2> and finally at the left rear in direction of <arrow 3>.
- Carefully swivel engine cover out starting at rear area.

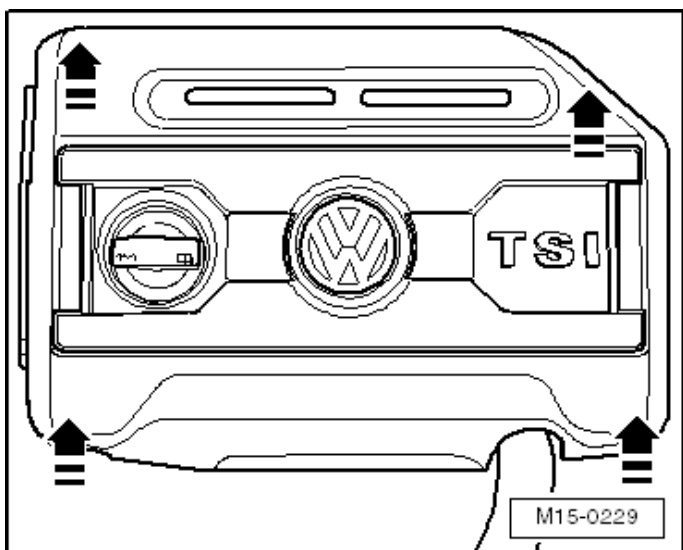
- **For 4 cylinder TSI engines:**
  - Remove the engine cover upward from the attaching points <arrows>.
  - Open the clamp and remove the air guide hose from the air filter.

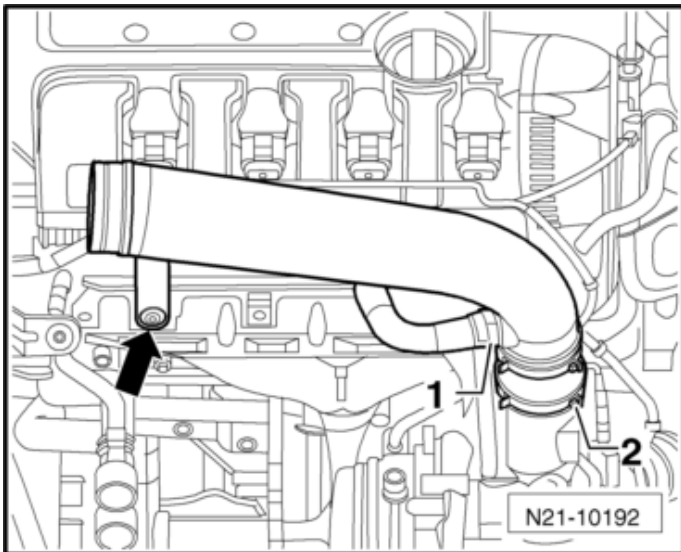
- Press the release button to disconnect the air duct hose <1>.
- Remove the air duct pipe bolt <arrow>.
- Loosen hose clamp <2> and remove air duct.
- Remove the intake hose between the intermediate pipe and the turbocharger.
- Seal the turbocharger with the Engine Bung Set - VAS6122-.

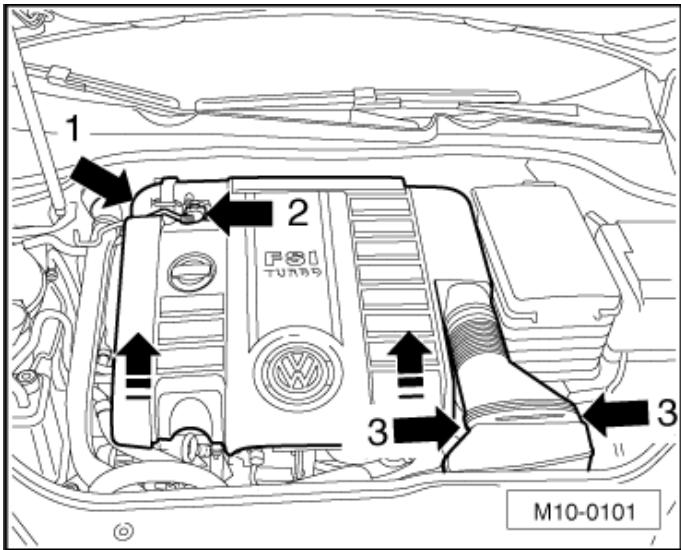
- **For 4 cylinder FSI engines:**
  - Disconnect the intake tube <arrow 1>.
  - Disconnect the electrical connector <arrow 2>.
  - Remove the bolts <arrows 3>.
  - Pull engine cover upward at the front <arrows> and remove the engine cover/upper air filter housing.

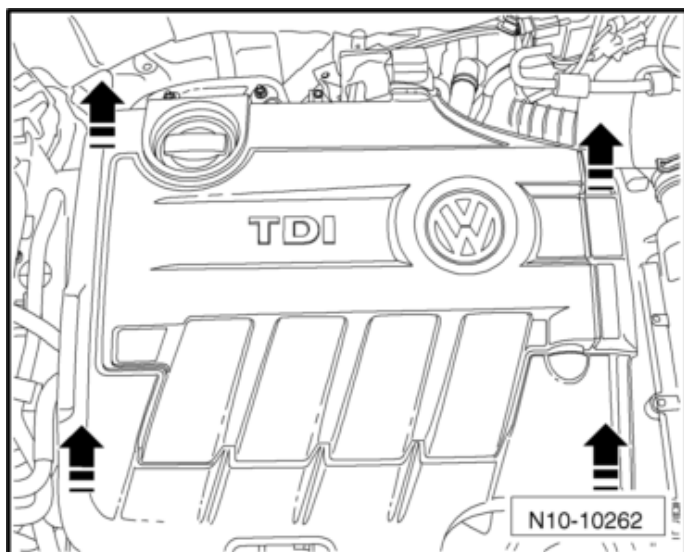
- Pull the engine cover at the corners in direction of <arrows> upward out of the mounts.

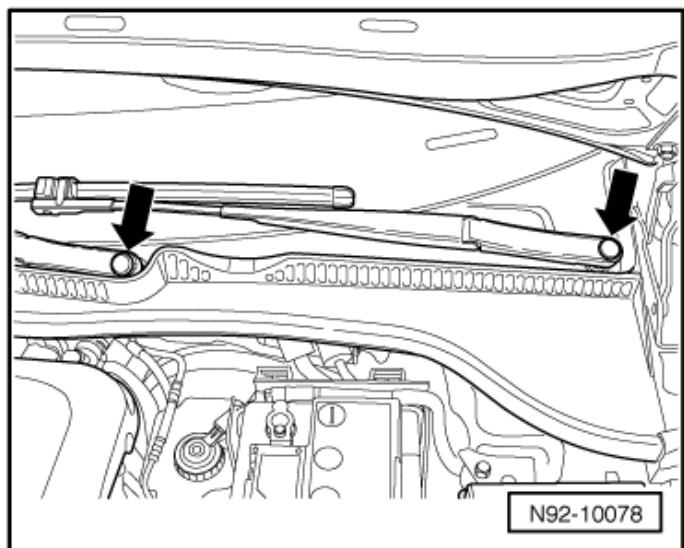
- Remove wiper arms:
  - Pry out the caps <arrows> with a screwdriver.
  - Remove the underlying nuts <arrows>.

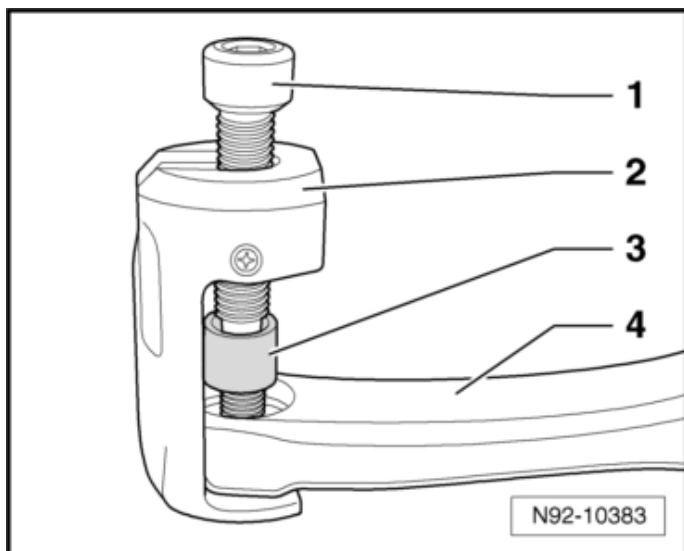
- Slide the Puller - Wiper Arm Kit - Puller 1 - T10369/1 <2> arm under the wiper arm <4>.

- The windshield wiper shaft can be damaged.
- Always use the thrust piece <3> to loosen the windshield wiper arm.
- Damage to the wiper shaft is not covered under this action.
- Turn the pressure bolt <1> on the Puller - Wiper Arm Kit - Puller 1 - T10369/1- clockwise until the thrust piece <3> makes contact with the wiper shaft. Turn the pressure bolt <1> on the Puller - Wiper Arm Kit - Puller 1 - T10369/1- clockwise with a hex socket wrench until the wiper arm <4> comes loose off the shaft.

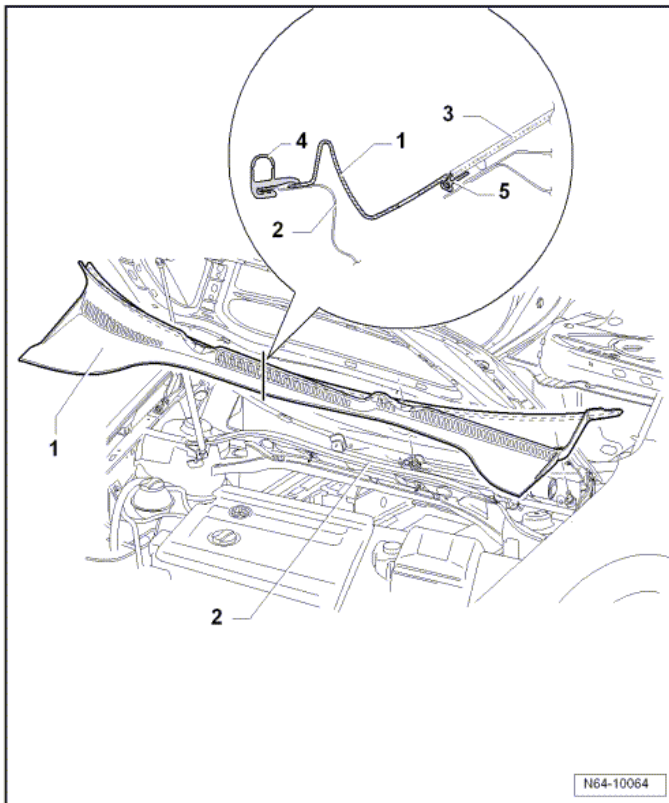
- Pull off plenum chamber seal <4> from the entire length of facing wall <2> of plenum chamber.
- Pull out plenum chamber cover <1> starting at right carefully upward from binding profile <5>.

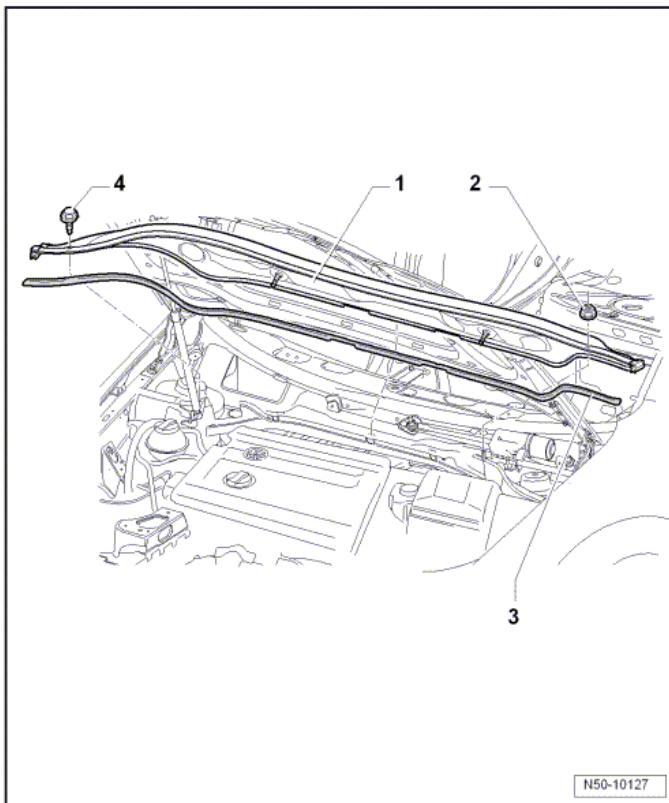
- Remove bolt <4> and nut <2>.
- Pull plenum chamber bulkhead upward and remove from the vehicle.

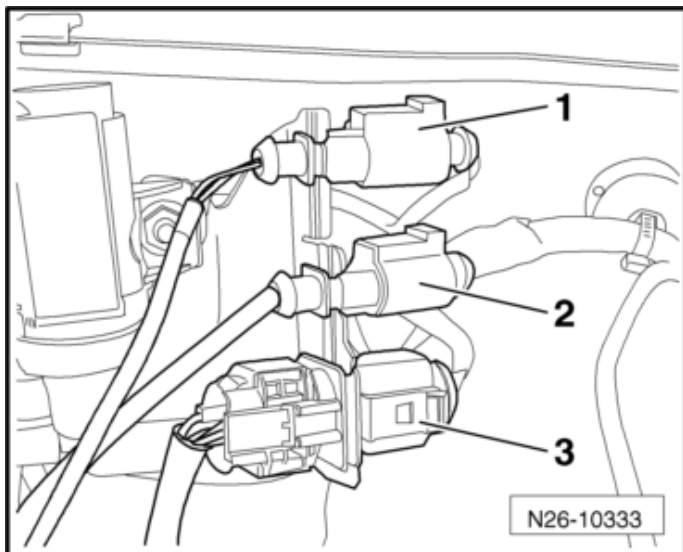
- Disconnect the connector for the Exhaust Gas Temperature Sensor 4 -G648- <2> and Heated Oxygen Sensor -G39- <3>.
- Unclip the Exhaust Gas Temperature Sensor 4 -G648- and Heated Oxygen Sensor -G39- cables from the brackets on the plenum chamber and engine.

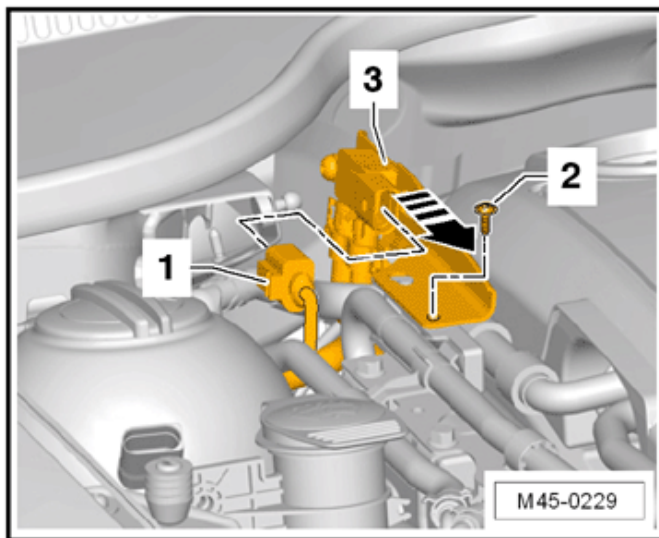
- Disconnect the connector <1> on the Exhaust Pressure Sensor 1 -G450-.
- Remove the screw <2> and then remove the bracket <3> together with the Exhaust Pressure Sensor 1 -G450- in <direction of arrow>.
- Move the bracket <3> and Exhaust Pressure Sensor 1 -G450- forward.

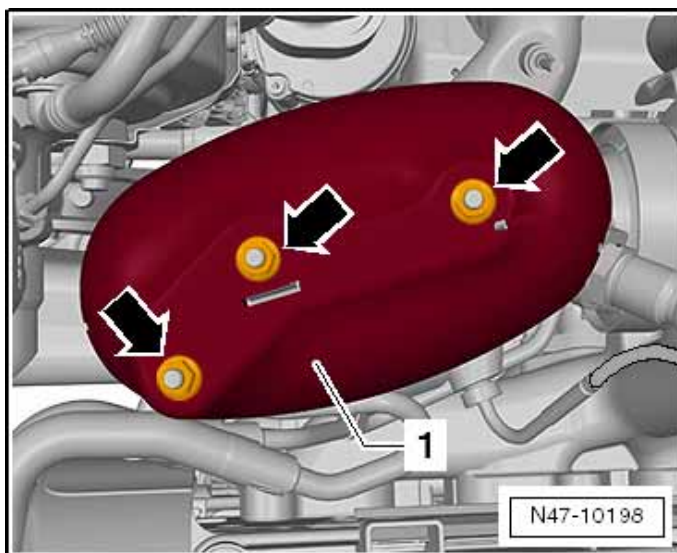
- Remove the nuts <arrows> and then remove the heat shield <1> from the diesel particulate filter.

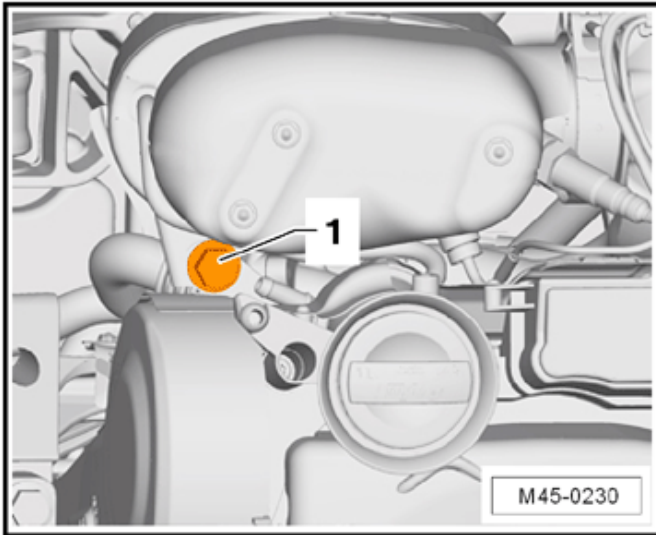
- Remove the particulate filter bracket bolt <1>.
- Raise the vehicle.

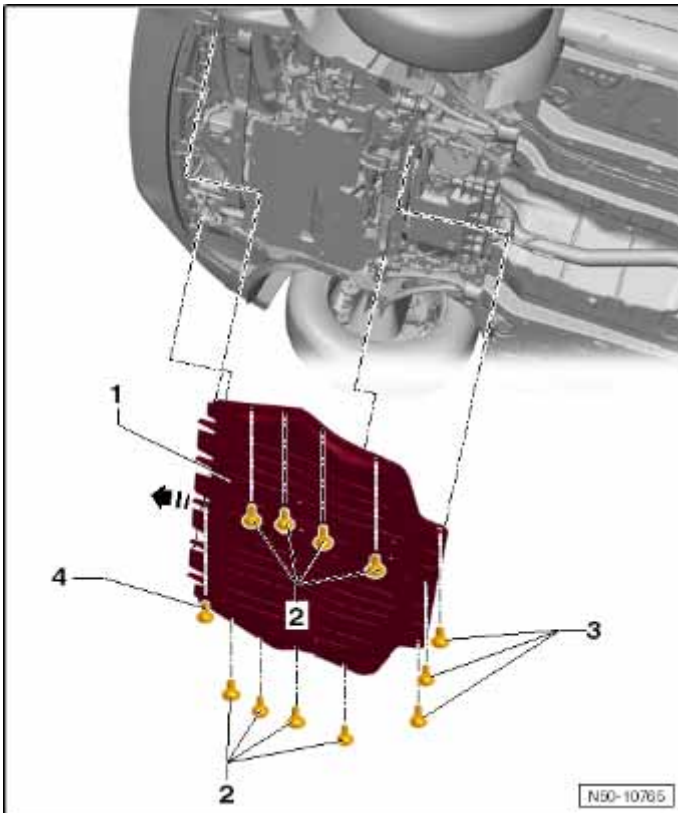
- Remove bolts <2> and <3>.
- Pull noise insulation <1> back, out of front bumper cover.

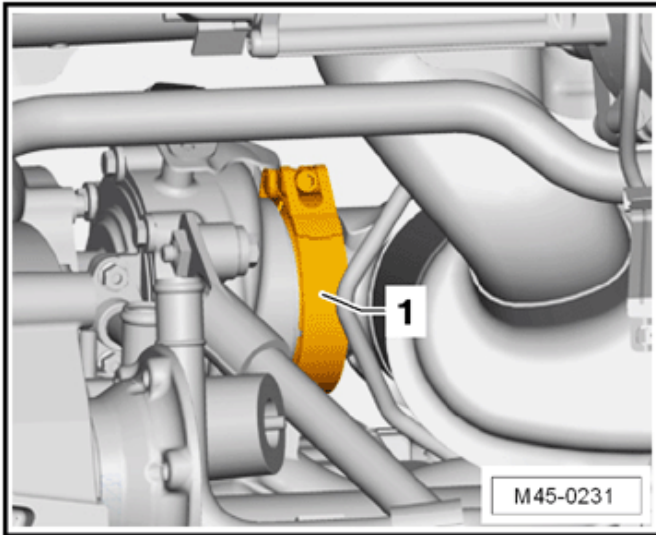
- Loosen and remove the turbocharger/particulate filter clamp <1>.

Position of clamp <1> may vary. If necessary, use 5 mm bit with ball head (e.g. T10058).

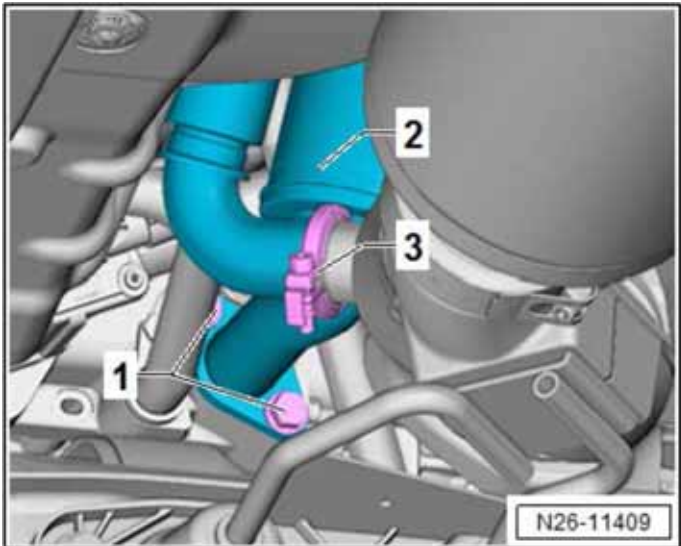
- Remove clamp <3> between EGR filter and Particulate filter.

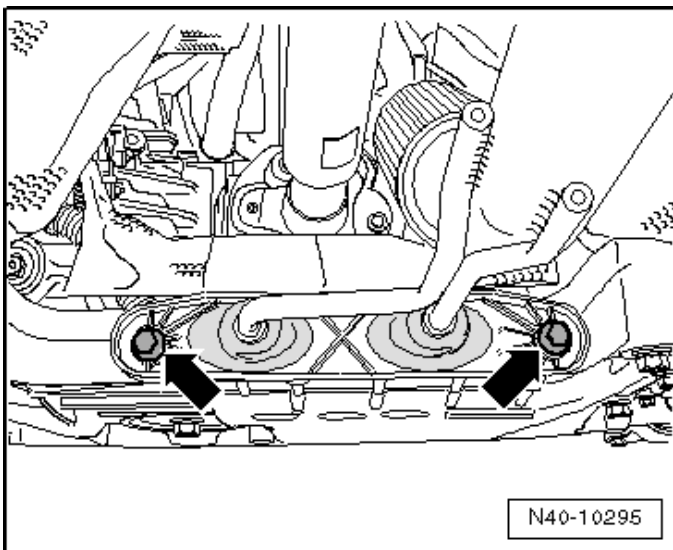
- Remove exhaust system bracket from subframe <arrows>.

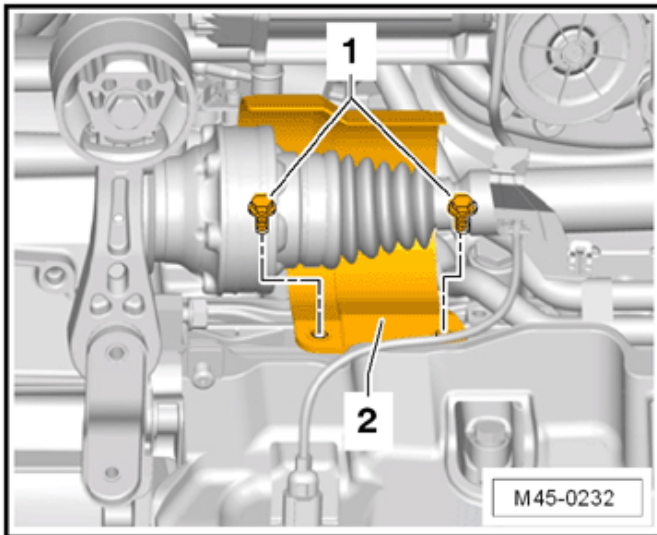
- Remove the bolts <1> and remove the drive axle cover <2>.
- Loosen the double clamp on the exhaust pipe and push it toward the rear (if required).

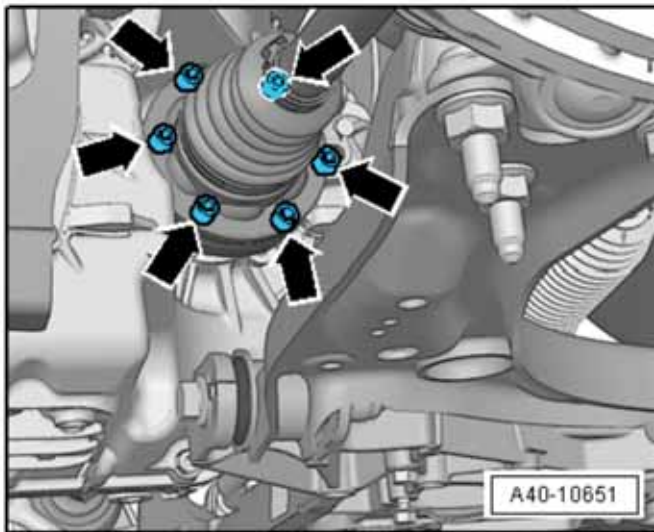
- Remove and discard bolts <arrows> and remove right drive axle from transmission.
- Rest drive axle on front subframe.

The drive axle does not need to be removed from the vehicle or unbolted from the wheel hub.

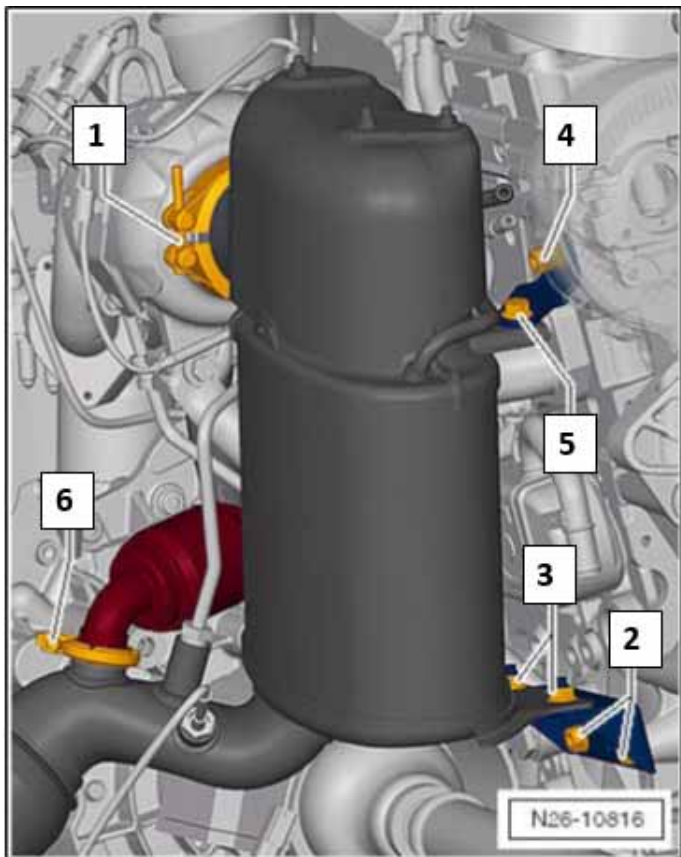
- Loosen bolt <4>, but do not remove.

Loosening this bolt now is required due to the tightening sequence to be performed during re-assembly.

Use a commercially available 13 mm combination wrench with a 15° offset and a total length of 140 mm to loosen nut <4>.

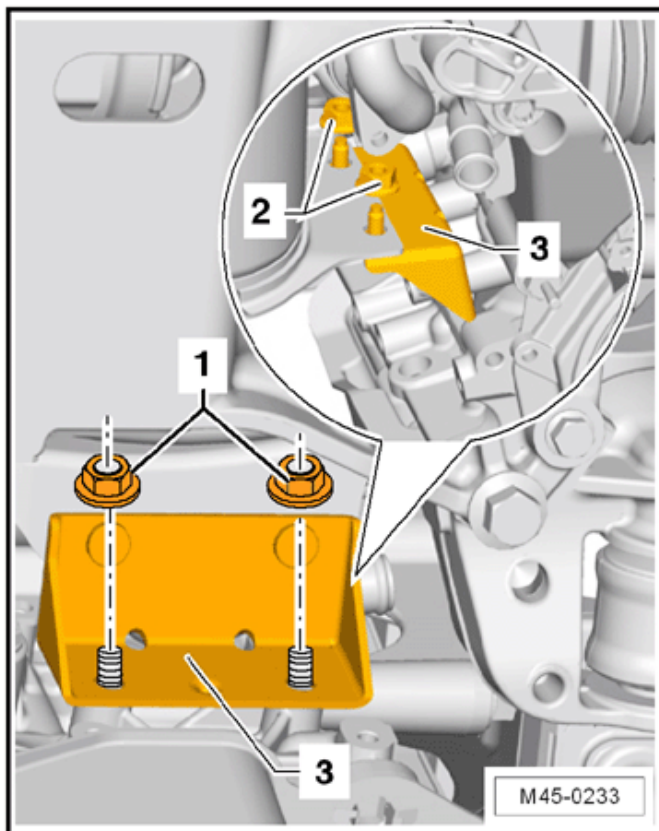
- Remove the nuts <1> and lower the particulate filter.
- Remove the nuts <2> and remove the particulate filter bracket <3>.
- Lower the particulate filter just enough so that it touches the steering gear.

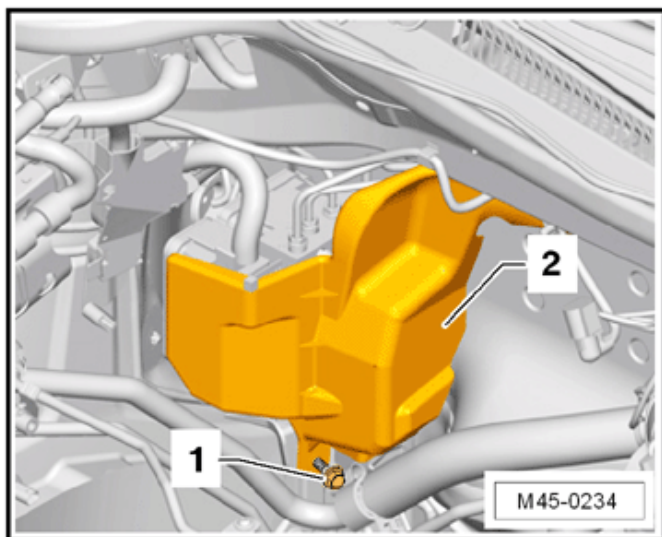
- Remove the nut <1> and remove the heat shield <2> (if equipped).

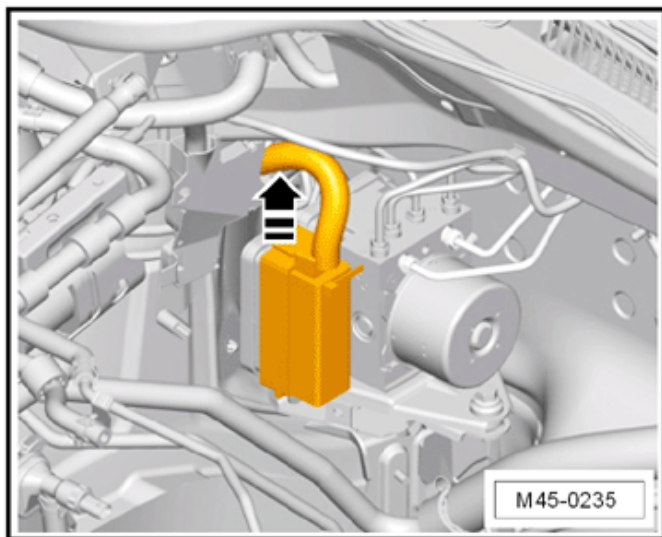
- Release and remove connector from control module in <direction of arrow>.

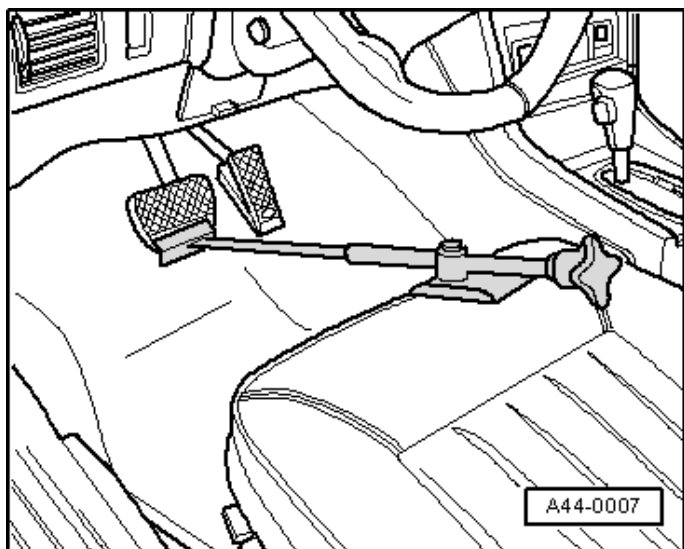
- Insert Brake Pedal Actuator -V.A.G 1869/2-.

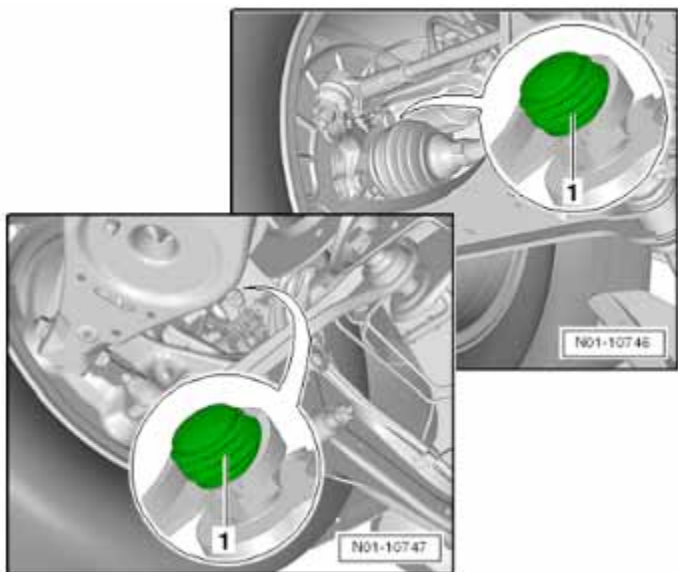
- Remove bleeder valve caps <1> from the left front and left rear brake bleeder valves.

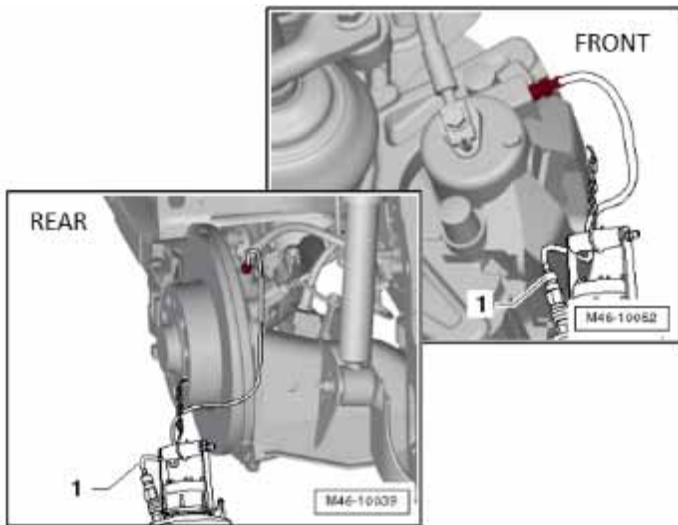
- Attach a bleed hose to the left front and left rear brake caliper breather valves.

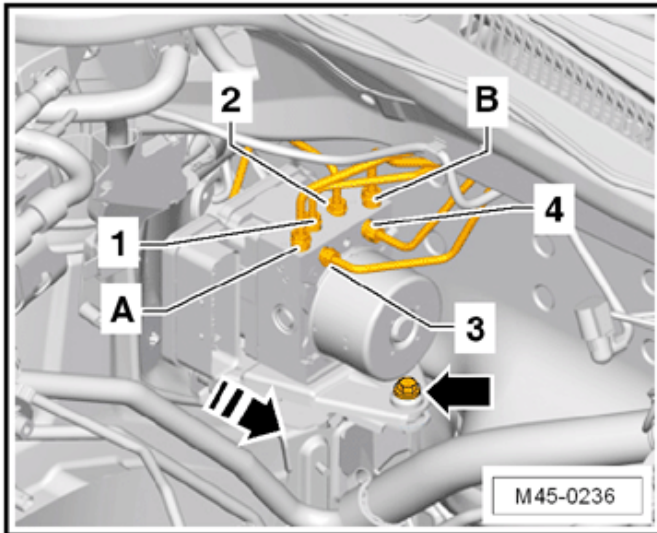
- To protect against escaping brake fluid, place a lint-free rag in the area under the control module and hydraulic unit.
- First, mark the installed position of both brake lines from master cylinder <A and B> and remove from the hydraulic unit.
- Seal threaded holes in the hydraulic unit with black sealing plugs (provided with new ABS module) and cover exposed brake lines using a clean plastic bag to prevent leaking brake fluid.
- Mark the installed position of brake lines (brake calipers) <1 through 4> and remove.
- Seal threaded holes in the hydraulic unit with clear sealing plugs (provided with new ABS module) and cover exposed brake lines using a clean plastic bag to prevent leaking brake fluid.
- Remove bolt <arrow> from the bracket.
- Remove the hydraulic unit, the control module and the side retainer in <direction of arrow> from the bracket rubber insulation.

When removing the brake lines from the ABS module, the threaded holes in the hydraulic unit must be sealed. The new ABS module includes sealing plugs. The black plugs are for threaded holes <A and B> in the work procedure and the clear plugs are for threaded holes <1 through 4> in the work procedure.

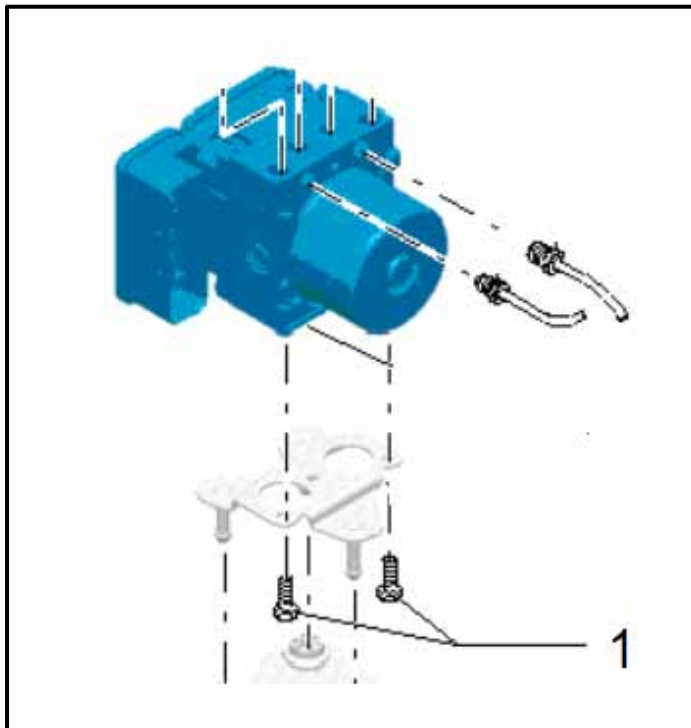
- Remove bolts <1> and separate the hydraulic unit from the bracket.

Remove the bracket from the hydraulic unit while the assembly is still in the engine compartment.

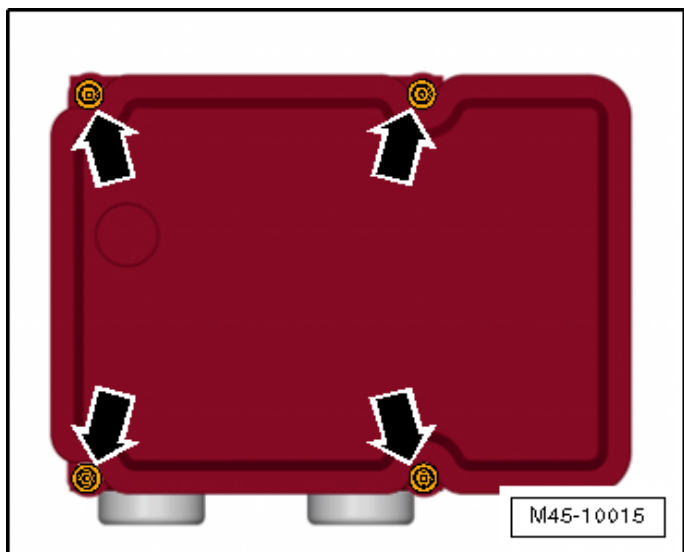
- Remove and discard bolts <arrows>.

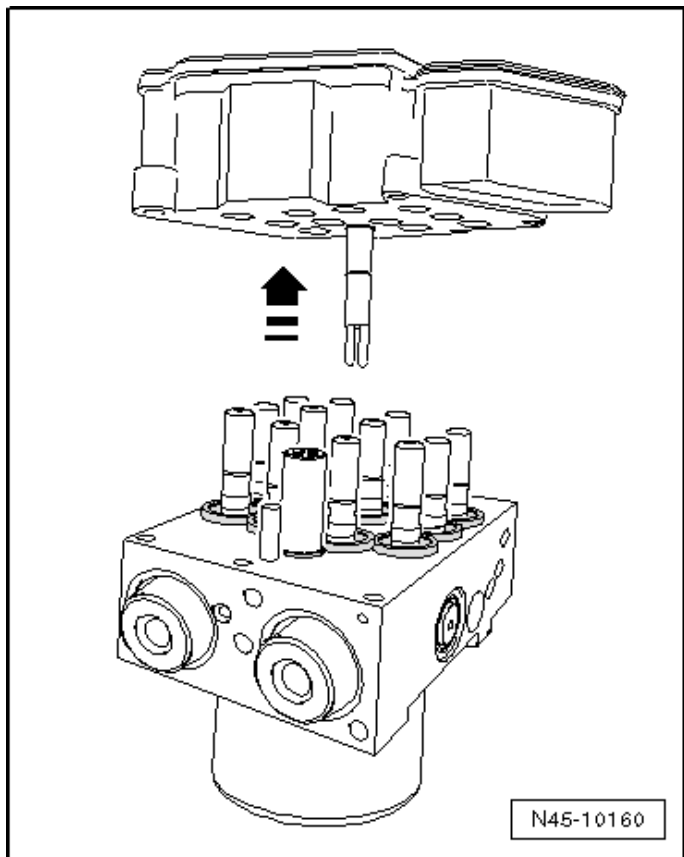
- Remove the ABS Control Module -J104- from the ABS Hydraulic Unit -N55- in the direction of <arrow> without tilting it.
- Carefully remove and discard all the seals from the valve domes on the ABS Hydraulic Unit -N55-.
