# Safety Recall

## Code: 45F2

<b>Subject</b>	<b>ABS Control Module Software</b>
<b>Release Date</b>	February 24, 2017
<b>Revision Summary</b>	<b>Work procedure updated.</b>
<b>Affected Vehicles</b>	<b>Certain 2009-2010 MY Volkswagen Vehicles</b>  <i>Check Campaigns/Actions screen in Elsa on the day of repair to verify that a VIN qualifies for repair under this action. Elsa is the <u>only</u> valid campaign inquiry &amp; verification source.</i> <ul style="list-style-type: none"><li>✓ Campaign status must show "open."</li><li>✓ If Elsa shows other open action(s), inform your customer so that the work can also be completed at the same time the vehicle is in the workshop for this campaign.</li></ul>
<b>Problem Description</b>	On certain vehicles, a fault within the antilock brake system (ABS) may cause the module to fail during ABS and/or electronic stability control (ESC) activation. This will cause warning lights for ABS, brake and the ESC systems to illuminate. If this happens, the brake system related vehicle stabilizing functions (ABS/ESC) may not be available, increasing the risk of a loss of vehicle control and could lead to a crash causing injury and/or property damage.

<b>

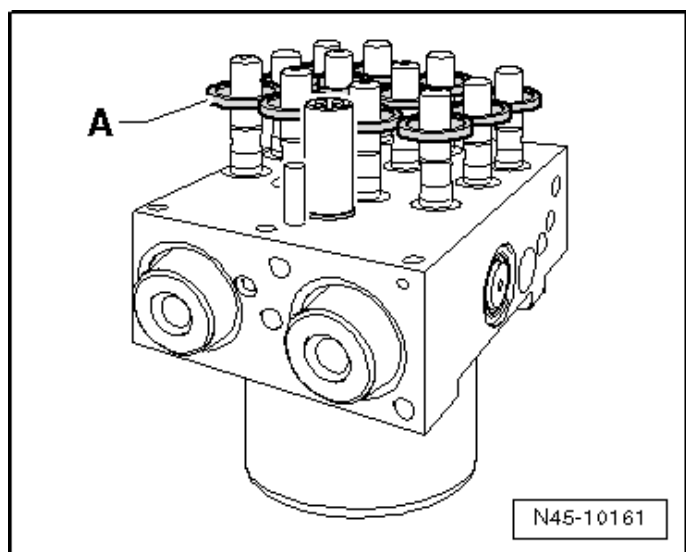
- Install new sealing rings <A> slightly over the valve domes as shown.

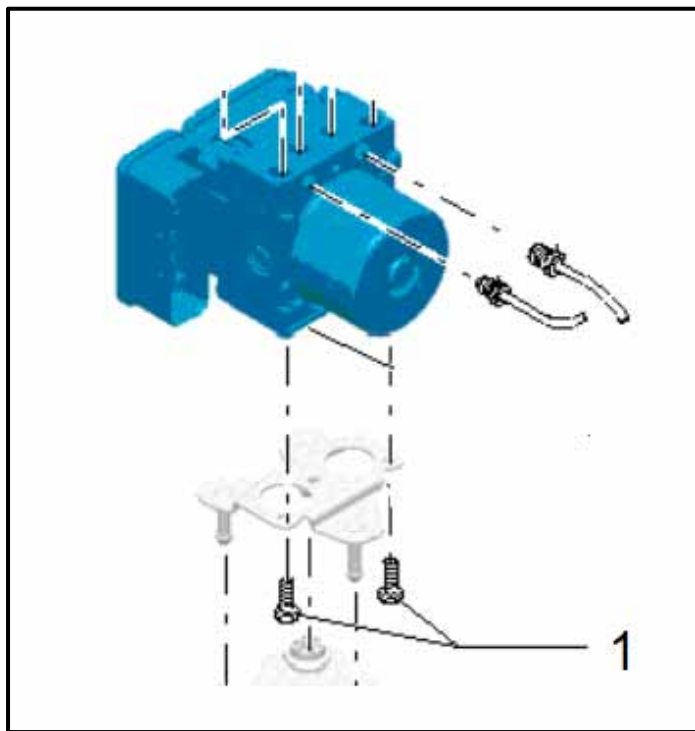
- Working inside the engine compartment, install the bracket to the ABS Hydraulic Unit -N55- and torque the bolts <1> to 8 Nm.

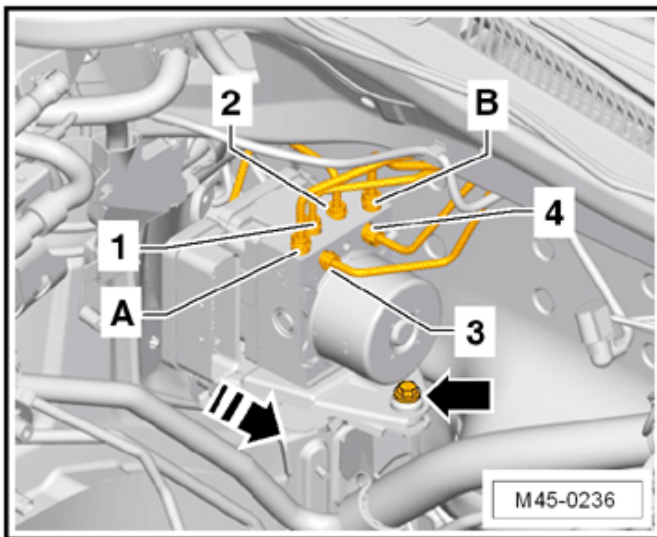
- Install the ABS Hydraulic Unit -N55- with the ABS Control Module -J104- and the bracket sideways into the rubber bushings on the console.

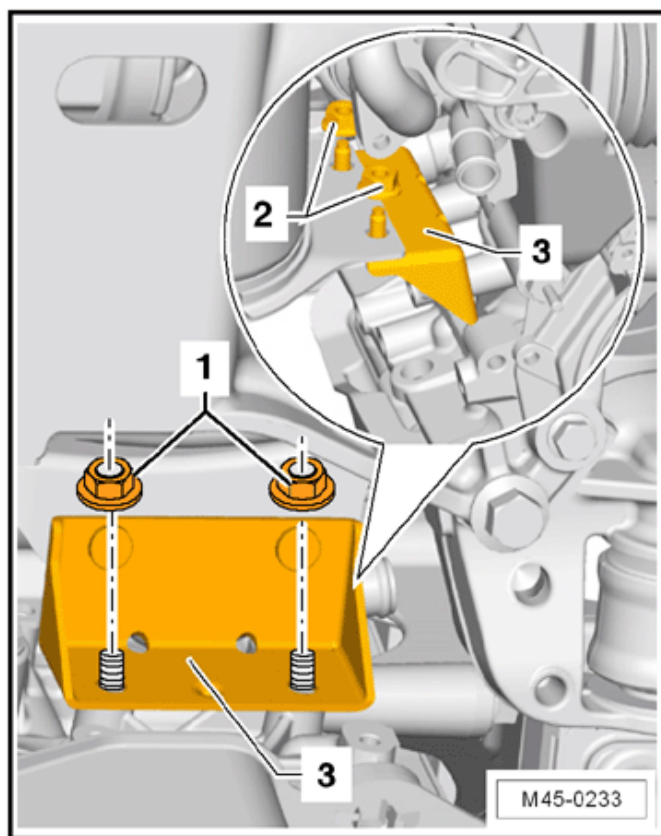
- Position new clamp and gasket onto particulate filter, but do not tighten clamp at this time.

- Install particulate filter bracket <3> with nuts <2> but do not tighten at this time.
- Position particulate filter onto bracket <3>.
- Install nuts <1>, but do not tighten at this time.

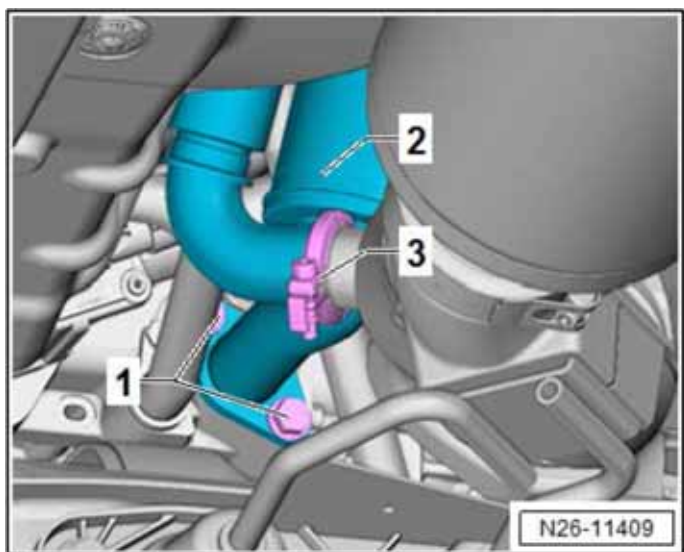
- Install new clamp and gasket between EGR filter and Particulate filter.

- Snug the clamp bolt by hand, but do not tighten at this time.

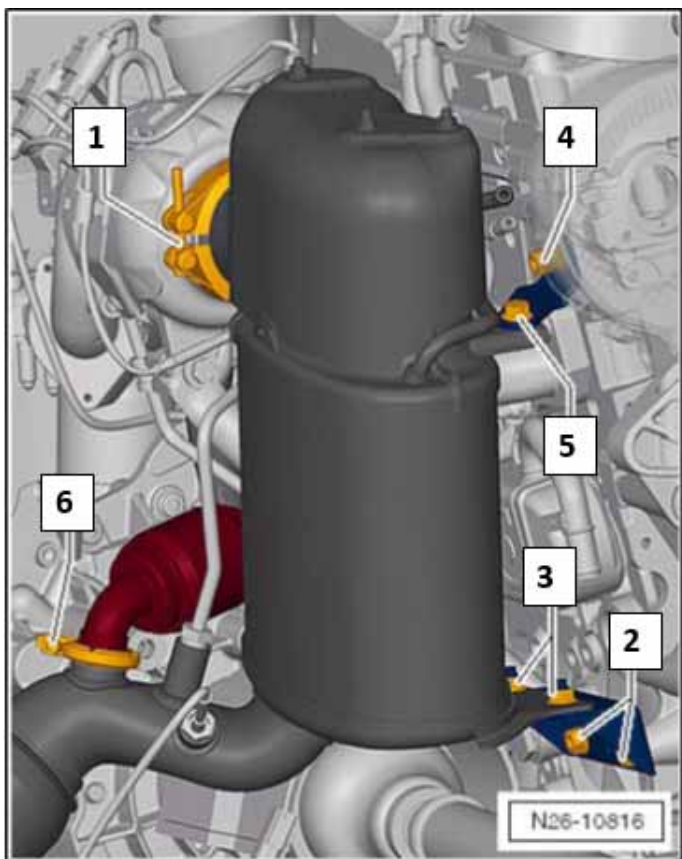
- Install bolt <5> loosely by hand.
- Particulate filter and bracket must be able to move.
- Tighten fasteners in the following order:

1	Tighten clamp <1>	7 Nm
2	Tighten nuts <2>	23 Nm
3	Tighten nuts <3>	23 Nm
4	Tighten nut <4>	23 Nm
5	Tighten nut <5>	23 Nm
6	Tighten nut <6>	3.5 Nm

Tightening sequence must be followed. Failure to follow this sequence can result in an exhaust leak. Diagnosis or repair of faults associated with an exhaust leak will not be covered by this action.

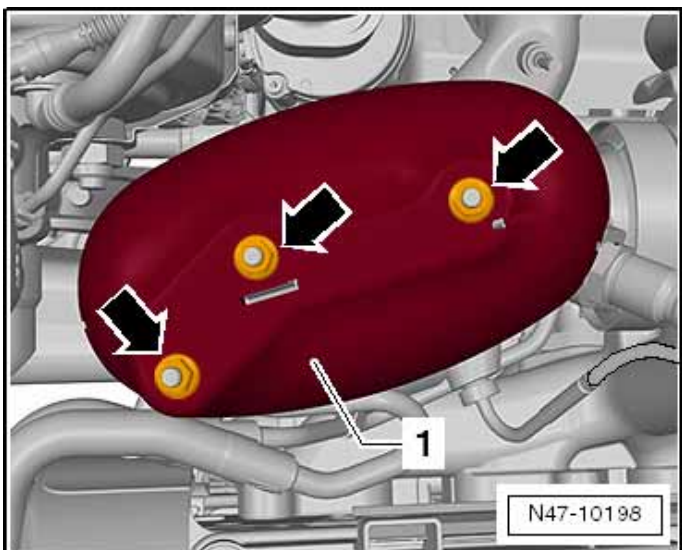
- Install heat shield <1> and torque nuts to 10 Nm.

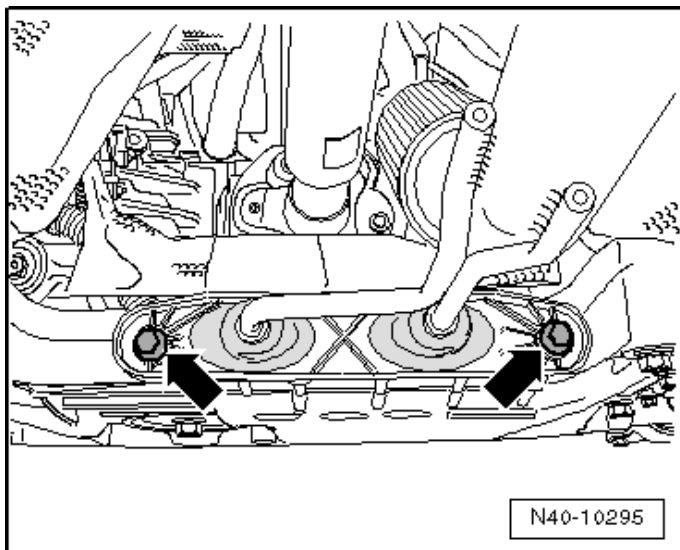
- Install exhaust system bracket and torque bolts <arrows> to 25 Nm.

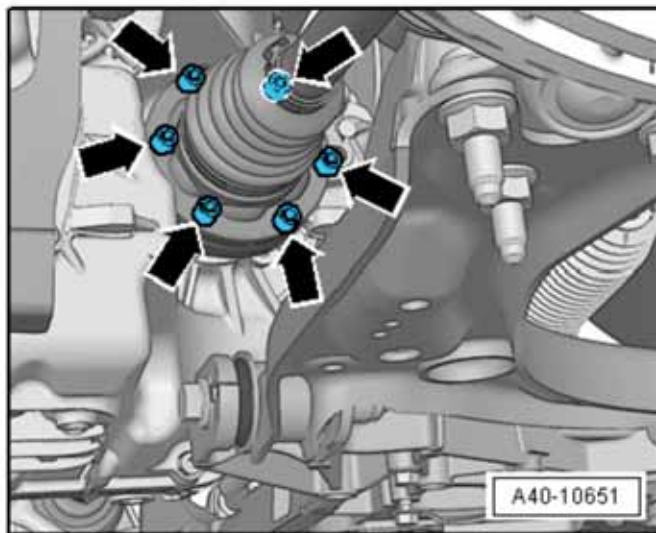
- Position right drive shaft and screw in new bolts <arrows>. Tighten bolts initially to 10 Nm, then tighten further to 70 Nm.

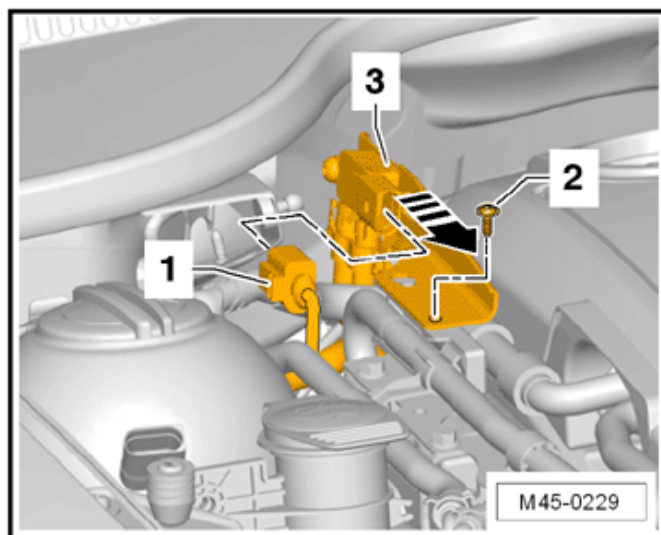
- Install the bracket <3> with the Exhaust Pressure Sensor 1 -G450- in <opposite direction of arrow> and torque bolt <2> to 4 Nm.
- Connect connector <1> to the Exhaust Pressure Sensor 1 -G450-.

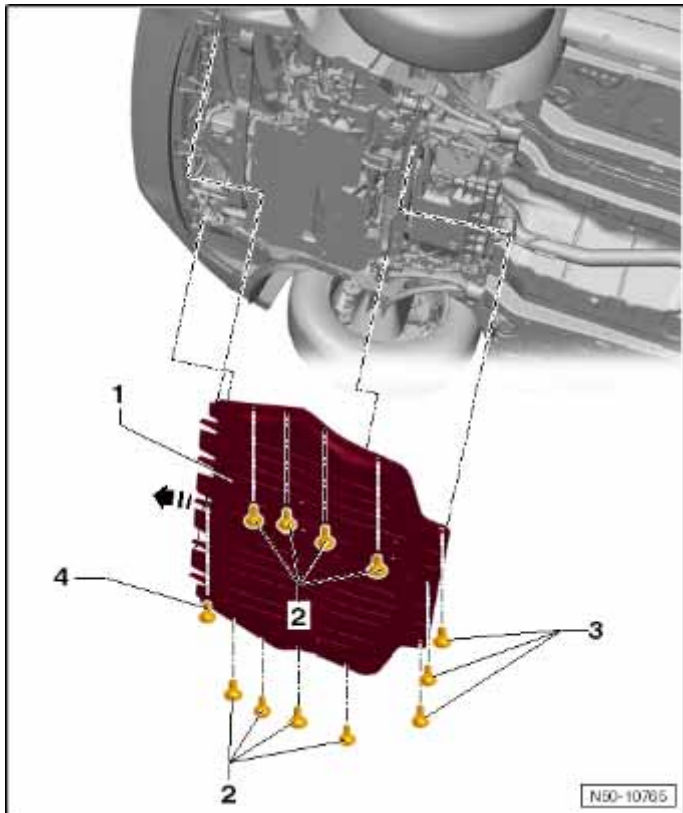
- Install noise insulation <1>. Torque bolts <2> to 2 Nm and bolts <3> to 6 Nm.

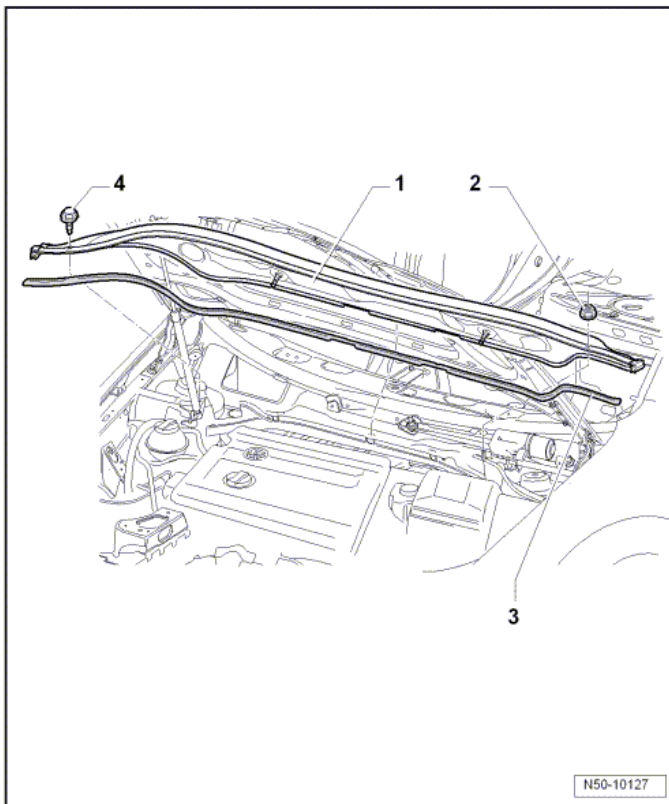
- Install plenum chamber bulkhead. When installing bulkhead, make sure seal <3> is seated correctly.
- Install bolt <4> and nut <2> and torque to 8 Nm.

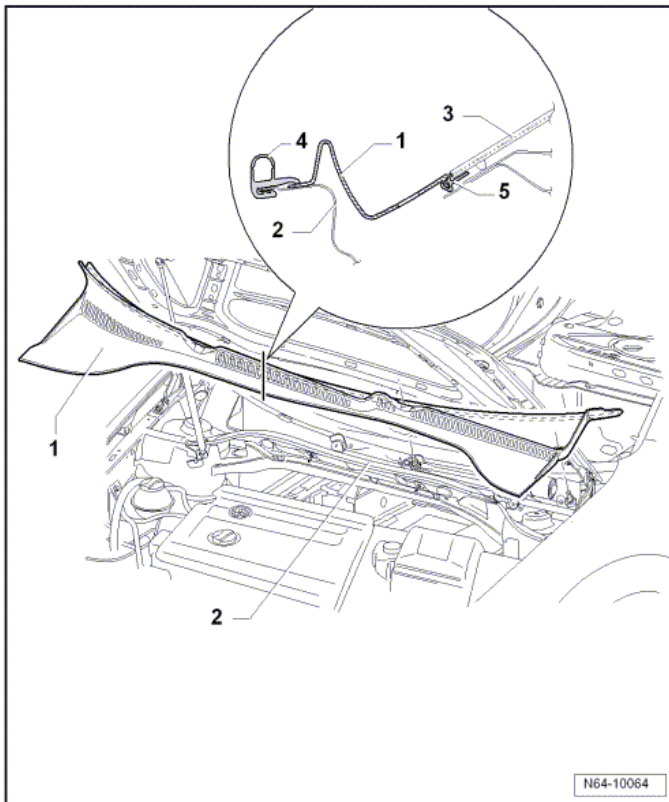
- Spray binding profile <5> with soap solution so that plenum chamber cover <1> can be pressed in more easily.
- Place plenum chamber cover <1> onto binding profile <2> and engage it with binding profile <5> starting from center using light pressure.
- Install plenum chamber seal <4>.

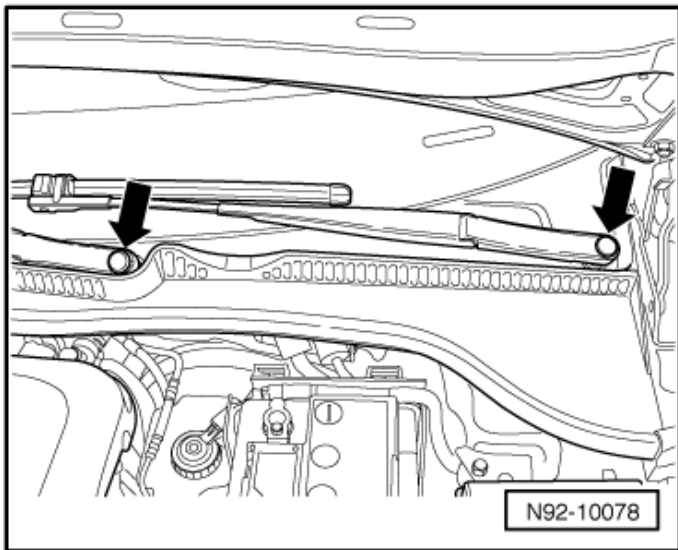
- Turn on the ignition and then switch the windshield wipers on and off so that the Windshield Wiper Motor -V- goes into its park position.
- Mount both wiper arms on the wiper arm shafts and install the nuts <arrows> hand-tight.

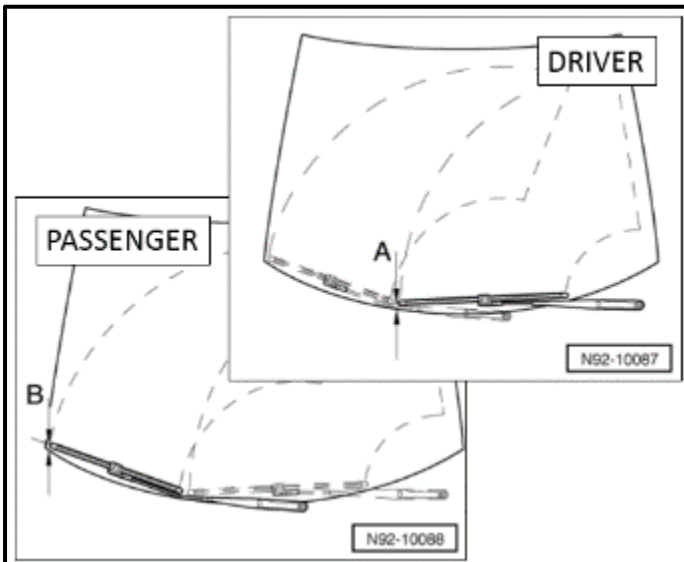
- Adjust the wiper blade park position.
  - For the driver side: distance <A> between tips of wiper lips and upper edge of plenum chamber cover must be 10 mm.
  - For the passenger side: distance <B> between tips of wiper lips and upper edge of plenum chamber cover must be 10 mm.
- Torque wiper arm nuts to 20 Nm and install protective caps.

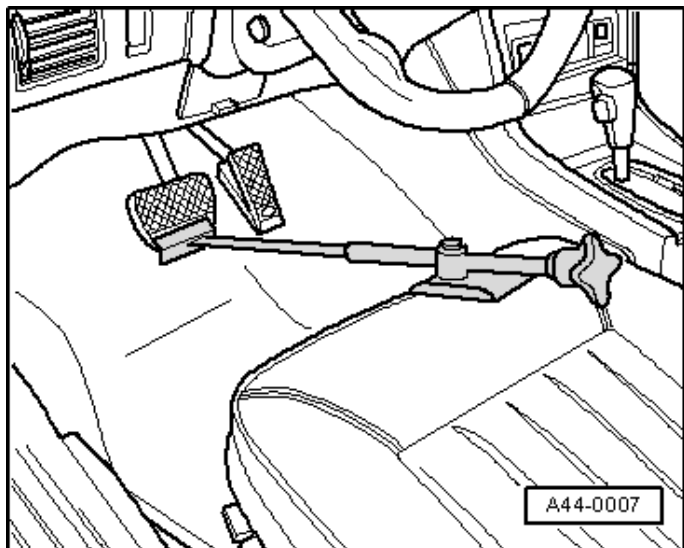
- Remove the Brake Pedal Actuator -V.A.G 1869/2-

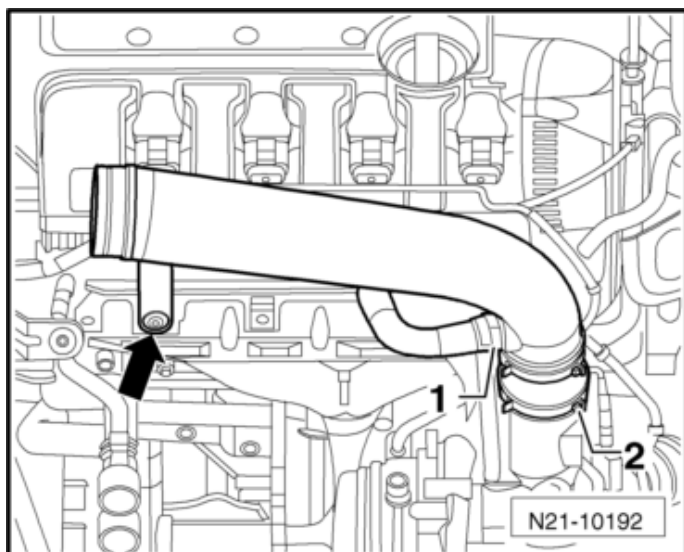
- Remove sealing bung from turbocharger.
- Install the air duct pipe and torque bolt <arrow> to 10 Nm.
- Install the intake hose between the intermediate pipe and the turbocharger.

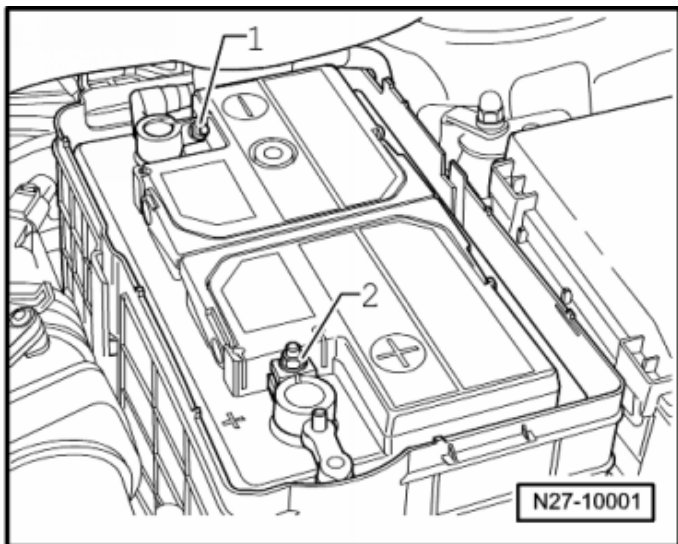
- Install engine cover.
- Connect the battery ground cable terminal by hand to the battery negative terminal.
- Torque the nut <1> to 6 Nm.
- Store previously recorded radio presets (if necessary)
- Set clock to local time.
- Activate the power window regulator one-touch up/down function.

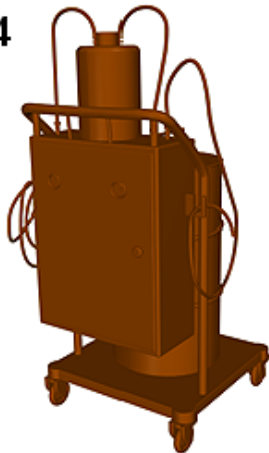
VAS 5234

- Attach the GRX3000VAS Tester/Charger (or equivalent) to the vehicle battery.
- Turn the ignition on.

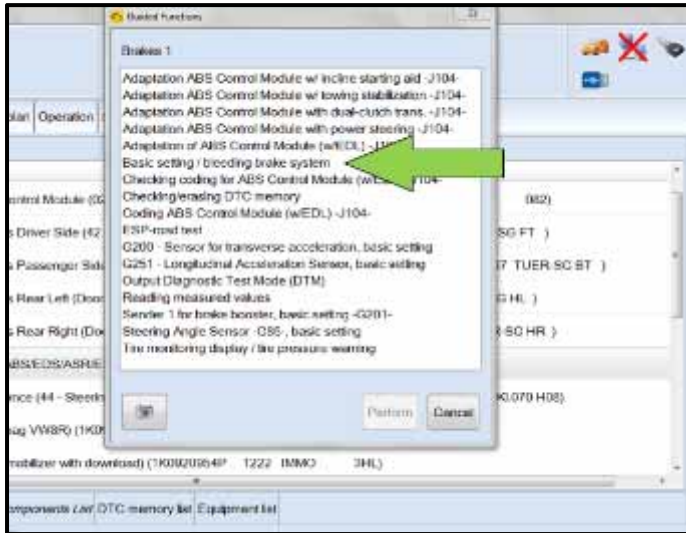
- Start the ODIS program.
- Hydraulic unit must now be bled once more via Guided Function test:
  - Select operating mode “Diagnosis”, scroll down and right click on Address Word 0003/ABS Control Module, select Guided Functions, select “Basic setting/bleeding brake system” <arrow> and follow on screen directions.
- After basic setting has been performed, remove the battery charger.

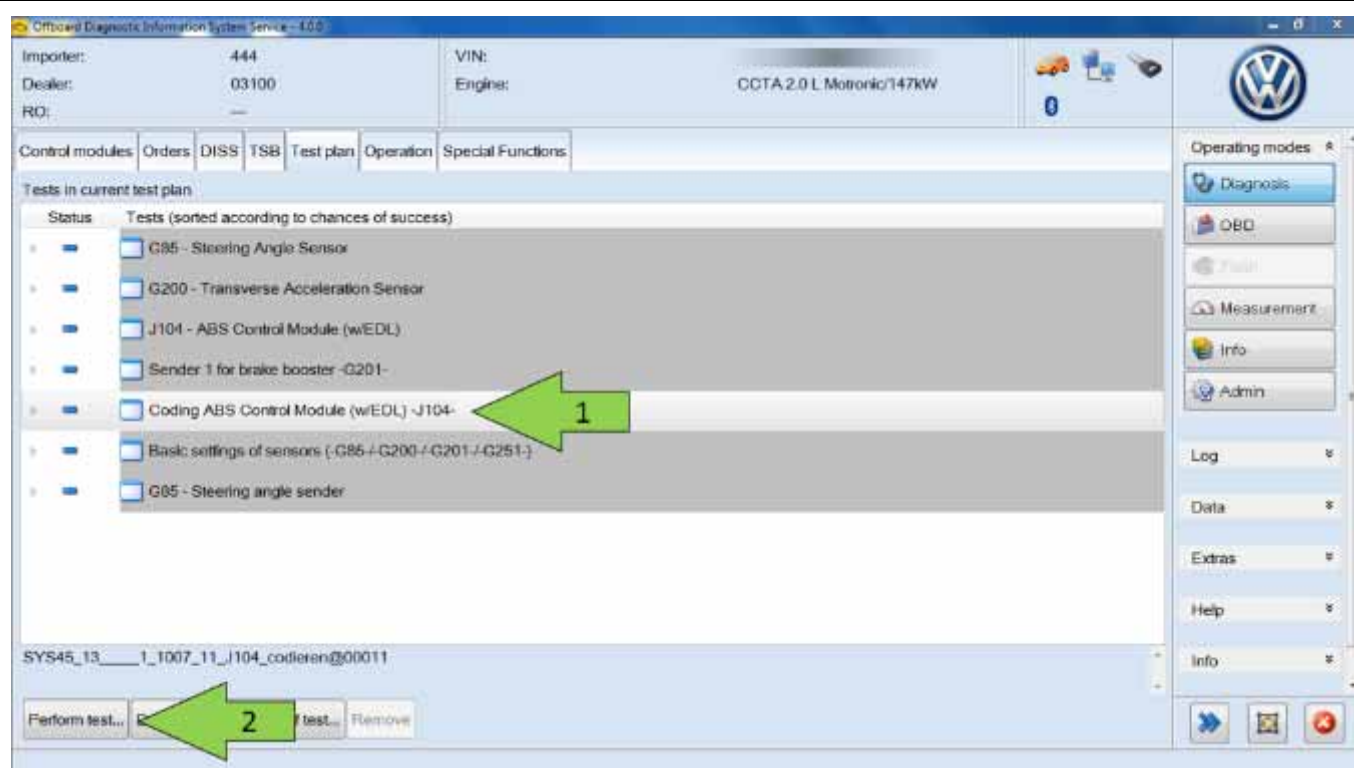
- Select "Coding ABS Control Module -J104-" <arrow 1>.
- Select "Perform test.." <arrow 2> and follow the on screen directions.

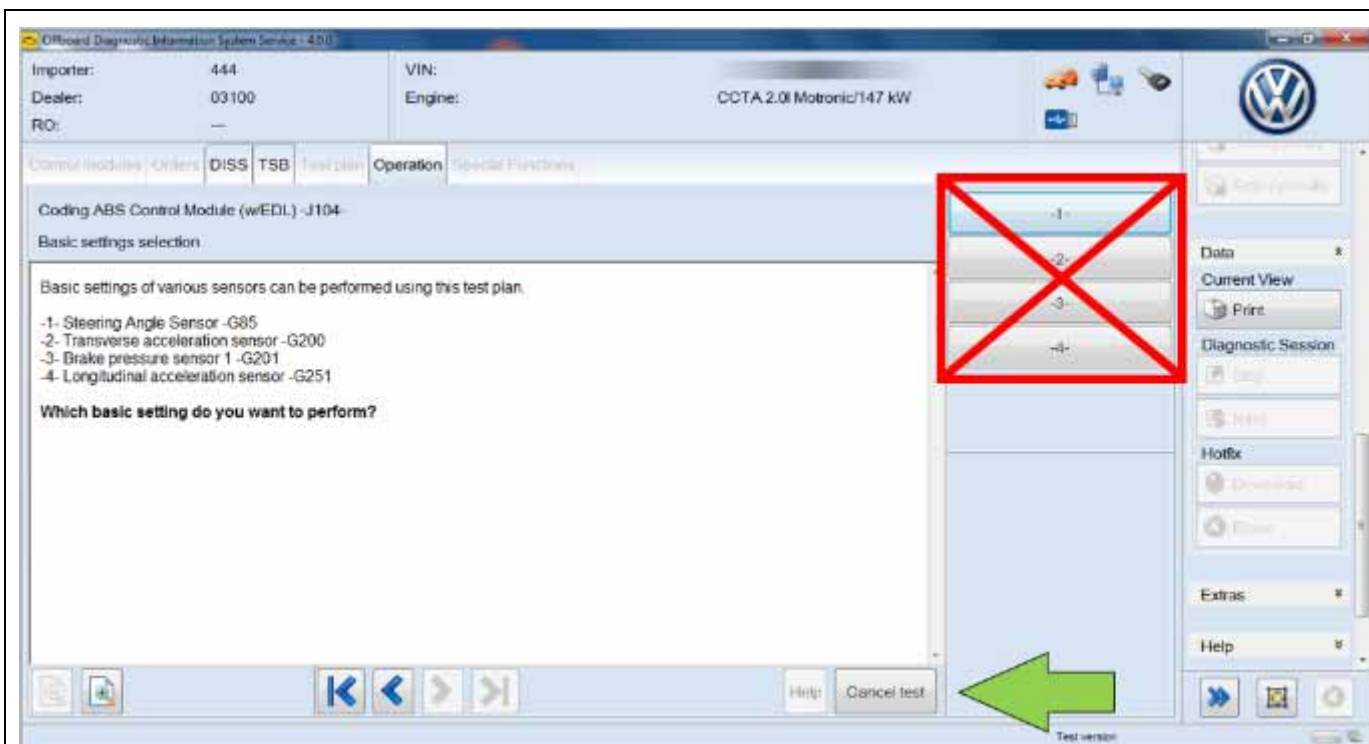
- After coding is completed, this screen may be displayed. DO NOT move forward in this test plan.
- Select “Cancel test” <arrow>.
- Remove the battery charger, close the hood.

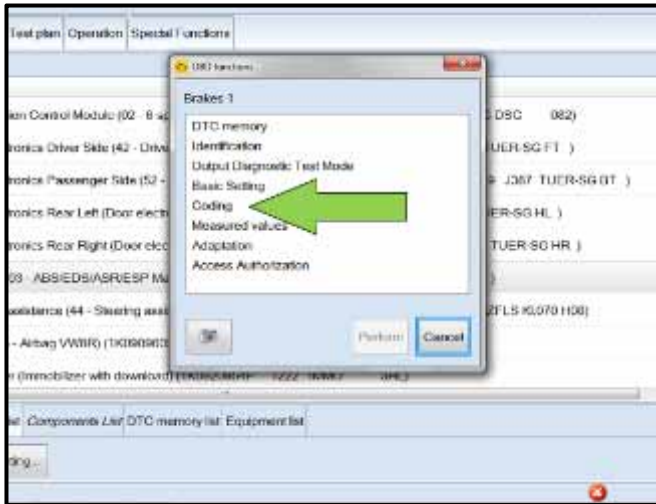
- Right click on Address 0003 (ABS Control Module), select “Control Module OBD” and then select “Coding”.

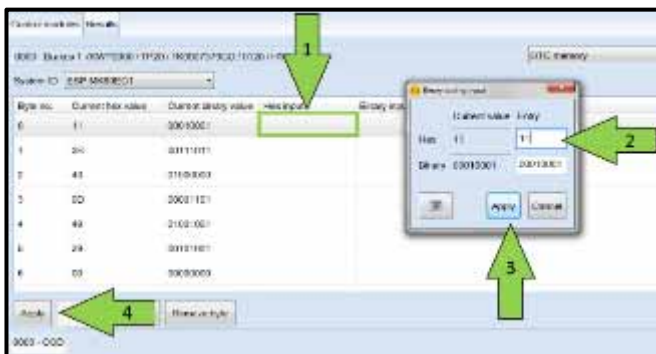
1. Left click on the empty box in the Hex Input column <arrow 1> for the appropriate coding byte.
2. Enter the previously recorded Hex value <arrow 2>.
3. Select Apply <arrow 3>.
4. Repeat for each coding byte.
5. Once all coding bytes have been entered, select Apply in the bottom left <arrow 4>.

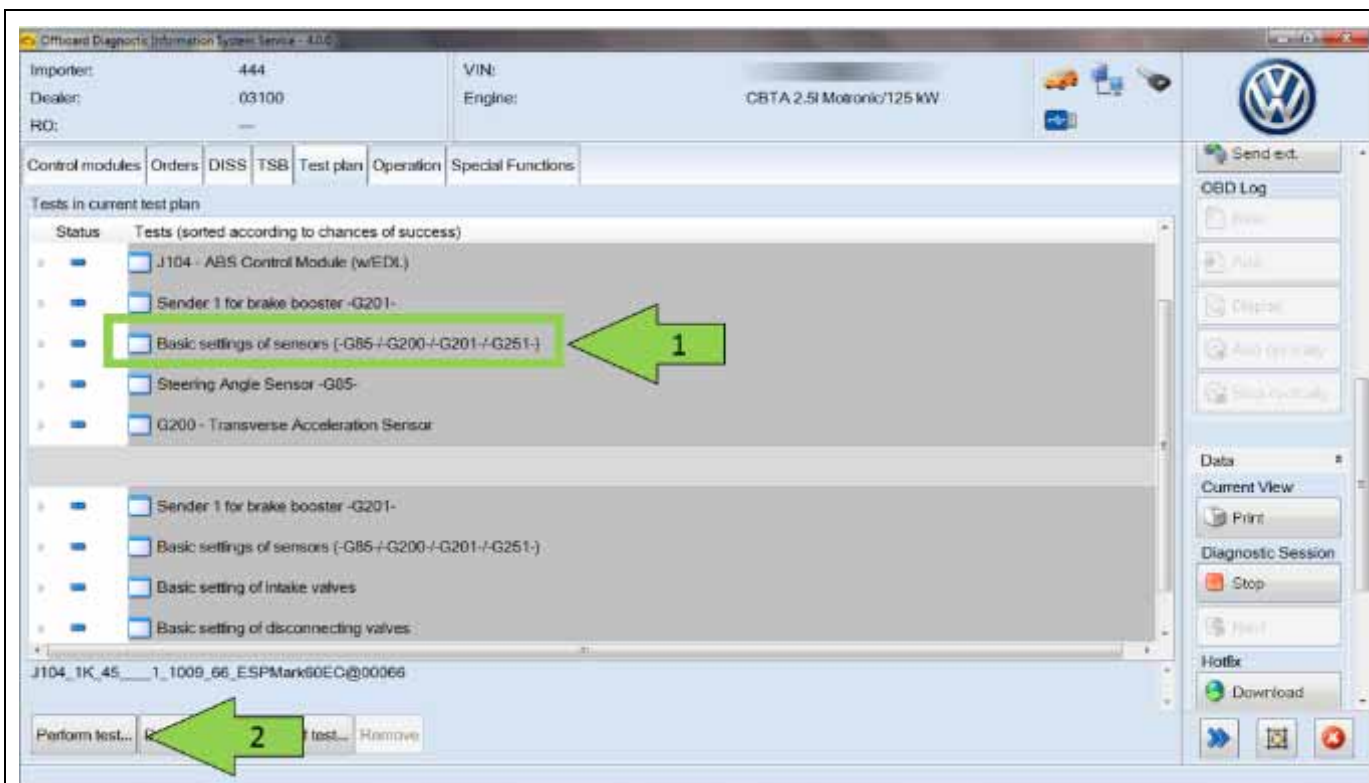
- Select “Basic settings of sensors (-G85-/G200-/G201-/G251-)” <arrow 1>.

- Select “Perform test..” <arrow 2> and perform the basic settings of all four sensors.
- Once the test plan is completed, the faults for each of the sensors can be cleared using Control Module OBD.
- Do not continue if the fault for “Brake pressure sensor 1 (G201)” is still stored. This fault must be cleared in order to set the basic settings of the intake and disconnecting valves.

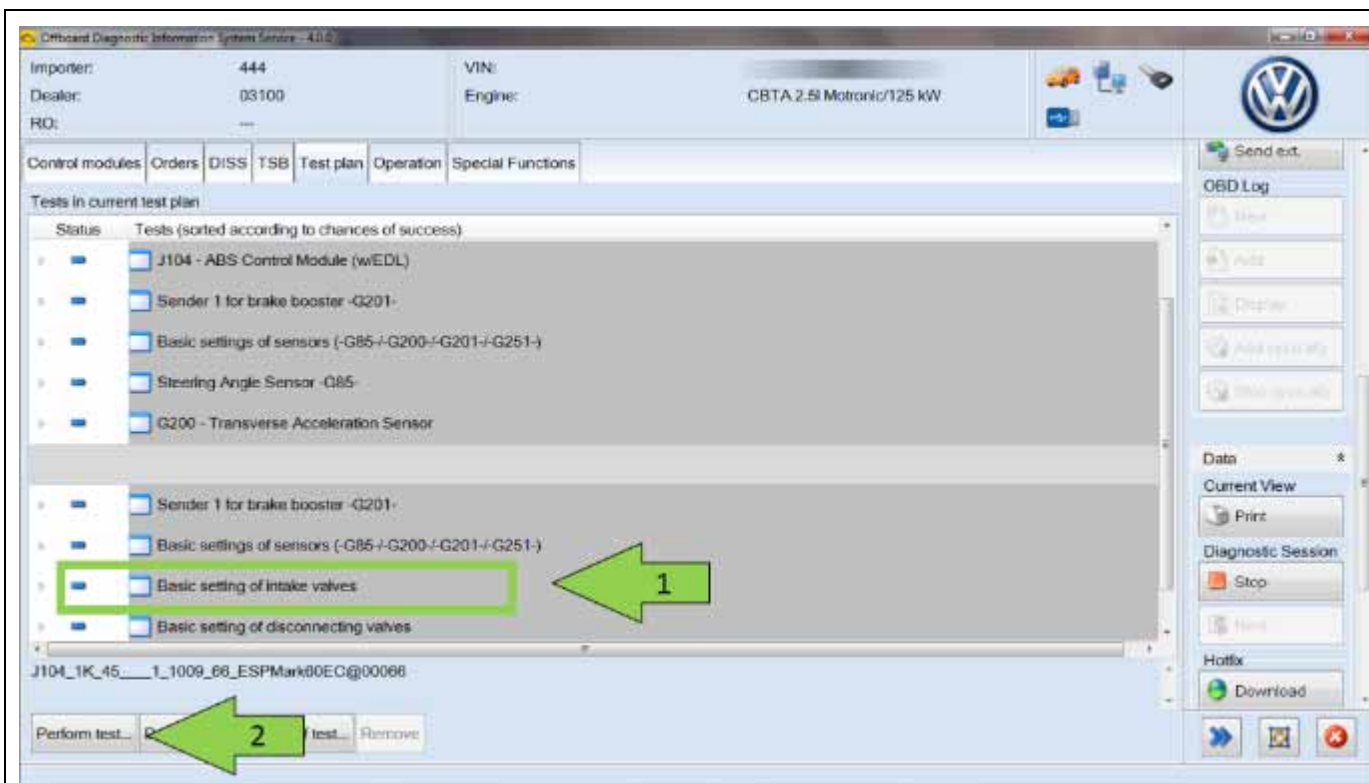
- Once the -G85-/G200-/G201-/G251- faults are cleared, select “Basic setting of intake valves” <arrow 1>.
- Open the hood.
- Select “Perform test..” <arrow 2> and follow on screen instructions.

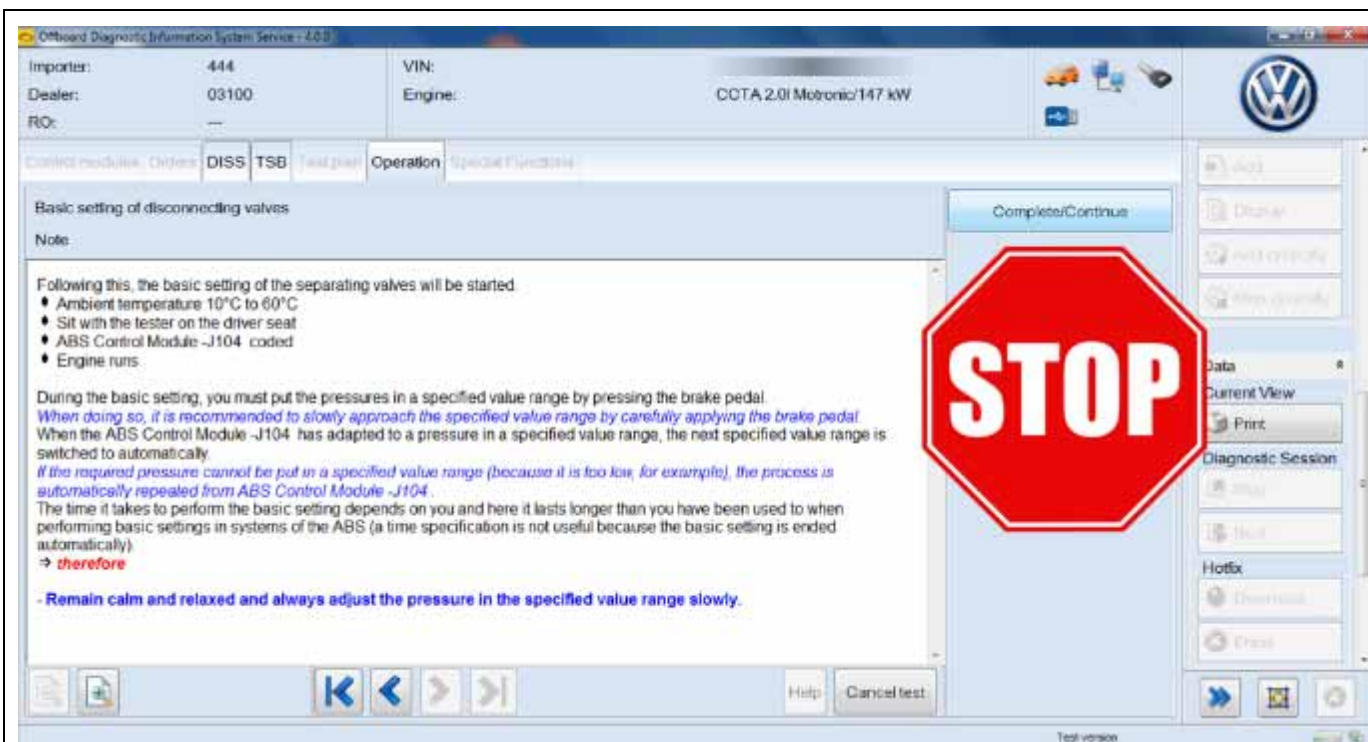
- When this message is displayed, **STOP!**
- Cycle the ignition off for 30 seconds.
- Turn the ignition back on and now press Complete/Continue.
- The test plan for setting the intake valves should now start.

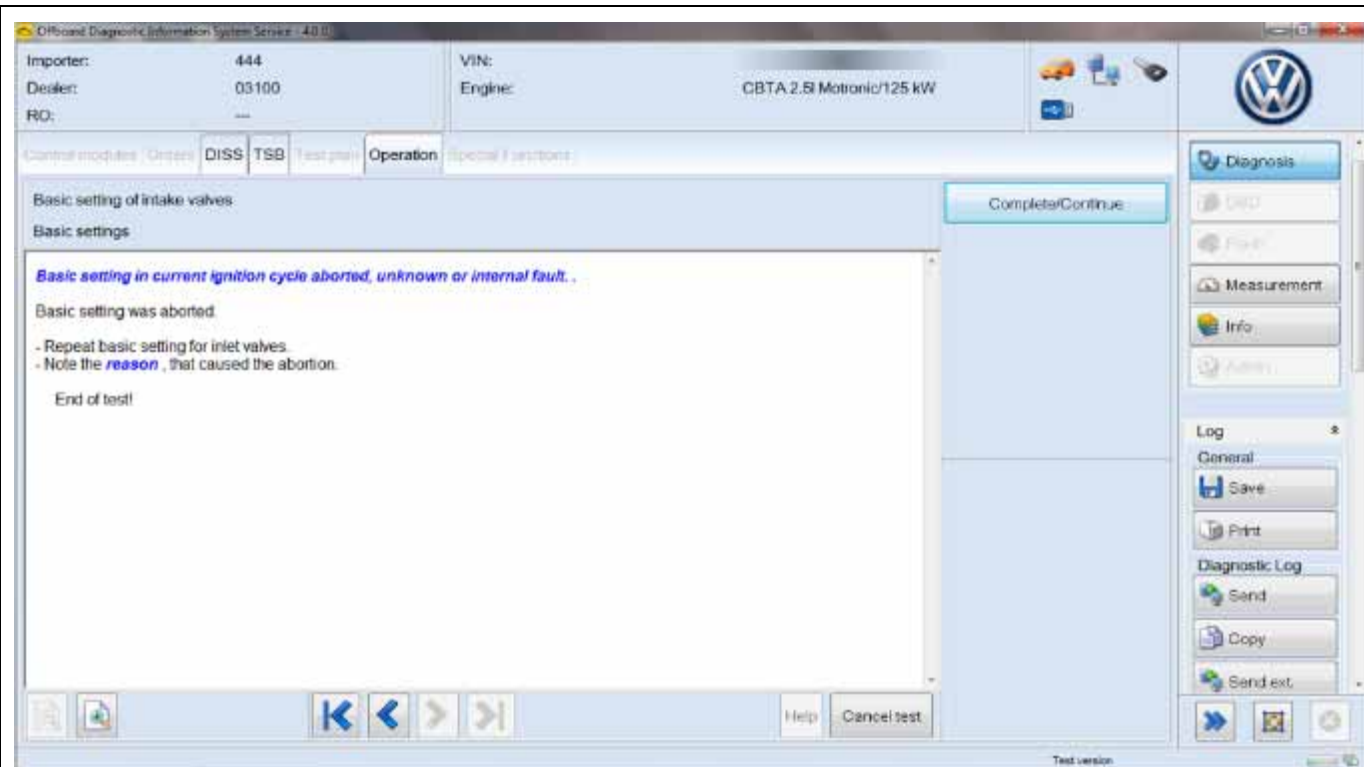
- It is possible that this screen is displayed after starting the “Basic setting of intake valves” test plan. The following have been found to get the test plan to start:
  - Clearing all vehicle system faults using Control Module OBD, cycling the ignition and repeating the test plan.
  - Exiting ODIS, rescanning the vehicle and repeating the test plan.
  - Shutting the engine off and leaving the ignition turned on for 30 minutes.

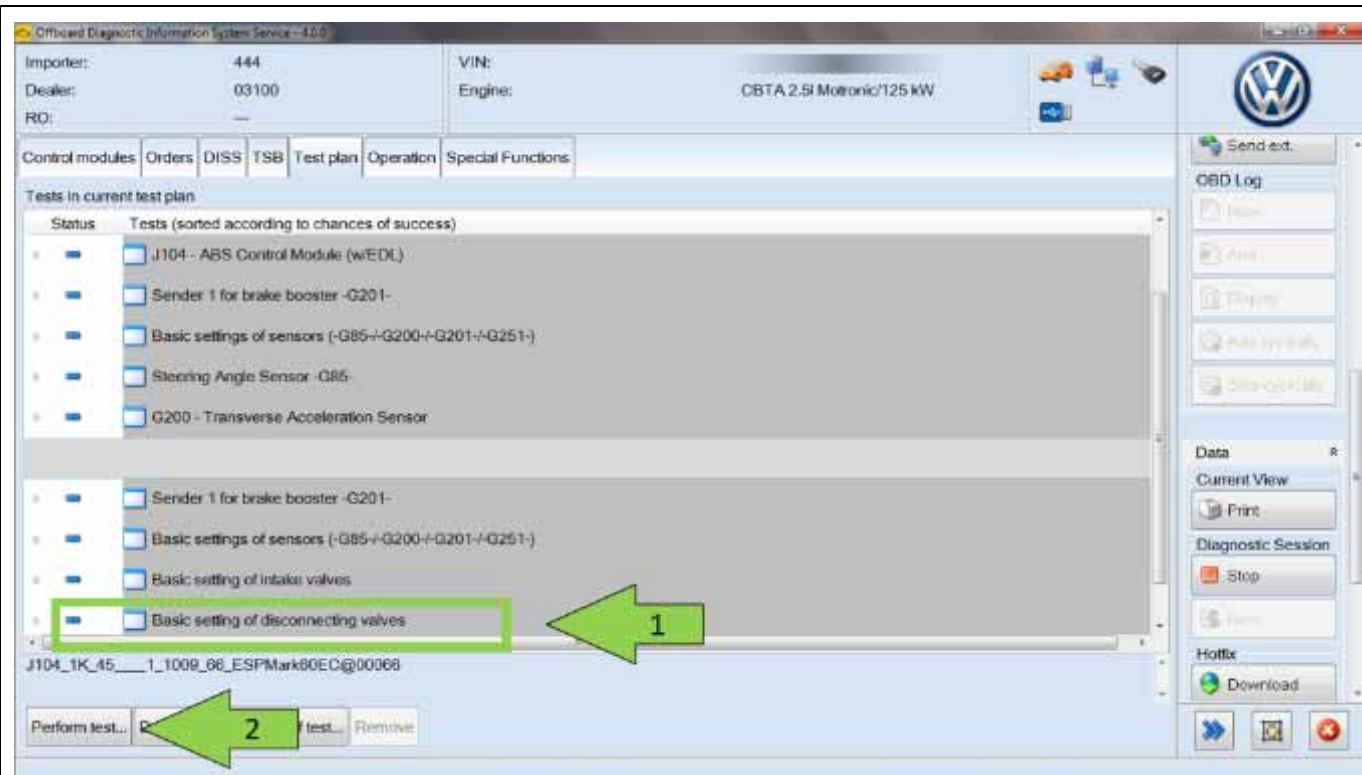
- Once the Basic setting of intake valves is complete, select “Basic setting of disconnecting valves” <arrow 1>.
- Select “Perform test..” <arrow 2>.
- An ignition cycle should not have to be performed.

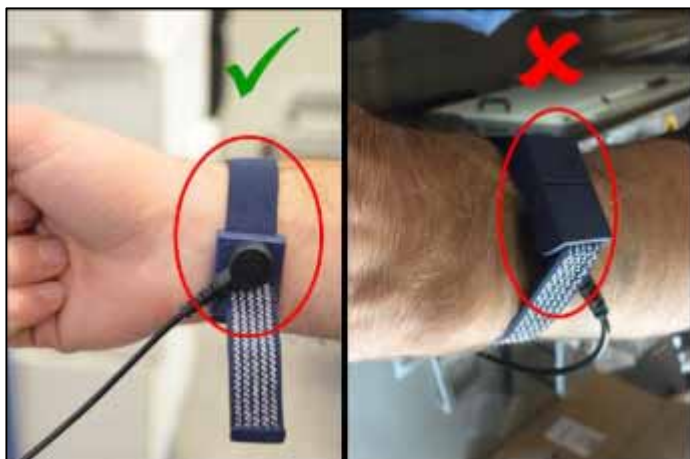
- Prior to beginning work, all parts and tools are to be placed on the ESD table mat.
- Assemble ESD workplace according to the instructions included with the ESD Workplace.
- The wall socket or extension cord used must have a sufficient ground.

The white dots on the wrist strap must be against the skin.
