# Product Safety Recall

## 15043 Driver Air Bag Replacement

**Reference Number:** N162028811

Involved are all 2006-2011 model year Saab 9-3 and 2006-2009 model year Saab 9-5 vehicles currently registered or previously registered in Alabama, California, Florida, Georgia, Hawaii, Louisiana, Mississippi, South Carolina, Texas, Guam, Puerto Rico, Saipan, U.S. Samoa or U.S. Virgin Islands.

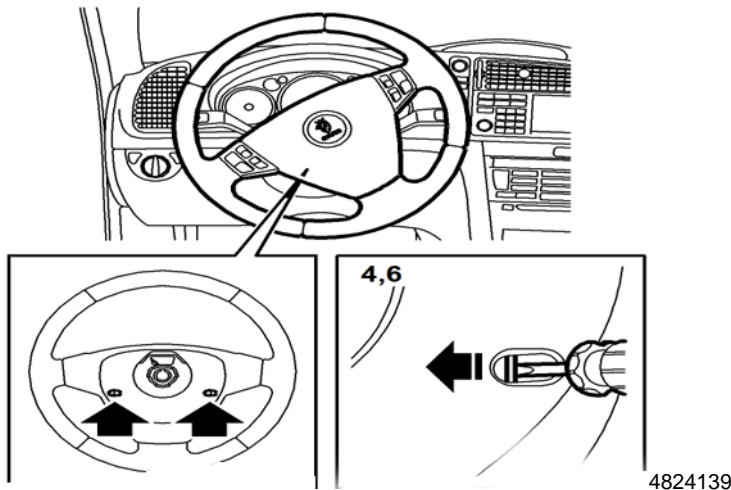
4. Bend away the spring clip with a screwdriver in the hole on the back of the steering wheel.
5. Turn the steering wheel 45° past the straight on position in the other direction.
6. Bend away the spring clip with a screwdriver in the hole on the back of the steering wheel.
