Product Safety Recall

15816 Front Passenger Air Bag Inflator

Reference Number: N150816

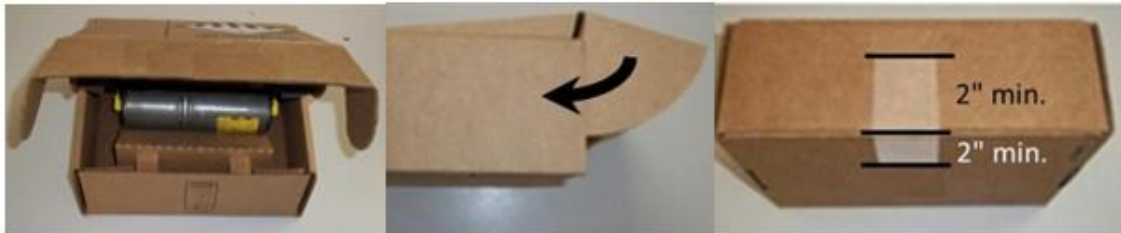
Close the top box flap, per box closure instructions located on front panel of box. Use a 2" wide x 4" long piece of clear packing tape to seal the box as shown below.
