Bulletin No.: 17130C  
Date: June 2016

# Recall Bulletin

**SUBJECT:** Loss of Key Reminder Chime

**MODELS:** 2013-2016 Chevrolet Sonic  
2013-2015 Chevrolet Spark  
2013-2016 Chevrolet Trax  
Equipped with Bring Your Own Media (RPO UF7)

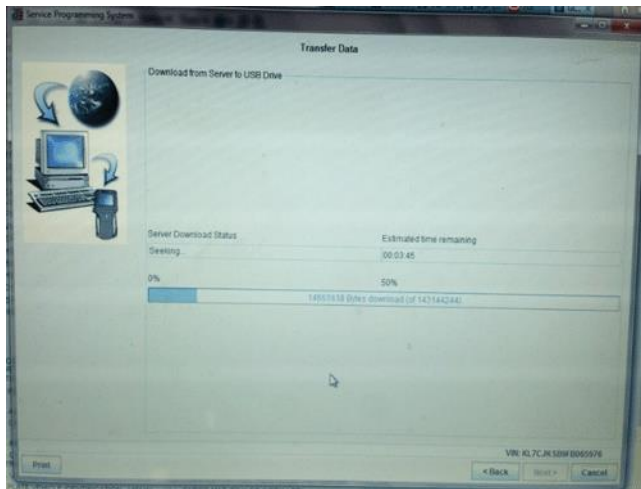
4516356

1. Install *EL-49642* SPS programming support tool.
2. Access the Service Programming System (SPS) and follow the on-screen instructions.  
**Note:** All existing files on the USB drive will be erased when the new files are copied.
3. Connect a USB drive to the computer.
4. On the SPS Supported Controllers screen, select A11 Radio – USB File Transfer, and follow the on-screen instructions.

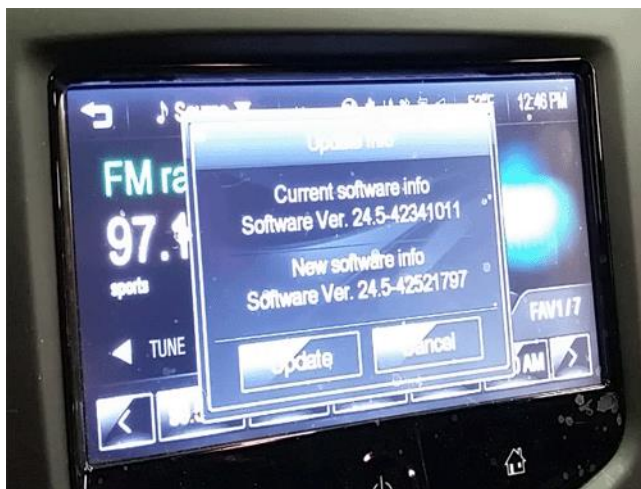
4516357

5. Upon completion of the file transfer, remove the USB drive from the computer.
6. Ignition ON, radio ON.
7. Connect the USB drive to the USB port in the vehicle.

**Note:** If "Update" is not selected within 30-60 seconds, the selection screen disappears and the USB drive will need to be removed and reinserted to initiate the USB software update again.

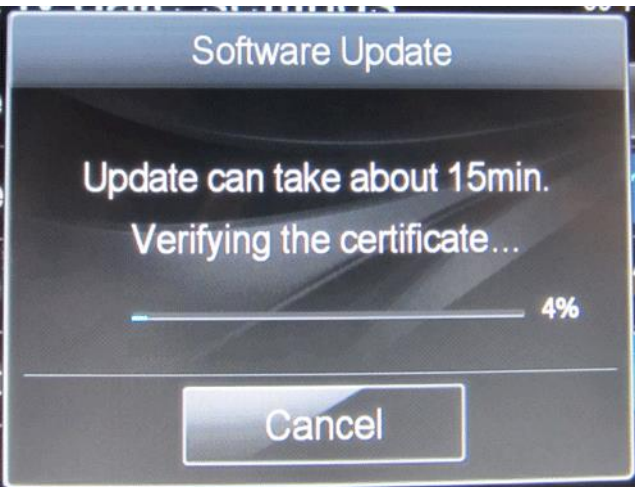
4516358

8. Follow the infotainment display on screen instructions and select "Update" when prompted. (Trax shown as example-Sonic and Spark will be similar).

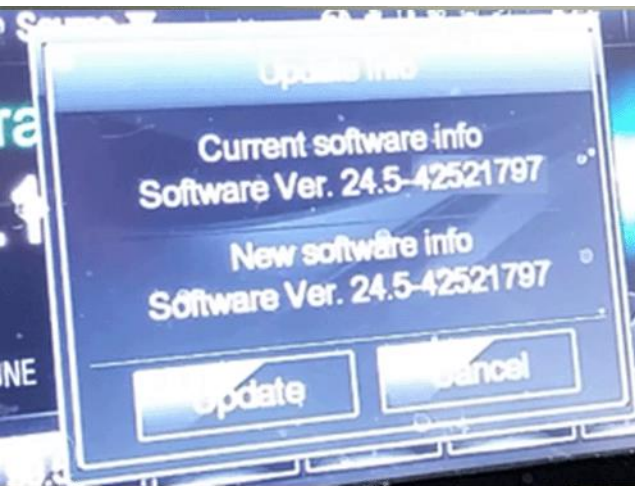
4516359

9. Programming will take several minutes.

**Note:** When USB programming has completed, the radio will go to the Home/Menu screen, and the calibration ID screen will show, confirming the current and new software is now the same. Audio should be playing before removing the USB drive. Select “Cancel” and continue to step 10. (Trax shown as example-Sonic and Spark will be similar).
