F/CMVSS Noncompliance Recall

45340 BYOM1 Lockup with Loss of Key Chime

Reference Number: A162045340

Correction	Reprogram the radio with corrected operating software.

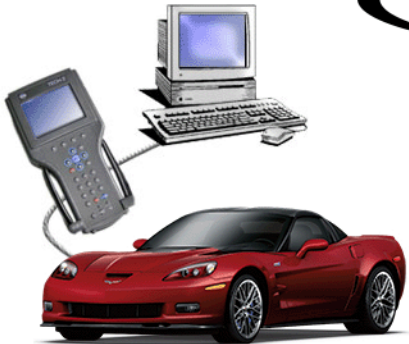
Action Complete
Radio - Programming (A11)
2017-12-06 09:14:03 EST

Warranty Claim Code: 8038A
Record this code on the warranty repair order (if applicable).

Important Notes/Remarks:
The Warranty Claim code is a required to confirm programming has been completed. Incorrect or missing Warranty Claim Codes may result in rejection of warranty claim.
Warranty claim codes for prior VINS serviced may be retrieved through "Settings" at SPS start page.
Follow the Controller Specific Instructions below.

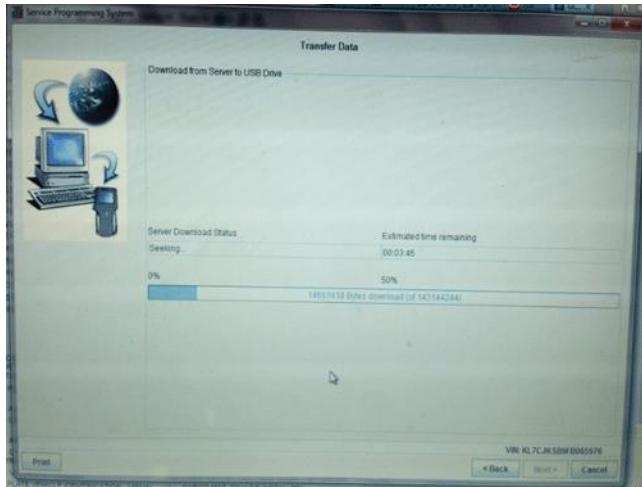
4516356

5. Upon completion of the file transfer, remove the USB drive from the computer.
6. Ignition ON, radio ON.
7. Connect the USB drive to the USB port in the vehicle.

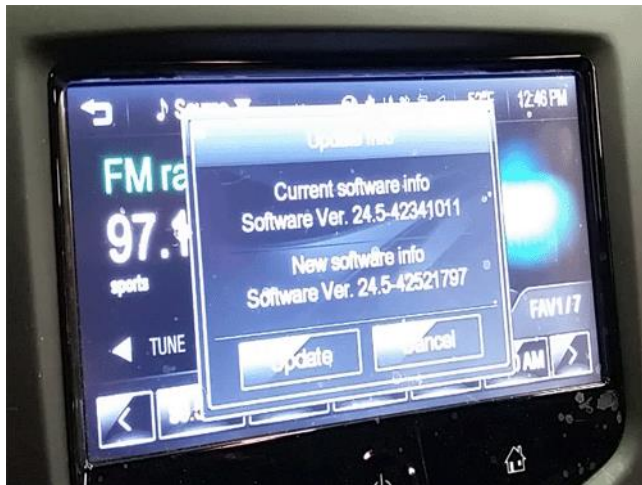
4516357

8. Follow the infotainment display on screen instructions and select "Update" when prompted. (Trax shown as example- Sonic and Spark will be similar).

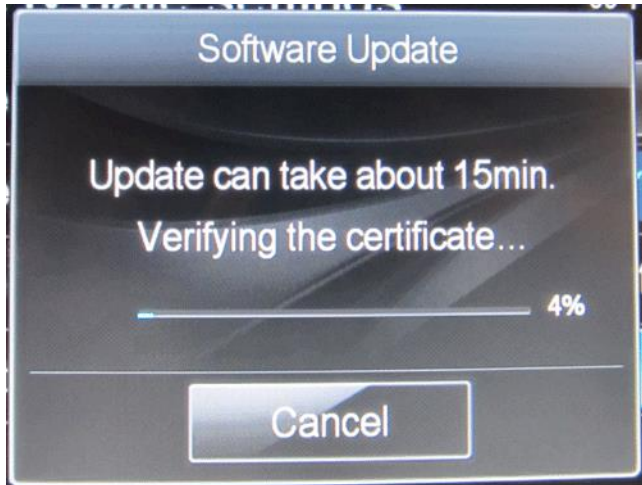
4516358

9. Programming will take several minutes.

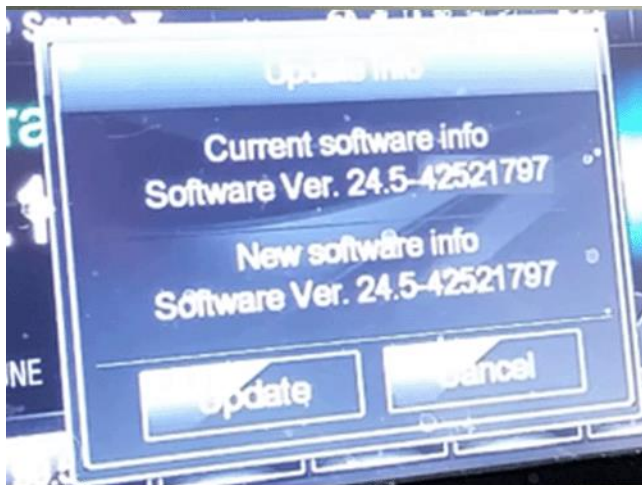
4516359

Note: When USB programming has completed, the radio will go to the Home/Menu screen, and the calibration ID screen will show, confirming the current and new software is now the same. Audio should be playing before removing the USB drive. Select “Cancel” and continue to step 10. (Trax shown as example-Sonic and Spark will be similar).

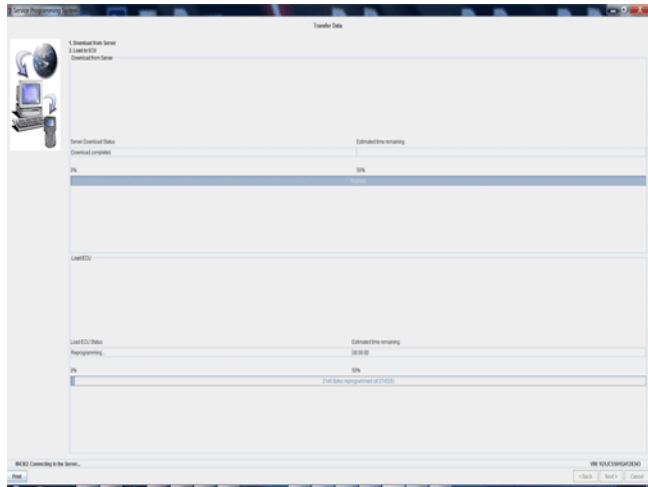
Note: After the radio has completed SPS programming, the radio will restart. DO NOT cycle the key or turn off the radio until audio is heard.
