SAFETY RECALL P082 (NHTSA # 17V015): TAKATA PASSENGER AIRBAG

SERVICE BULLETIN

NO.: SRE17-08

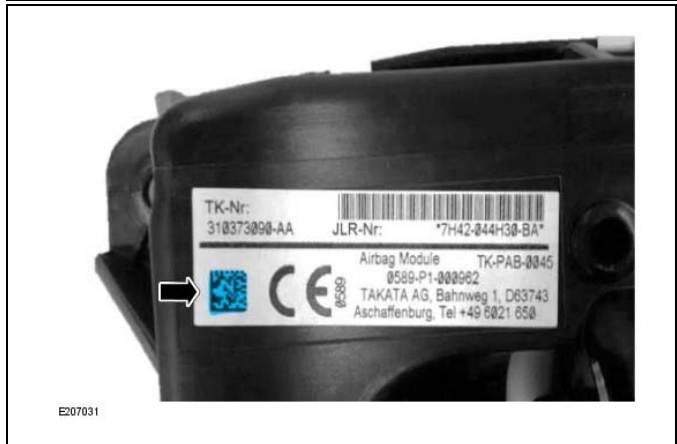
2. Locate the QR code on the NEW passenger airbag module label.
