## newschannel update

| RE: <b>Recall Campaign 2018100009 Takata- Priority Group 5 Phase 2 All Zones Replace Driver-side and Passenger-side Airbags</b> -Certain MY10 W207 (E-Class Coupe), MY08-09 204 (C-Class), and MY 2010 X204 (GLK-Class) vehicles | DATE: October 29, 2018 |

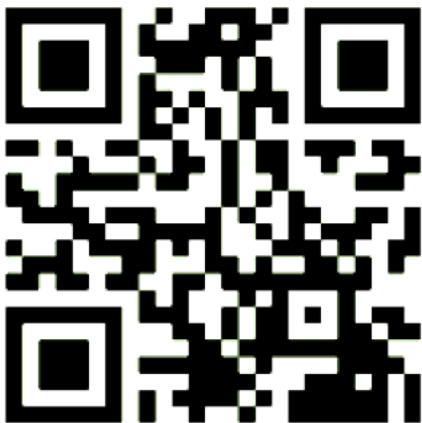
Figure 1

- To install and transmit the data a WiFi connection is required.
- After downloading the App, a one-time security authentication is required by means of encrypted QR code. Verification can be performed by scanning the QR code below, before using the application.

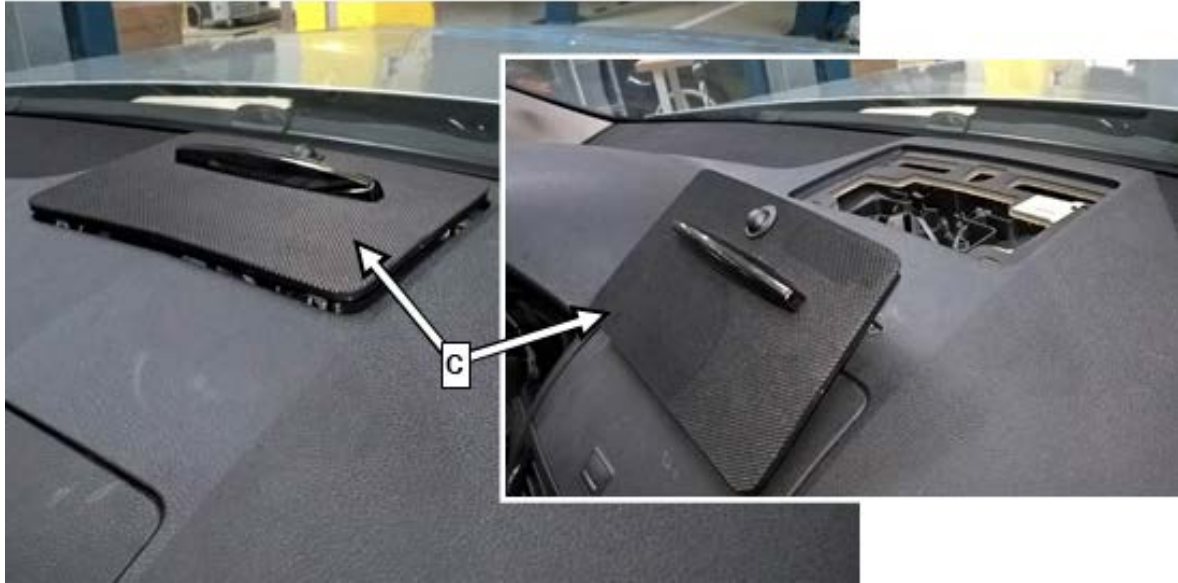
Figure 6

6. Unclip and remove cover (**C**, figure 6) at the instrument panel on top.  
**i** With a sound system, also remove speaker under the cover.

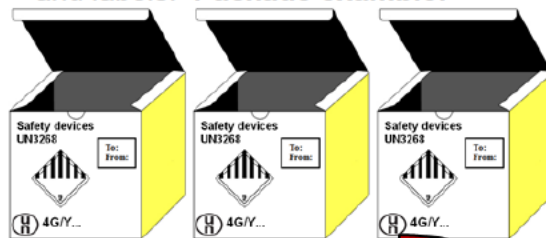
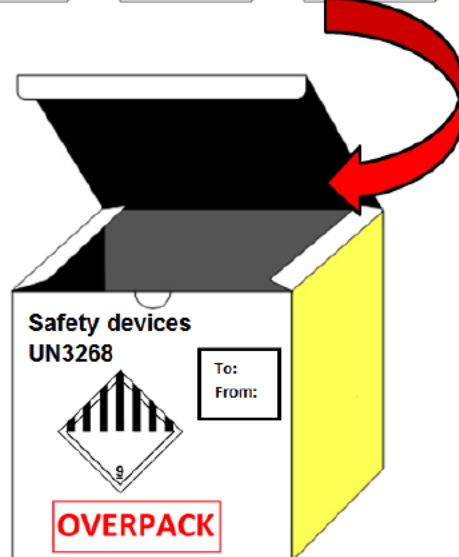
- Package each airbag in a separate UN spec box prepared with the labels/markings described above.
- Place each individual airbag box inside a larger non-UN spec box to keep the shipment together.
- This larger box is called an "OVERPACK."

- The OVERPACK must have the identical markings and label as the boxes contained inside.
- The OVERPACK must have the "OVERPACK" statement on the same face as the hazard markings and labels. **Package example:**
