December 2017
FL745AB
NHTSA #17V-521
Transport Canada #17-407
REVISED NOTICE

Subject: Western Star 4900 Front Springs

Models Affected: Specific Western Star 4900 vehicles manufactured November 18, 2016, through July 21, 2017.

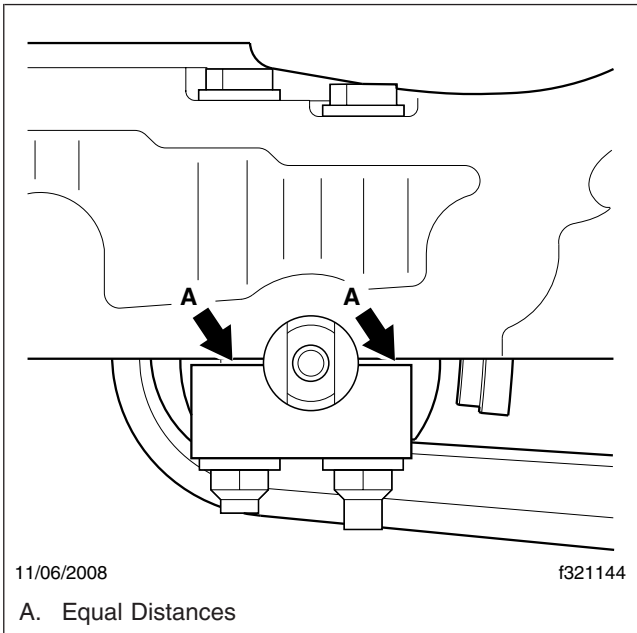
Fig. 2, Spring Drive Bracket and Retainer Installation

- 15.3 Install the retaining bolts down through the spring drive bracket and attach the retainers. Tighten the nuts evenly to maintain equal clearance between the retainers and the spring drive bracket, but do not fully tighten them at this time. They need to be loose enough to adjust. See [Fig. 2](#).
