<b>GROUP</b> <b>Safety Recall Campaign</b>	<b>MODEL</b> <b>2011-2014MY Optima (QF/TF)</b> <b>2012-2014MY Sorento (XMa)</b> <b>2011-2013MY Sportage (SL)</b>
	<b>NUMBER</b> <b>SC147 (Rev 4, 08/07/2017)</b>	<b>DATE</b> <b>June 2017</b>
<b>SAFETY RECALL CAMPAIGN</b>		
<b>SUBJECT: THETA II ENGINE INSPECTION AND/OR REPLACEMENT</b>

This bulletin provides the procedure to inspect, and if necessary, replace the engine long block assembly on the following vehicles:

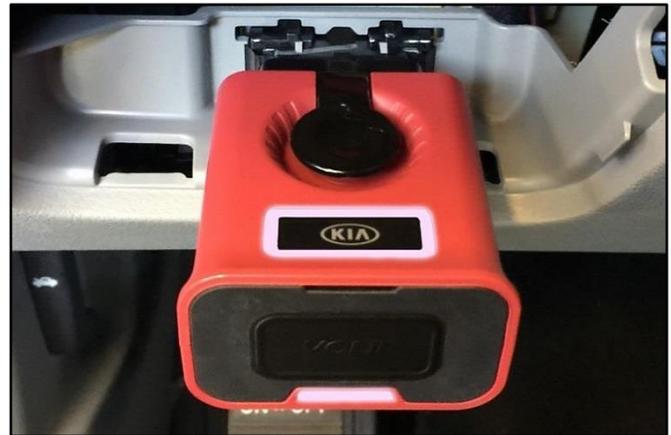
- Connect the VCI-II to the OBD-II connector and launch the KDS application from the KDS tablet home page.

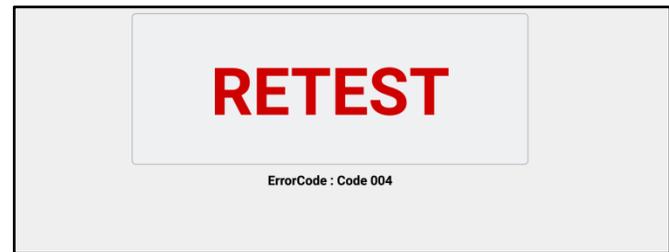
19. After the completion of the engine noise inspection, the KDS will automatically generate/display a “PASS” or “NO PASS” result.

- If the inspection result is “PASS”, proceed to the next step.
- If the inspection result is “NO PASS,” proceed to the replacement procedure on page 9\*.
- If the inspection result is “RETEST” with an error code, see Adapter Error Code chart in Appendix 4 on page 25 for corrective action then repeat the inspection procedure starting from step 9.

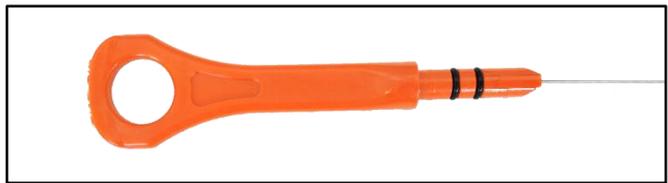
**Orange Dipstick (P/N: 26611 2G050QQK)**

On all vehicles with an inspection result of “PASS”: Change the oil and filter and refill with 5W-30 oil. Use the new (ORANGE) or verified (RED) dipstick to verify proper oil level after oil change and if applicable, reset the maintenance reminder on the instrument cluster.

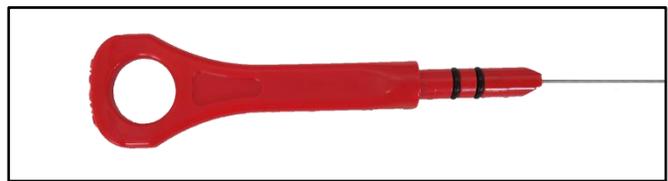
**Red Dipstick (P/N: 26611 2G040)  
(NO REPLACEMENT REQUIRED)**

If the vehicle is equipped with a RED dipstick, replacement is not necessary.

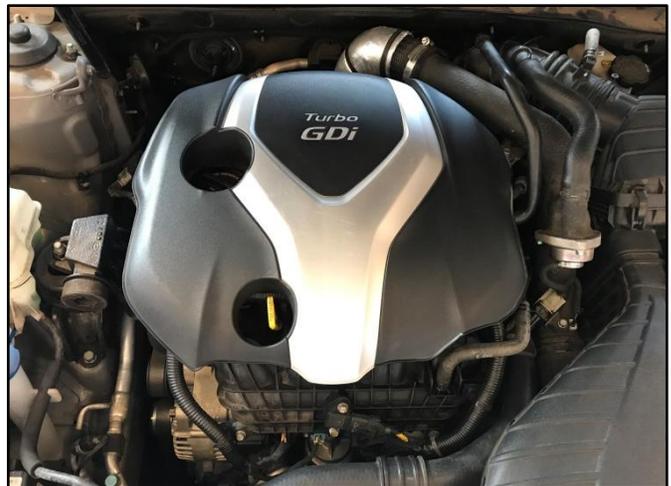
1. Remove the engine assembly by referring to the “Engine And Transmission (Transaxle) Assembly → Engine And Transmission (Transaxle) Assembly → Repair procedures” chapter in the applicable Shop Manual on KGIS.

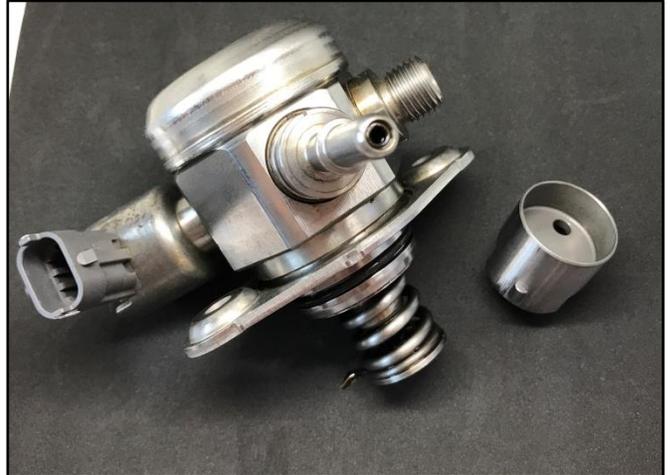
High Pressure Pump & Roller Tappet:

**Tightening torques of pump bolts:**  
 9.4 – 10.9 lb.ft (12.8 – 14.7 N.m,  
 1.3 – 1.5 kgf.m)

**Tightening torques of pipe flare nut:**  
 19.5 – 23.9 lb.ft (26.5 – 32.4 N.m,  
 2.7 – 3.3 kgf.m)
